Re: Permit No. M-1980-244; Cripple Creek & Victor Gold Mining Company; Cresson Project; Technical Revision 135 – Initial Adequacy Review Response

**VALLEY LEACH FACILITY 2
PHASE 3 STAGE A.1
RECORD OF CONSTRUCTION REPORT
REVISION-1**

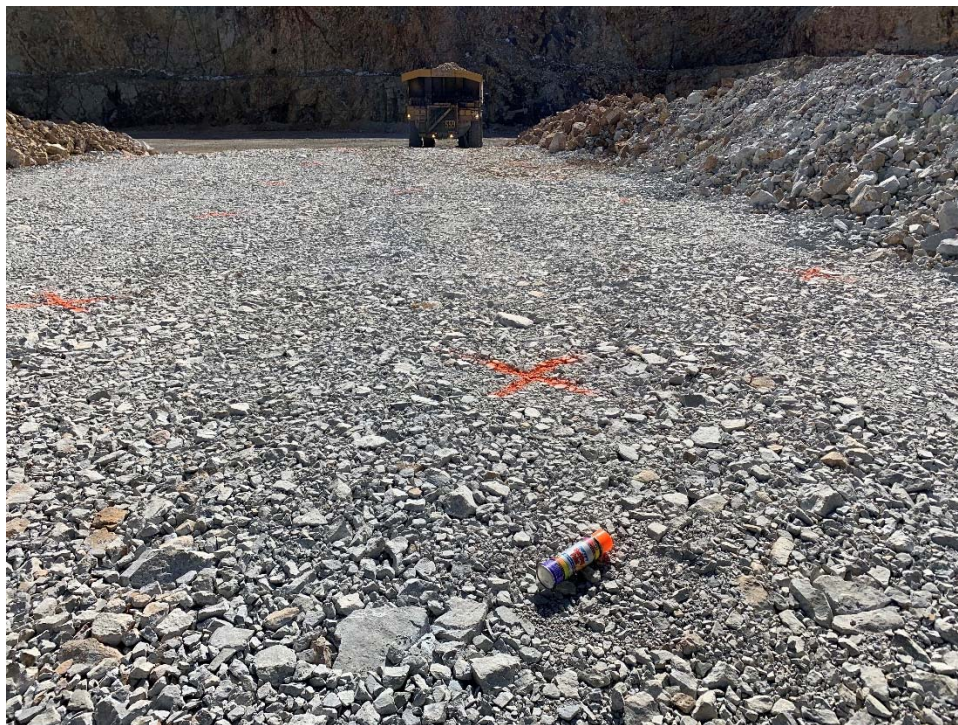
October 18, 2021 – High Compaction Backfill Test Pad surface after wheel rolling with paint can for scale (TW)

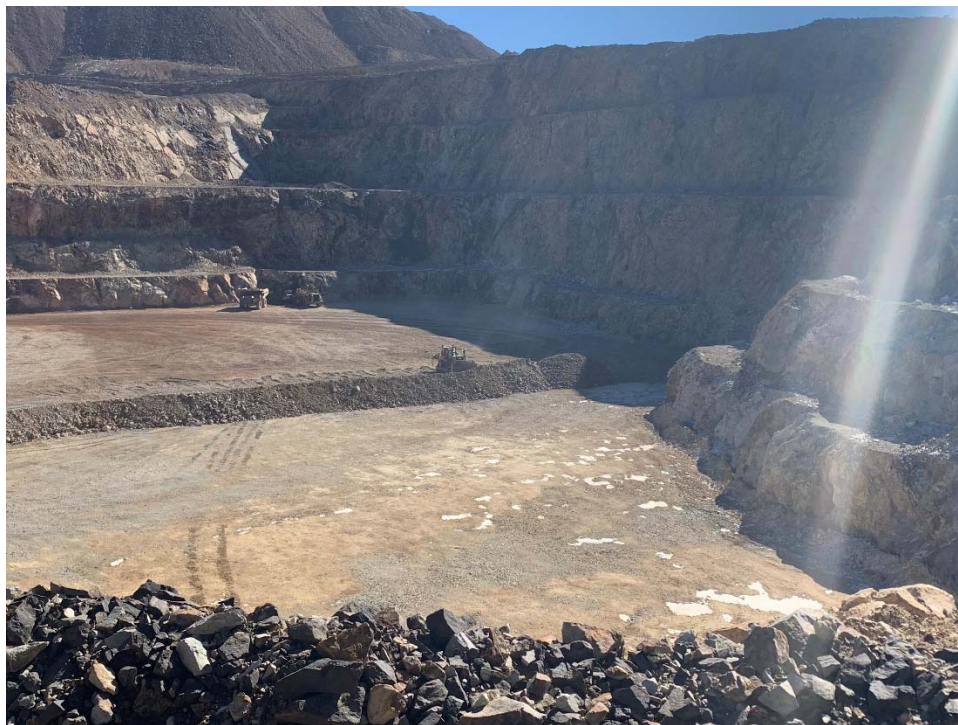
October 26, 2021 – High Compaction Backfill oversized material removal (TW)

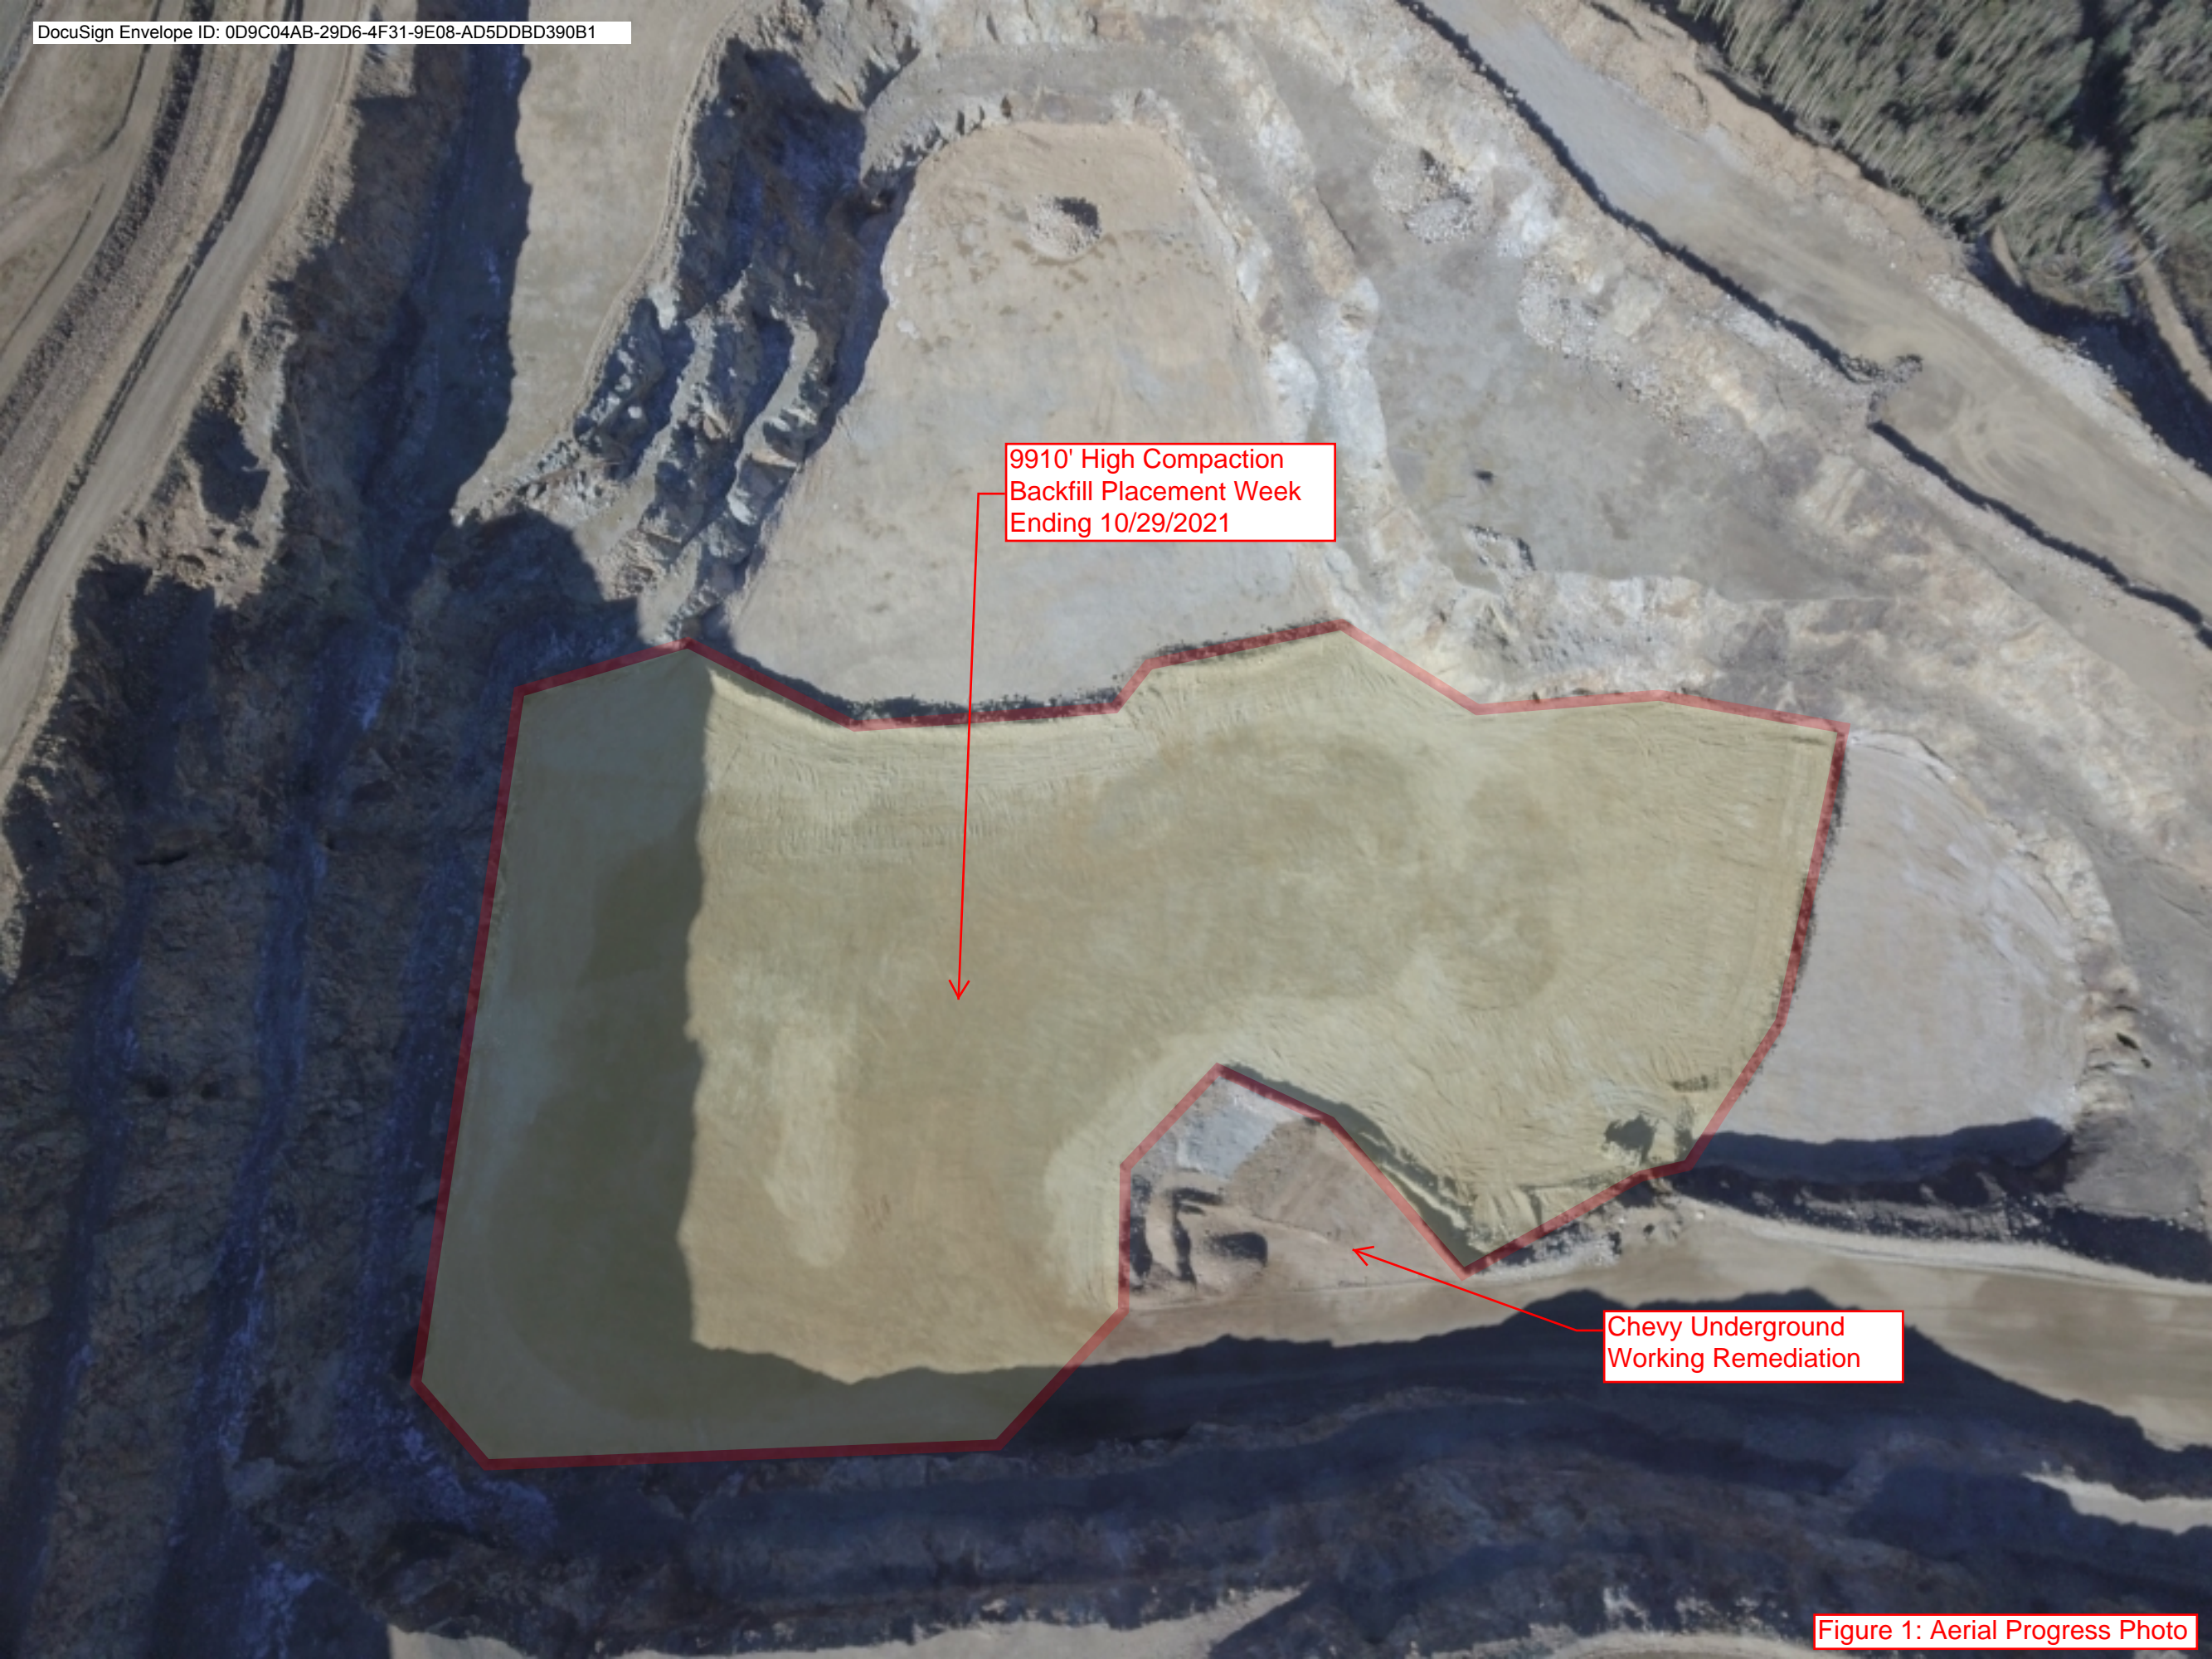
Figure 1 – High Compaction Fill Progress Aerial Photo

9910' High Compaction
Backfill Placement Week
Ending 10/29/2021

Chevy Underground
Working Remediation

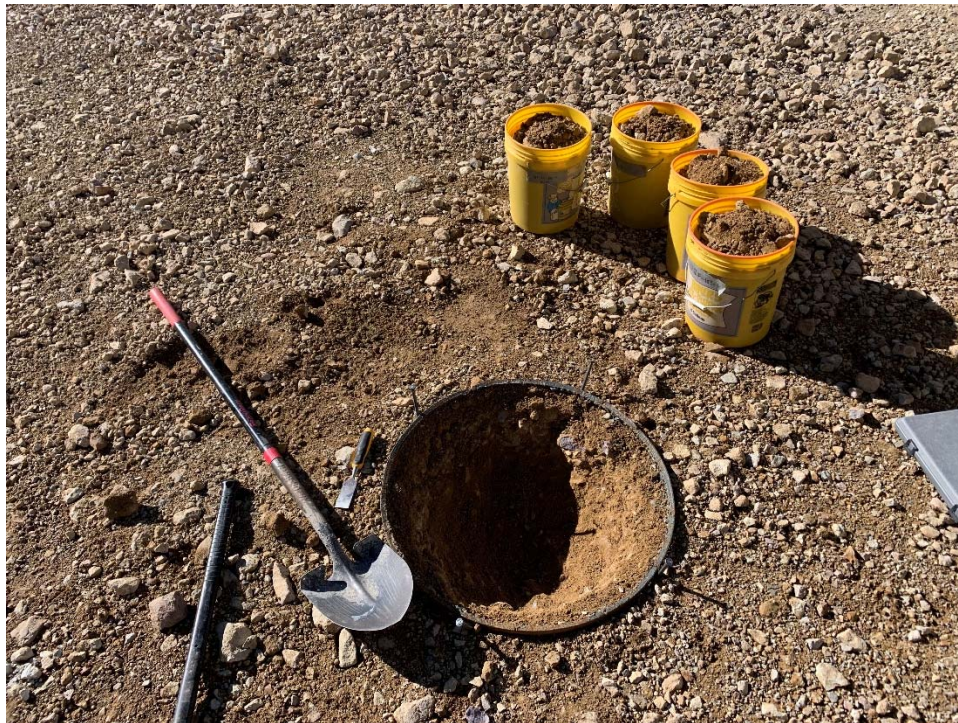
November 11, 2021 – High Compaction Backfill water volume replacement excavation (TW)
