M-1997-081 Everhart Pit

RE: M-1997-081 Everhart Pit

EXHIBIT 1

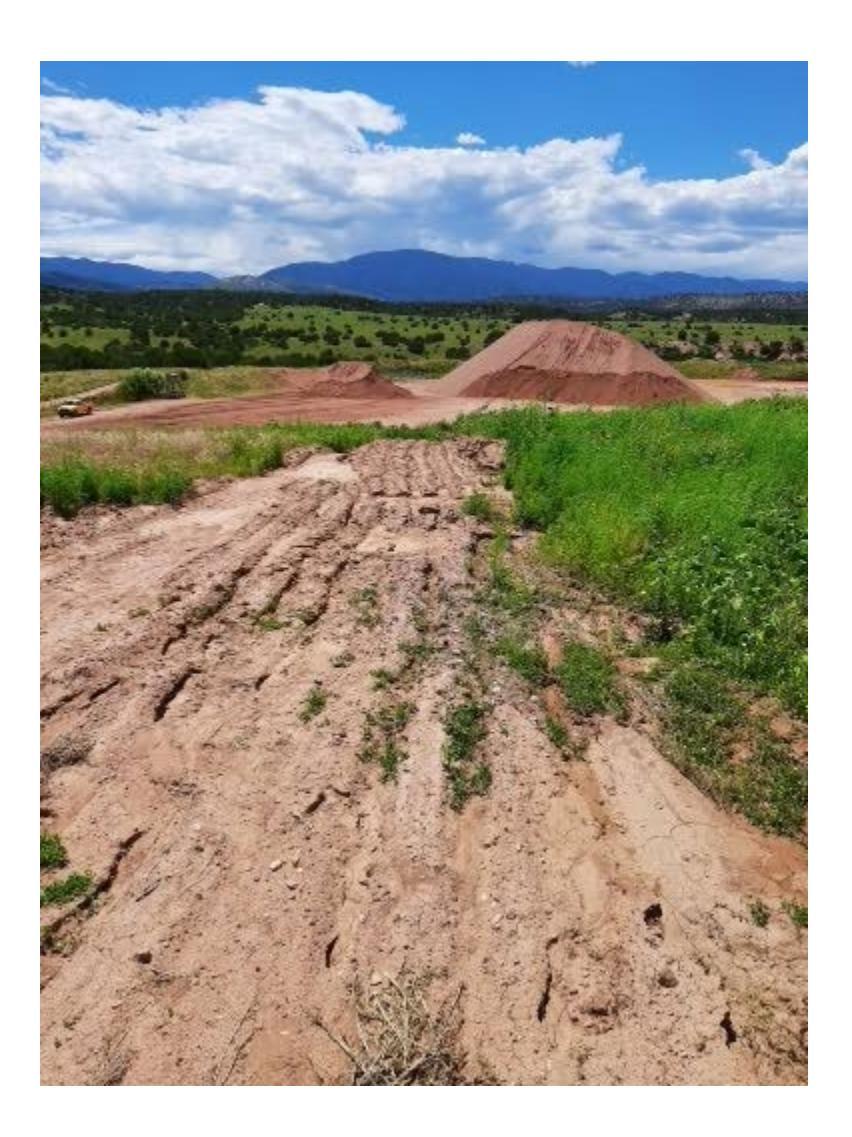
We have been diligently working to make the repairs noted above. Due to the many rainstorms, our work is continually being washed away. Please see attached Exhibit 1 that depicts our attempts at again trying to fill in the gullies and ruts after a rainstorm. The storms have washed away many of our roads and our Road and Bridge team has been trying to make repairs due to public safety. Due to our team devoting their time on repairing our roads that are closed we have been limited to the number of team members that can work at the site. We respectfully request an extension of 30 days due to the prediction of rainstorms this weekend and to allow the site to dry out before we attempt to repair the erosion gullies and ruts.

This area was repaired but washed out after last weekend's rainstorm.

CORRECTIVE ACTIONS: The Operator shall provide photo documentation to the Division verifying erosion gullies and ruts have been repaired, and that the site has have been reconstructed and stabilized to prevent erosion damage by the corrective action date.

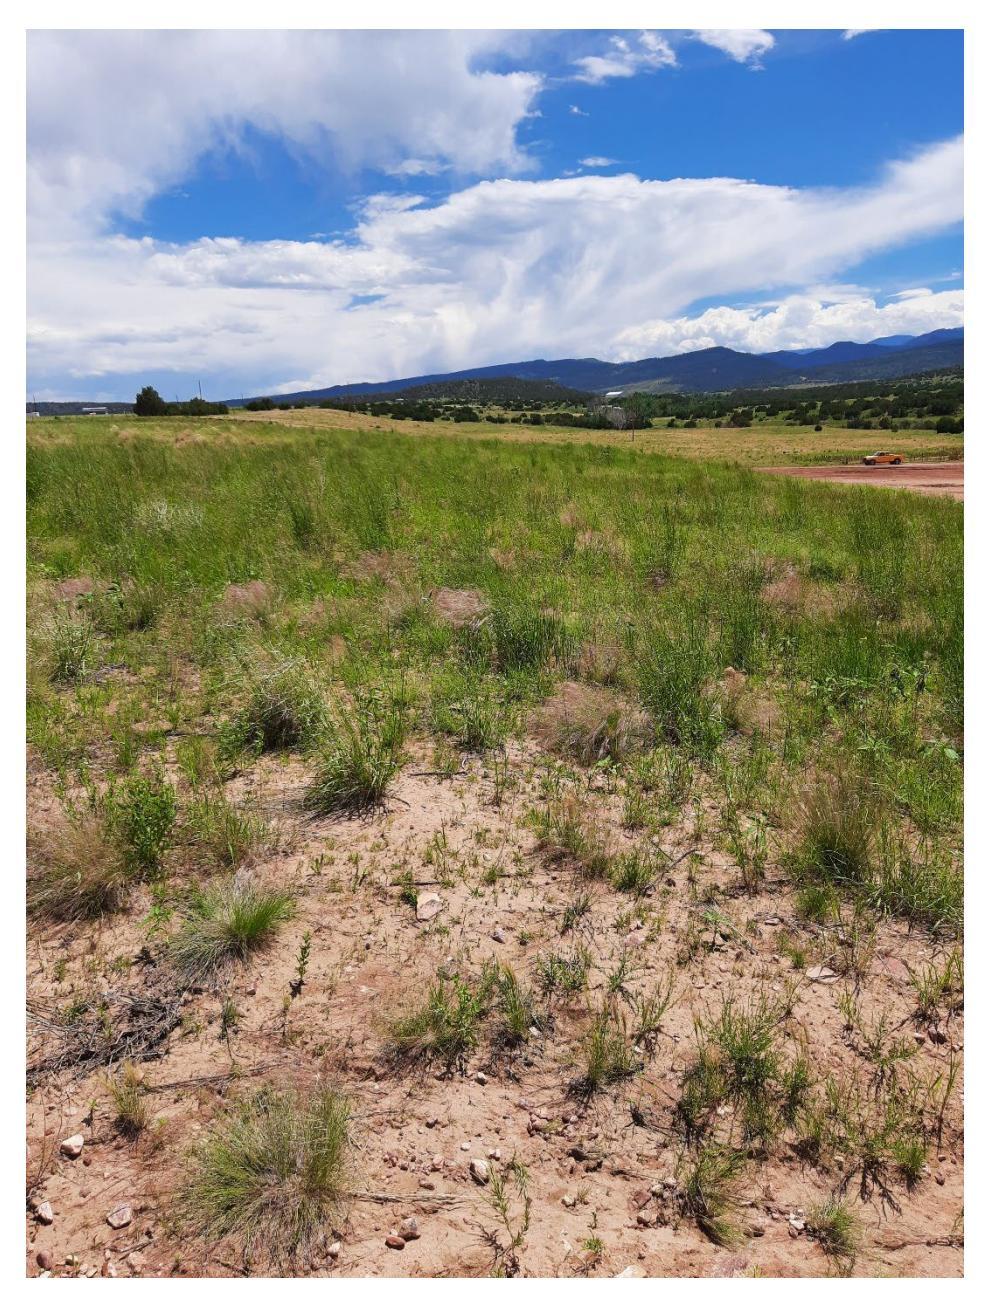
EXHIBIT 2 PAGE 2

Existing vegetation looking south at south boundary line.

The Re-Vegetation of impacted area has commenced. The first step towards corrective action will be to use stockpiled overburden (topsoil) over the face of the effected area. The soil will be at least 6 inches deep. The reason for this is to provide the best growing conditions and nutrients to encourage germination. Also, topsoil this deep also provides better bonding to subsoil. After this is complete, we will use a seed blend of side oats grama, switchgrass, little bluestem, blue grama and sand dropseed. These are native species and should thrive in this environment. We plan to Hydro mulch this area and schedule a water truck to water the seed to encourage germination. If you should have any questions, please feel free to reach out and give us a call.

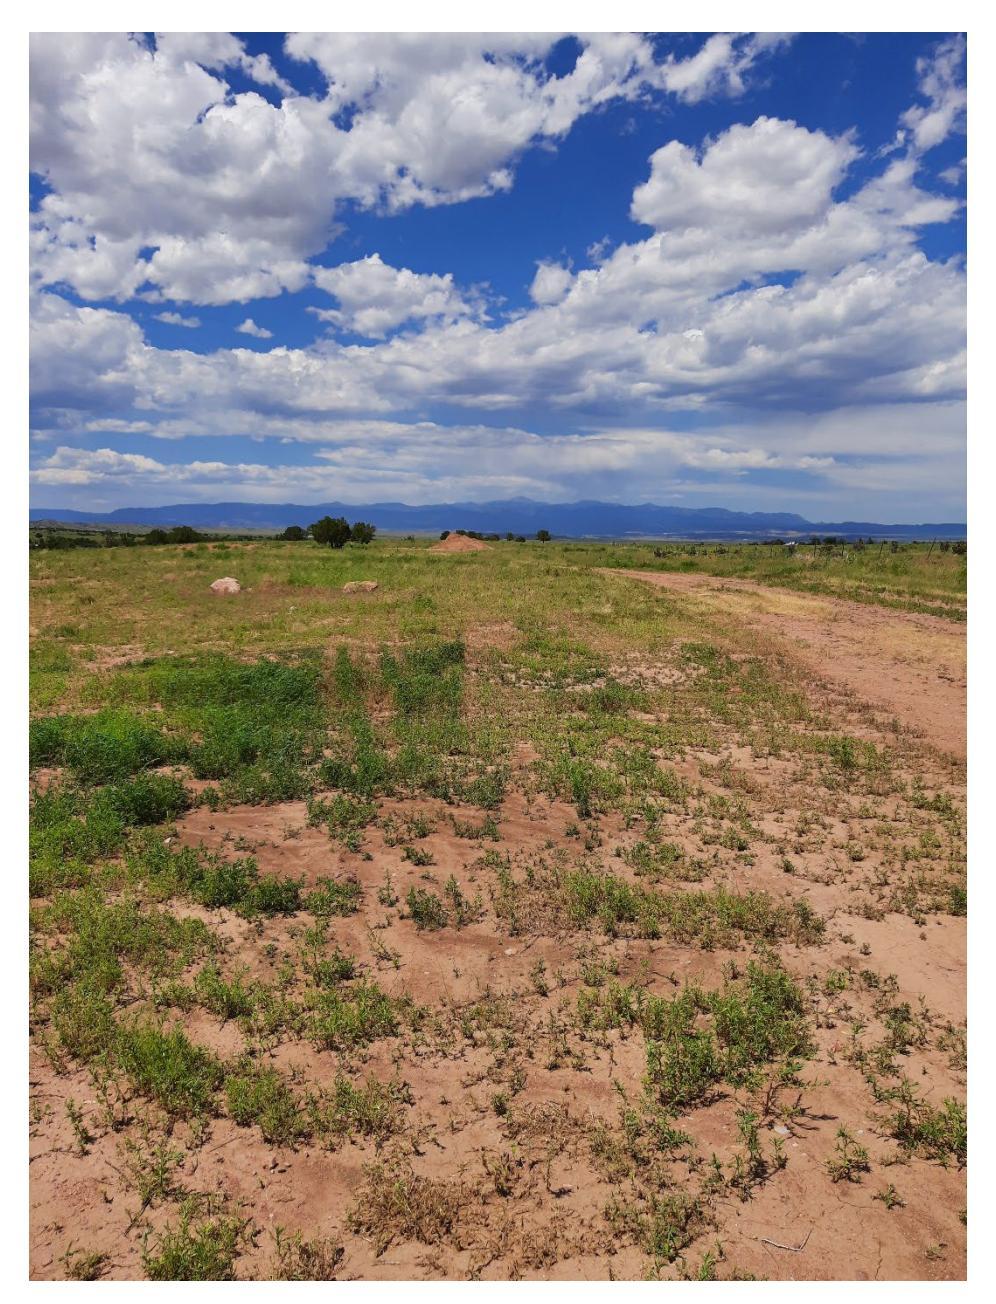
EXHIBIT 2 PAGE 3

Existing vegetation looking northeast from the southeast corner.

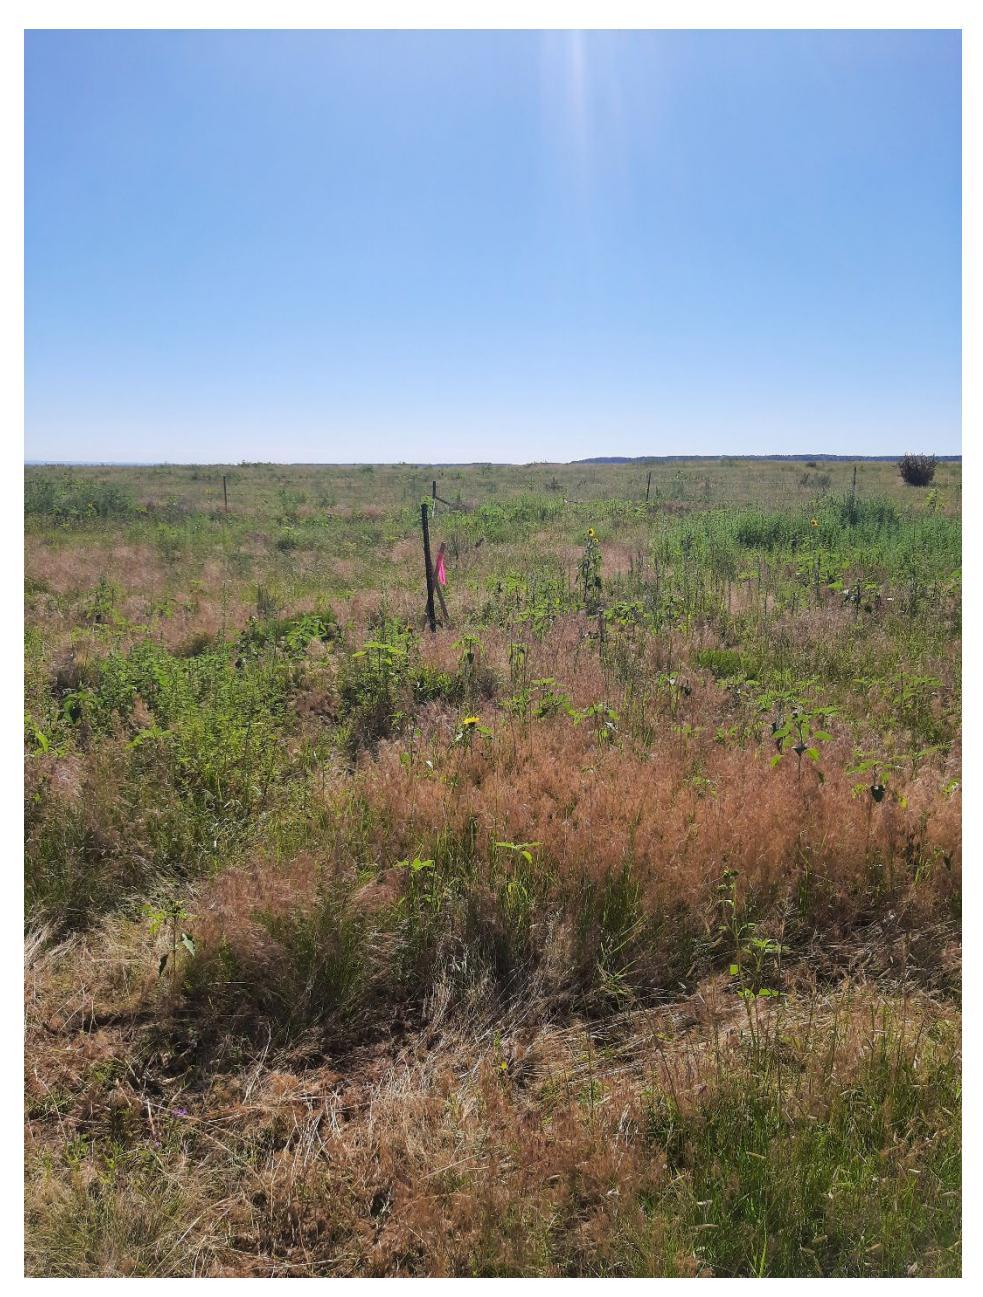
EXHIBIT 3 PAGE 1

Northeasterly corner of the mine area set with a t-post.

Our surveyor for Roads and Bridges visited the site and set the 150-foot buffer and the mine area boundary. See attached Exhibit 3. The mine area contains approximately 10 acres and will be depicted on next year's annual report map.

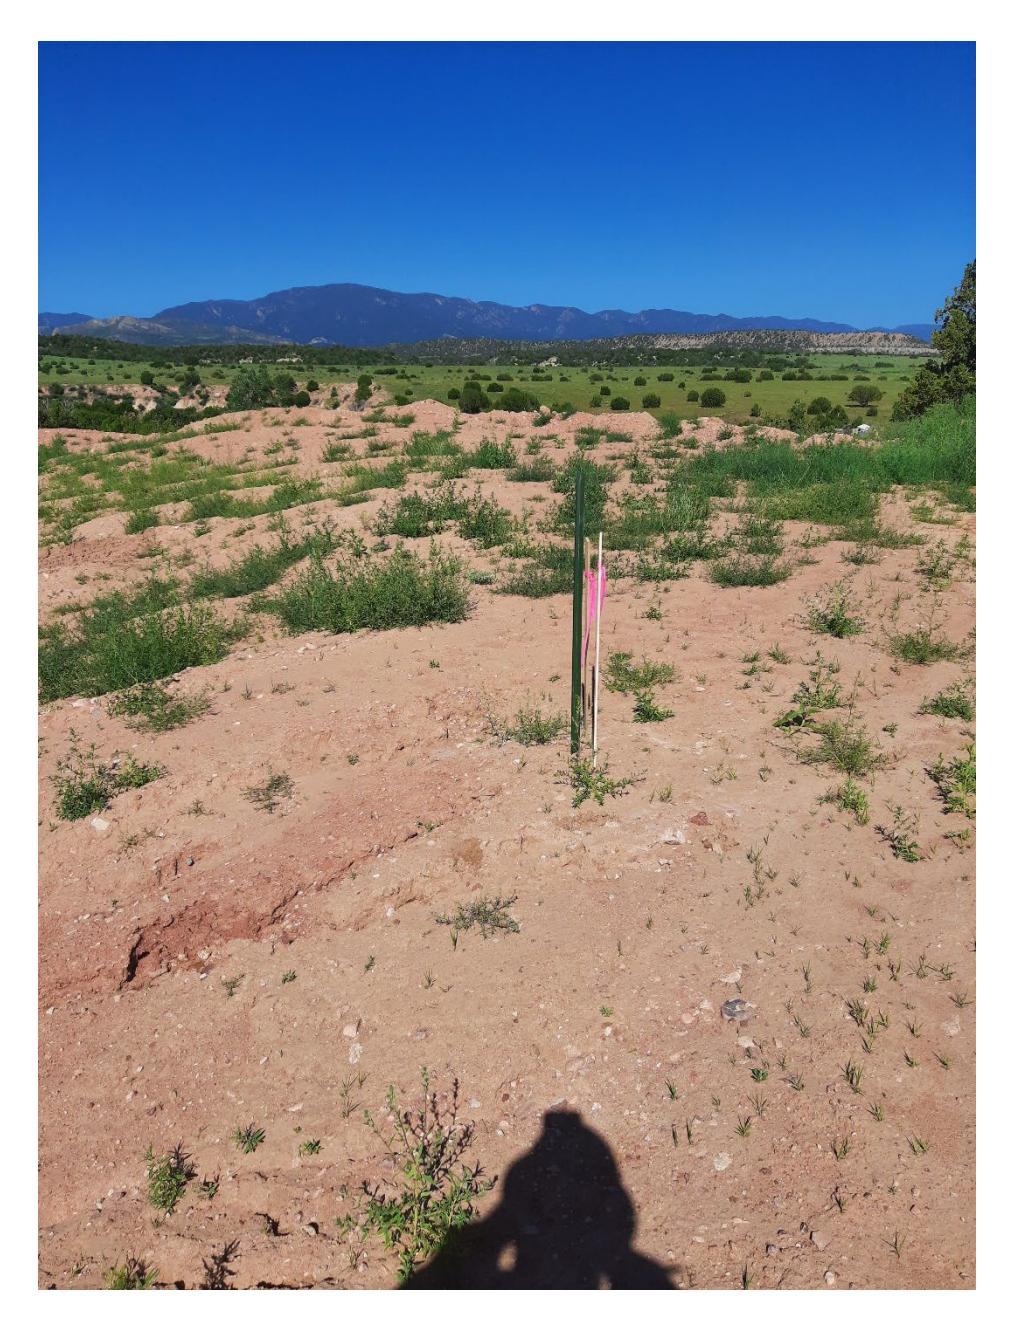
EXHIBIT 3 PAGE 2

North center of the mine area also being the 150-foot buffer set with a t-post.

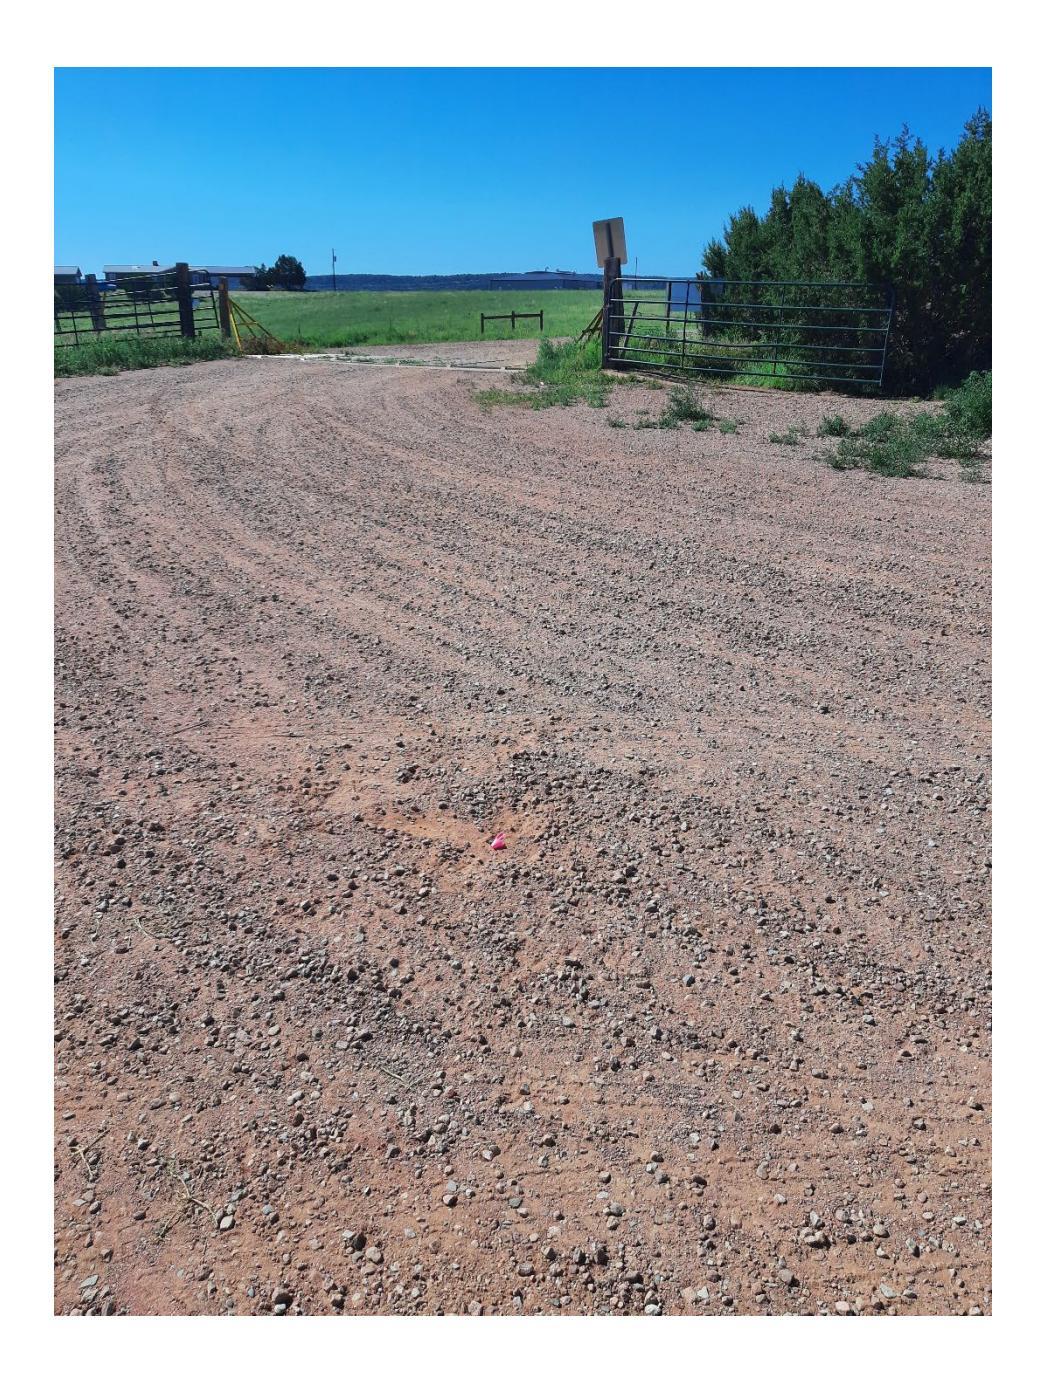
EXHIBIT 3 PAGE 3

Southeast corner of the mine area set with a 5/8" rebar 16" long.
