Inspection Report, HGLO, C-1992-081

Permit Number: C-1992-081 Mine Name: Hayden Gulch Loadout Operator: Hayden Gulch Terminal, LLC Operator Address: Ms Miranda Kawcak 29515 Routt County Road 27 Oak Creek, CO 80467 County: Routt Operation Type: Loadout Permit Status: Active Ownership: Private

Inspection Start Date: July 18, 2023 Inspection Start Time: 13:30 Inspection End Date: July 18, 2023 Inspection End Time: 14:00			Inspection Type: Coal Partial Inspection Inspection Reason: Normal I&E Program Weather: Clear
Joint Inspection Agency:		Joint Inspection Contacts:	
None			
Post Inspection Agency:		Post Inspection Contacts:	
None			
Inspector(s):	Inspector's Signature: Signature Date:		
Hunter Ridley	Hunter Ridley July 27, 2023

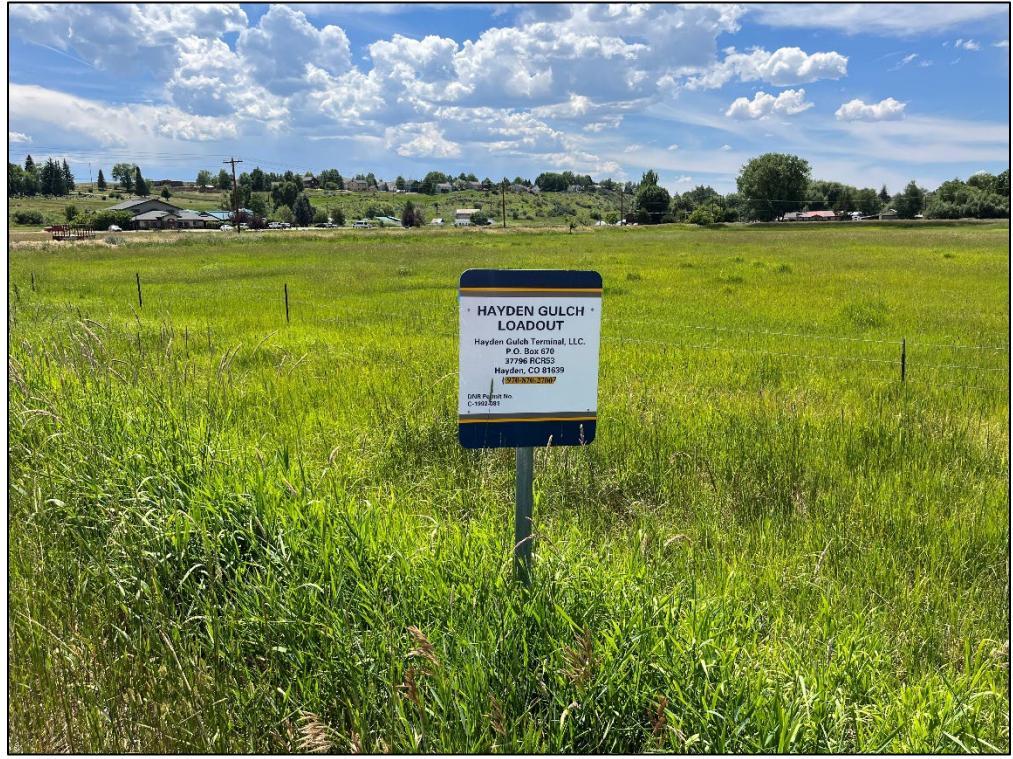
Mine identification markers were observed at the entrance to the unreleased haul road and adjacent to the unreleased agricultural section north and south of Hwy 40 (Photos 1 and 2).

Photo 1: Mine signage located at access road to the site at the intersection of Highway 40 and Hawthorne St.

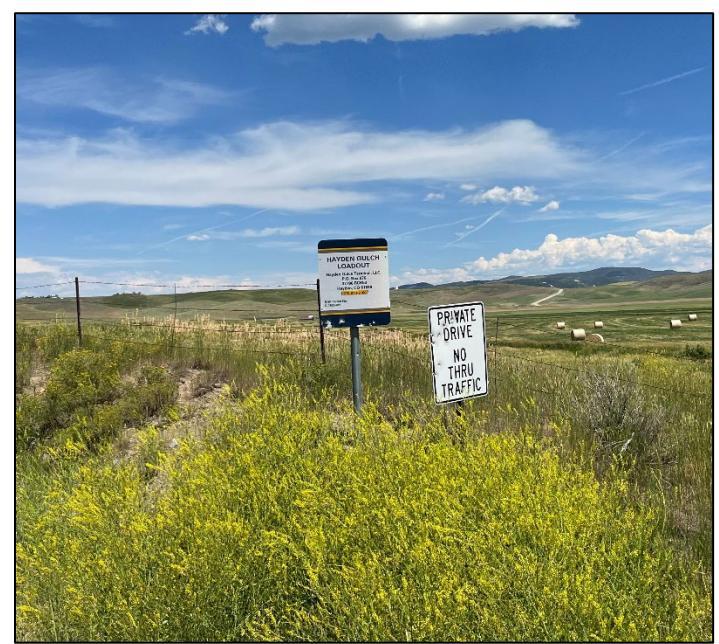
Photo 2: Mine signage posted at the western edge of the site's haul road which intersects with County Road 53.

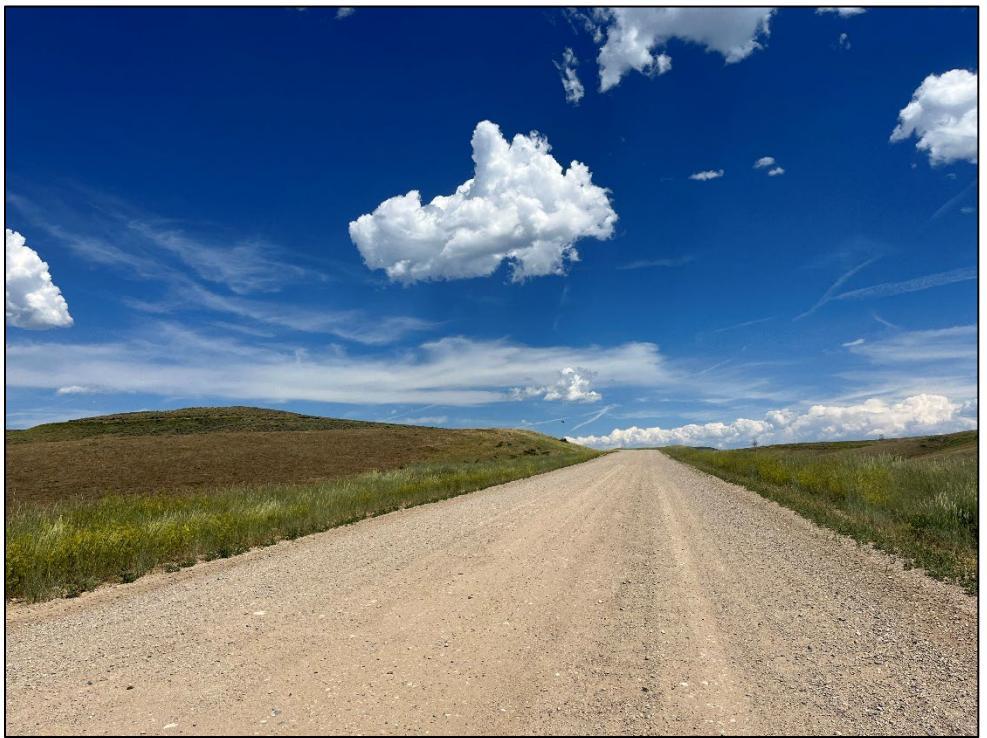
The haul road was well maintained and free of erosional features (Photo 3). This haul road and its associated permanent topsoil pile features to the east will be ready for release this year (Photo 7).

Photo 3: View east of the eastern end of the site's haul road.

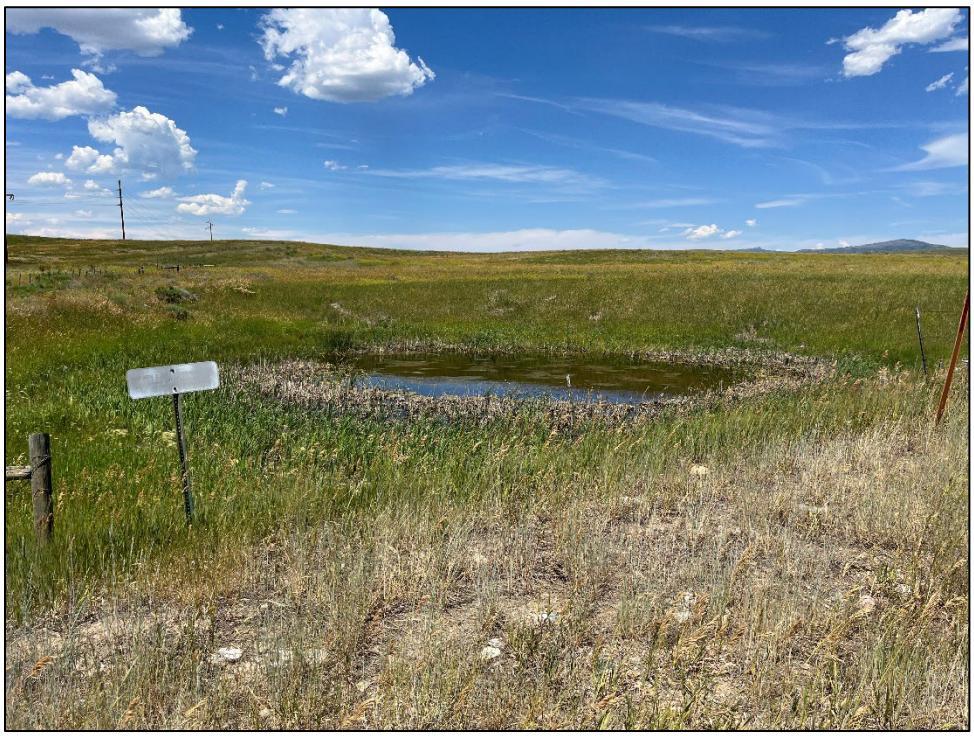
Truck Loop Pond 001 and Rail Loop Pond 002 were both full and functioning properly. Rail Loop Pond 002 is accessed by walking a portion of the Sage Creek Trail located on the site's previously released acreage. Truck Loop Pond 001 is accessed from the side of the southern unreleased haul road (Photo 4).

Photo 4: Truck Loop Pond 001 located on the western side of the site's previously released acreage.

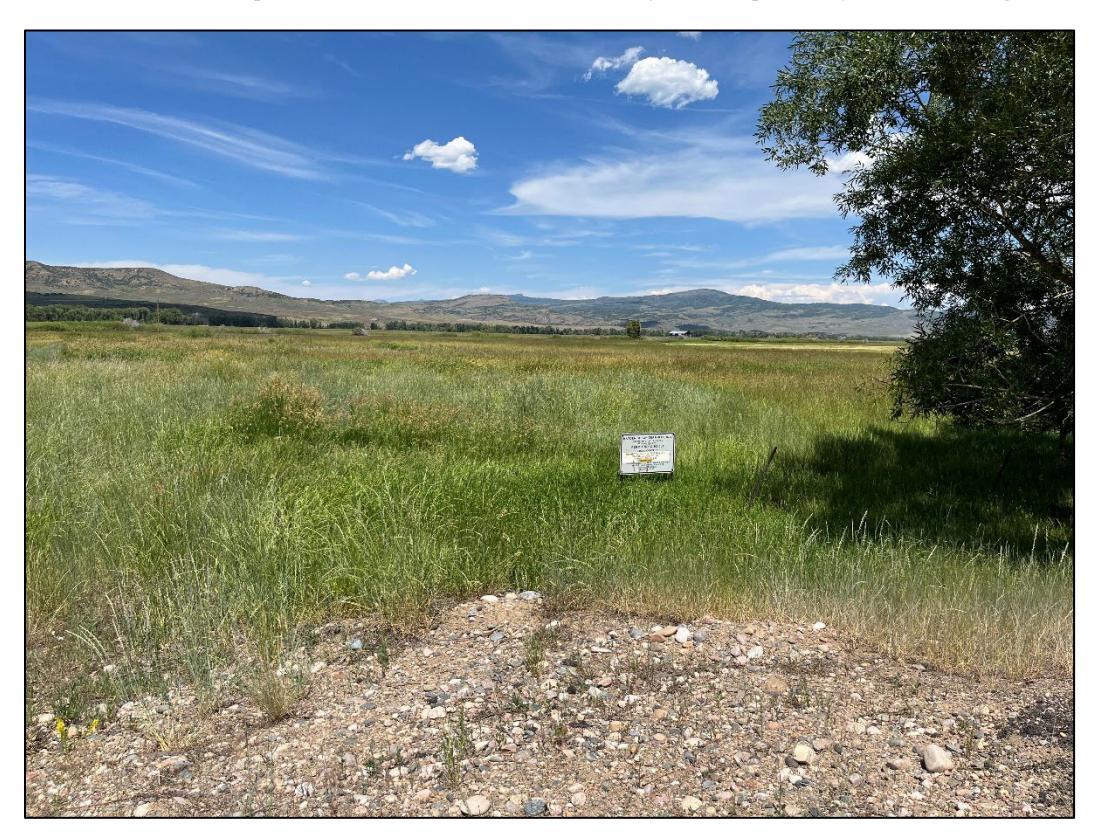
The remaining permit area North of Hwy 40 was well vegetated. This portion of the permit is planned to be incorporated into adjacent hay fields. Inspection contact stated previously that they are aiming to release this final area in the current year (Photos 5 and 6).

Photo 5: Unreleased acreage on the northern side of Hwy 40.

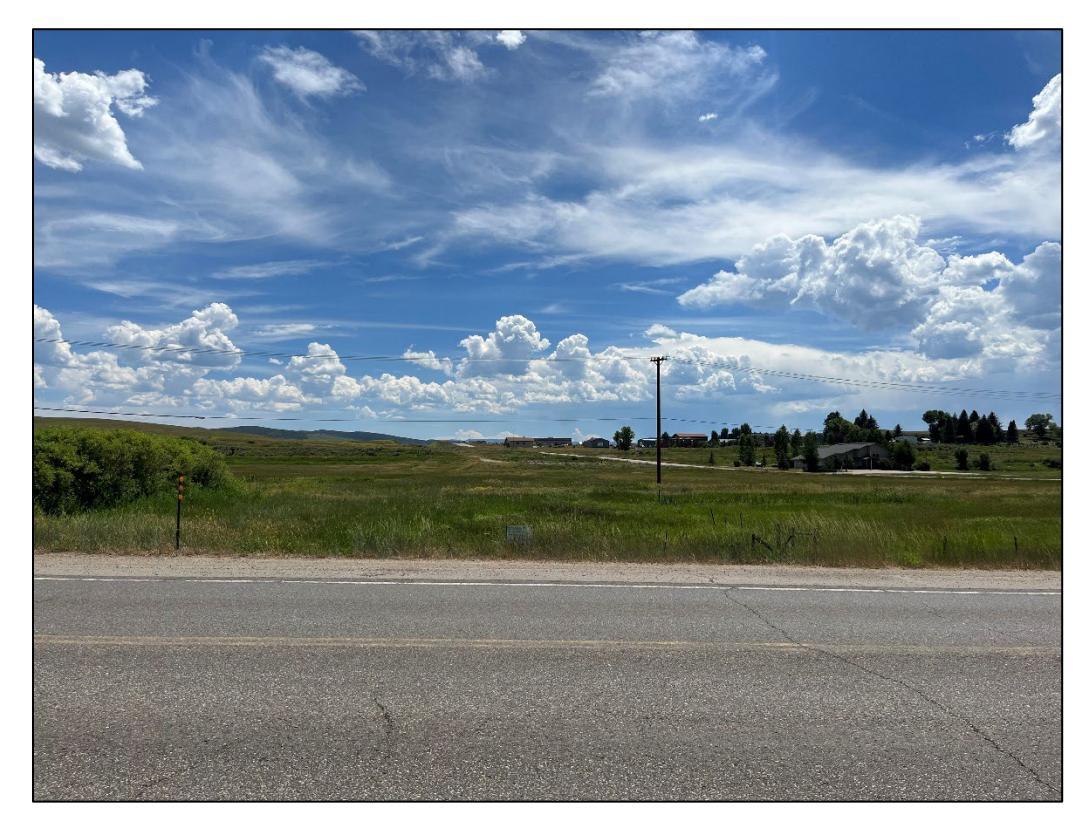
Photo 6: Unreleased agricultural acreage on the south side of Hwy 40.

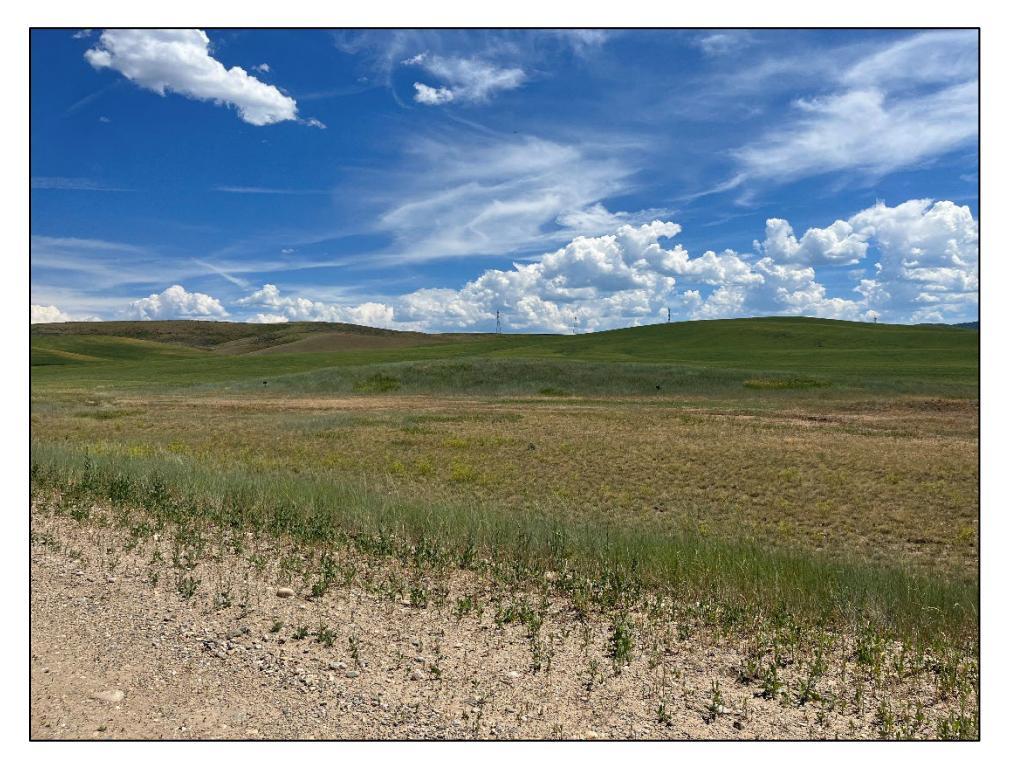
Photo 7: Permanent topsoil pile feature along the haul road.
