The Division of Reclamation, Mining and Safety has conducted an inspection of the mining operation noted below. This report documents observations concerning compliance with the terms of the permit and applicable rules and regulations of the Mined Land Reclamation Board.

- Attachments: 1. Approved Reclamation Plan Map TR-1
 - 2. SWSP Kirtright Pit Map
 - 3. Aerial Permit Map 2023
- cc: Jared Ebert; DRMS
- ec: Richard Coulson, Coulson Excavating Company, Inc., <u>caitlyn@coulsonex.com</u> Ken Coulson, Coulson Excavation Company, Inc., <u>ken@coulsonex.com</u> Peter Wayland, Weiland, Inc., <u>pwayland@weilandinc.com</u>

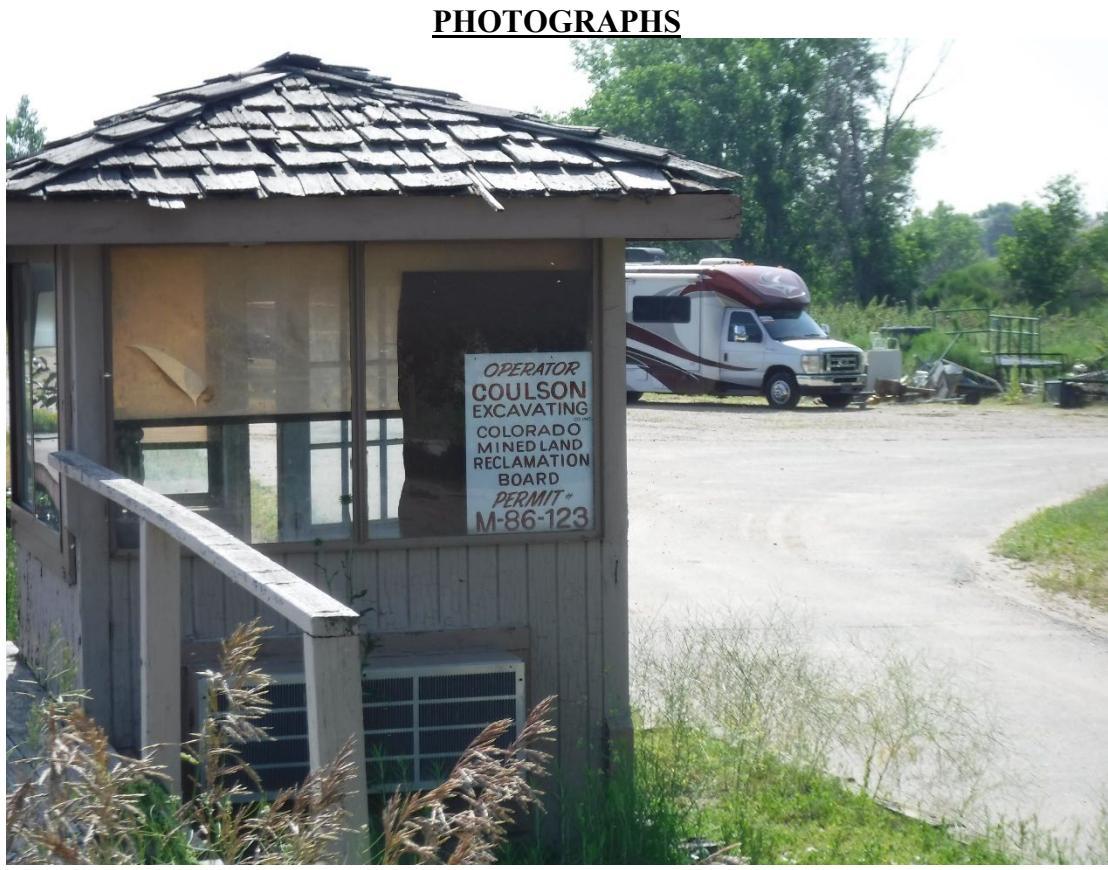
Photo 1: Mine sign at primary mine entrance

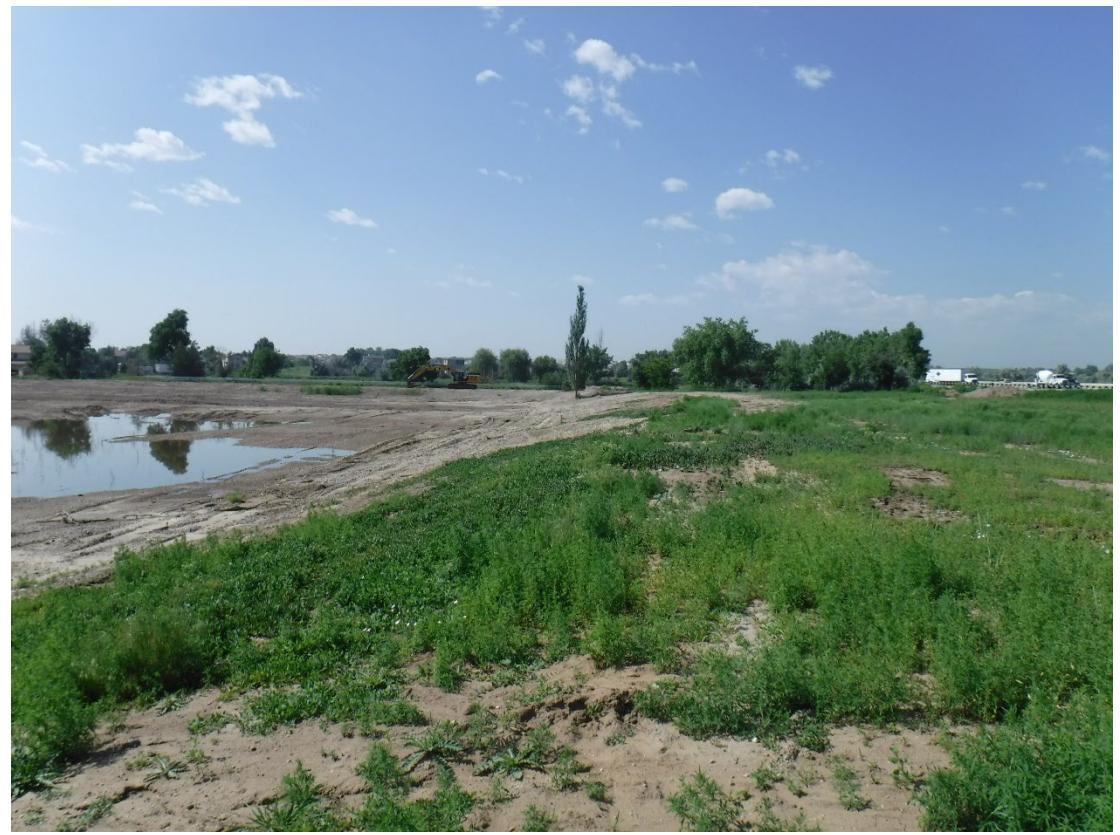
Photo 2: Looking south along an overburden stockpile adjacent to western permit boundary

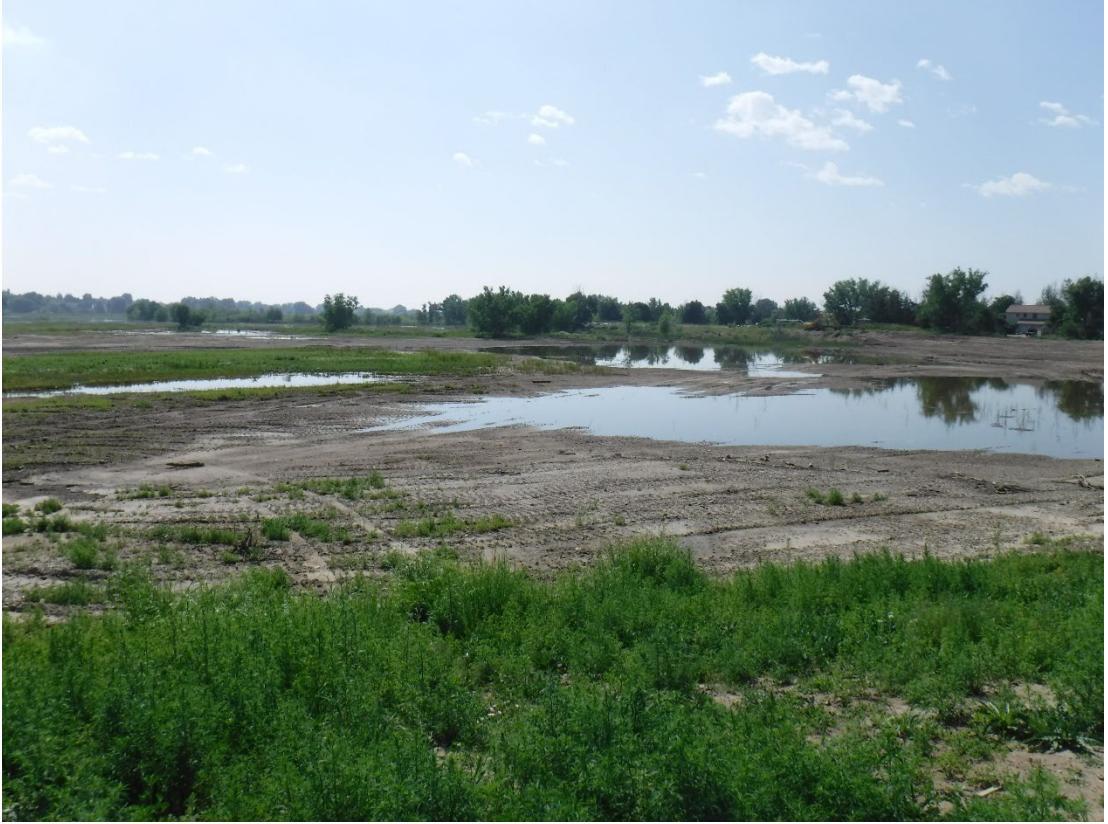
The site was not active at the time of inspection but recent grading disturbances were visible. The Operator indicated that they were grading and filling in ponds located in the northwest quadrant of the permit area with material located along the western and northern permit areas and removing material from the southwestern area of permit adjacent to the Pre-1981 pond. The Operator stated that this activity was being done to help the permanent augmentation plan for the site by filling in the Pond 1 area (Attachment 2). A review of aerial imagery after the inspection it was determined that during the course of grading at the site the Operator has affected approximately 4.7 acres outside the approved permit boundary, Attachment 3. From observation made during the inspection the land outside the permit boundary appears to have been stripped of material using a dozer that then pushed that material into the permit area to fill Pond 1. Also, the dozer may have scraped material into a pile that then was loaded in haul trucks, using an excavator, which then hauled the material to the fill area. At the time of inspection the land was bare and consisted heavy equipment tracks. The land has been disturbed as a result of reclamation activities associated with a mining operation. The land affected outside the permit boundary, approximately 4.7 acres, is being cited as a Possible Violation pursuant to C.R.S. 34-32.5-109(1) for failure to first obtain a reclamation permit before engaging in a mining operation and will require a hearing before the Mined Land Reclamation Board.

Photo 3: Looking east across the backfilled location of the Pond 1 area

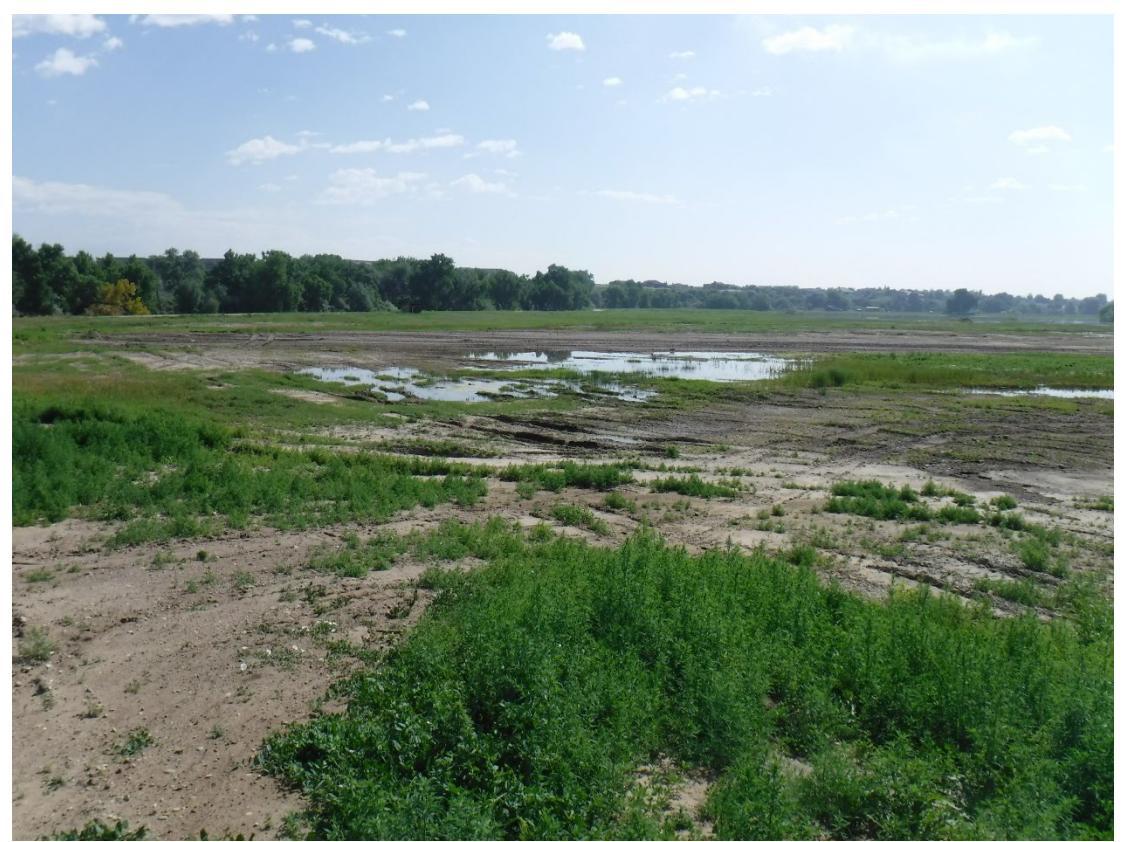
POSSIBLE VIOLATION: Land has been affected outside of the approved permit boundary. This is a possible violation at this time pursuant to: 1.) C.R.S. 34-32.5-109(1) for failure to first obtain from the board or office a reclamation permit prior to engaging in a new operation.

Photo 4: Looking northeast across the area that is located north of the approved permit boundary used to source fill material for the Pond 1 area

CORRECTIVE ACTIONS: This possible violation will require a hearing before the Mined Land Reclamation Board (MLRB). The schedule and other details for the MLRB hearing will be provided under a separate document to be sent via certified mail to the operator.

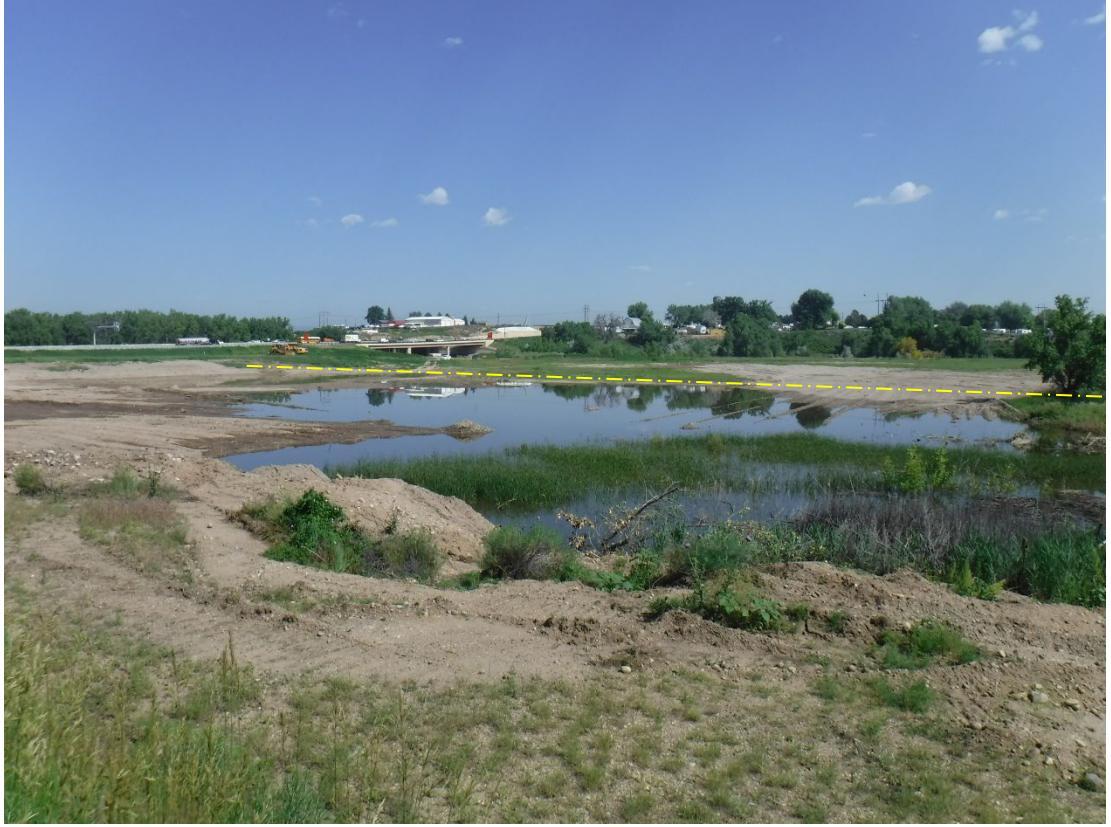
Photo 5: Looking north across the graded area, yellow line approximate permit boundary

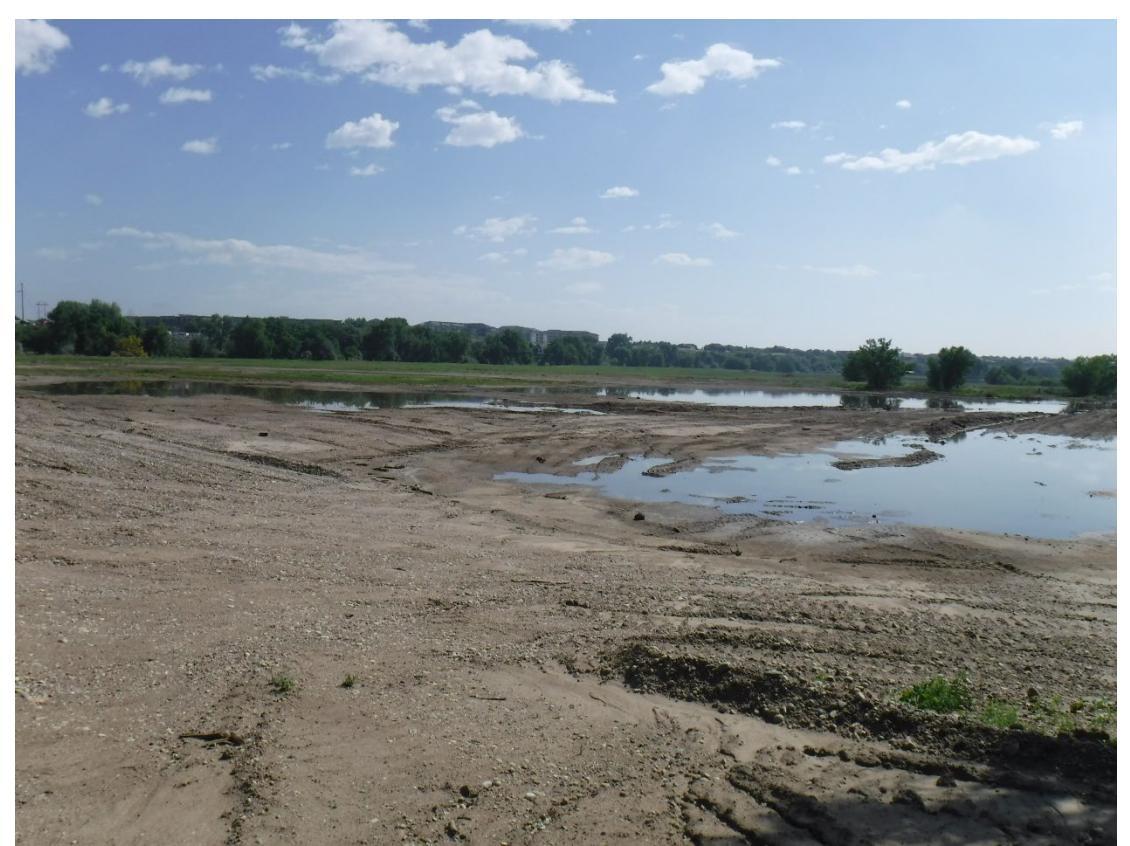
Photo 6: Looking east across the filled Pond 1 area

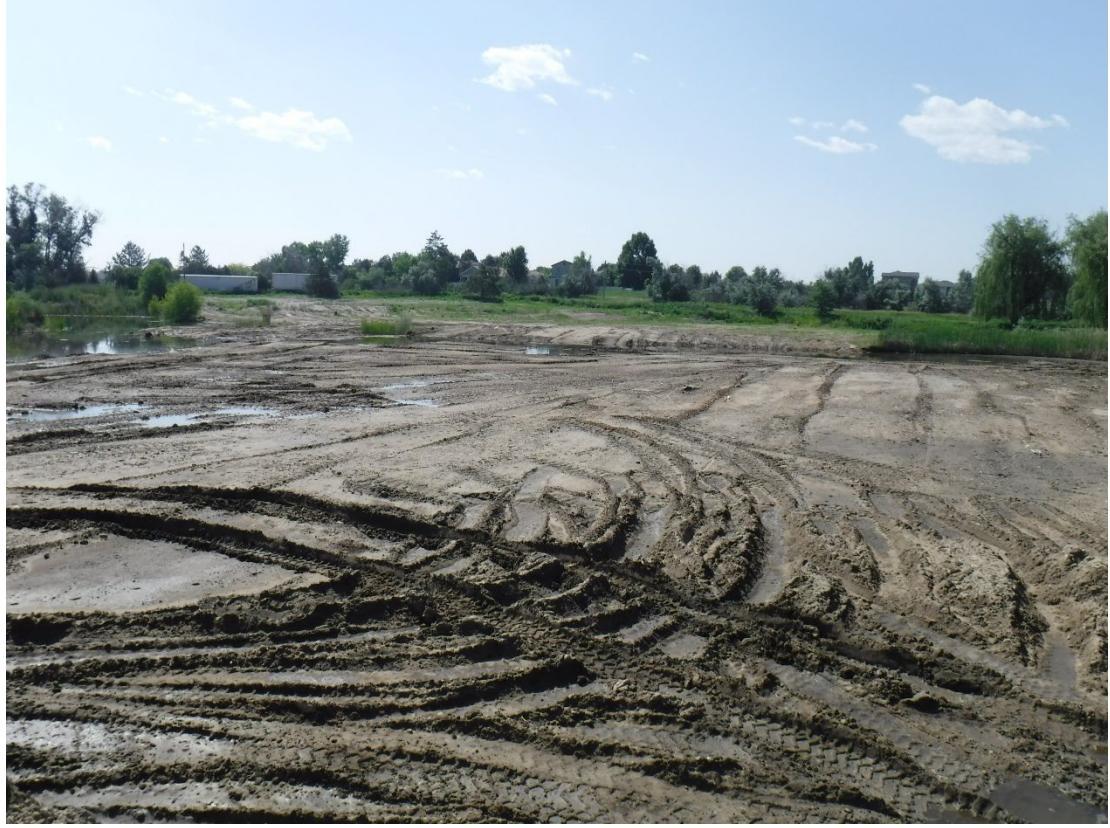
It appears the removal of material from the southwestern area may be enlarging the Pre-1981 pond area beyond the approved 0.76 acres in the current SWSP. The Division estimates the pond area to be approximately 1.2 acres in size. The island areas are about 0.17 acres in size thus indicating the Pre-1981 pond is now approximately 1 acre in size. The Division contacted the Department of Water Resources (DWR) regarding the increase in pond size. DWR stated that as long as the Operator accounts for the increase in pond size during renewal of the SWSP there is no further action required.

Photo 7: Southwestern quadrant area, west of the Pre-1981 Pond, used to source fill material

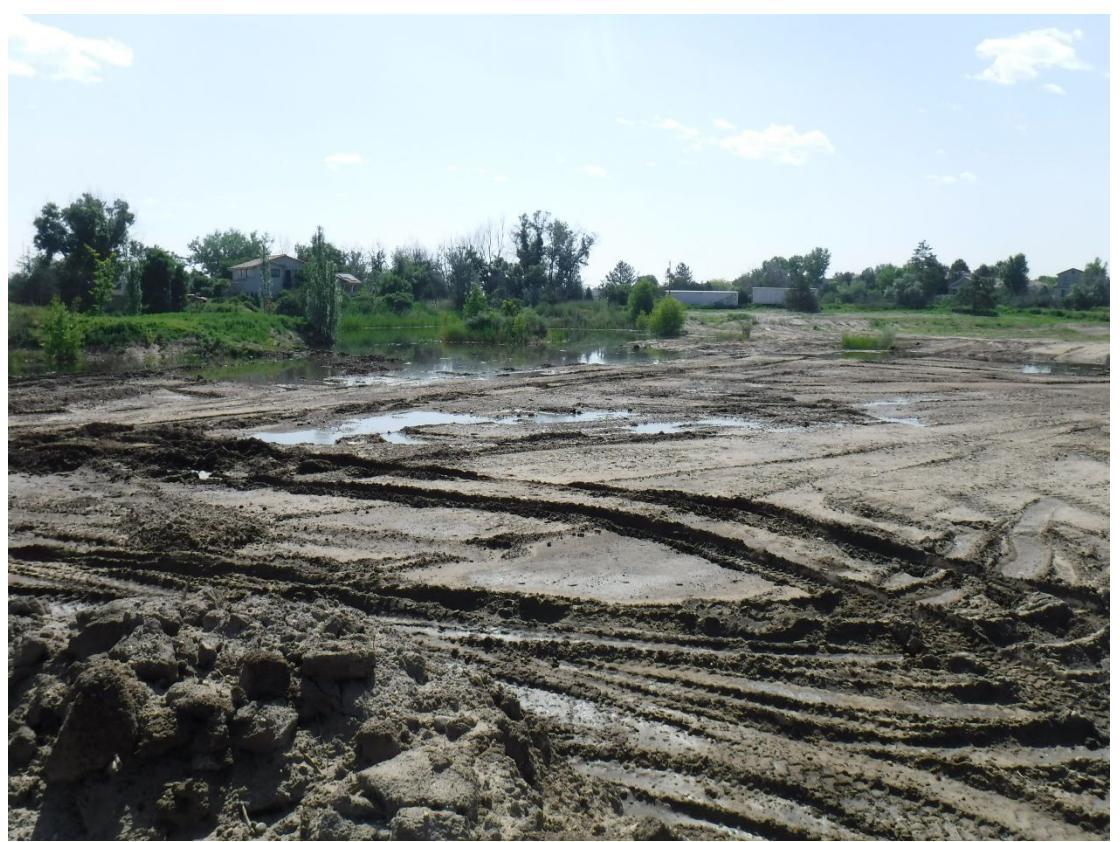
Photo 8: Southwestern quadrant area, looking towards Pre-1981 pond

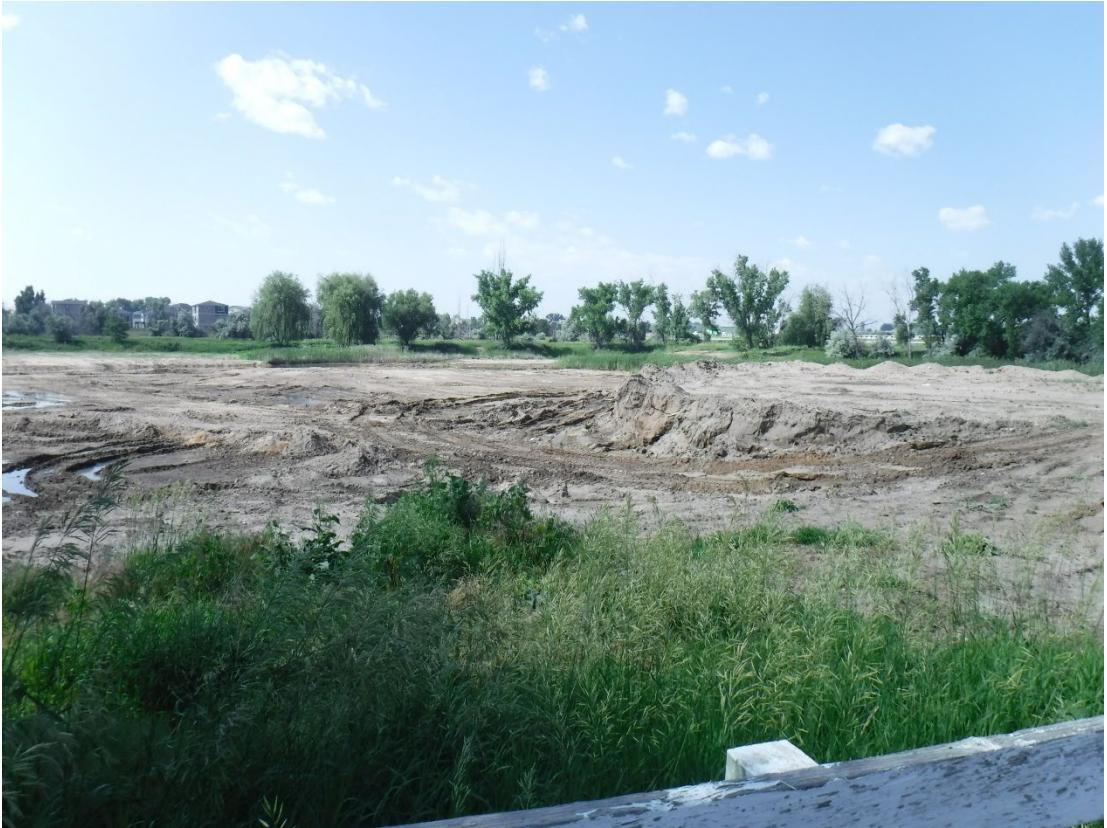
Photo 9: Looking at Southwestern quadrant area from main road

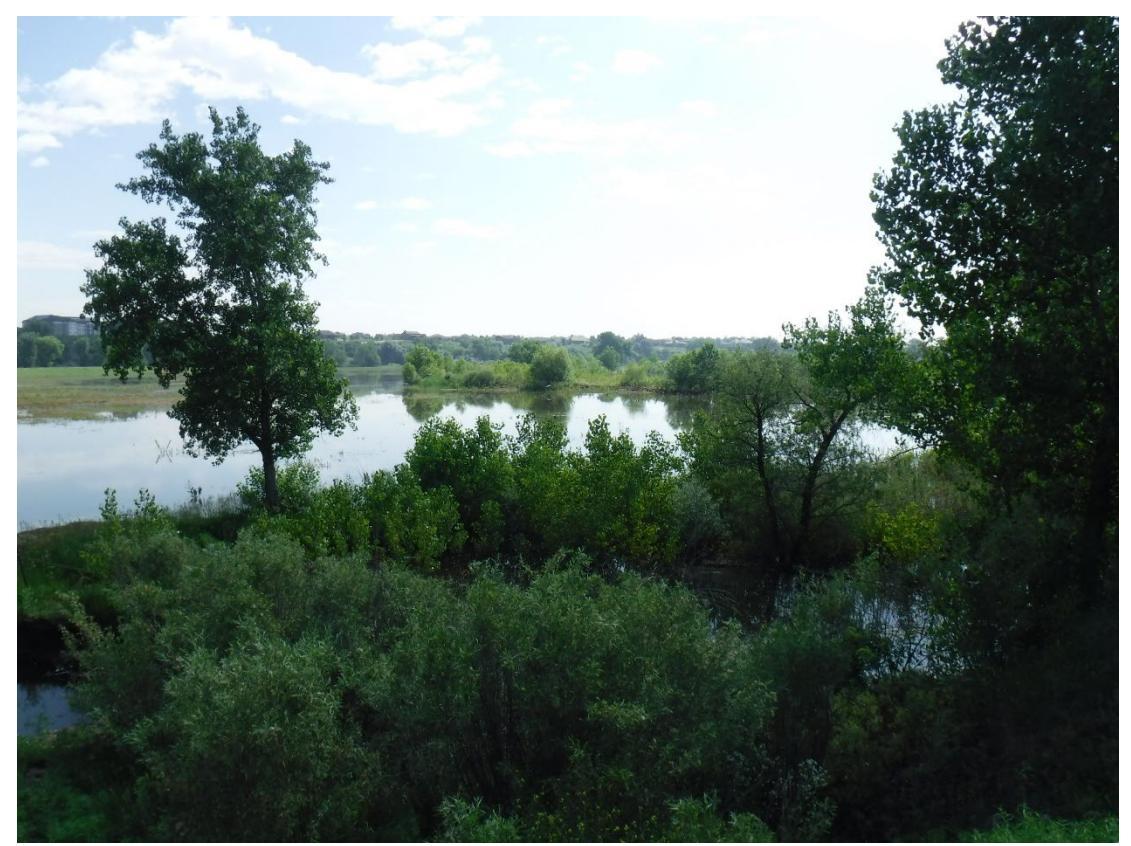
Prior to the inspection the Big Thompson River, located north of the permit area, over topped its banks and flowed through the site from west to east. After the river subsided, water remained captured on property to the north of the permit boundary and within the permit boundary. The Operators consultant stated that when the water was flowing across the site the river was "open call" meaning that anyone could remove water from the river without injuring any water rights. The Division subsequently verified this with DWR. However, the flood waters remain very close to Ms. O'Brien's residence.

Photo 10: Looking northeast across the permit area, the water seen is from the Big Thompson flooding the permit area

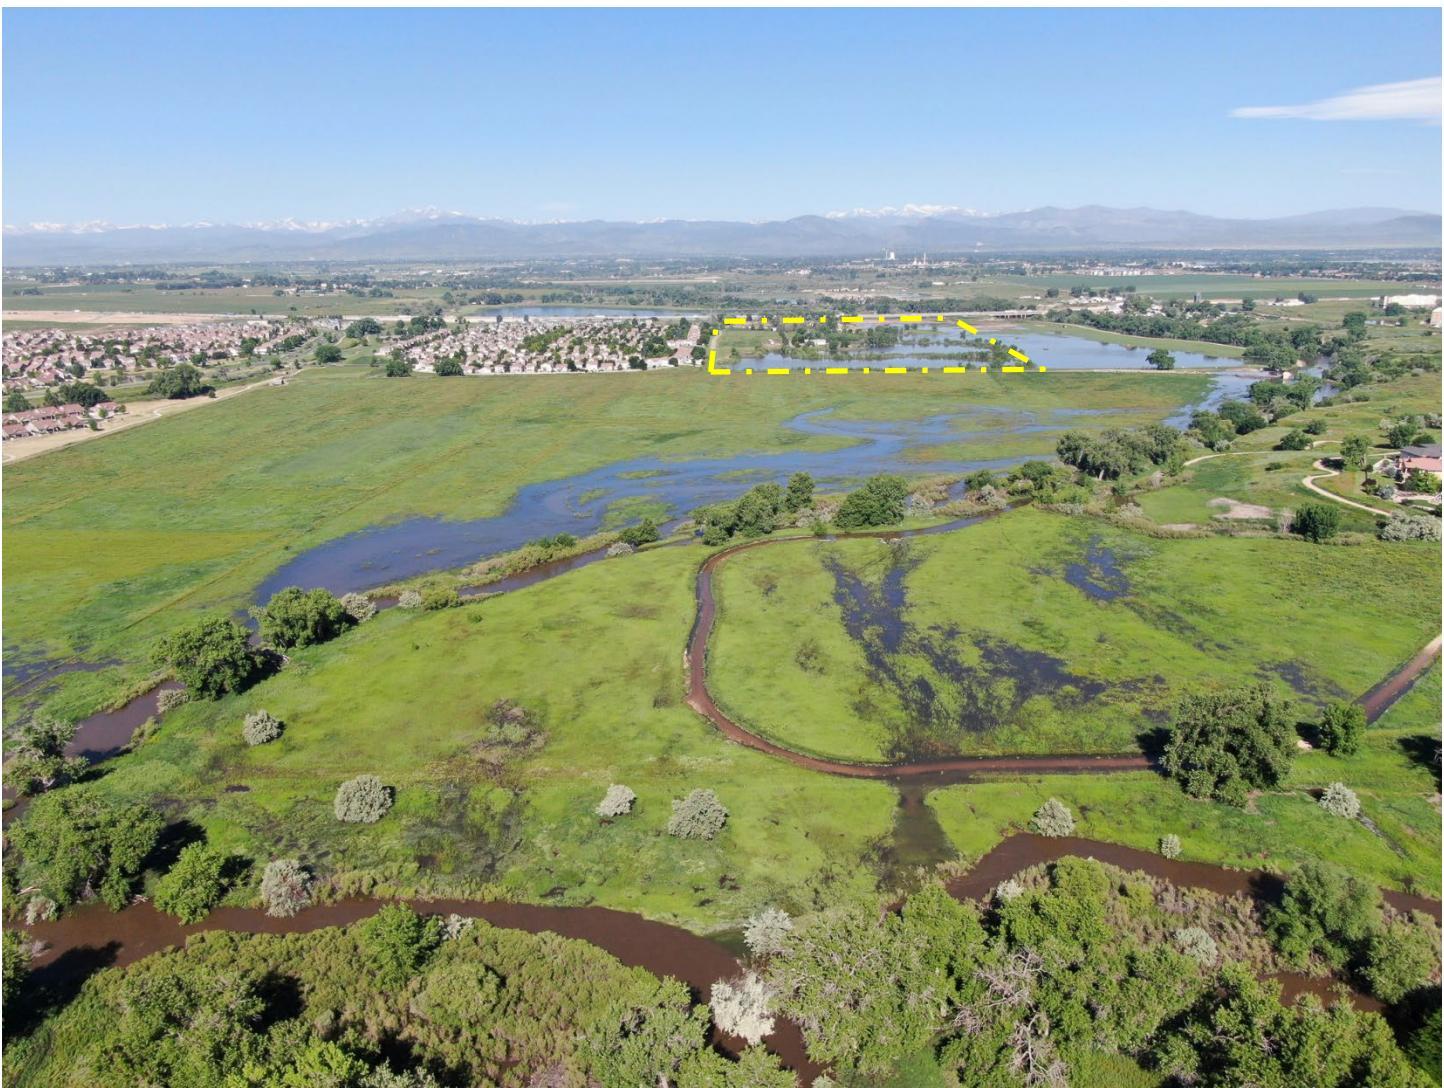
Photo 11: Aerial image, looking to the West, provided to the Division on June 20, 20223 showing the flooding of the area by the Big Thompson River. Yellow polygon is the approximate permit boundary of the Kirtright Pit. Photo provided by Terry Baldino.

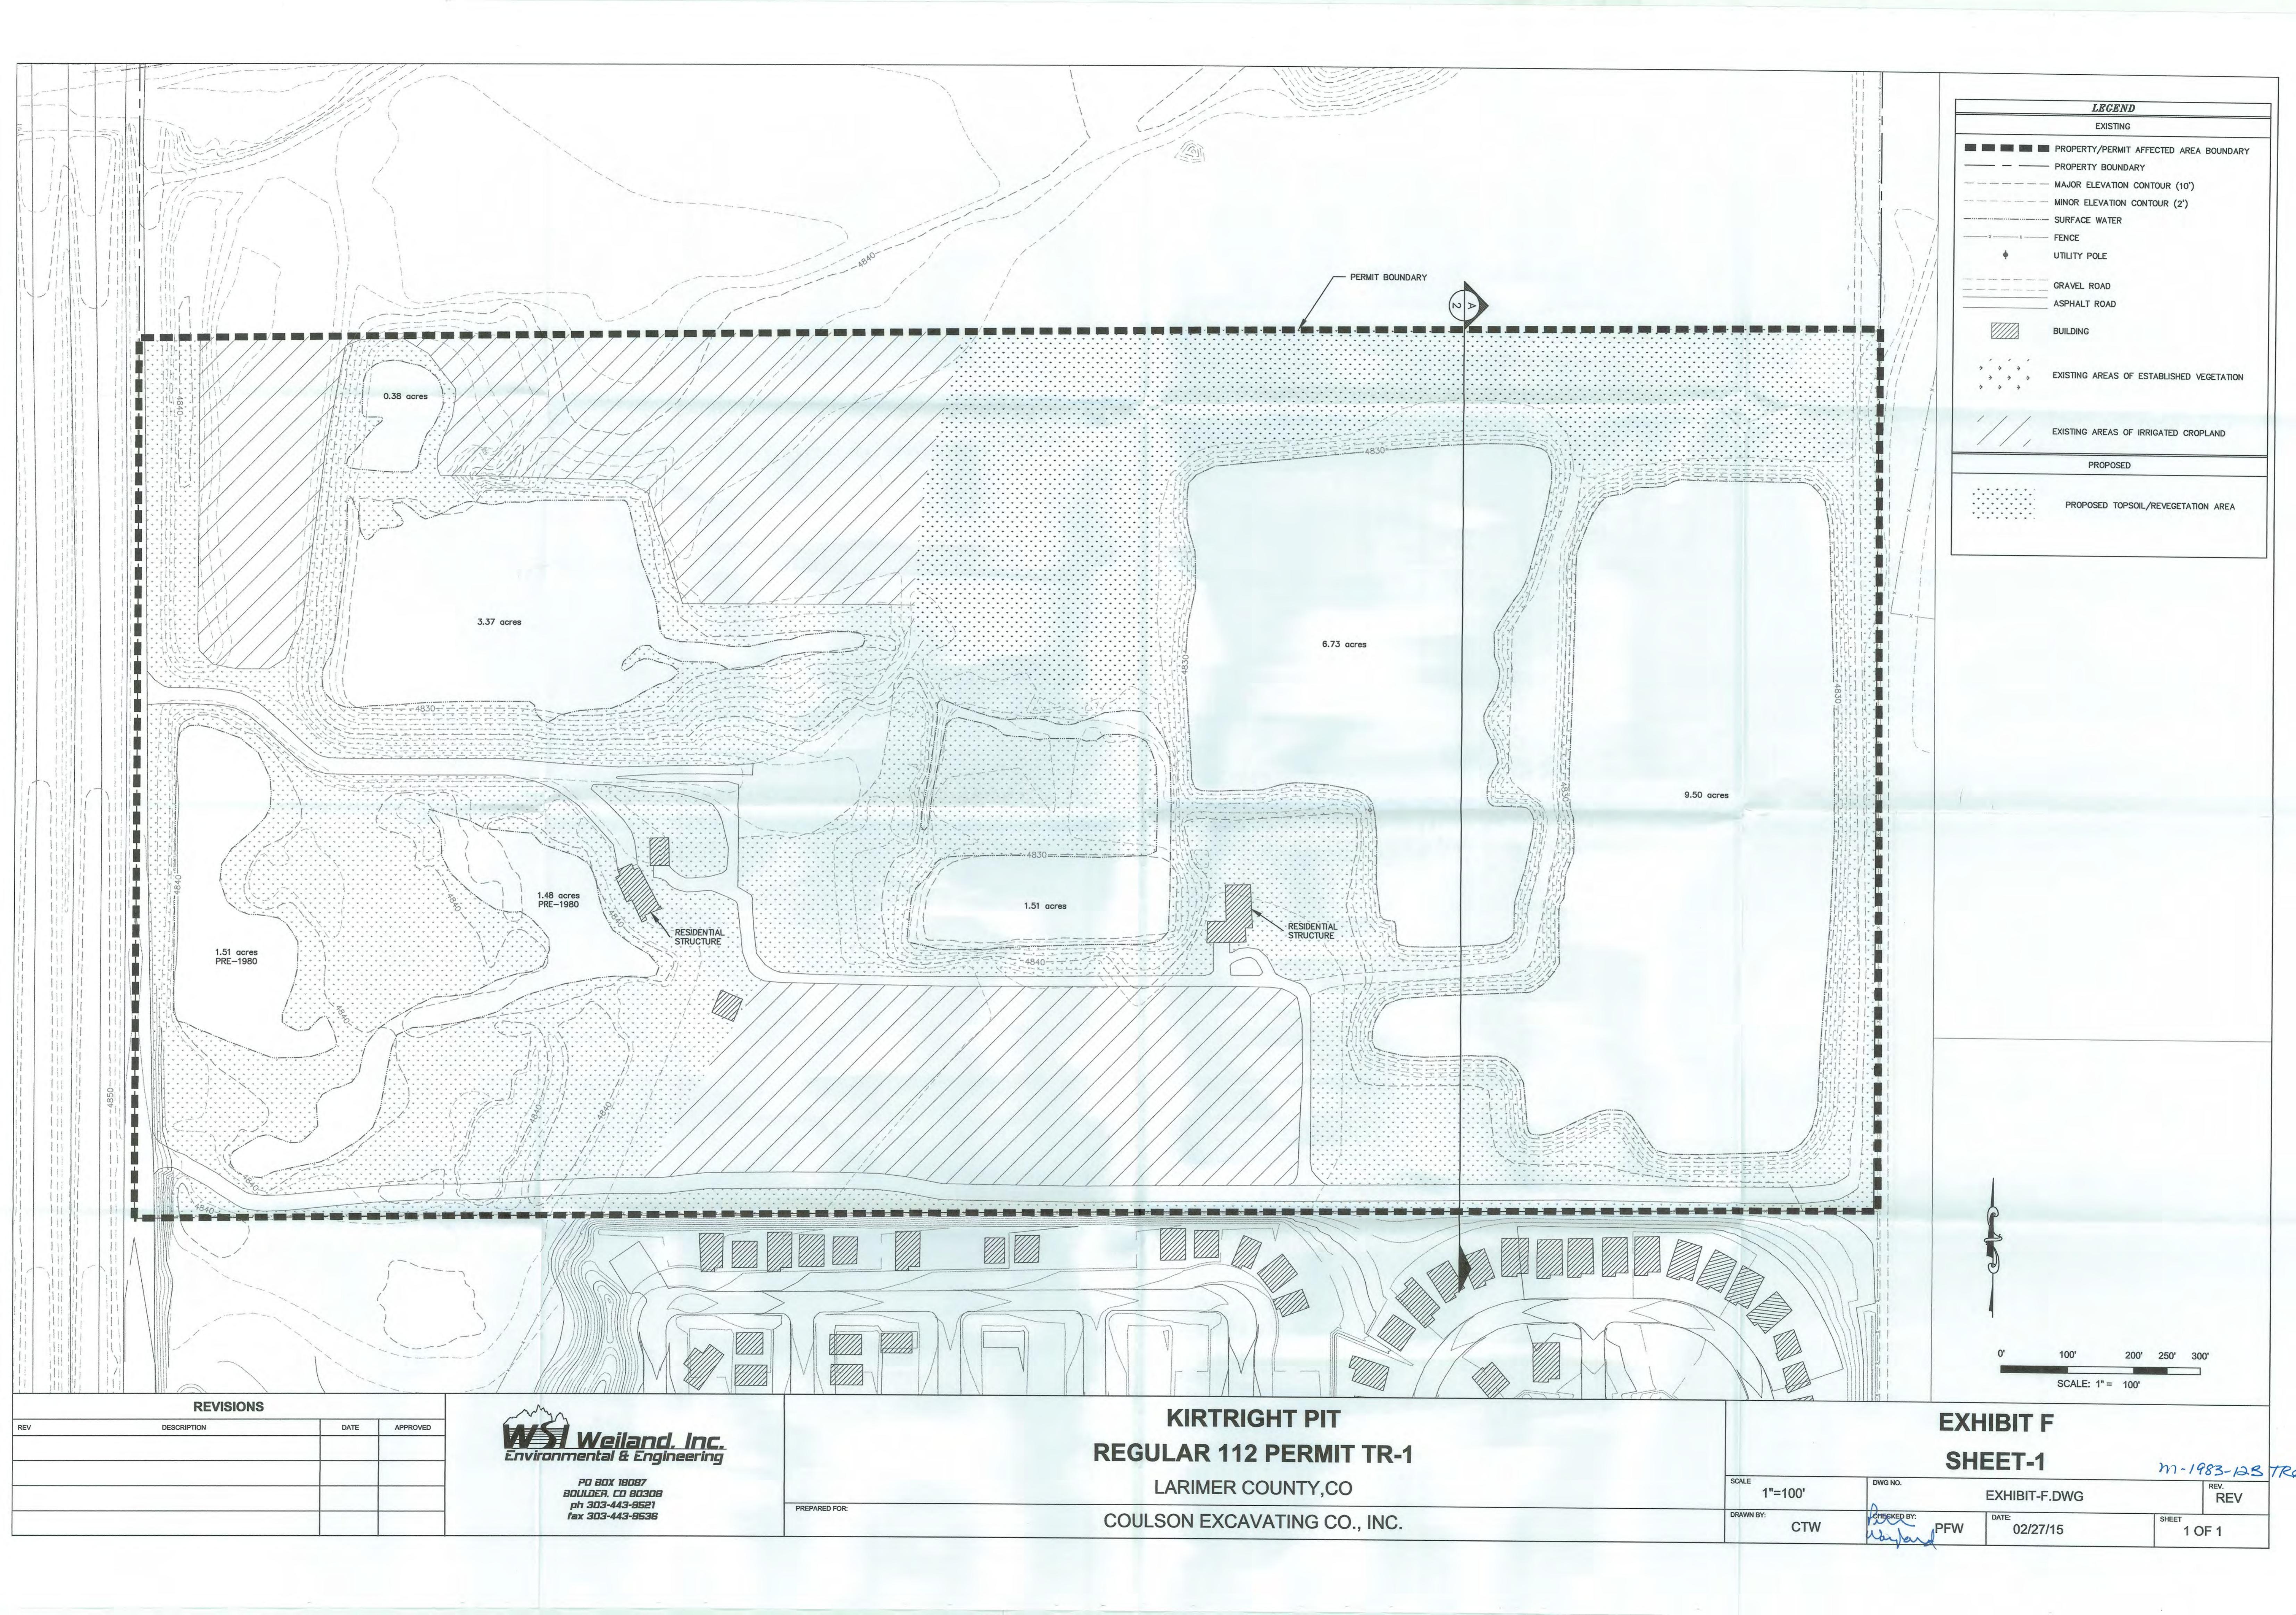
Attachment 1

The site consists of multiple irregular shaped pit excavations. These pit excavations are depicted on the currently approved reclamation plan map (Attachment 1) that was approved with Technical Revision No. 1 (TR1). Two large open water ponds are located on the east side of the site, the TR1 reclamation map indicates they are to be 6.73 and 9.5 acres in size. A 1.51 acre pond is to be located near the center of the site west of a residence constructed on the west side of the eastern pit excavations. In the southwest portion of the site, several pre-1980 ponds, 1.51 and 1.48 acres in size were to exist. Proposed in the northwest portion of the site was to be a small .38 acre pond and a 3.37 acre pond.

As mentioned in the SWSP mining at the site has been completed and according to the annual reports mining activities at the site last occurred in 2008. From the previous inspection reports and the SWSP, final reclamation of the ponds and site needs to wait until the approval of the final Augmentation Plan which scheduled for water court in 2024. The Operator has deviated from the currently approved reclamation plan by filling in the Pond 1 area located in the northwest portion of the permit. Additionally, the existing pond areas do not match those shown on the approved reclamation plan map. Therefore, the Operator will need to revise their reclamation plan.
