# Geotechnical Addendum

2022 Annual Report

Aggregate Industries Deer Creek Quarry

Permit M1977-014 Jefferson County, Colorado

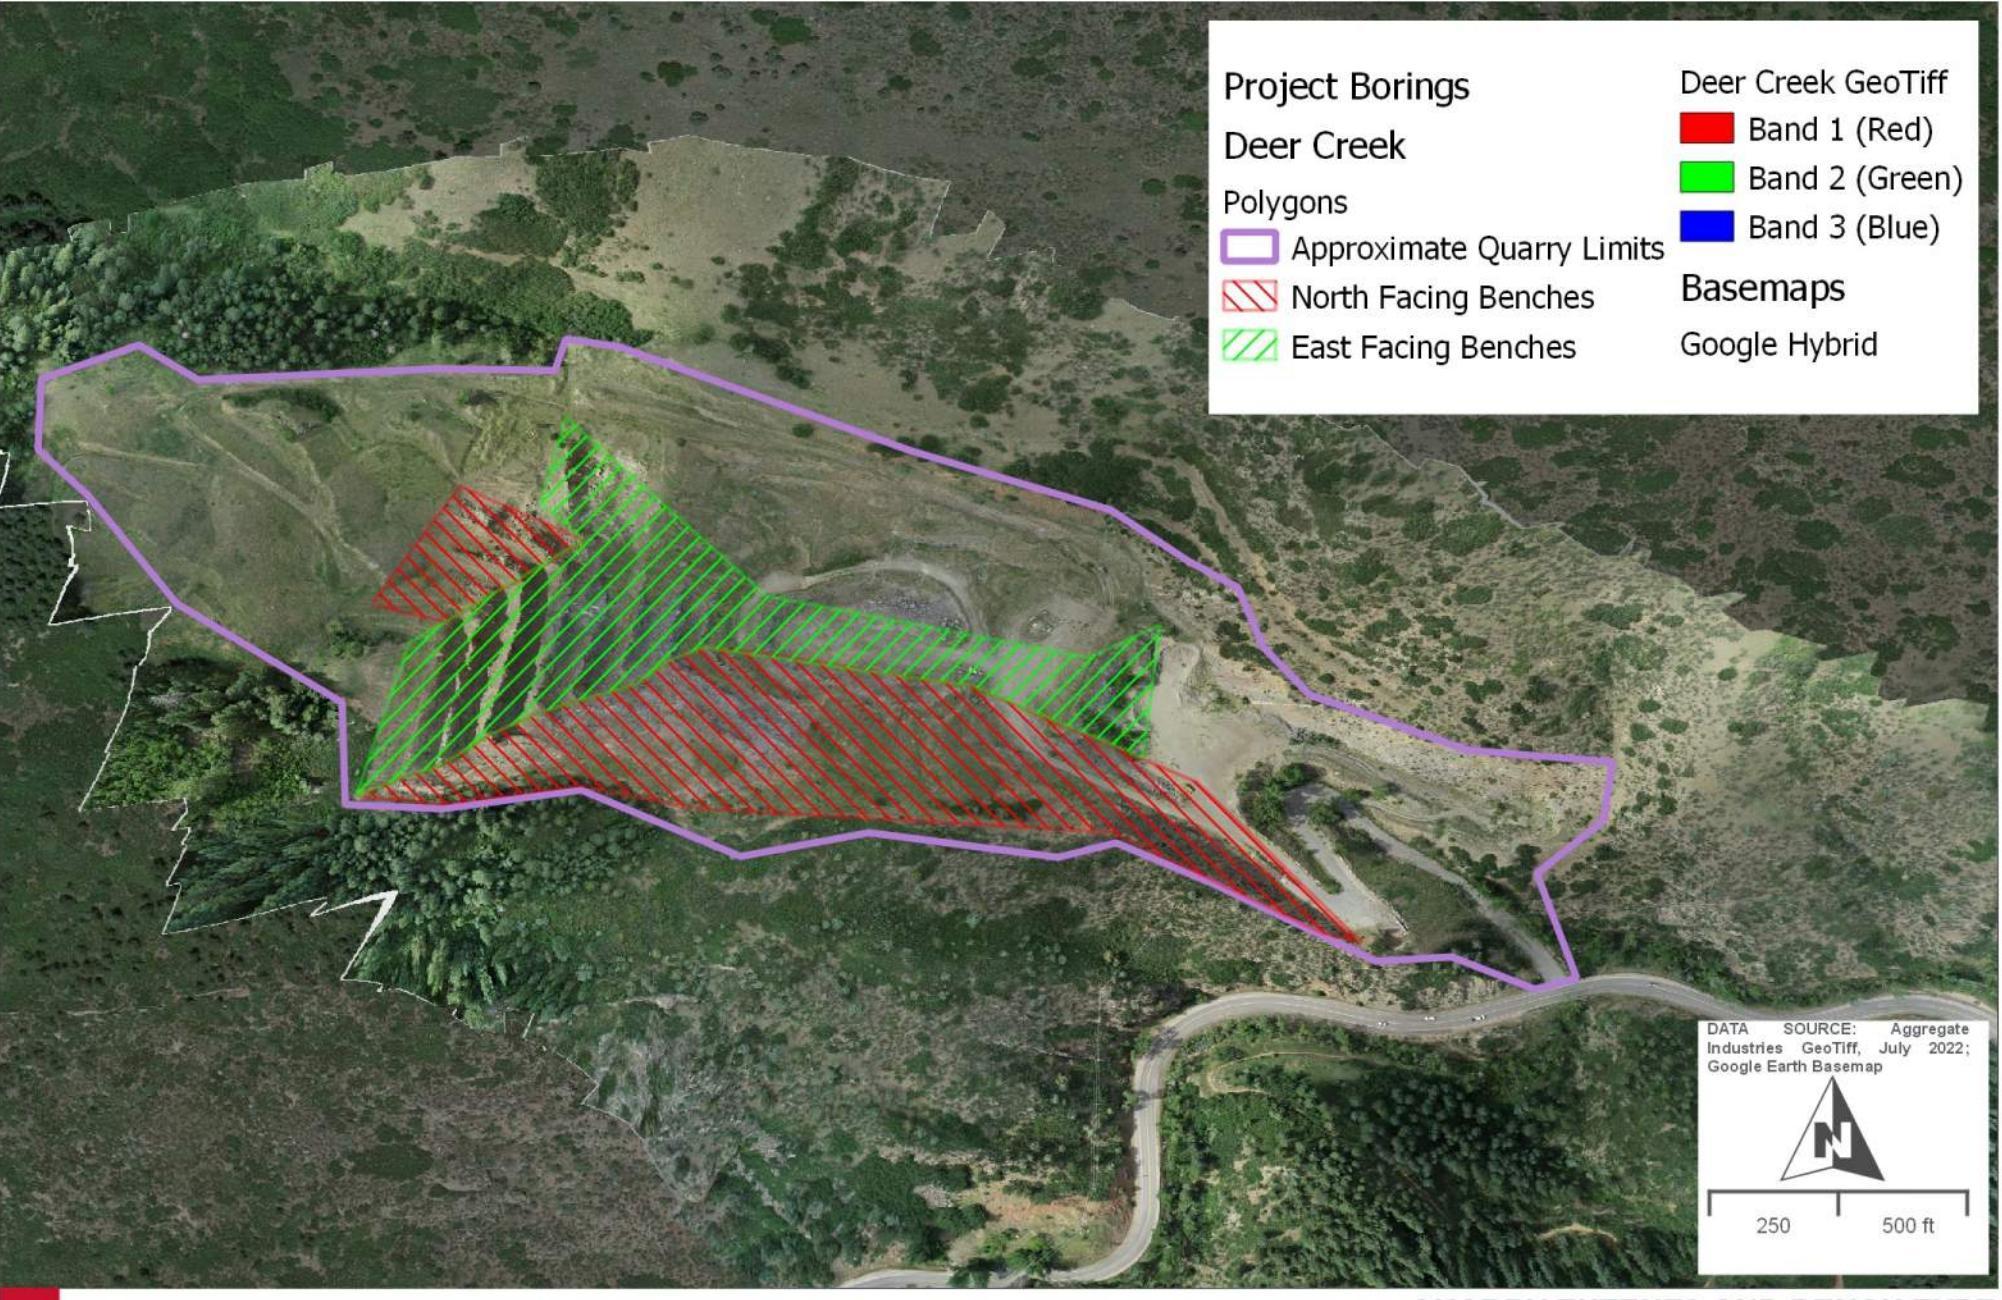
QUARRY EXTENTS AND BENCH TYPE DEER CREEK QUARRY JEFFERSON COUNTY, COLORADO FIGURE 2

The quarry consists of two dominant highwalls, to the west and to the south. East facing highwall extends from approximately elevation (El.) 6820 above mean sea level (msl) to El. 6380. The north facing highwall begins at approximately El. 6650. Both highwalls have been unmined since approximately 2003, with limited mining activities including moving stockpiled materials and material storage occurring along the floor of the pit and the lower bench at approximately El. 6420. An access/haul road is present to the north of the pit and provides access to the benches of the east facing highwall. Refer to Figures 2 and 3, Quarry Extents and Bench Type and Quarry Aerial Map and Bench View, respectively, for additional information.

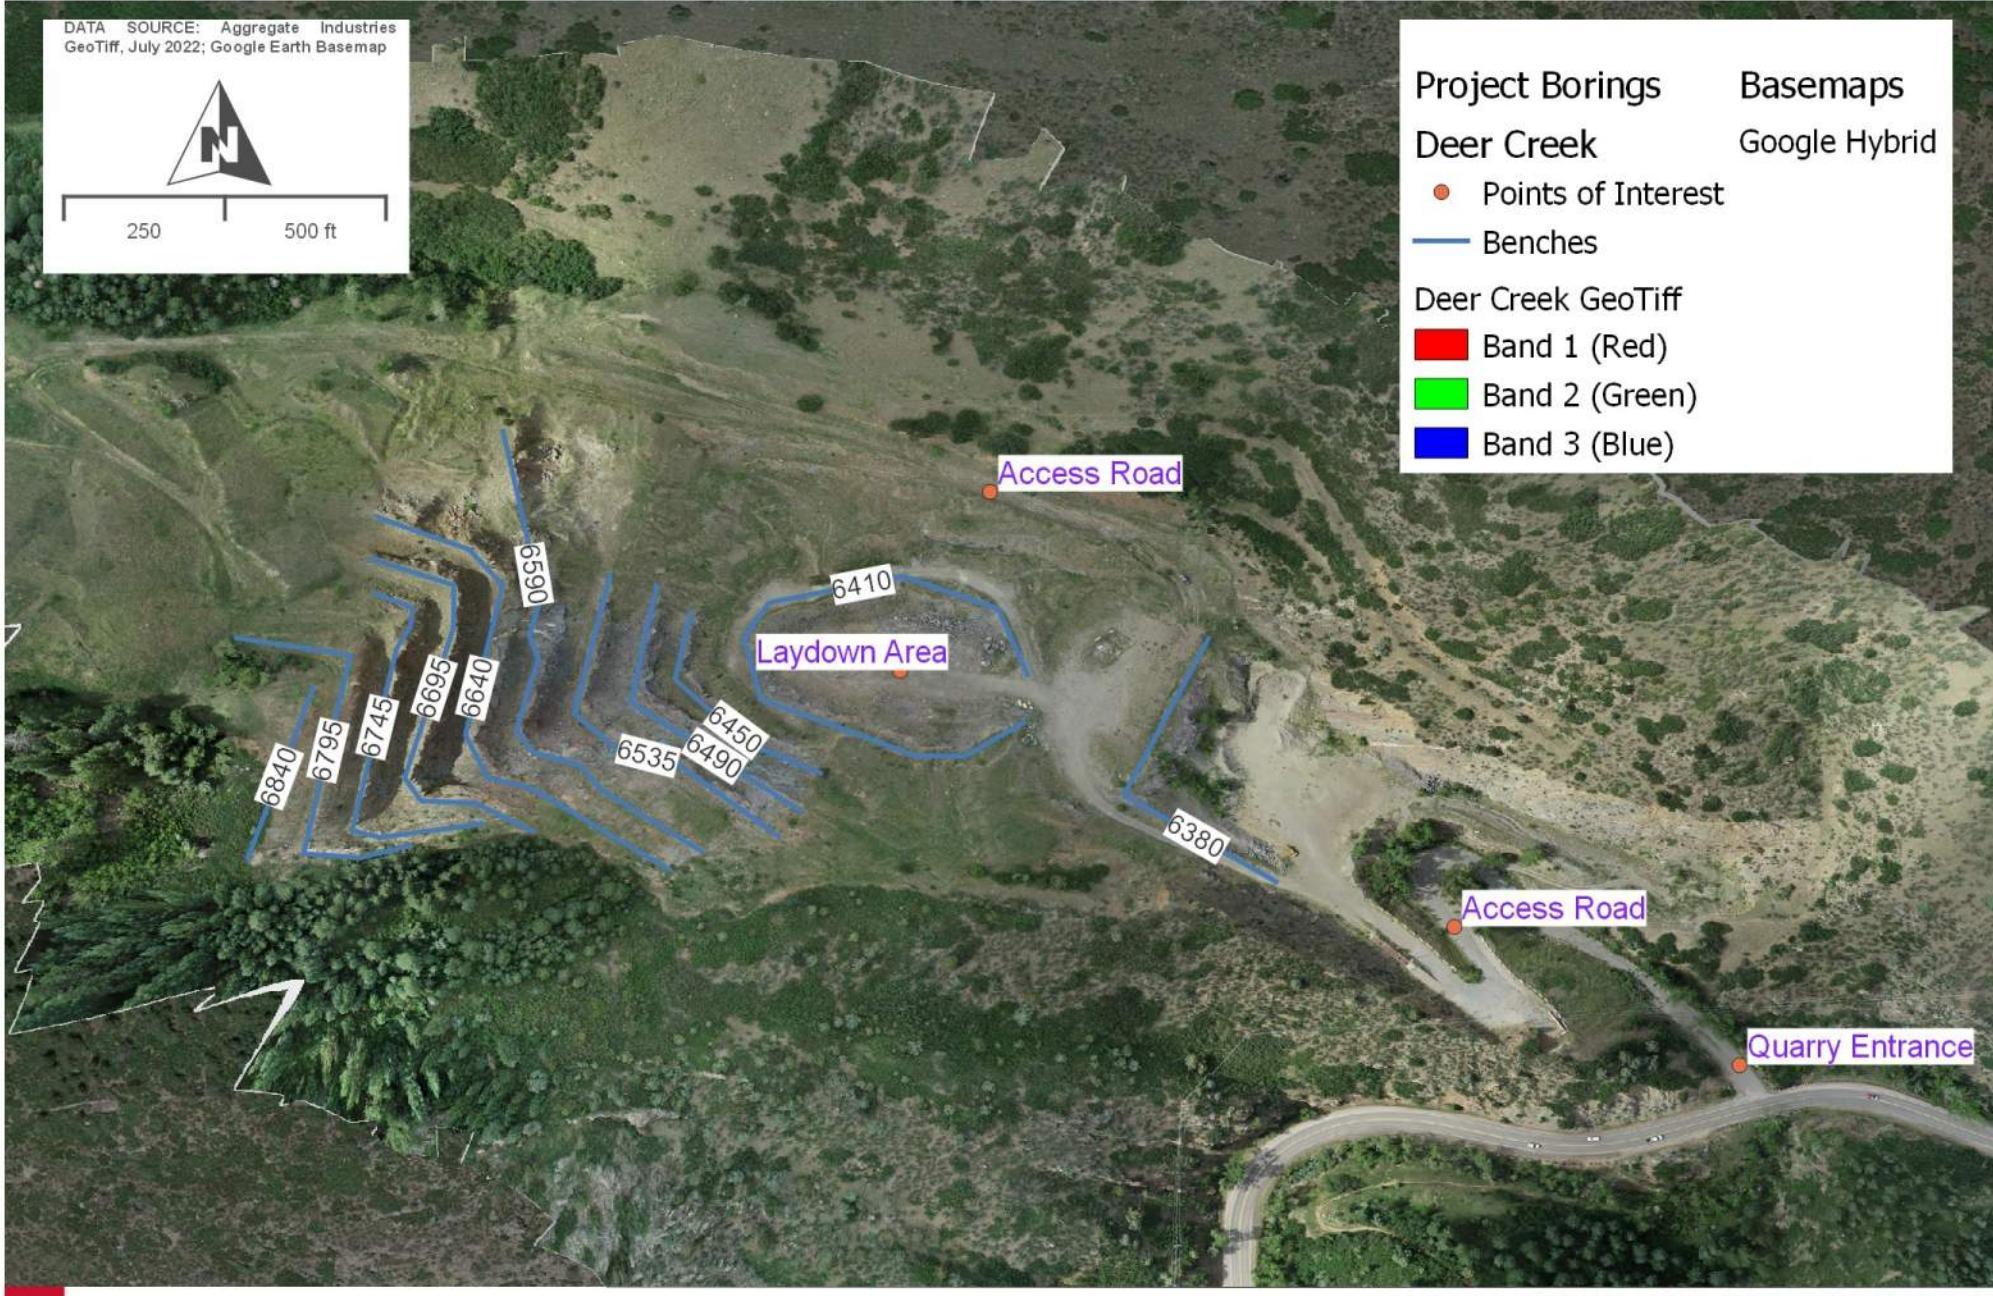
QUARRY AERIAL MAP AND BENCH VIEW DEER CREEK QUARRY JEFFERSON COUNTY, COLORADO FIGURE 3

Based on aerial imagery, no appreciable mining occurred in 2022. Historical imagery from 2021 indicated the site was previously being used as a storage facility for timber in the laydown area to the east of the highwalls. Existing benches did not appear to be mined, with no recent impacts noted. The access road leading to the upper benches to the north of the highwalls was viewed during the site visit. In general, the access road was overgrown with vegetation, and had experienced numerous slope failures that has currently left the road inaccessible to typical vehicular traffic.

Site reclamation has been performed at the quarry prior to HDR's involvement. The upper benches have developed vegetation on the slopes, and historical rockfall has continued to fill the benches. East facing benches have continued to perform well, with little to no significant rockfall. The north facing bench, specifically at approximately elevation El. 6625 experienced a significant rockfall event within approximately the last two (2) years, based on historical imagery. The volume of the slide appeared to be approximately 100 cubic yards and was contained within the lower bench. Similarly, continued development of rockfall at the corner of the east and north facing highwalls has continued. Various benches appear to be at near capacity, resulting in some rockfall likely to fall beyond the next lower bench. Particularly, Benches 6695, 6640, and 6490. During the site evaluation performed by HDR, noted recent rockfall was identified along the lower access road leading to the laydown area.

Due to the presence of recent rockfall conditions, and the potential kinematic failure risk identified through the kinematic analyses, HDR recommends that continued monitoring as part of the annual inspections continue moving forward. Additionally, any on site work performed at the quarry should be performed with the utmost concern for potential localized failure, and all safety measures shall be maintained. If rockfall persists beyond an adjacent lower bench, as noted during our research, benches should be cleaned and/or stabilized to mitigate excessive rockfall energies.

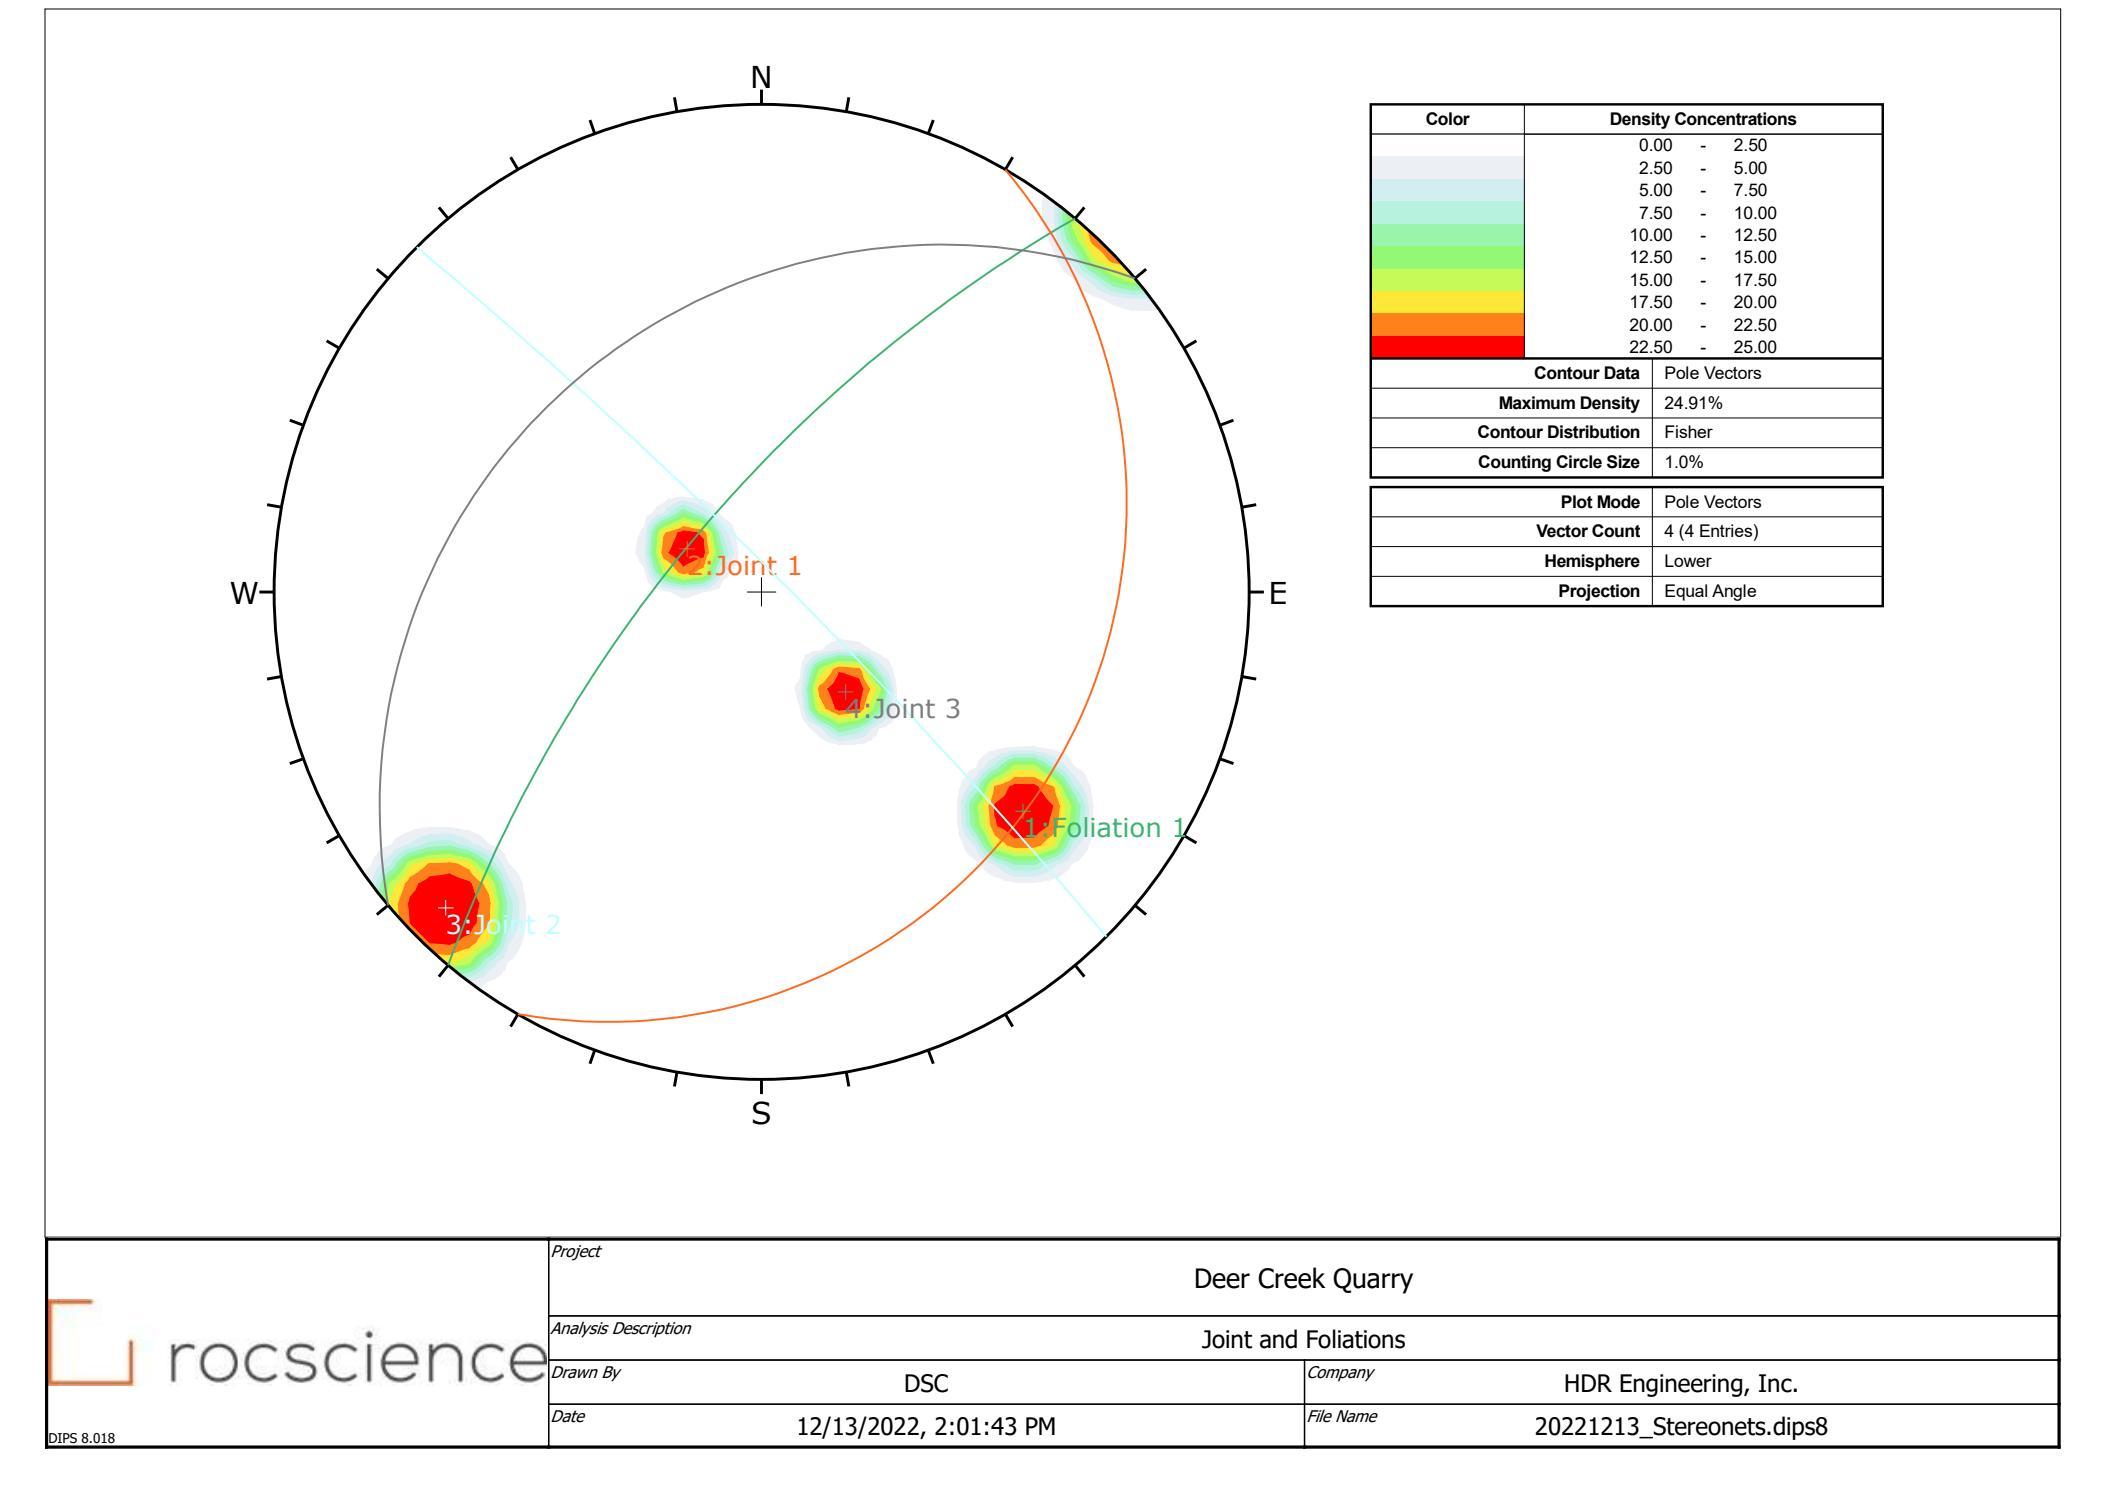
Joints and Foliations

In general, three (3) joint sets were noted. Set 1 (J1) was identified as being oriented at 20°,120° using the dip/dip direction notation. Set 2 (J2) was approximately 85°,45° and Set 3 (J3) was approximately 30°,320°. Foliation throughout the site varied locally; however, a prominent foliation feature (F1) noted throughout was identified at approximately 70°,310°.
