2023 August Inspection Reports Partial: Williams Fork, Yoast SEneca IIW

PERMIT INFORMATION

Permit Number: C-1981-044 **Mine Name:** Williams Fork Mines **Operator:** Moffat County Mining, LLC

INSPECTION INFORMATION

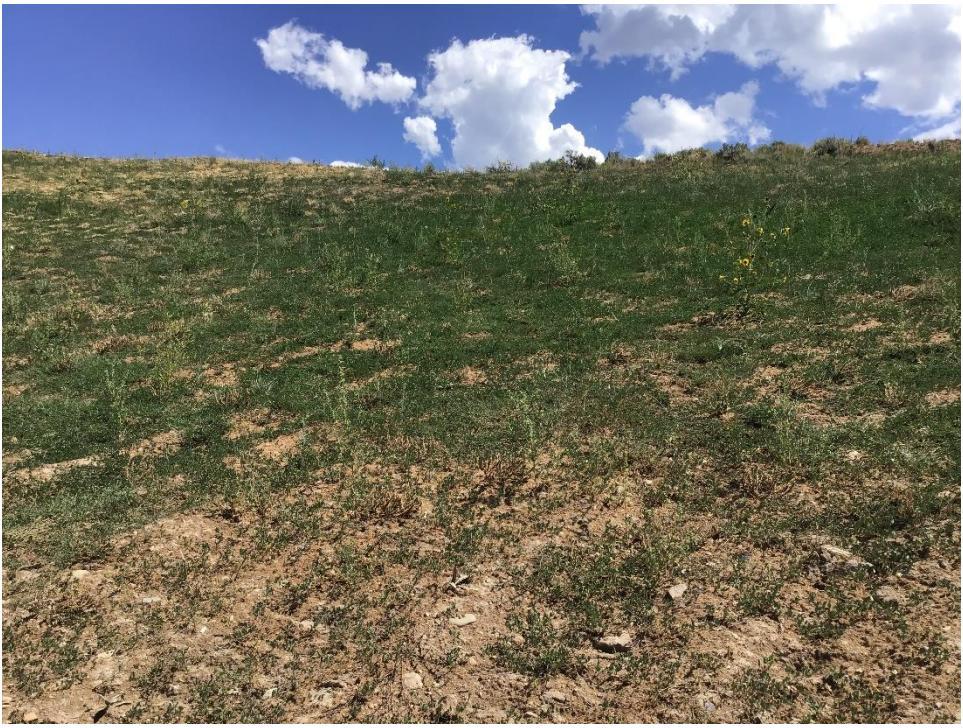
Reclamation is progressing as permitted. Facilities have been removed throughout the site and reclamation has been completed. Topsoil below the 5A Portal was placed and will be seeded within the next weeks. Hydroseeding the portal slope was completed, and a few grasses appeared to be emerging.

Photo 1: Hydroseeded slope at o the 5A Portal.

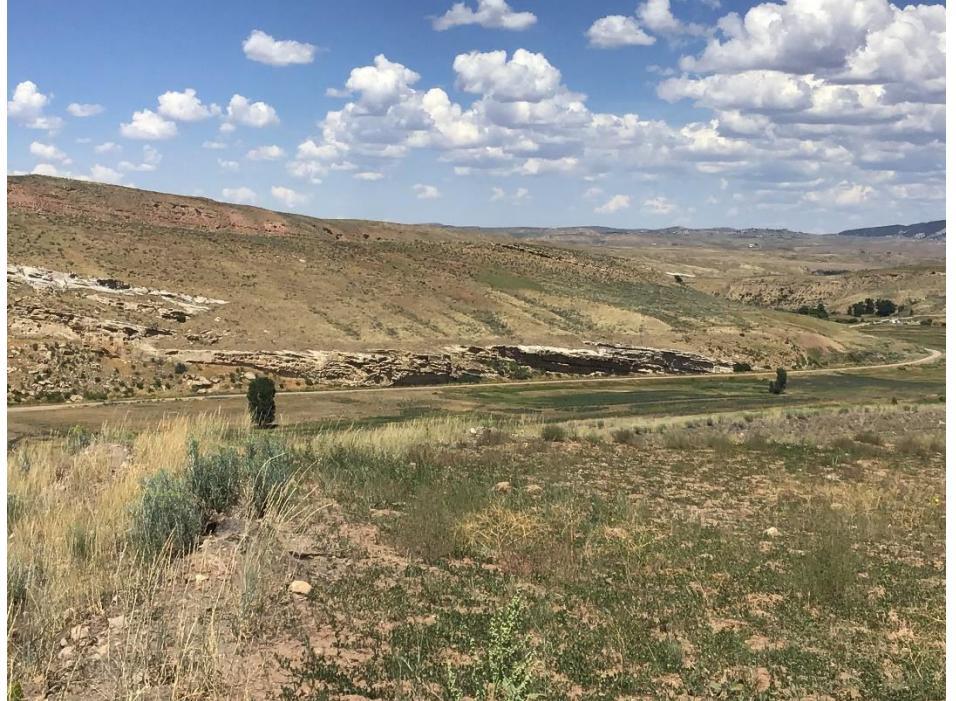
- With the eception of the slope to the 5A-P1 Pond, reclamation, (topsoil and seeding) has been completed as has hydroseeding at the 5A Portal.
- Cropland areas along the Williams Fork River were dry stubble having been harvested earlier in the season. Alfalfa was present in the field.

Photo 2: Overview of the cropland area along the Willliams Fork River looking northwest from above.

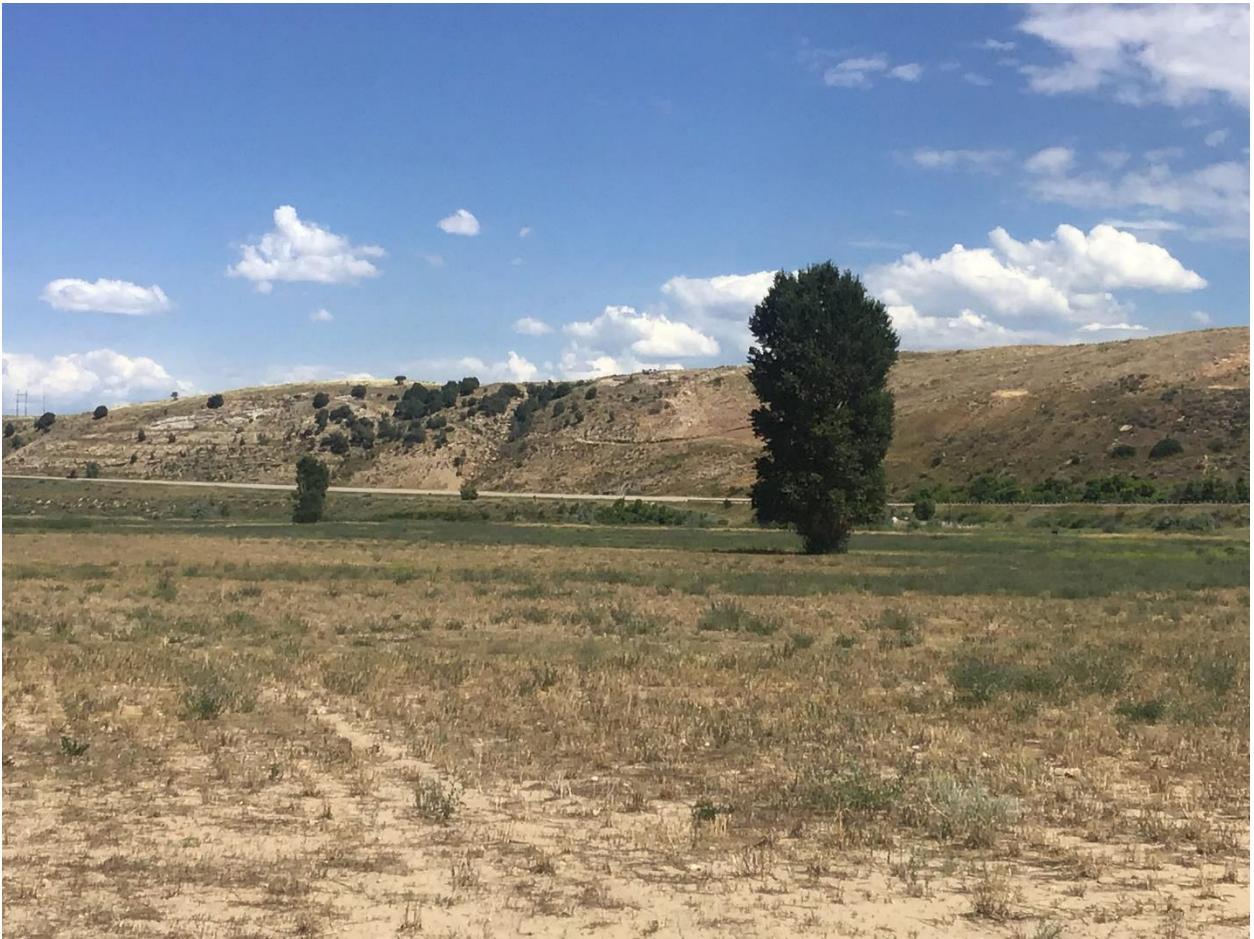
Photo 3: Cropland area along the Williams Fork River, looking north.
