Re: Division's Second Response to Inspection Report Problem Submissions for the Pueblo County Aggregate Project (PCAP), M-2016-009

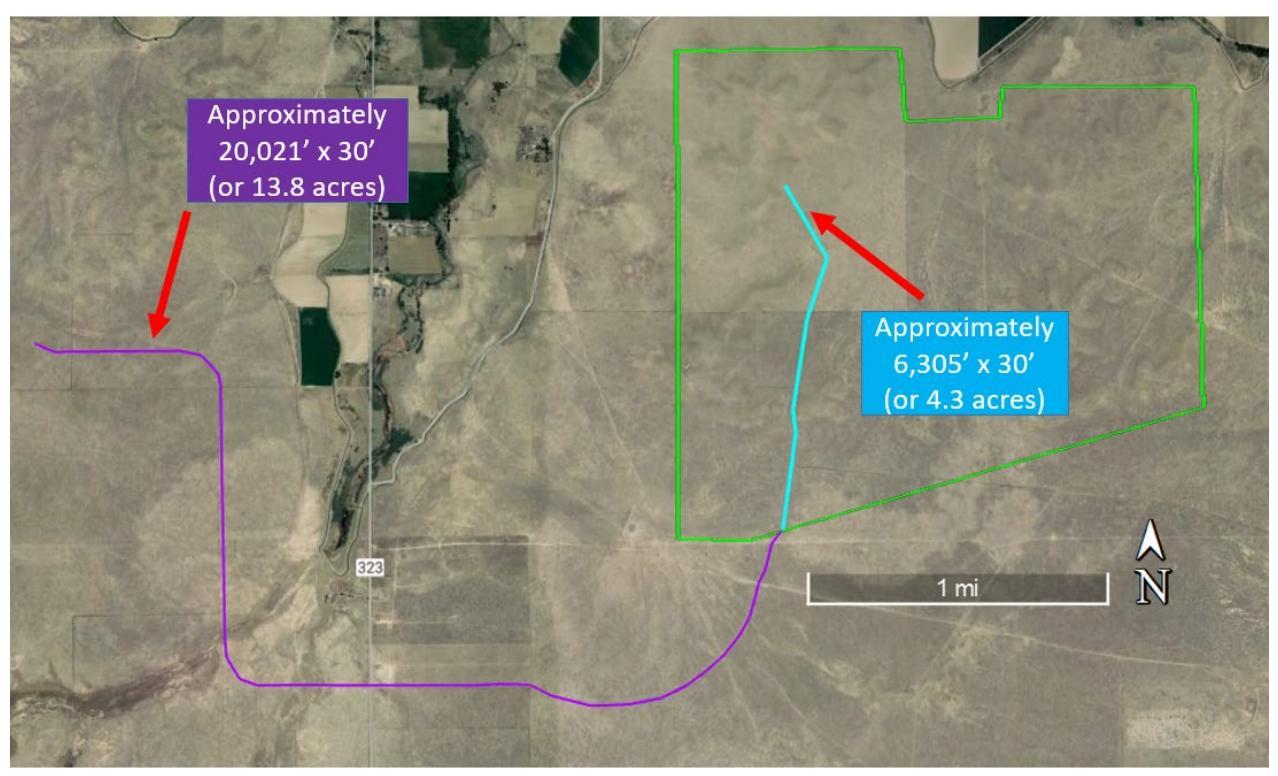
- The Division's preliminary cost estimates provided in the previous response letter dated September 8, 2023 estimated reclamation responsibility for 15 acres of active mining, haul road acreages, and 25% of the currently affected but un-released reclaimed land. Until this land is released either through final bond release, an acreage reduction, or a surety reduction, the Division must hold a bond for this area to cover liability for at least some reseeding and weed control.
 - To clarify, the Division estimates the haul road acreages for the South Haul road and the Phase 1 internal haul road to equate to approximately <u>18.1</u> acres for the duration of mining in Phase 1 (see below).

Given the information provided above in the Operator's response, upon receipt of a surety reduction request, an updated reclamation cost estimate will be conducted at that time. The Operator will be asked to clarify what reclamation work will be required to be completed (back filling, grading, topsoiling, seeding, etc.) prior to initiating mining in a new 15 acre area. The tasks not required to be completed prior to moving to the new area will need to be included in the Division's cost estimate. This may result in the reclamation cost estimate accounting for reclaiming the active 15 acres, haul road acres, and the remaining tasks in the un-released partially reclaimed acres. The Division will also ask the Operator to clarify the maximum amount of acres that will be disturbed at one time in each Phase (this being the 15 acres to be actively mined, the haul roads, plus any un-released reclaimed areas).

• The Division will not issue a surety increase at this time due to the Operator's intentions to submit a Technical Revision to revise the mine plan. The Operator shall submit the Technical Revision to the mine plan by **October 8, 2023.**
