MINERALS PROGRAM INSPECTION REPORT PHONE: (303) 866-3567

MINE NAME:	MINE/PROSPECTING ID#:	MINERAL:	COUNTY:
Whitewater Pit 500	M-1977-129	Sand and gravel	Mesa
INSPECTION TYPE:	WEATHER:	INSP. DATE:	INSP. TIME:
Surety-Related Inspection	Clear	August 29, 2023	09:50
OPERATOR:	OPERATOR REPRESENTATIVE:	TYPE OF OPERATION:	
Whitewater Building Materials Corporation	Mark Gardner	112c - Construction Regular Operation	
REASON FOR INSPECTION:	BOND CALCULATION TYPE:	BOND AMOUNT:	
Priority	Complete Bond	\$287,500.00	
DATE OF COMPLAINT:	POST INSP. CONTACTS:	JOINT INSP. AGE	NCY:
NA	None	None	
INSPECTOR(S):	INSPECTOR'S SIGNATURE:	SIGNATURE DAT	Е:
Amy Yeldell	Amy Geldell	September 20, 2023

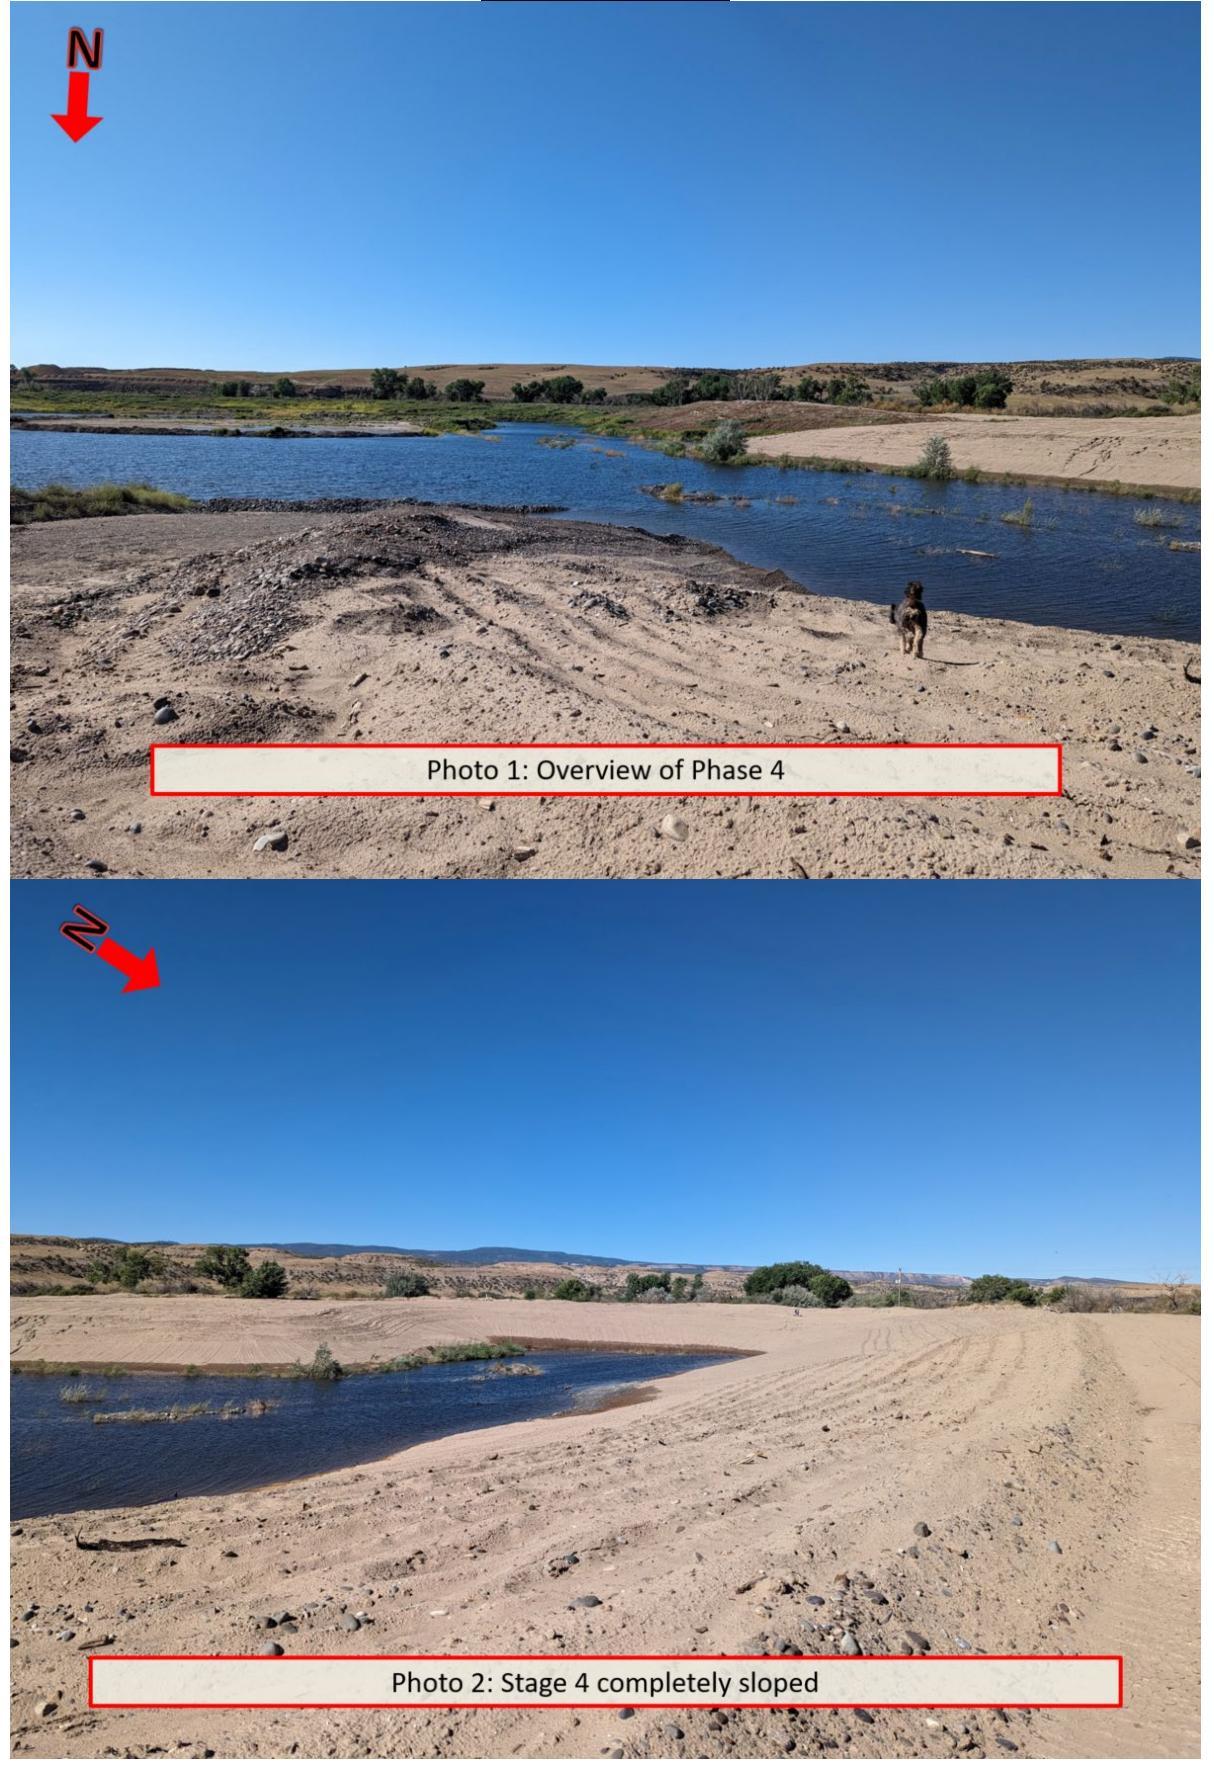
All backfilling and grading has been completed in Phase 4. All slopes have been graded to a 3H: 1V or less. See Photos One and Two

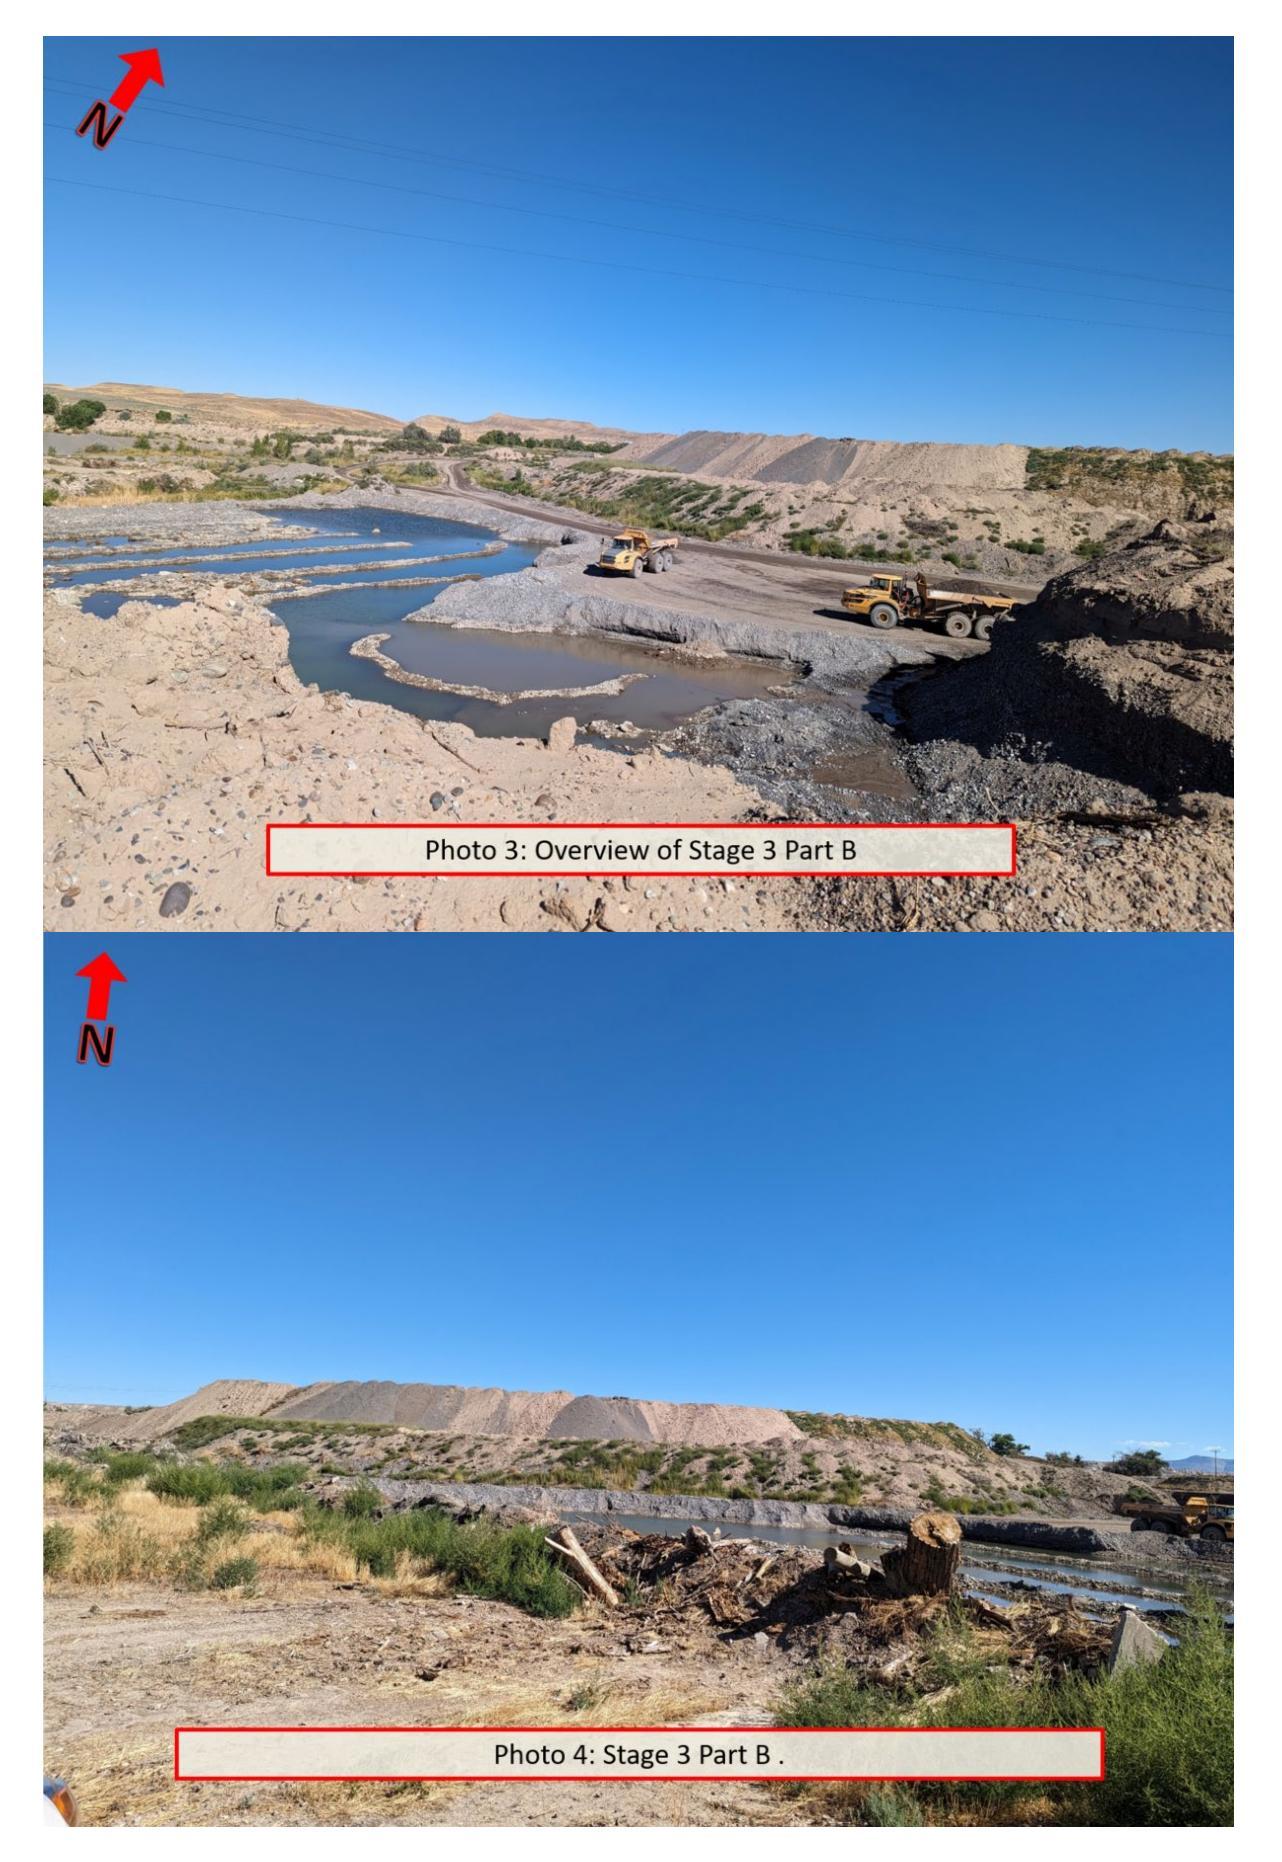
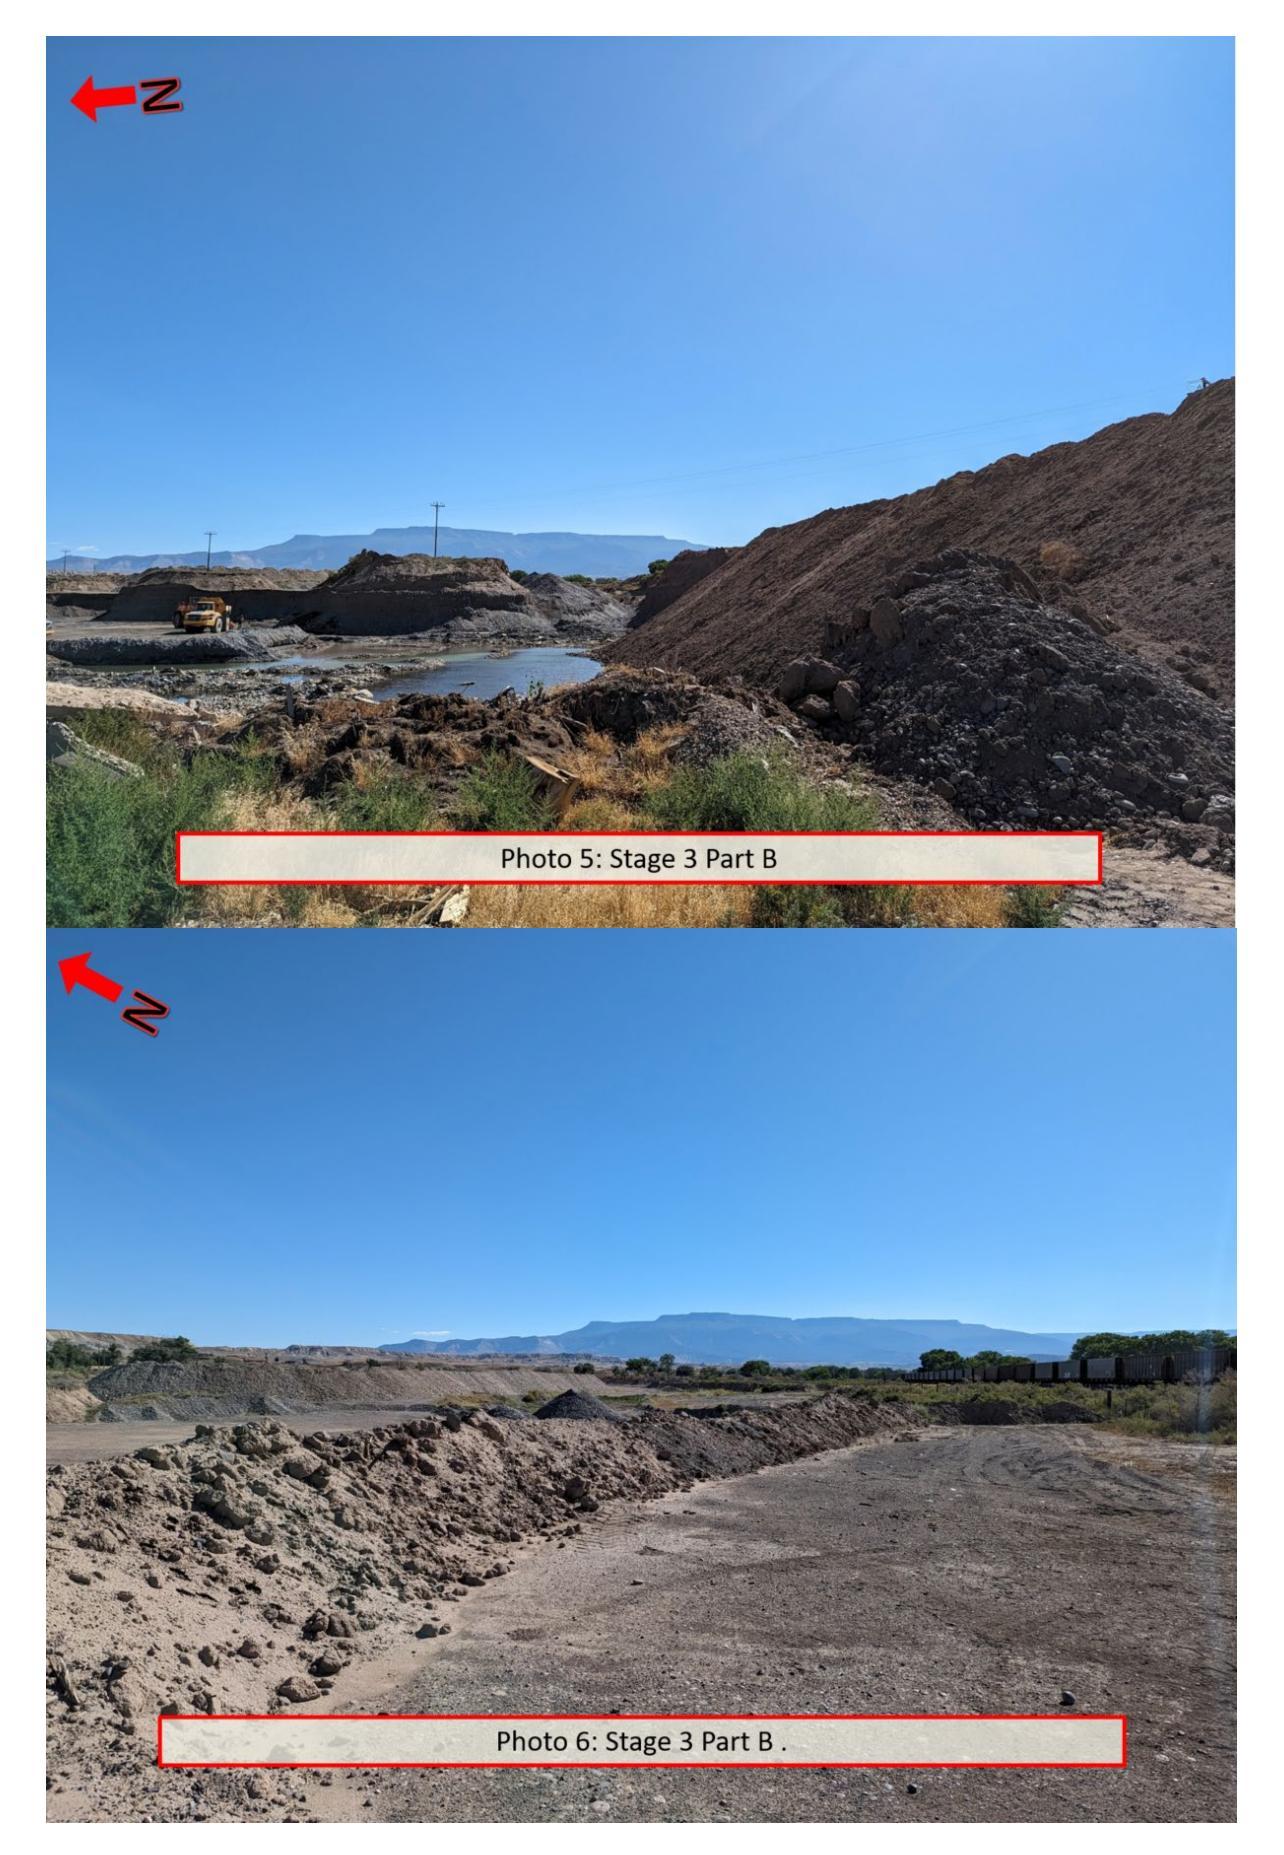
Stage 3 Part B (3N) is mined to a depth of 20 feet (Photos Three - Six). The pit floor has been partially backfilled in areas. A portion of the southern highwall along the railroad tracks has been sufficiently graded to a 3H: 1V or less, approximately 500 LF. A portion of southwestern highwall adjacent to the railroad track is approximately 1H: 1V slope and will require backfill. The remainder of the highwalls within the pit are at a 2H: 1V and will be mined through as the operation progresses. These highwalls can be cut/fill, approx. 3,000 LF, averaging 20 ft. high . The road through the middle of the phase has been removed and mining has occurred up to the electrical pole islands which area at a 1H: 1V and will require backfill. Within Stage 3 Part B there is approximately 1,600 LF of 1H: 1V slope.

Stage 3 Part B (3S) is partially mined out (Photos Three - Six). The western side of Stage 3 Part B remains unaffected. Mining will continue on the remaining 16.85 acres on the east side of the stage. Imported material is being used as backfill in this stage. A large stockpile (4 ac) of overburden is located along the northern edge adjacent to Coffman Road. Additional stockpiles of imported material are being stored on the east side of the phase. A powerline runs through this phase. "Islands" are being maintained around the poles. Eventually the Operator plans to backfill underneath the right of way to provide/ maintain access to the powerline.
