Job Number: 99-3983

Subject: Quarterly Observation Report, Refuse Pile, Foidel Creek Mine, Routt County, Colorado.

TCC Refuse Pile-Quarterly Inspection

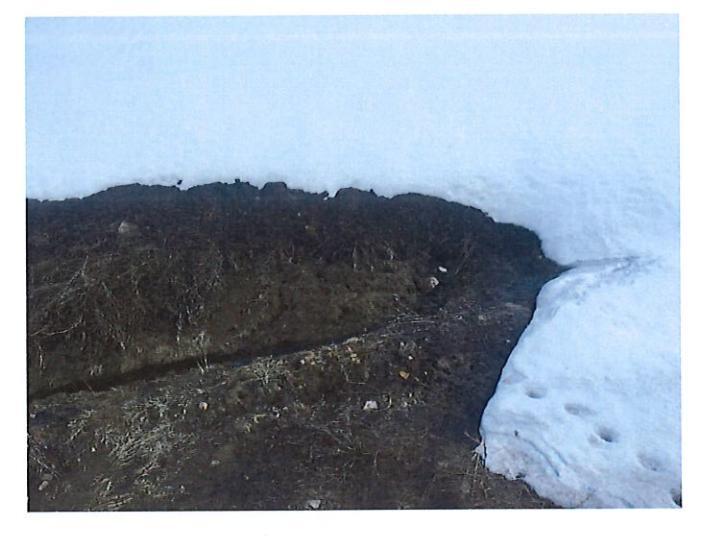
March 29, 2019-Underdain Outlet

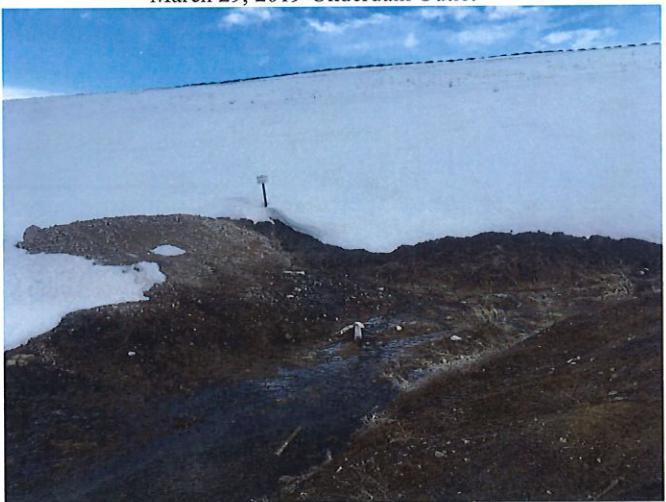
A seepage area at the toe of the northeast end of the refuse pile expansion area, approximately 30 feet northwest of the outlet of the underdrain, developed in fall 2014. At the time of our observations, the seepage was surfacing at the toe of the slope and flowing into the drainage from the undrain outlet then into the existing pond east of the Refuse Pile Expansion Area. The discharge was clear, with no evidence of sediment. No signs of washout, slumps or slope instability were observed at this time. The seepage area will be monitored during future inspections and noted in our inspection reports. Photographs of the seepage area taken at the time of our inspection on March 29, 2019 are attached.

March 29, 2019- Underdrain Outlet/Seepage Area

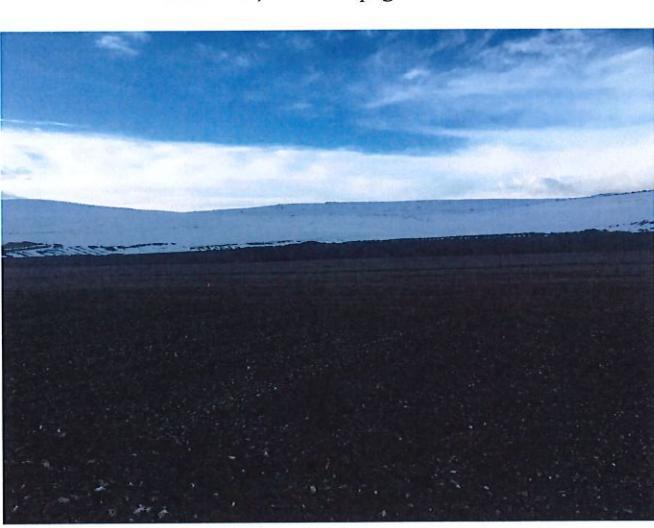
March 29, 2019-Expansion Area-East End

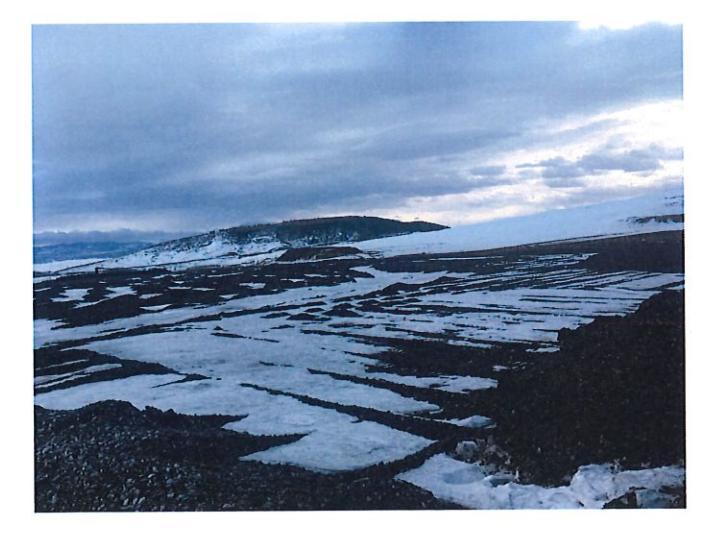
March 29, 2019-Expansion Area-West End

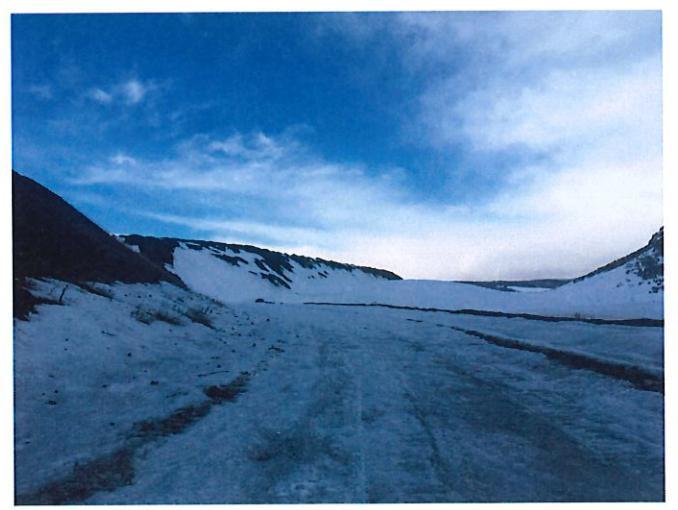
The internal roadways in the new expansion area of the pile are in good condition. The upper haul road to Areas 2, 3 and 4 of the refuse pile was not accessible at the time of our site visit due to snow.

March 29, 2019-Road to Area 2, 3, 4
