## MINERALS PROGRAM INSPECTION REPORT PHONE: (303) 866-3567

MINE NAME:		MINE/PROSPECTING ID#:	MINERAL:	COUNTY:
New Cache Agricultural Pond 1		M-2015-003	Gravel	Weld
INSPECTION TYPE:		WEATHER: Clear	INSP. DATE:	INSP. TIME:
Monitoring			November 1, 2023	13:30
OPERATOR:		<b>OPERATOR REPRESENTATIVE:</b>	TYPE OF OPERATION:	
The New Cache La Poudre Irrigating Compar		Ethan Cozzens, Dale Trowbridge	112c - Construction Regular Operation	
<b>REASON FOR INSPECTION:</b>		BOND CALCULATION TYPE:	BOND AMOUNT:	
Normal I&E Program		Complete	\$39,560.00	
DATE OF COMPLAINT:		POST INSP. CONTACTS:	JOINT INSP. AGENCY:	
NA		None	None	
INSPECTOR(S):	INSPECTOR'S SIGNATURE:		SIGNATURE DATE:	
Hunter Ridley			November 6, 2023	
	Huntee	. Ridley

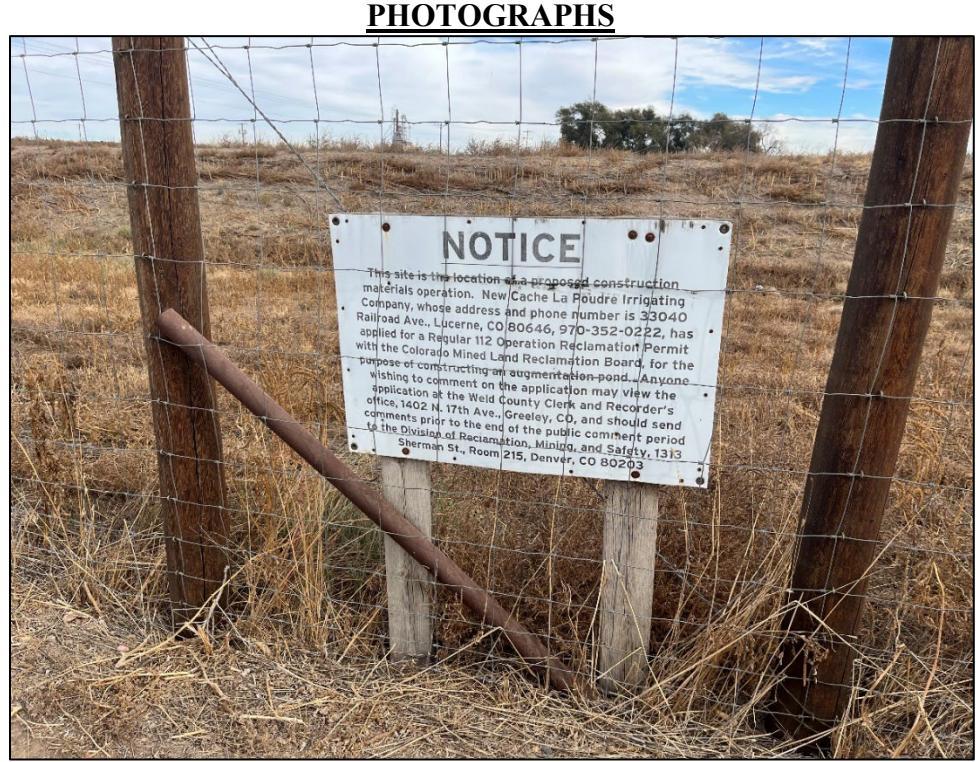
An entrance sign was posted (Photo 1) and permit boundary markers in the form of a fence was observed as required by Rule 3.1.12. The larger fence was established to keep the public and animals out of the pond. The second, smaller fence seen in Photo 5 is the actual permit boundary line.

Photo 1: Mine sign posted at the site entrance.

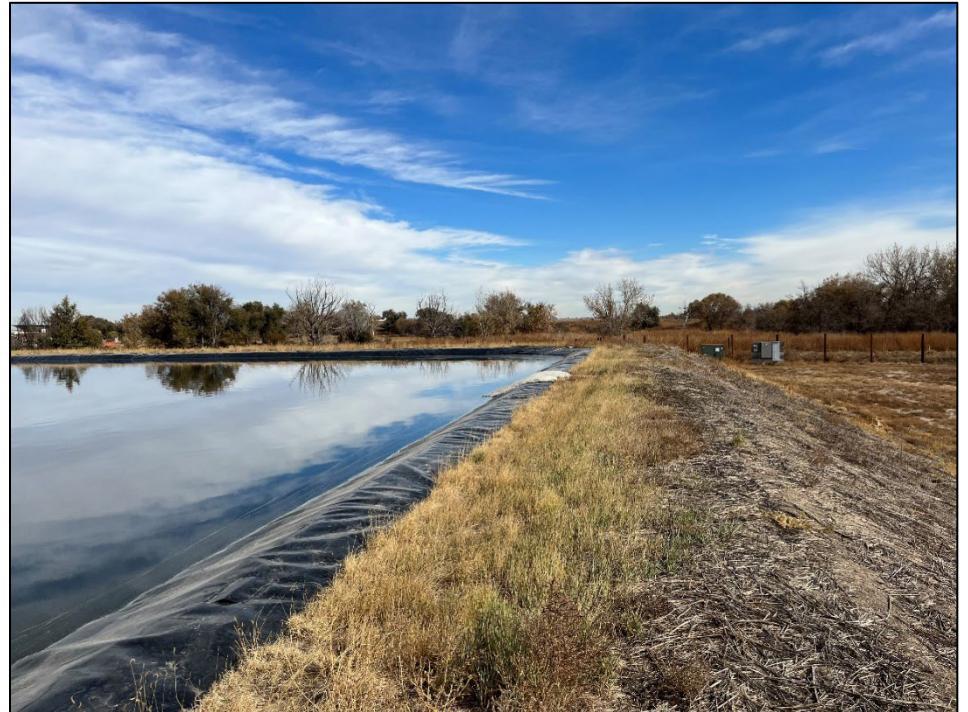
Reclamation grasses included in the approved mix such as blue grama and western wheatgrass were observed during the inspection. These species where in full coverage along the first ~2 foot, flat perimeter of the lined pond (Photos 2 and 4). As the slope increases, vegetative cover drops dramatically and weedy species such as Kochia and Russian thistle are present. The Operator seems to be following the approved noxious weed plan, as no noxious weed species were observed at the site during the inspection. The Operator stated that they had tried several seeding methods including broadcast seeding and hydro-mulching with little to no permanent success. Since the reservoir is lined, it is possible that the embankment around the liner was compacted during construction. Compaction prevents roots from permanently stabilizing and prevents water from percolating through as usual. Additionally, the site had very little topsoil to begin with which was re-spread over the site in reclamation. These two factors are potential causes for the unsuccessful establishment of vegetation on the embankment slopes. The following suggestions could aid in successful reclamation at the site:

Photo 2: View east of the south facing slope of the agricultural pond.

- Disc harrowing to help increase the depth of the root zone
- Introducing a cover crop to help stabilize soils while native seeds establish

The Division encourages the Operator to attempt one or more of these suggestions at the site in order to complete reclamation in a timely manner. The Division does not recommend regrading of the slope, as this could reduce the integrity of the embankment. Ultimately however, full and final reclamation of the site is up to the responsibly of the Operator. If the above suggestions do not result in successful revegetation, the Division would encourage the Operator to reach out to a private consultant for advice on reclamation at the site. The Division will not release the site until revegetation meets all the requirements and reclamation standards outlined in Rule 3.

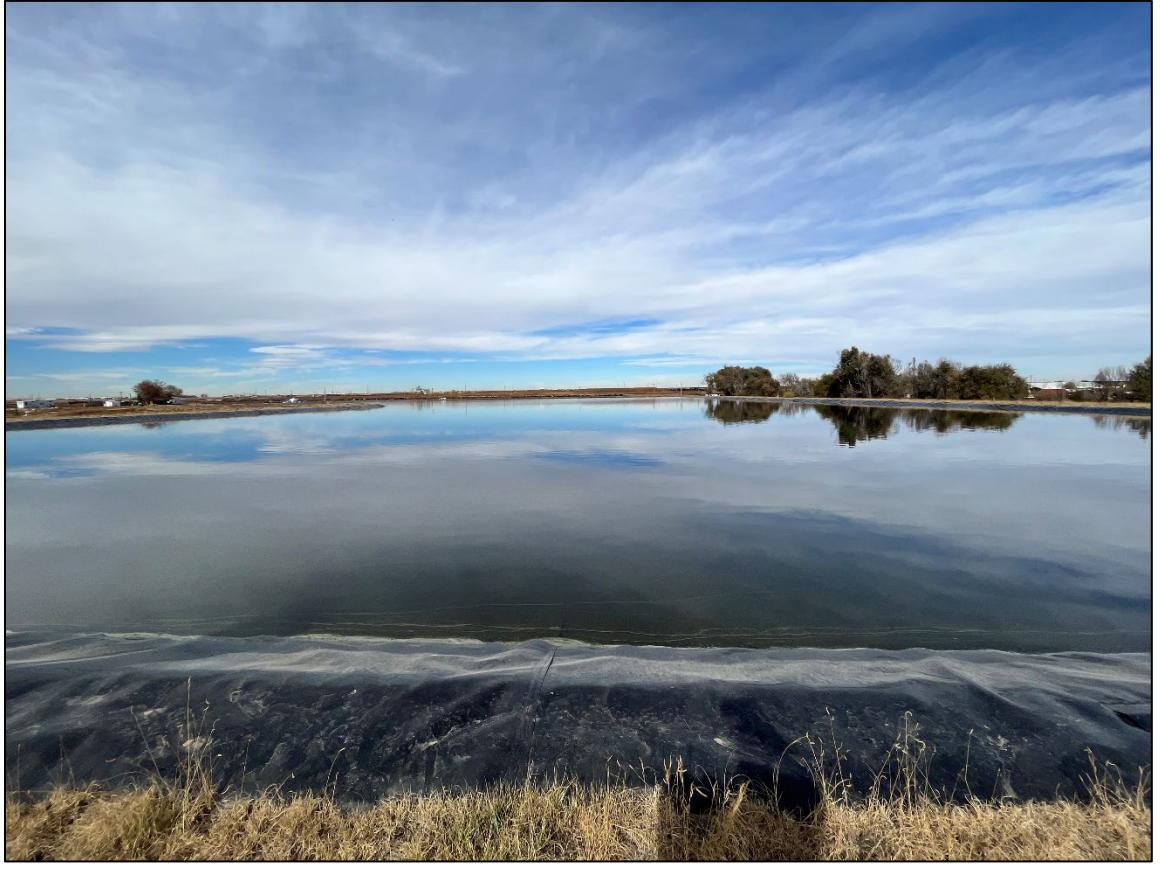
The site is permitted for 16.2 acres with 13.0 acres disturbed by the creation of a 9.13 acre agricultural pond (Photo 3). The construction of the pond and liner has been complete since 2016 and reseeding first occurred in 2016/2017. The only activities to have occurred since the Division's last inspection are attempts at seeding the remaining acres of disturbance at the site which are not taken up by the agricultural pond. The site has been in final reclamation for well over the five year time limit set under Rule 3.1.3. Therefore, it is important that the Operator shall with all reasonable diligence, work to reclaim the site to the conditions approved under the Reclamation Plan in a timely manner.

Photo 3: View north of the completed agricultural pond.

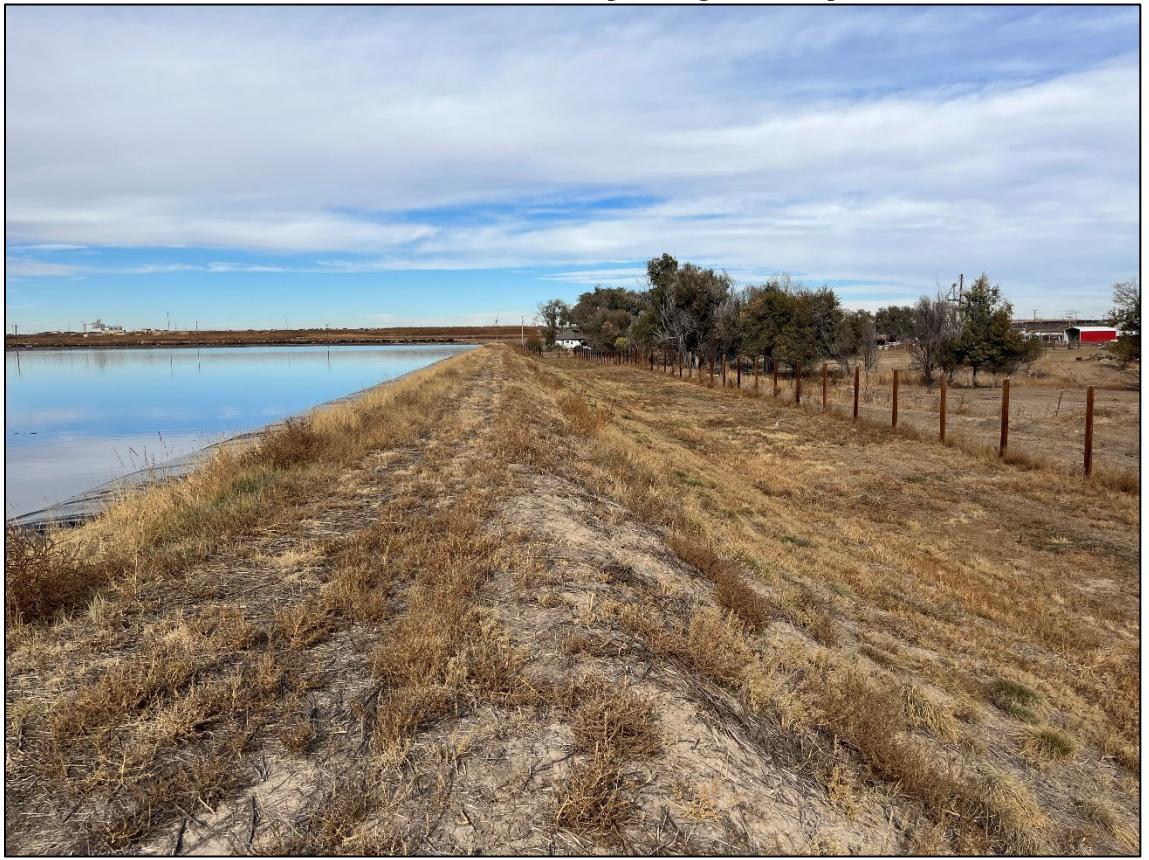
Photo 4: View north of the east facing slope of the agricultural pond.

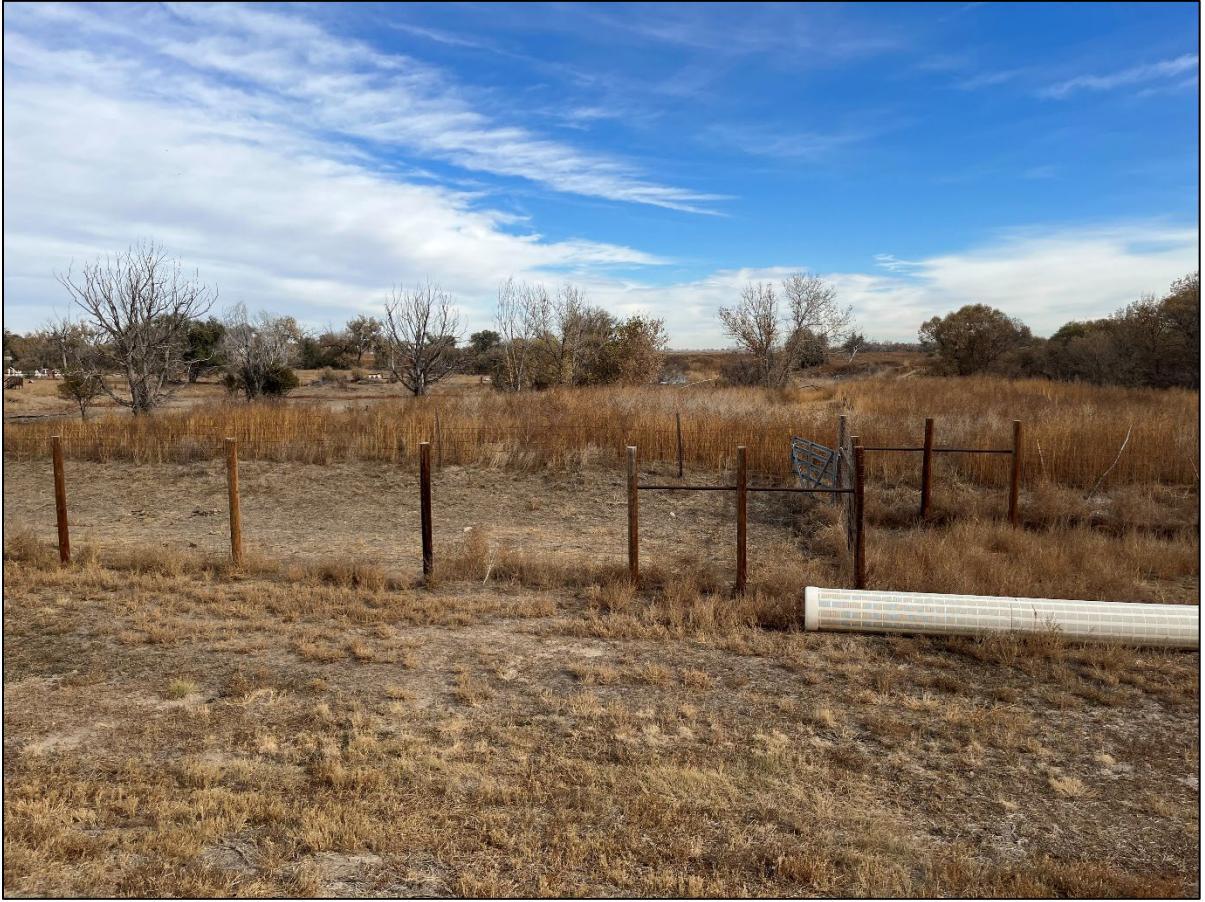
Photo 5: View east of the permit boundary fences.
