MINERALS PROGRAM INSPECTION REPORT PHONE: (303) 866-3567

MINE NAME:	MINE/PROSPECTING ID#:	MINERAL:	COUNTY:
La Poudre Sand & Gravel	M-1983-090	Sand and gravel	Weld
INSPECTION TYPE:	WEATHER: Clear	INSP. DATE:	INSP. TIME:
Monitoring		November 15, 2023	12:00
OPERATOR:	OPERATOR REPRESENTATIVE:	TYPE OF OPERATION:	
Bestway Concrete Company (BURNCO)	Devon Glosser	112c - Construction Regular Operation

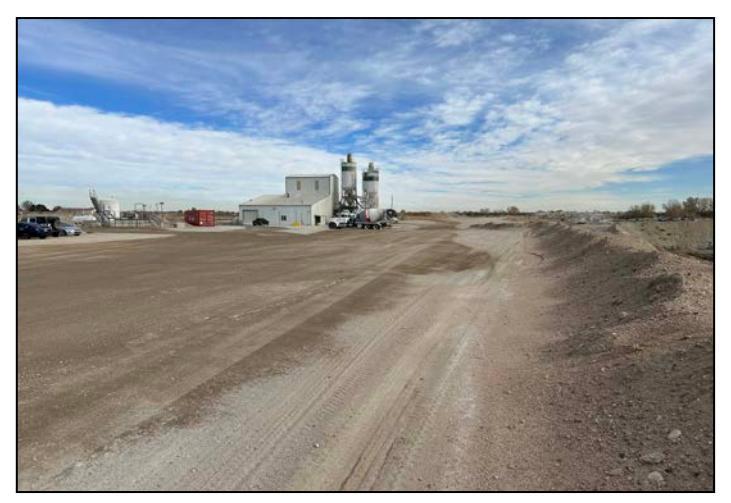
DRMS toured the site with the Mr. Glosser. No mining activity was observed within the permit area. The only site activity observed during this inspection was associated with the concrete batch plant located in the NW area of the permit. The post-mining land use for this site as identified in AM2 is developed water resource, not industrial/commercial. In addition, the 2023 SWSP submitted and approved for the site indicates that no additional material excavation will take place in this permit. Based on this information, DRMS has concluded that mining activity has ended at the LaPoudre Sand & Gravel permit. Final reclamation of the site may not be delayed for the purposes of maintaining operations at the existing concrete batch plant.

Photo 1 – Concrete plant in NW area of permit.

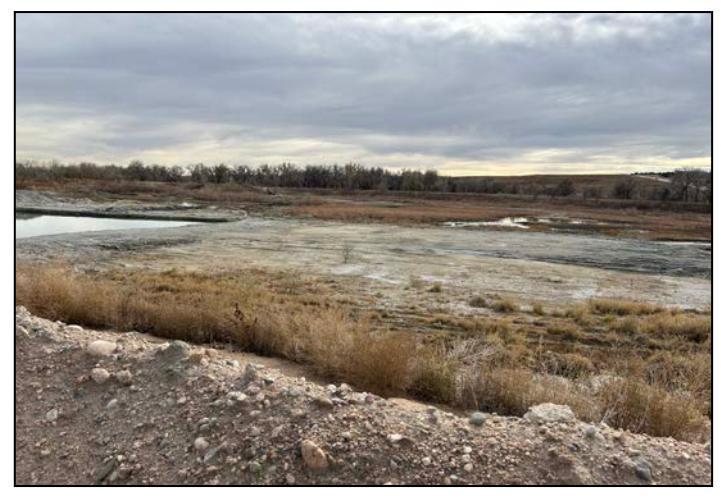
The eastern two reservoirs have been lined and contain water at this time. The slurry wall surrounding the water bodies in the north-center and north-east area of the site has been approved by the SEO's office. The final reclamation for the western exposed groundwater area (approx. 32 acres) has not been sufficiently addressed at this time. DRMS previously bonded to install a slurry wall around this area, however, mining is now complete and no slurry wall design has yet been submitted. This will need to be addressed either through backfill to at least two feet above static water level, installation of an SEO approved liner, or submittal of a permanent augmentation plan.

Photo 2 – Mined unlined area of groundwater exposure south of concrete plant on west side of permit.

The current reclamation plan needs to be updated and clarified pursuant to C.R.S. 34-32.5-116 (1). The operator must provide sufficient information to describe or identify how the operator intends to conduct reclamation.

CORRECTIVE ACTIONS: The operator shall submit a Technical Revision, with the required \$216 revision fee, which will provide sufficient detail as to how the site will be reclaimed, <u>including addressing existing exposed</u> groundwater areas within the permit area, and an enforceable timeline to complete the remaining required reclamation, by the corrective action date.

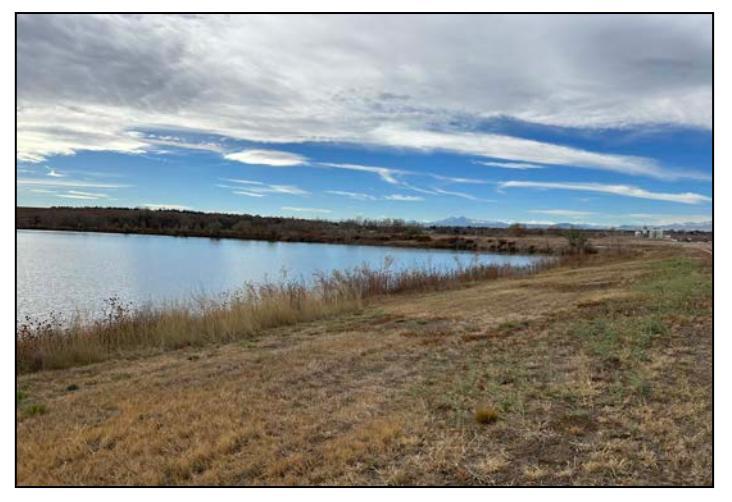
The reclamation vegetation surrounding the eastern reservoir has deteriorated and will need to be reestablished and properly maintained until that portion of the permit is released. It was also noted that the shoreline of this reservoir will also now likely require re-sloping prior to release due to wave damage over time.

Photo 3 – Lined reservoir area on east end of permit. Vegetation and shoreline sloping will require maintenance in this area.

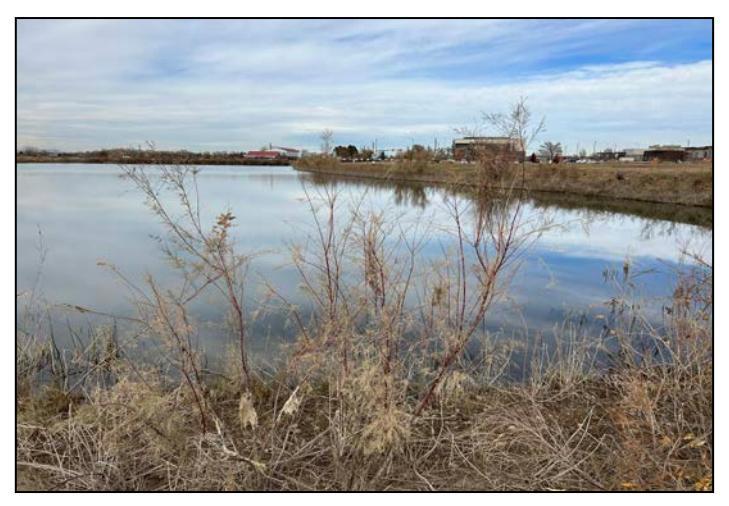
PROBLEM/POSSIBLE VIOLATION: Problem: Russian olive and Tamarisk trees are present within or have volunteered into the permit area and are becoming established. This is a problem for failure to employ the existing weed control plan and weed control methods for a state listed noxious weed species within the permitted area, and to reduce the spread of weeds to nearby areas as required by Section 3.1.10 (6) of the rule.

As noted on the first page of this report, as well as in the previous 2020 inspection, Tamarisk, Russian olive, cheat-grass, bindweed, and several other noxious weeds were noted during this inspection. These noxious species will need to be controlled or eliminated, and proof of this will need to be provided to the Division by the listed corrective action date of 5/31/24. Continued weed control measures, mowing at a minimum and likely spraying in some areas, will need to be implemented to control noxious weeds within the permit area.

Photo 4 – Representative photo of Tamarisk and Russian olive that will need to be eliminated from the permit area by corrective action date.

CORRECTIVE ACTIONS: The operator shall implement the existing weed control plan, eliminate the Russian Olive and Tamarisk present on site, and provide proof to the Division that this has been done by the corrective action date.
