**Date:** December 19, 2023

**RE: Adequacy Review No. 3, TR-9, Water Level Change and Pit Drain Evaluation Report,  
Review Memo, NCCI Pit #1, File No. M2001-107**

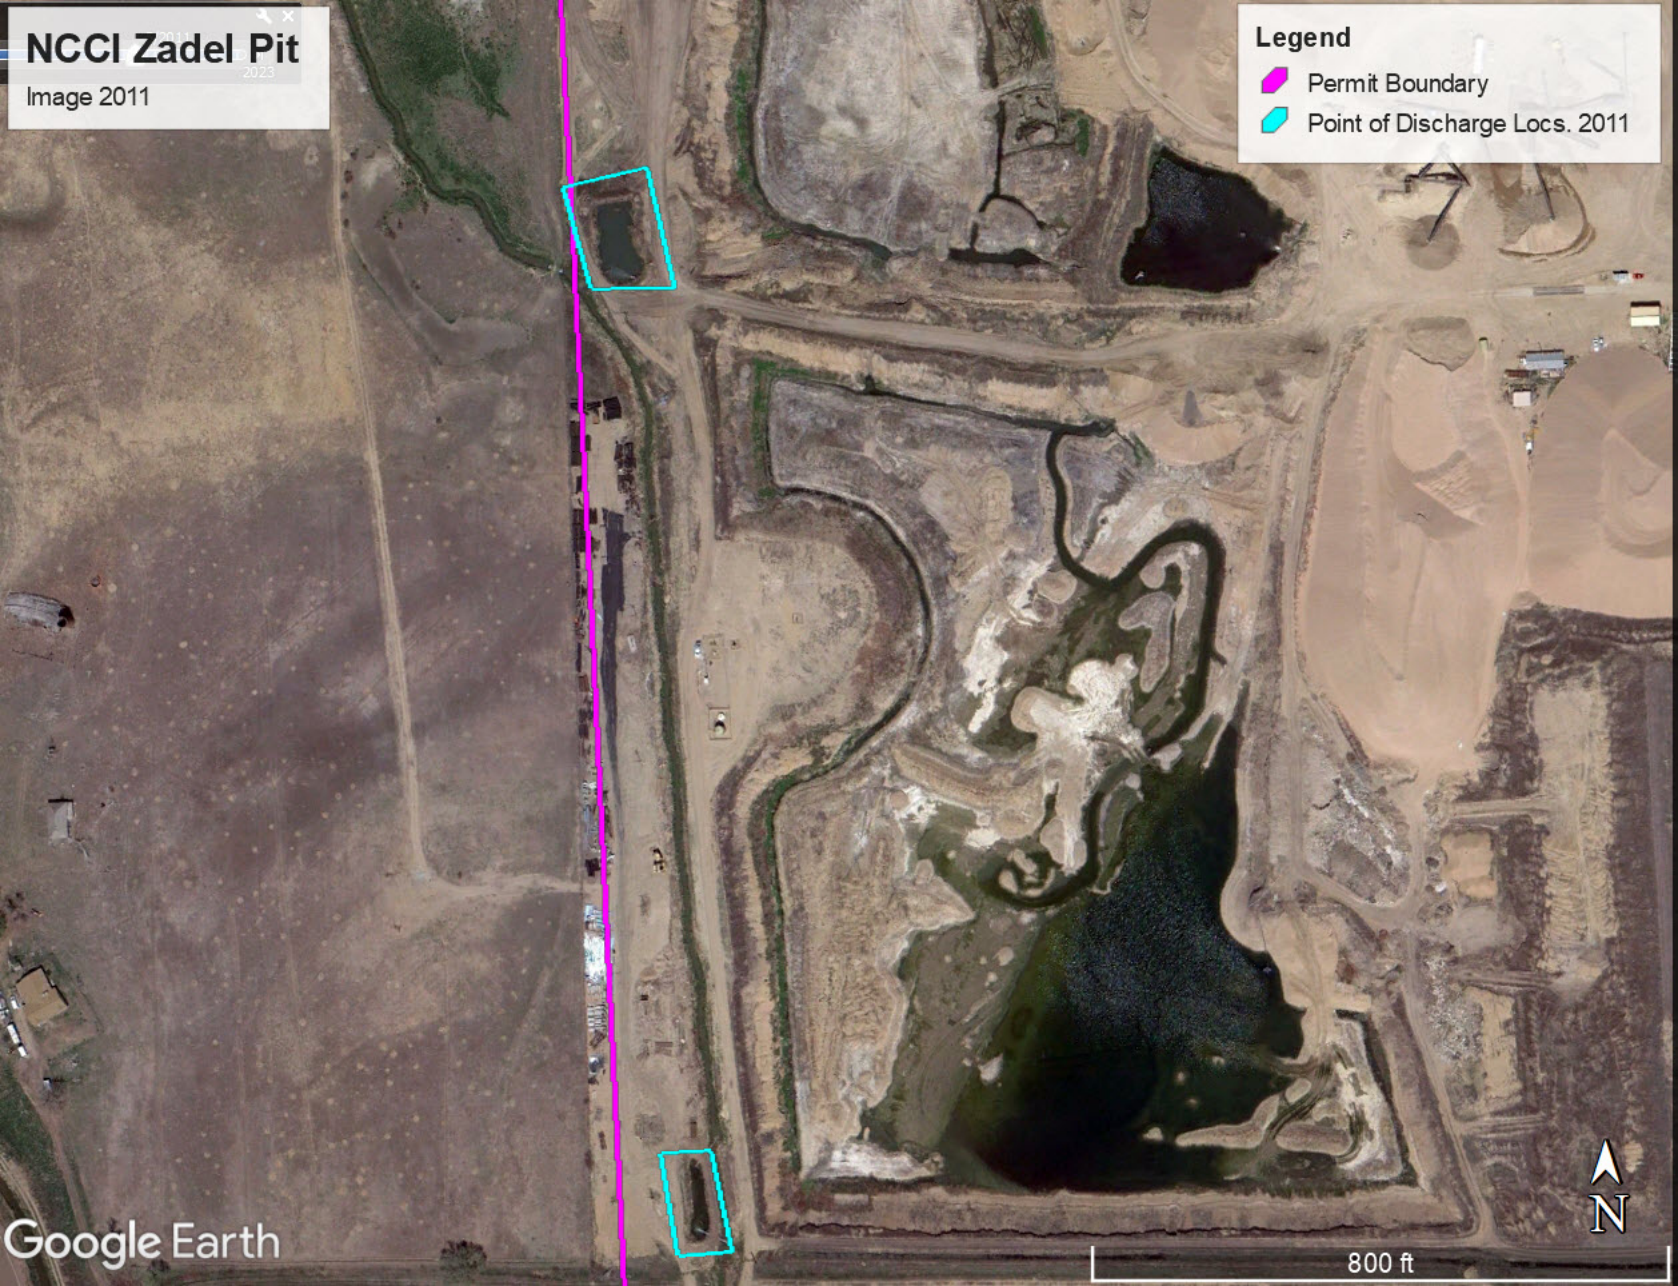
## **Attachment 1**

While there was ponding near and around the site that ponding has significantly increased over time. Please provide a map of the historical discharge points used during dewatering and the time frames when they were used. The Division's review of aerial imagery indicates two points were being used as discharge areas in 2011 south of the area in question (Attachment 1). In 2008, there appears to be a ditch that was installed to drain operations to the east along with direct discharge to LDC further south (Attachment 2). While ponding conditions may have existed prior to the initiation of mining operations those operations have negatively exacerbated the pre-existing conditions.

# NCCI Zadel Pit

Image 2011

- Permit Boundary
- Point of Discharge Locs. 2011
