## MINERALS PROGRAM INSPECTION REPORT PHONE: (303) 866-3567

MINE NAME:		MINE/PROSPECTING ID#:	MINERAL:	COUNTY:
Peters Pit No 2		M-1987-186	Sand and gravel	Weld
<b>INSPECTION TYPE:</b>		WEATHER: Windy	INSP. DATE:	INSP. TIME:
Monitoring			December 19, 2023	11:30
OPERATOR:		<b>OPERATOR REPRESENTATIVE:</b>	TYPE OF OPERATION:	
Weld County Public Works		Nate Gibson	112c - Construction Regular Operation	
<b>REASON FOR INSPECTION:</b>		BOND CALCULATION TYPE:	BOND AMOUNT:	
Normal I&E Program			\$0.00	
DATE OF COMPLAINT:		POST INSP. CONTACTS:	JOINT INSP. AGENCY:	
NA		None	None	
INSPECTOR(S):	INSPECTOR'S SIGNATURE:		SIGNATURE DATE:	
Hunter Ridley			January 2, 2024	
	Hunter	Ridley

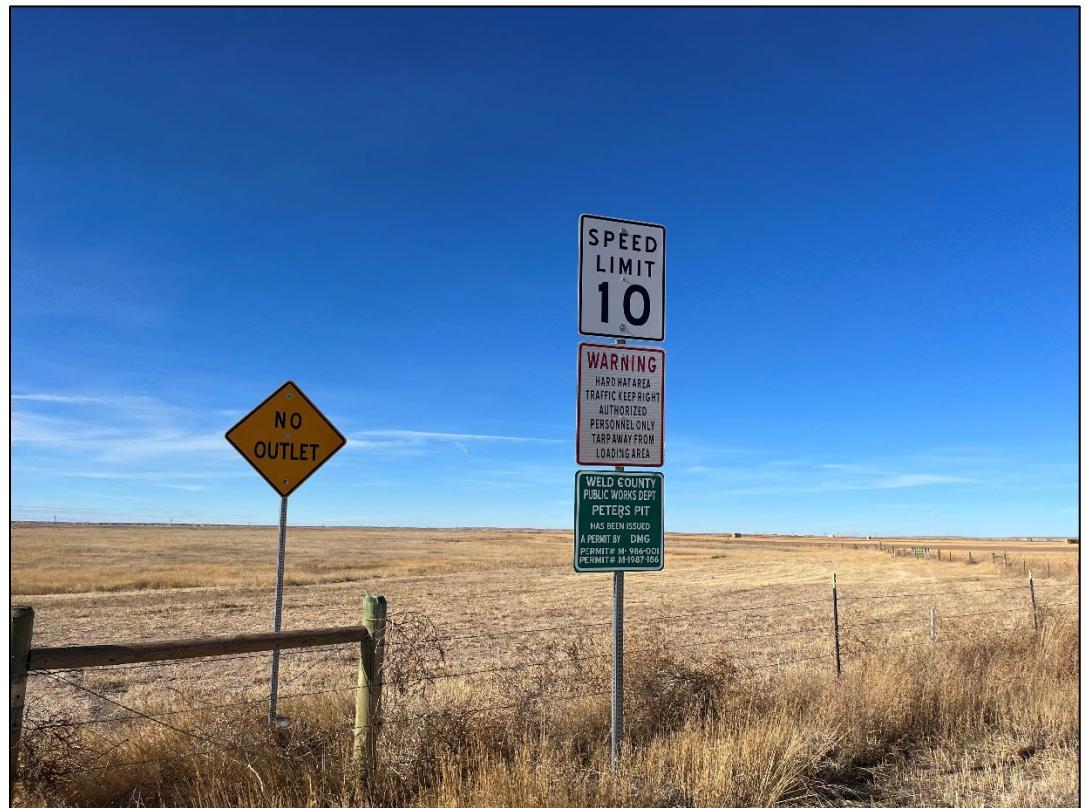
Boundary markers were observed as required by Rule 3.1.12. A mine identification sign was posted at the site entrance (Photo 1) and t-posts deleineated the sites permit boundary corners (Photo 4). The sign met all requirements of Rule 3.1.12. The site is currently in final reclamation. No mining activity has occurred at the site since 2014. The site has been reclaimed as per the approved Reclamation Plan. Slopes have been graded to 4H:1V, 1-2 feet of topsoil and overburden has been replaced, and the site has been revegetated with a seed mixture recommended by the Soil Conservation Service which includes western wheatgrass, sideoats grama, blue grama, little bluestem and switchgrass.

Photo 1: Mine signage located just off CR 136.5.

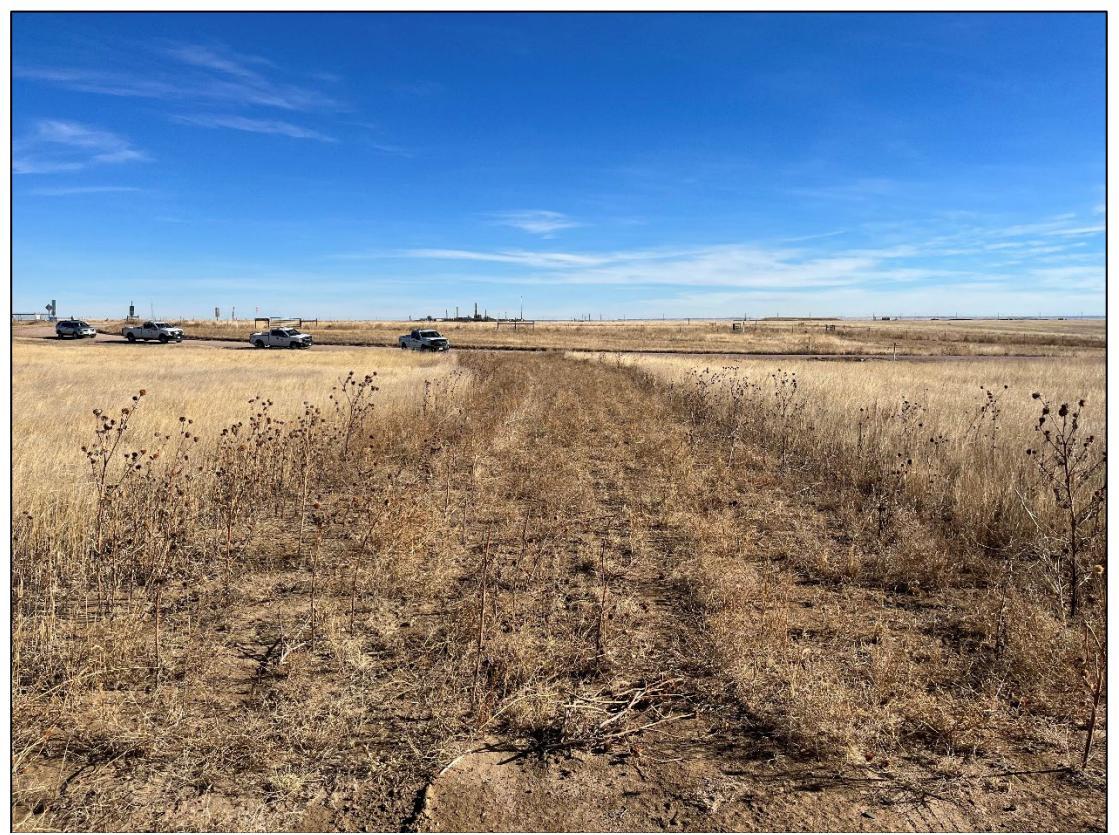
Photo 2: View east of the access road.

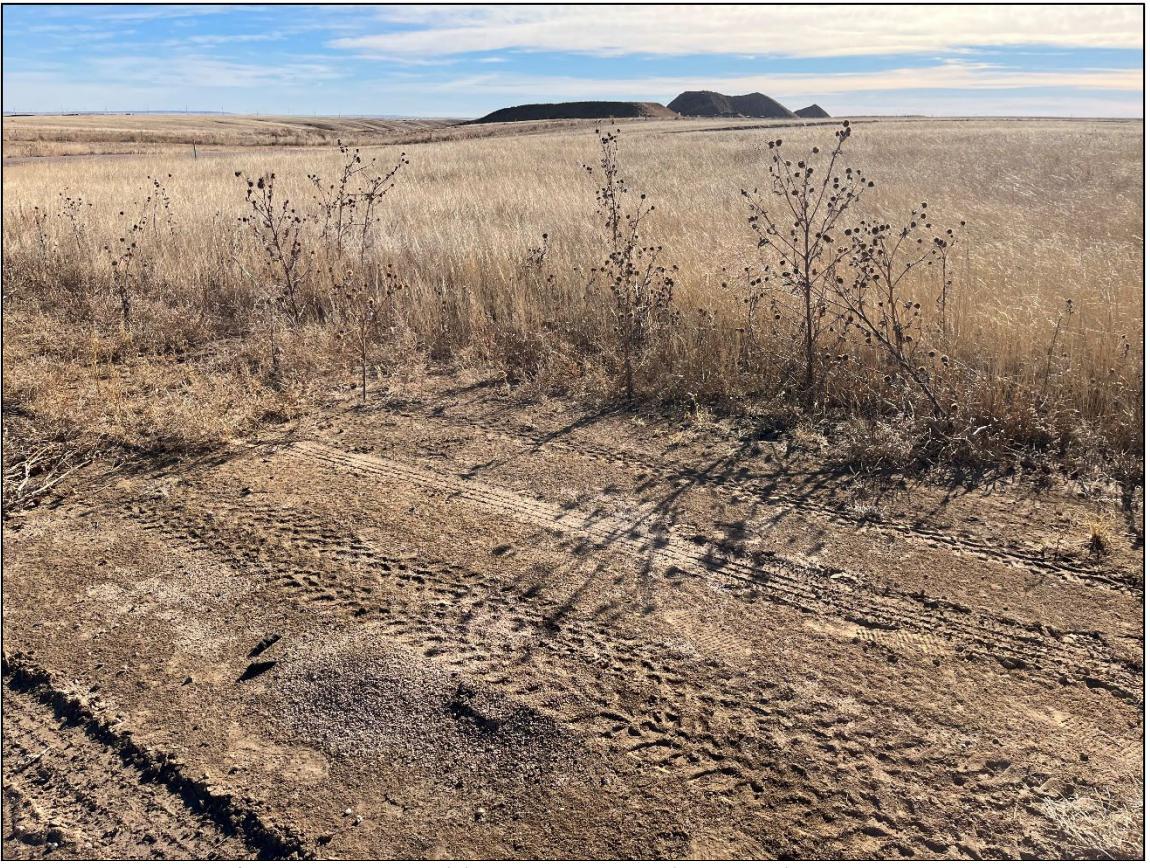
As reported in the Division's last inspection report from 2018, The southern 10 acres and two peninsula areas were reclaimed in 2015. These areas remain vegetated with well-established grasses (Photos 5 and 6). The remaining 22 acres, including the access road, were reclaimed in 2017. This 2017 reclamation area consisted predominantly of native grasses. Annual weeds were not growing in excess in these reclaimed areas. No noxious weeds were noted during the inspection, however annual weeds such as thistles, sweet clover, and kochia were noted along the partially reclaimed access road. The access road was also bare in a few areas (Photo 2 and 3). The Operator stated that the access road was last drill seeded in 2022 but explained that they have been struggling with revegetation of this area. The Division recommended control of annual weeds in this area to encourage growth of native species in the seed mix.

Photo 3: Bare spots are visible along the partially reclaimed access road.

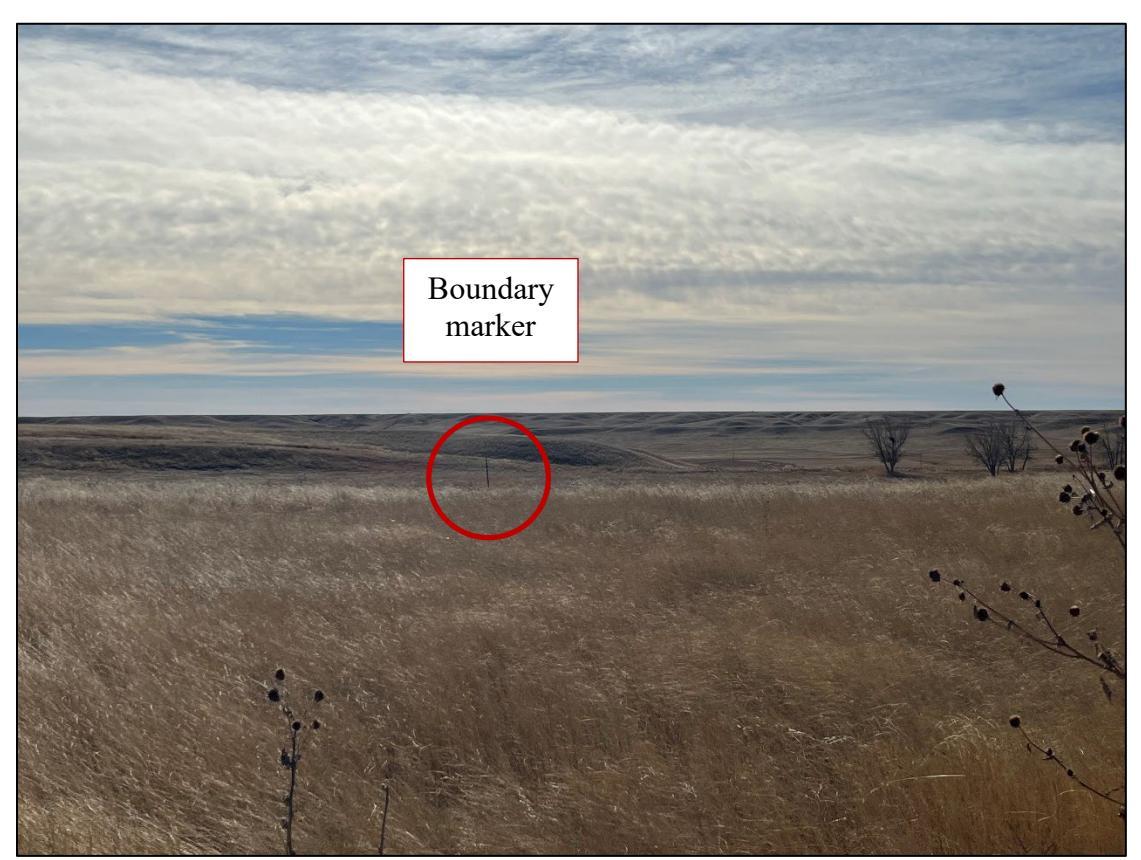
Photo 4: T-posts delineate the permit boundary corners.

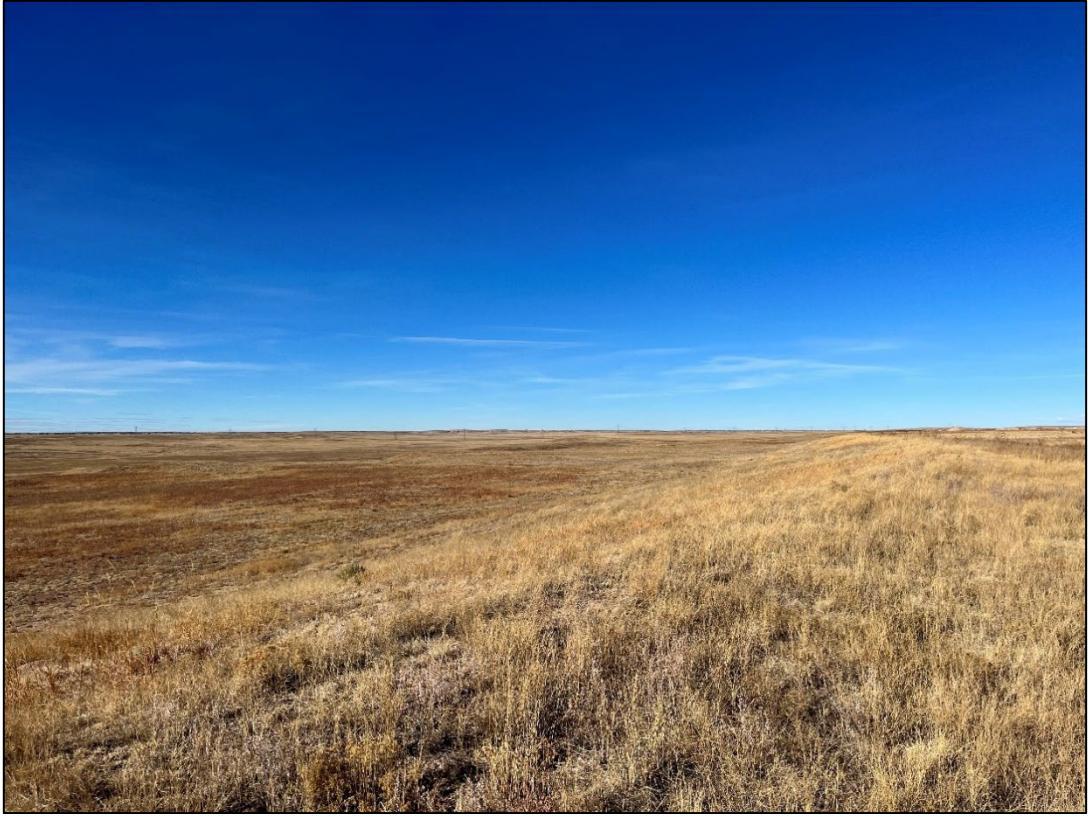
Photo 5: View north of the reclaimed pit floor.

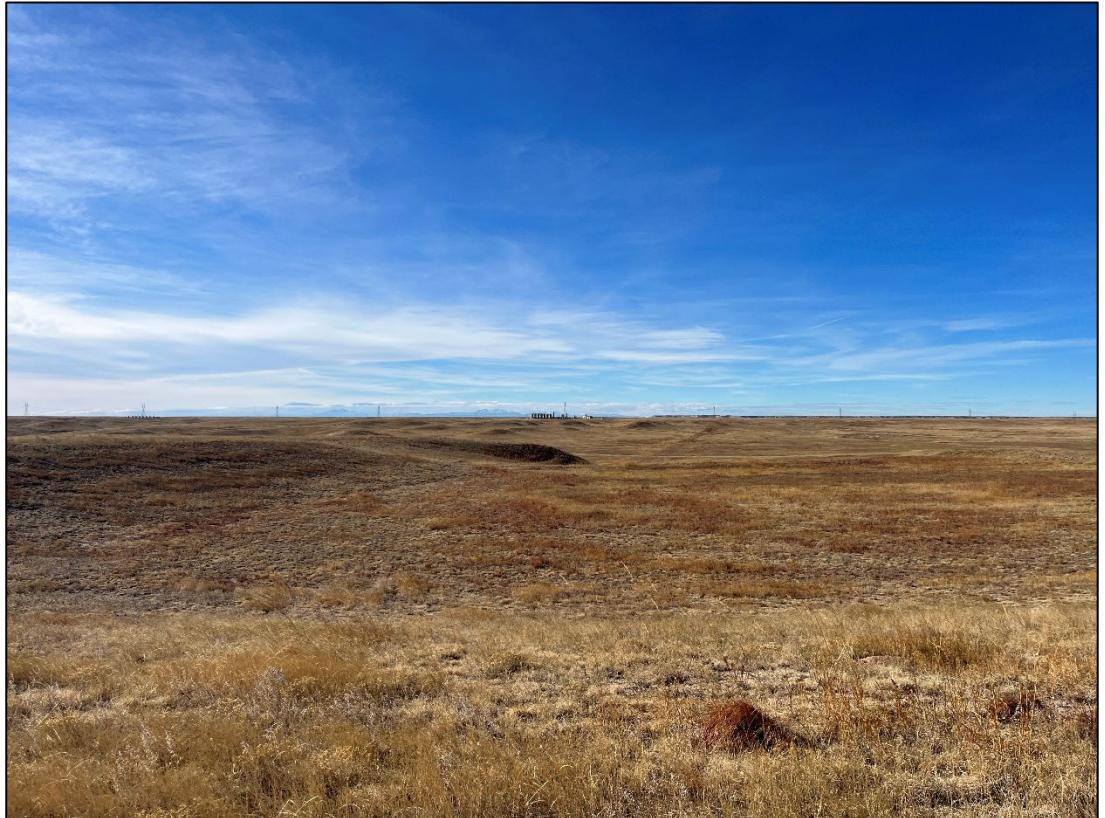
Photo 6: View to the west from the access road of the reclaimed pit floor.
