# **GEOTECHNICAL REPORT**

2024 Annual Report Structural Geology Evaluation Specification Aggregates Quarry

### Martin Marietta Materials Golden, Colorado

Schnabel Reference 23180001.000 February 6, 2024

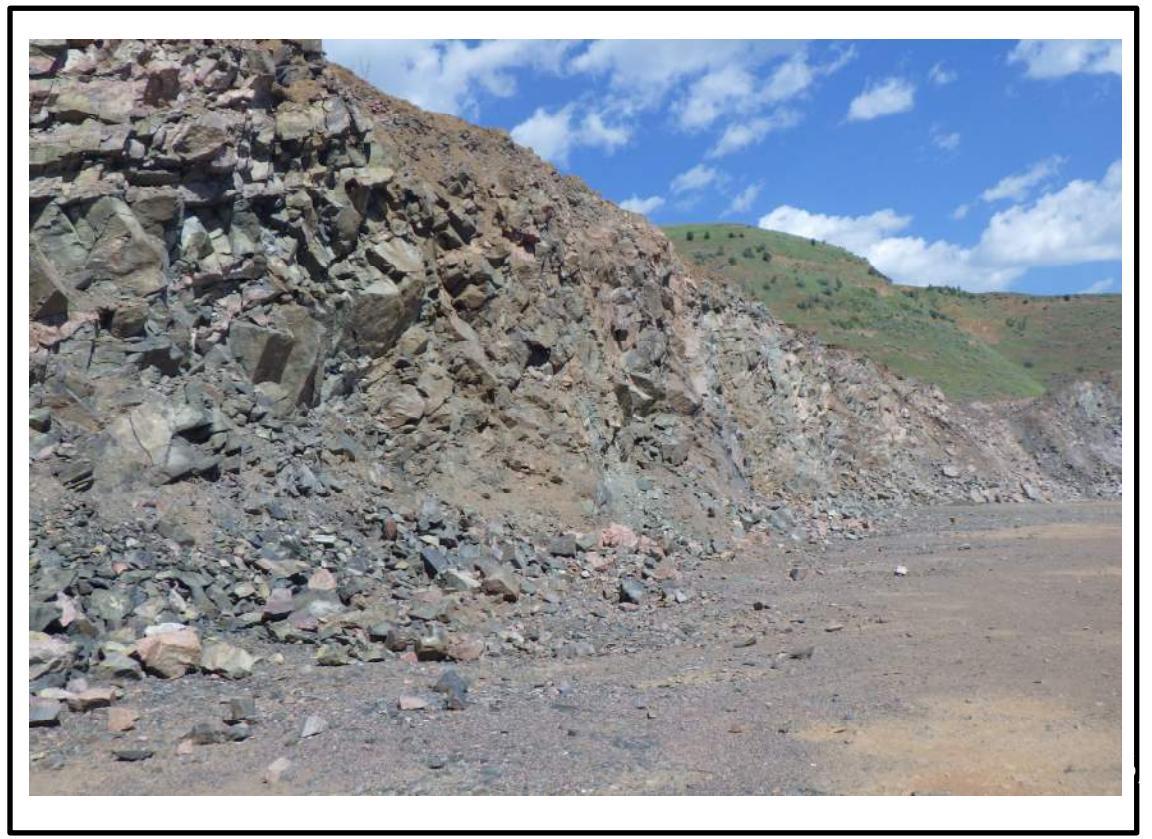
Photo 1: Looking West at Southern Walls, Bench EL 6440 (June 2023)

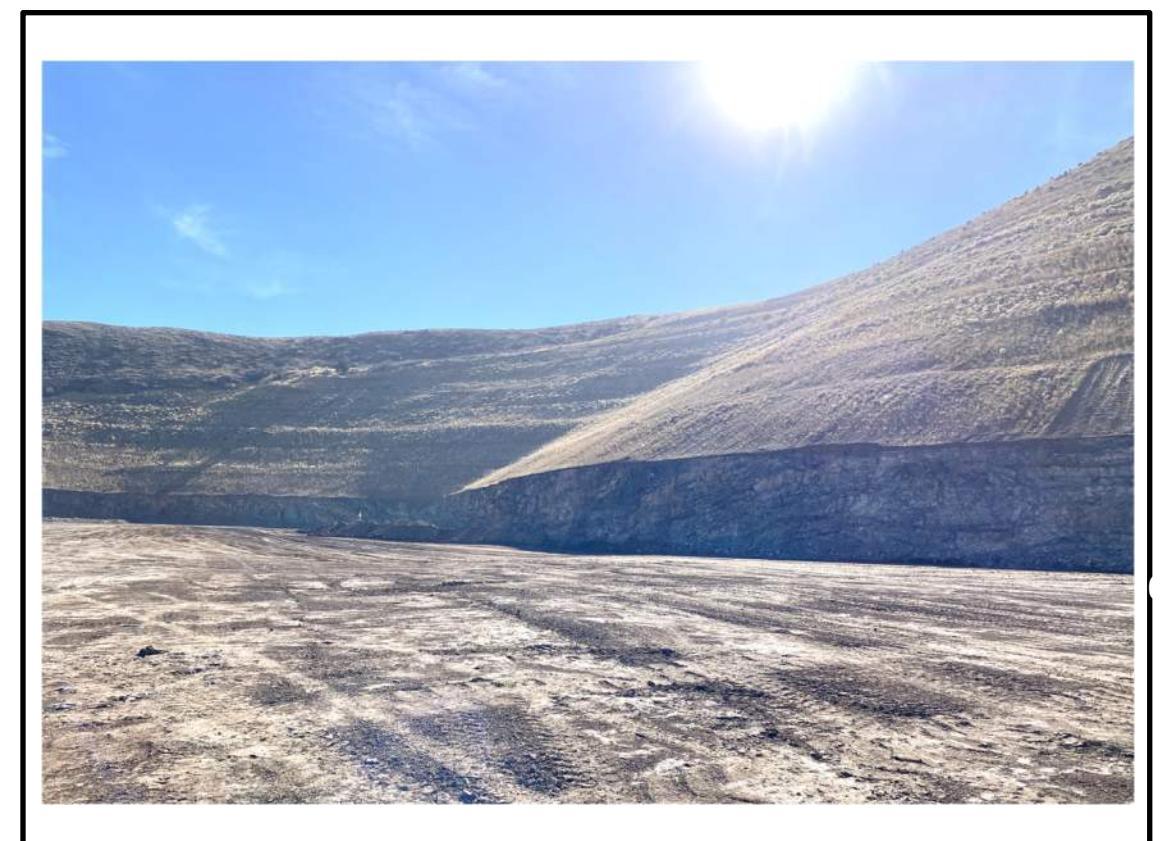
Photo 2: Looking SE at Southern Walls, Bench EL 6440 (November 2023)

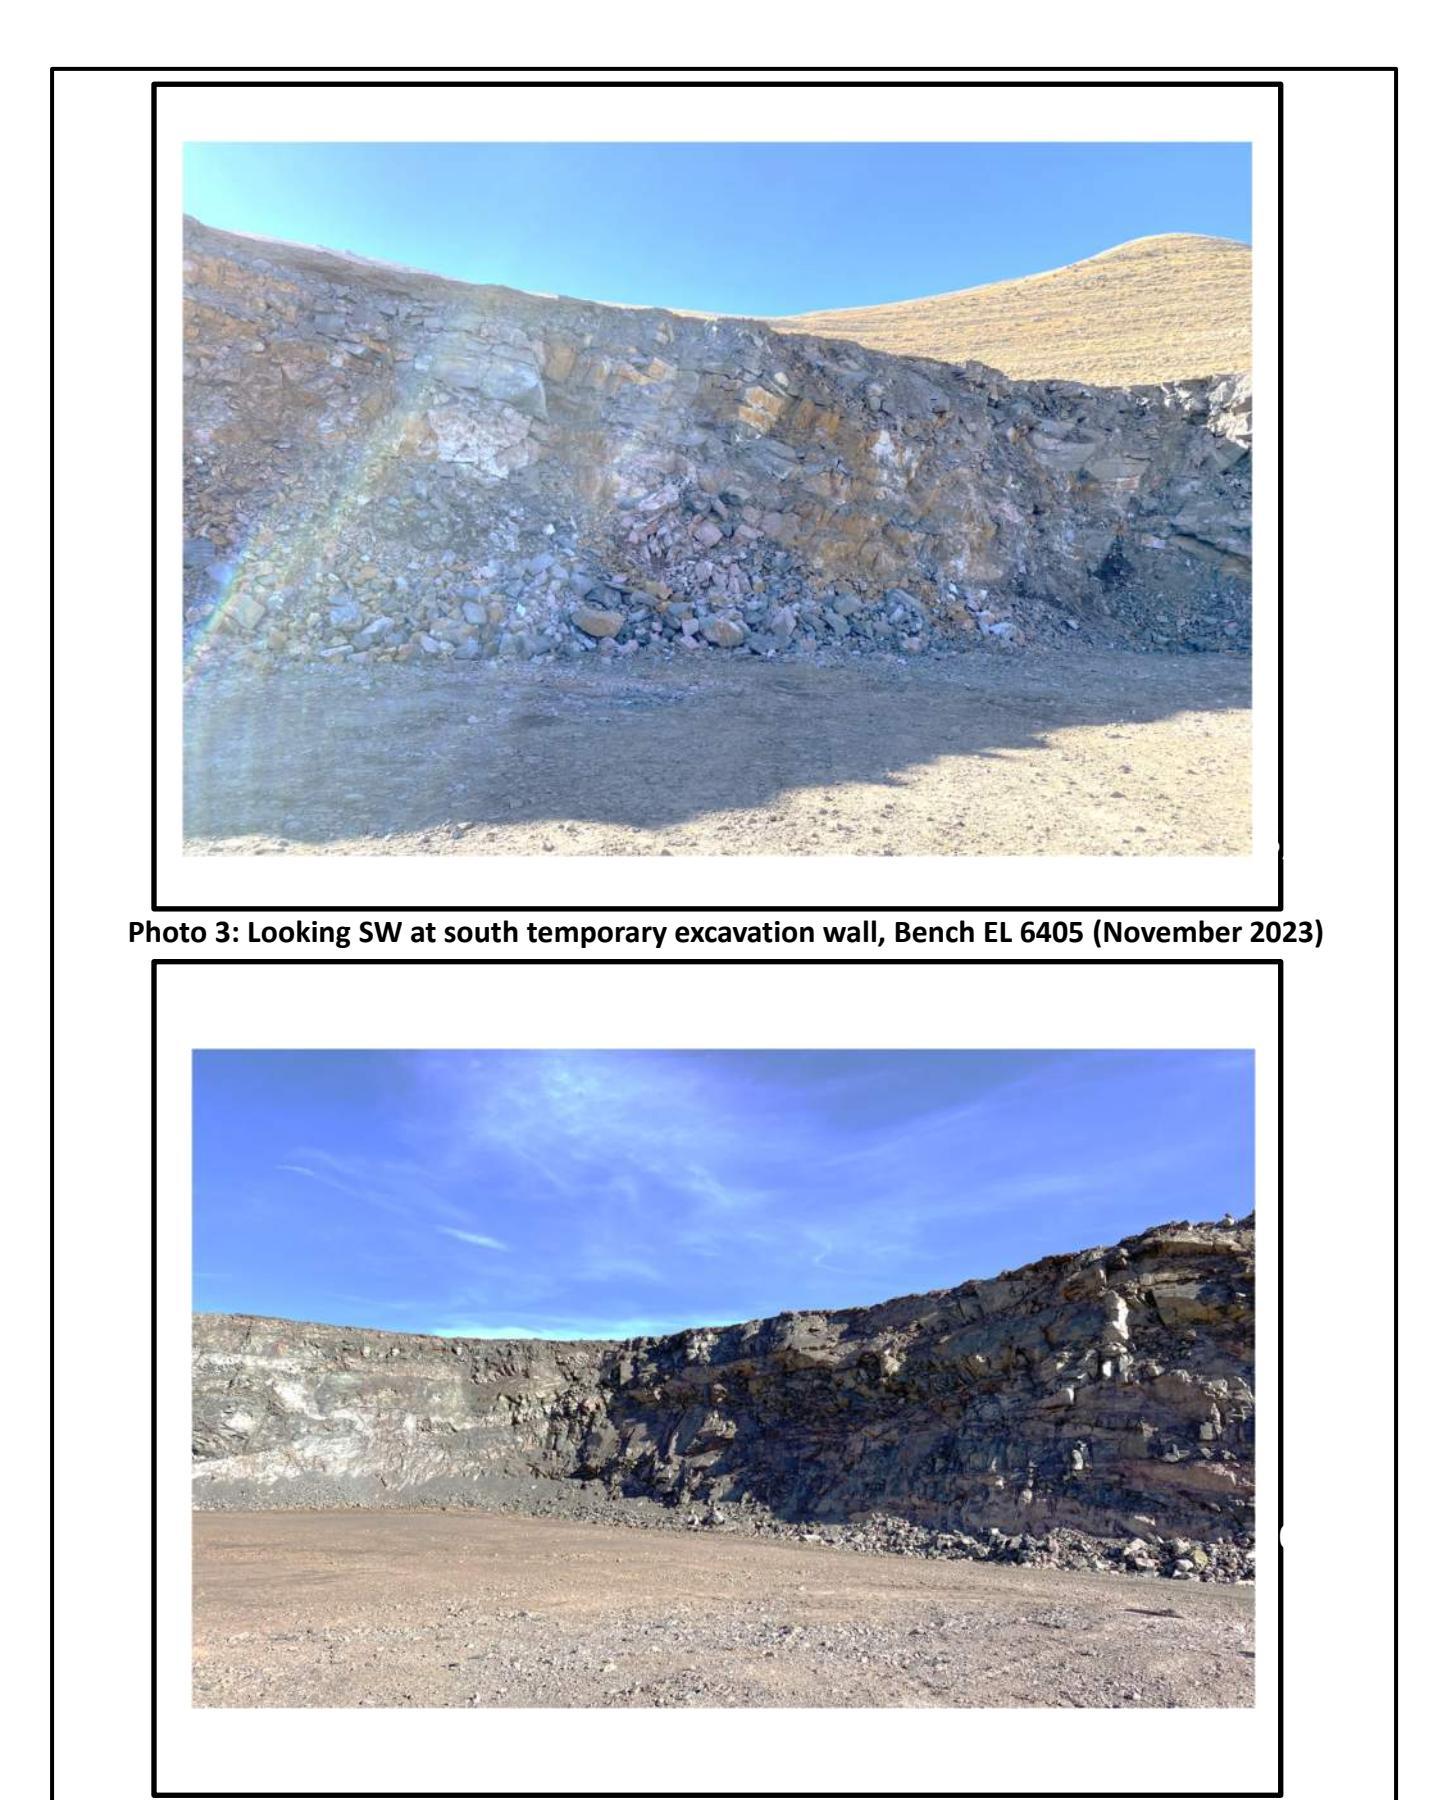
Photo 4: Looking NE at East temporary excavation wall, Bench EL 6405 (November 2023)

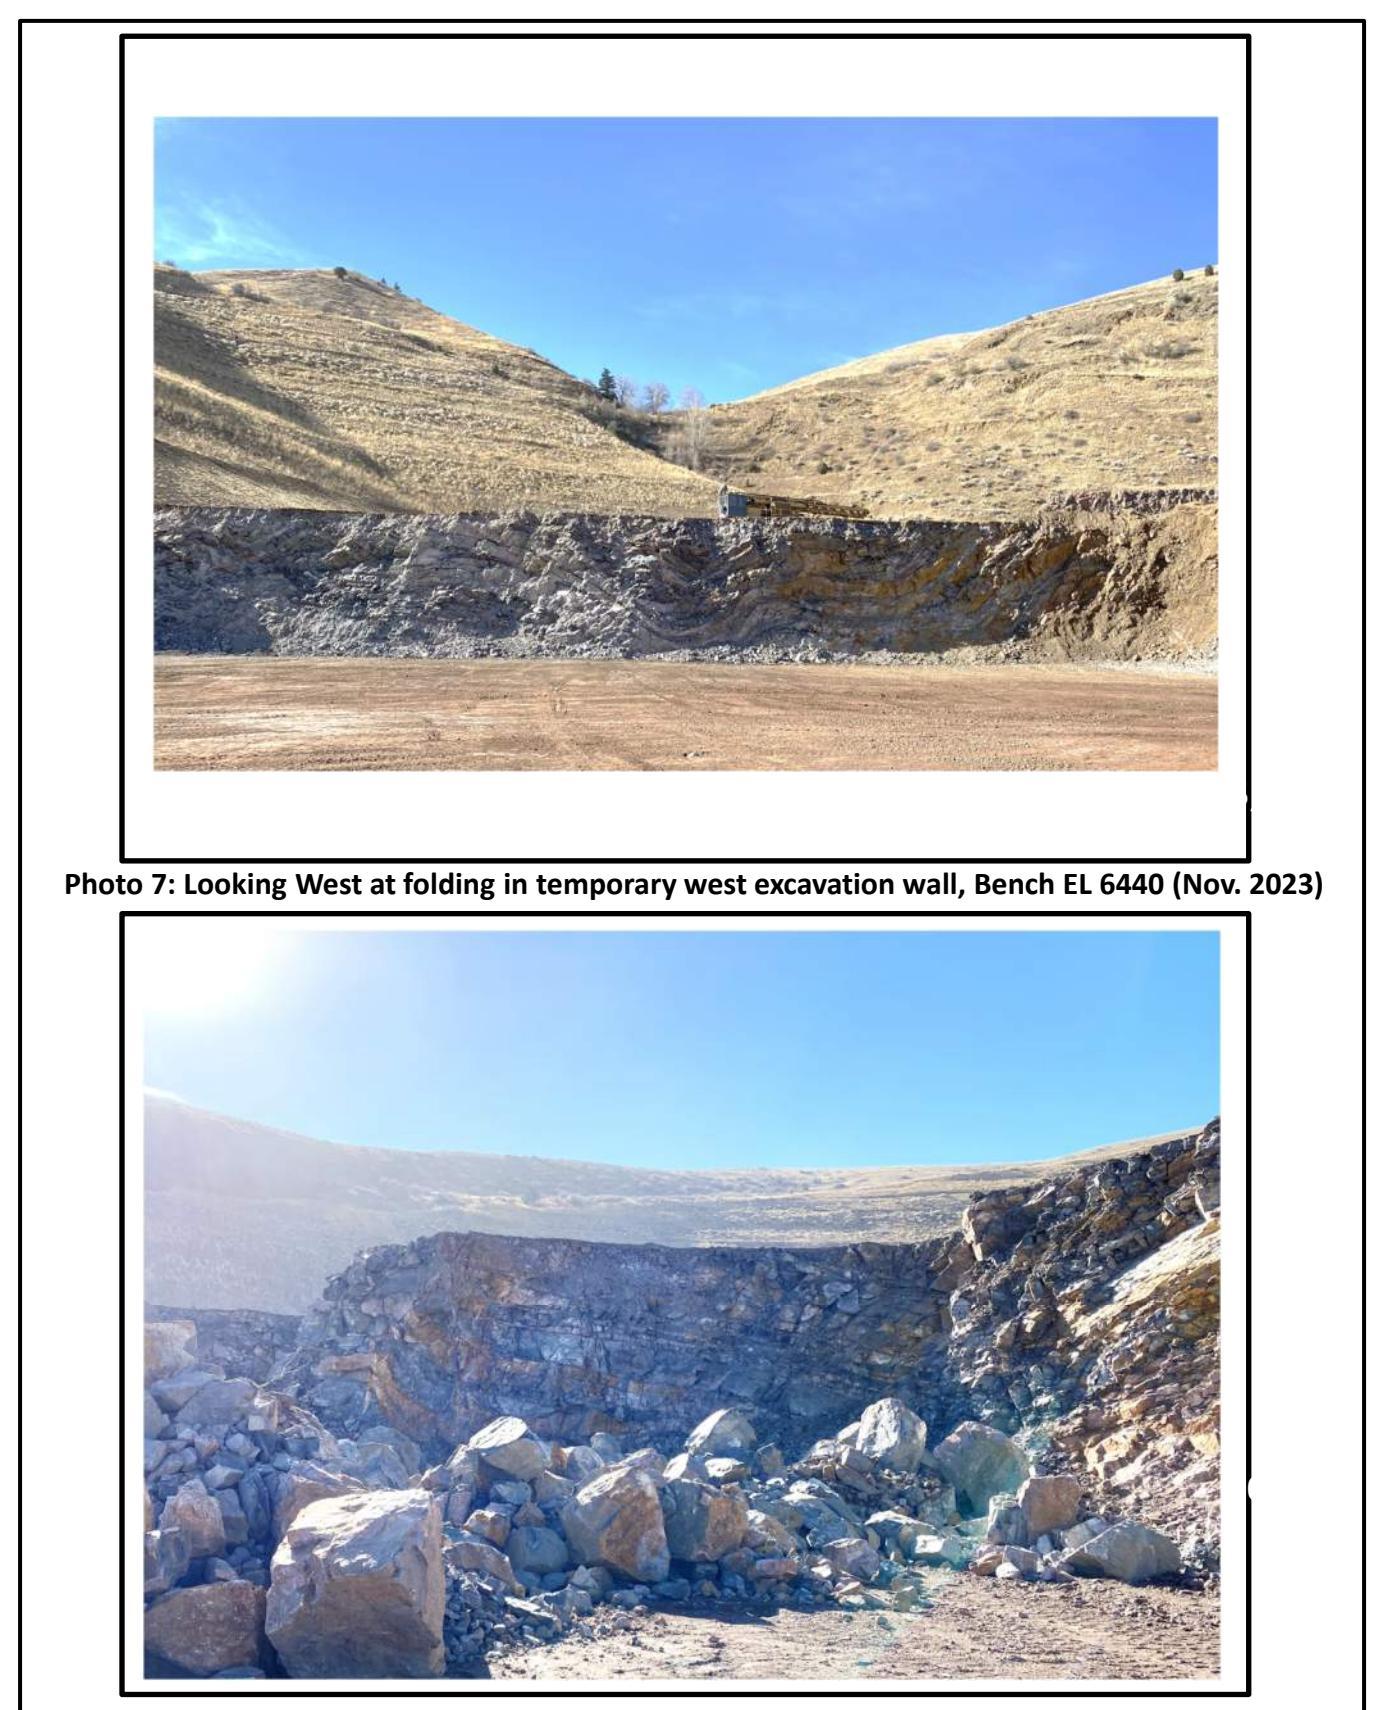
Discontinuity orientations on the EL 6.440 ft bench were measured in the south, southwest, and west temporary excavation walls during our 2023 site visits. Along the south temporary excavation wall, a fault exposure was observed near Station 24-01 (Photo 5) as well as multiple small scale shear zones (Photo 6). During the November 2023 inspection, folding and foliation was also observed in the west temporary excavation wall of the EL 6.440 ft bench near Station 24-03 (Photo 7). Discontinuity orientations measured on the EL 6,405 ft bench walls only occurred during the November 2023 inspection, and were measured in the west, south, and east temporary excavation walls. A fault exposure was observed at a corner of the west temporary excavation wall near Station 24-04 (Photo 8). Rock in the northern portion of the west temporary excavation wall appeared to be more massive and became more fractured as measurements advanced further south (Photo 9). Metamorphic banding was also observed in the west temporary excavation wall. A localized small scale shear zone was observed near Station 24-05 in the northeast corner of the east temporary excavation wall at bench EL 6,405 ft (Photo 10). Shear zones observed during the 2023 inspections correspond to some previous shear and fault measurements observed in 2022, but appear to be localized. Previous fault and shear zone measurements along with those observed in the 2023 reporting year are shown in Figure 3 and presented in the stereonet in Figure 4.

Photo 8: Looking south at fault in corner of south and west temporary excavation, Bench EL 6405 (November 2023)

We also recommend that known faults are tracked and observed in new exposures to confirm orientation and character for supplemental stability analysis, as needed. We expect the southern fault identified by Gable (1968) and in previous years site visits (**Figure 3**) may be exposed in other locations as excavation continues in the Southern Expansion Area. As recommended in the previous reports, evaluations will be conducted during future investigations to assess whether or not any of the foliation sets (F-1 through F-3) are caused due to localized faulting that may have resulted in "structural regions" that have created areas in which the varying orientation of the foliation planes occur. These questions will continue to be addressed as more data is collected.

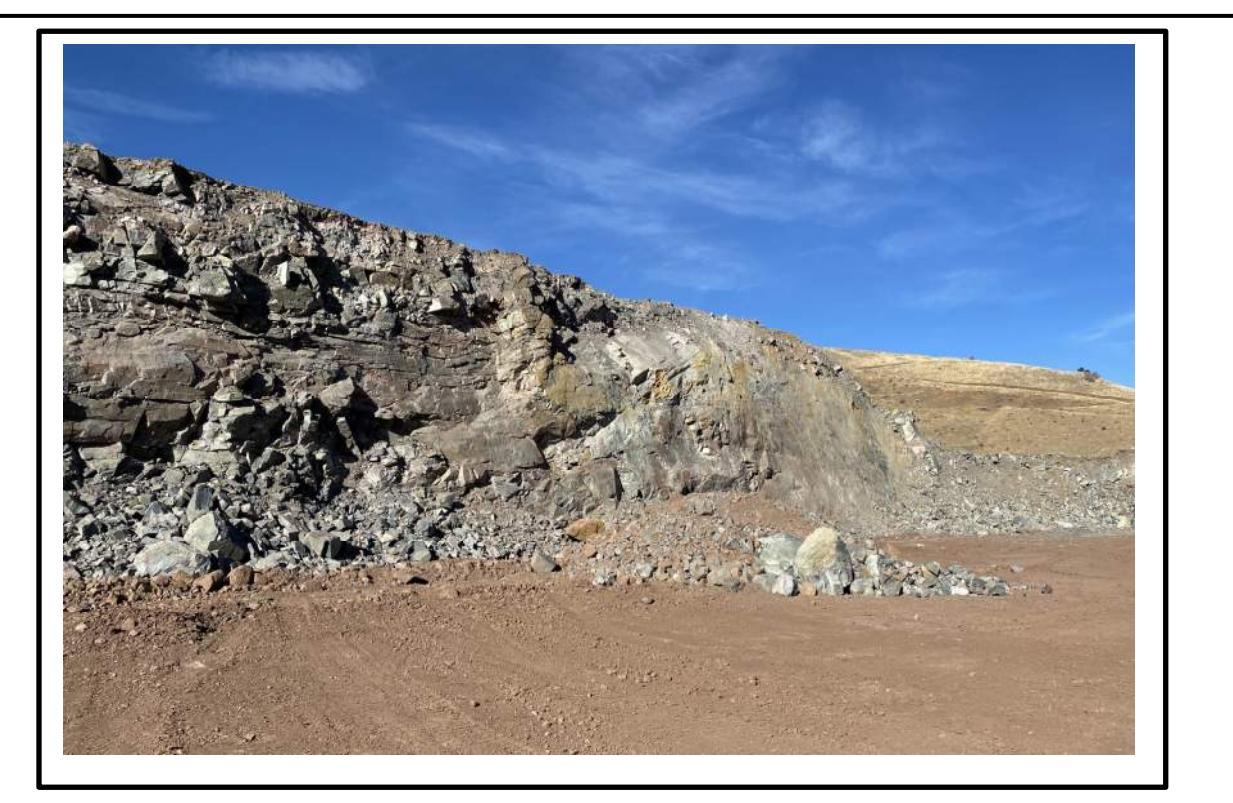
Photo 9: Looking NW at massive face of west temporary excavation, Bench EL 6405 (November 2023)

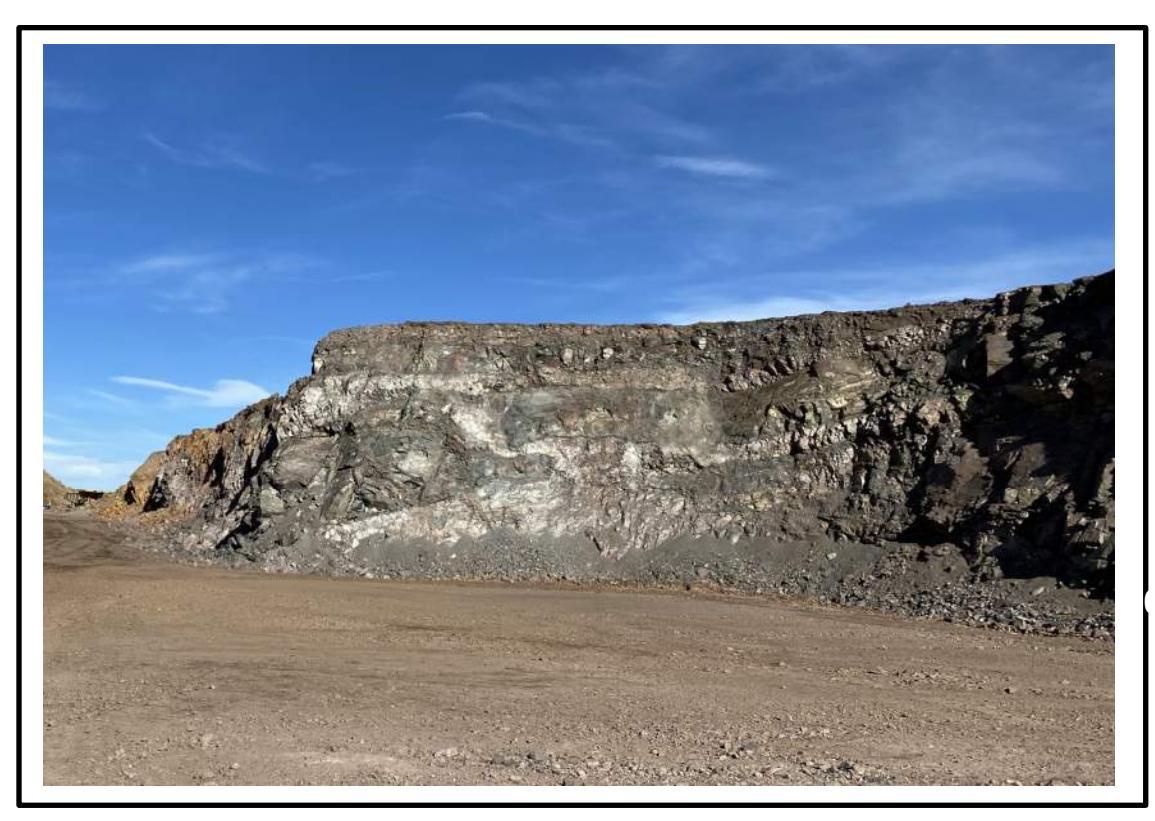
Photo 10: Looking NW at localized shear zone in east temporary excavation, Bench EL 6405 (November 2023)

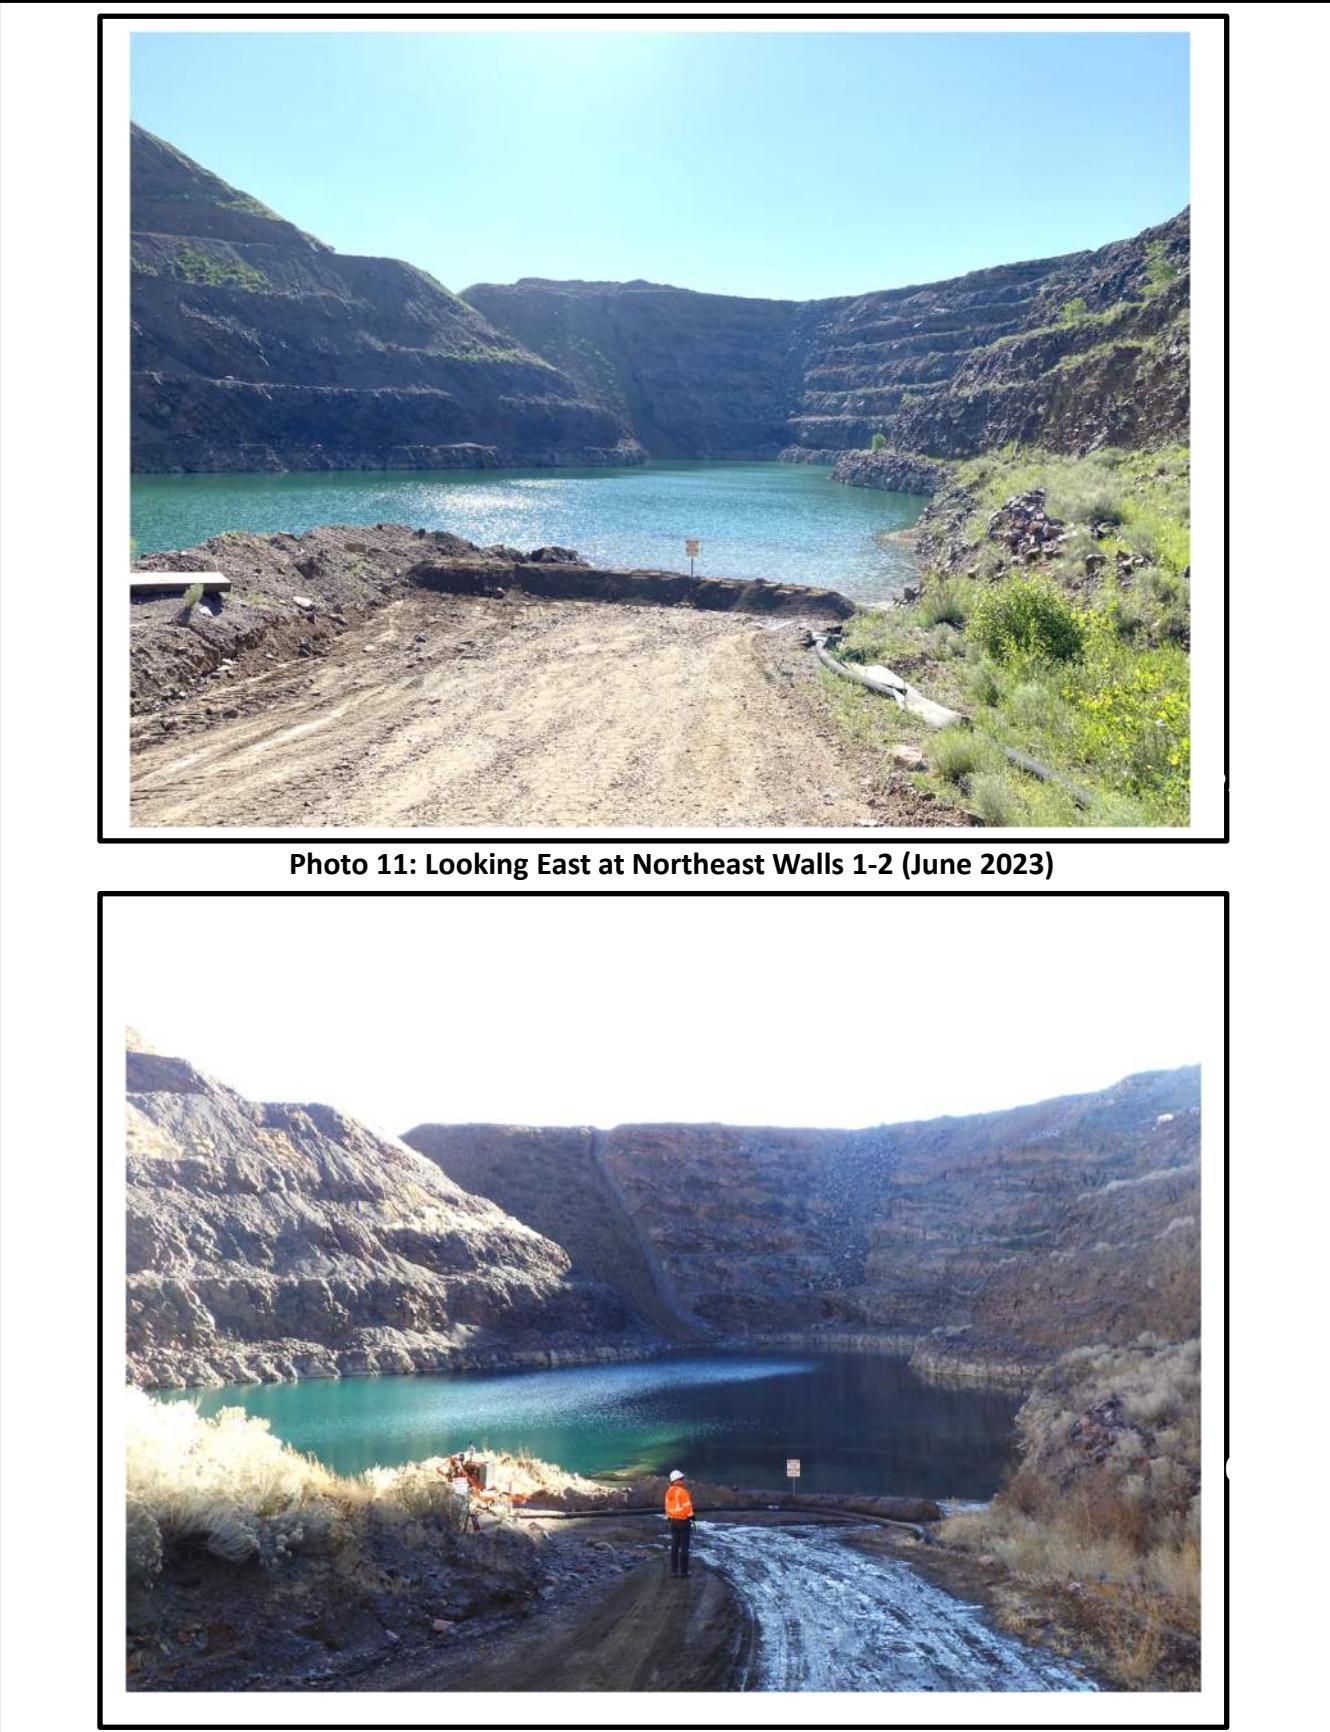
Photo 12: Looking East at Northeast Walls 1-2 (November 2023)

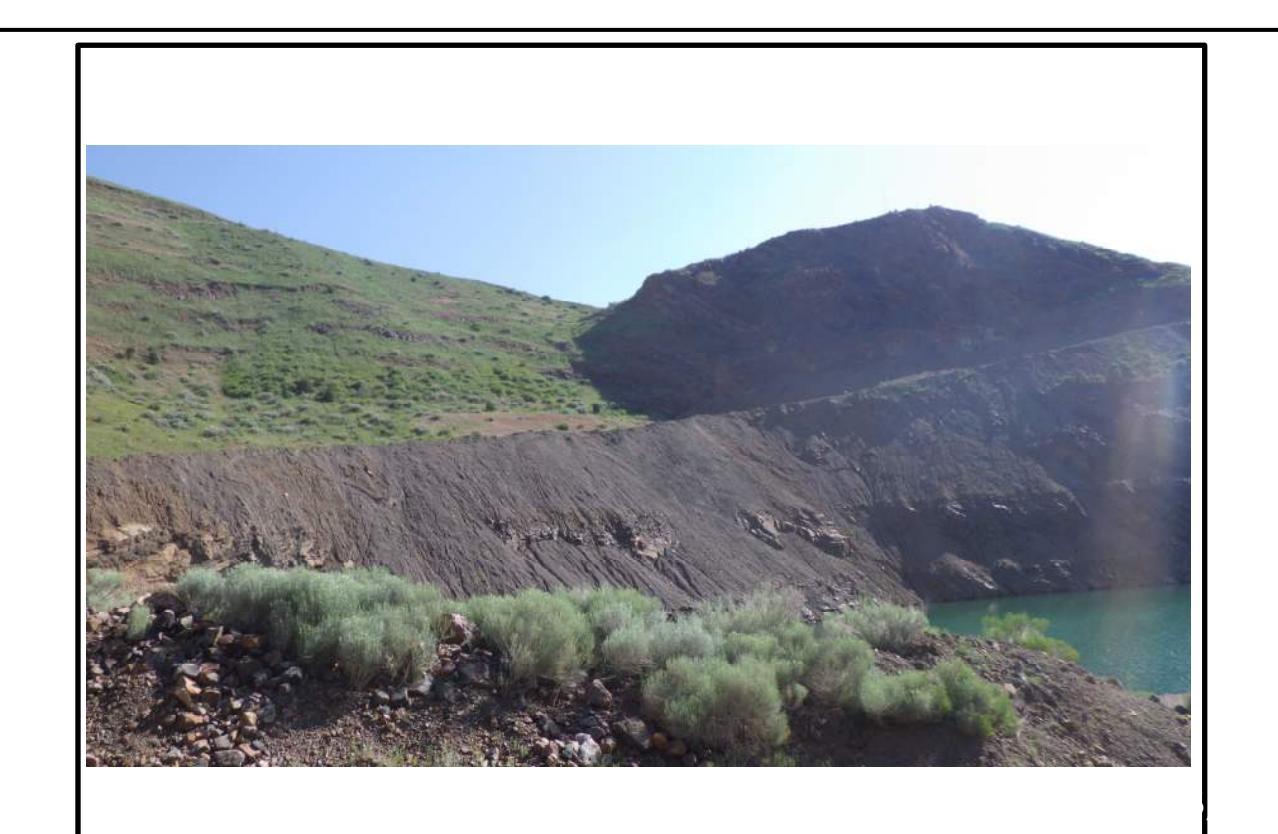
Photo 13: Looking East at access road temporary walls in Main Pit (June 2023)

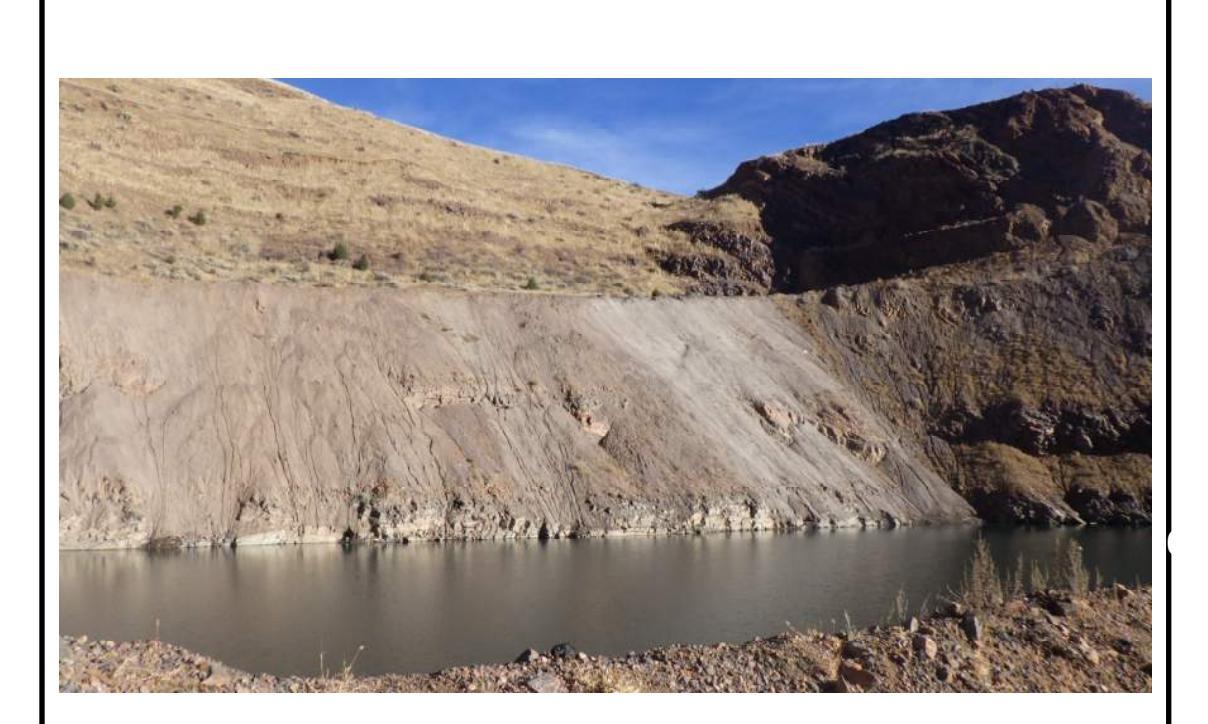
Photo 14: Looking East at access road temporary walls in Main Pit (November 2023)

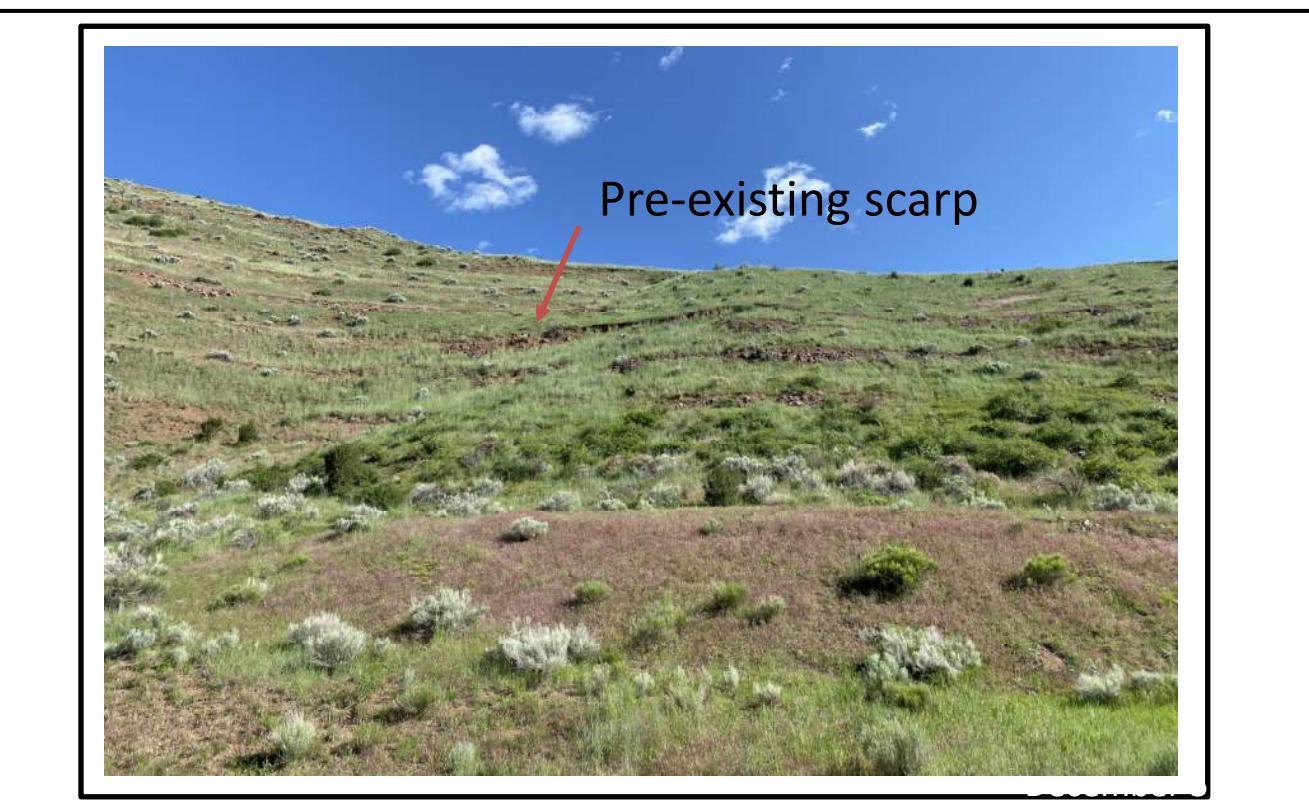
After planar failure along foliation planes in 1998 and 1999, the overall effective angle of the last three benches of the Northeast Wall 1 and the Northwest Wall were reduced to an overall angle of 35°, which is consistent with the 2003 Lachel geotechnical evaluation (Lachel, 2003). The failure surfaces (i.e., the surfaces along which movement has occurred) remain at a "residual strength" and therefore are less resistant to additional loading. Based on visual inspection from the access road and bottom of the pit, these slopes did not appear to show signs of additional movement during the site visits for this study (Photos 13-16). It is important to note that in the Spring of 2023, Spec Agg experienced significant amounts of rainfall that was evident in greener vegetation along the slopes of the Main Pit in the June 2023 inspection. In the November 2023 inspection, a stake was observed in the Main Pit noting where the high water elevation was observed (Photo 17). During the November 2023 inspection, access was given by Martin Marietta to visually assess the slopes from the top of the highwalls of the Main Pit in addition to visually assessing from the access road (Photo 18). From viewing the slopes at a higher perspective, no signs of significant movement were observed. Although the slope configuration is currently stable, the failure mechanism could potentially be reactivated, resulting in movement of additional material. The Northwest Wall, Northeast Wall 1, and Northeast Wall 3 as shown in Figure 2 should continue to be visually monitored for indications of instability from the Main Pit access road and from the top of the Main Pit slopes when access is possible.

Photo 15: Looking North from Main Pit access road at pre-existing scarp on Northeast Wall 1 (June 2023)

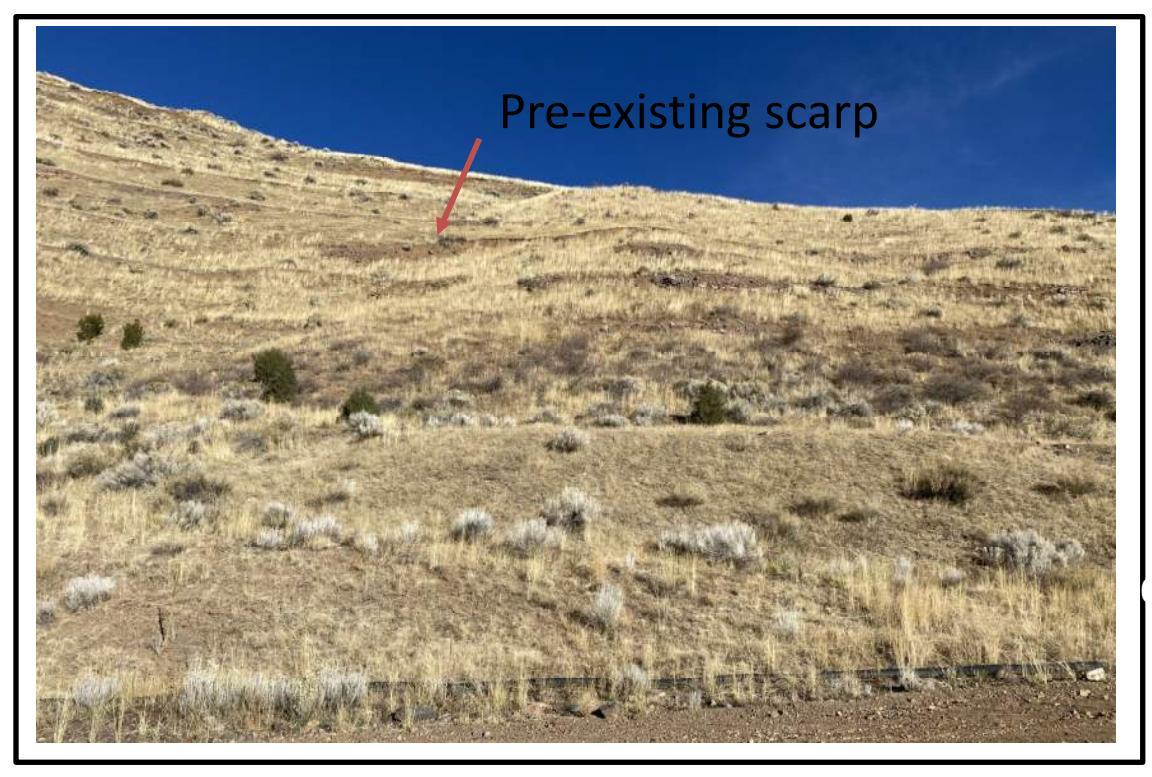
Photo 16: Looking North from Main Pit access road at pre-existing scarp on Northeast Wall 1 (November 2023)

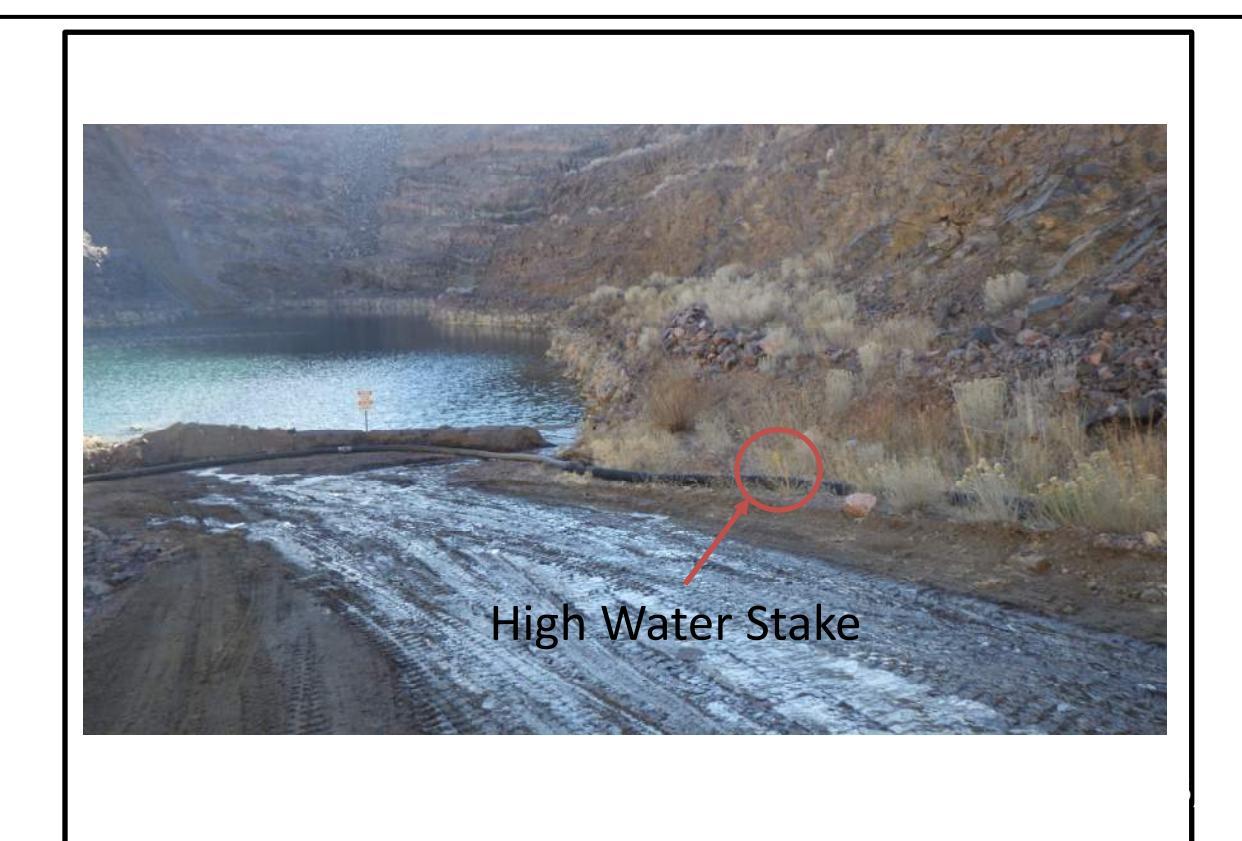
The quarry walls observed during the 2023 site visits appeared to be relatively dry; with the exception of minor seepage visible in the southwest corner of the Main Pit, which has been documented in the past. Other than minor seepage observed along the temporary access road to the Southern Expansion Areas, no major seepage was observed. Additionally, we observed impounded water in the Main Pit floor (**Photos 11 and 12**). It is our understanding that there has been intermittent pumping of the impounded water to maintain water level during the past year.

Photo 17: High waterline stake observed at bottom of Main Pit (November 2023)

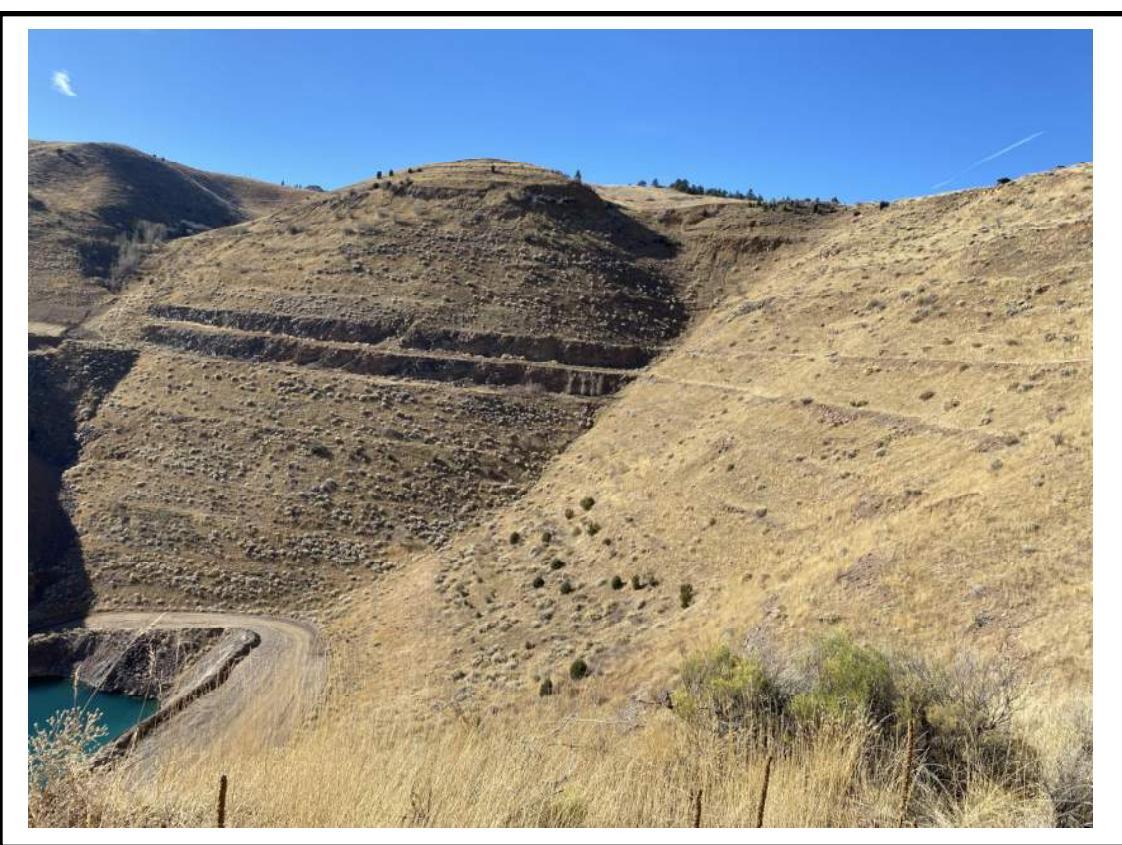
Photo 18: Looking West at Northeast Walls from top of Main Pit
