MINERALS PROGRAM INSPECTION REPORT PHONE: (303) 866-3567

MINE NAME:	MINE/PROSPECTING ID#:	MINERAL:	COUNTY:
Western Slope Flagstone Quarry No. 2	M-1996-076	Gravel	Mesa
INSPECTION TYPE:	WEATHER: Clear	INSP. DATE:	INSP. TIME:
Multi Person Inspection		March 19, 2024	13:00
OPERATOR:	OPERATOR REPRESENTATIVE:	TYPE OF OPERATION:	
Rudolph Fontanari	None	112c - Construction Regular Operation	
REASON FOR INSPECTION:	BOND CALCULATION TYPE:	BOND AMOUNT:	
High Priority	Complete Bond	\$234,840.00	
DATE OF COMPLAINT:	POST INSP. CONTACTS:	JOINT INSP. AGE	NCY:
NA	DRMS	None	
INSPECTOR(S):	INSPECTOR'S SIGNATURE:	SIGNATURE DAT	Е:
Amy Yeldell	1 9 111	March 27, 2024	
Clayton Wein	Amy Geldell		
-	V

PERMIT #: M-1996-076 INSPECTOR'S INITIALS: ACY INSPECTION DATE: March 19, 2024

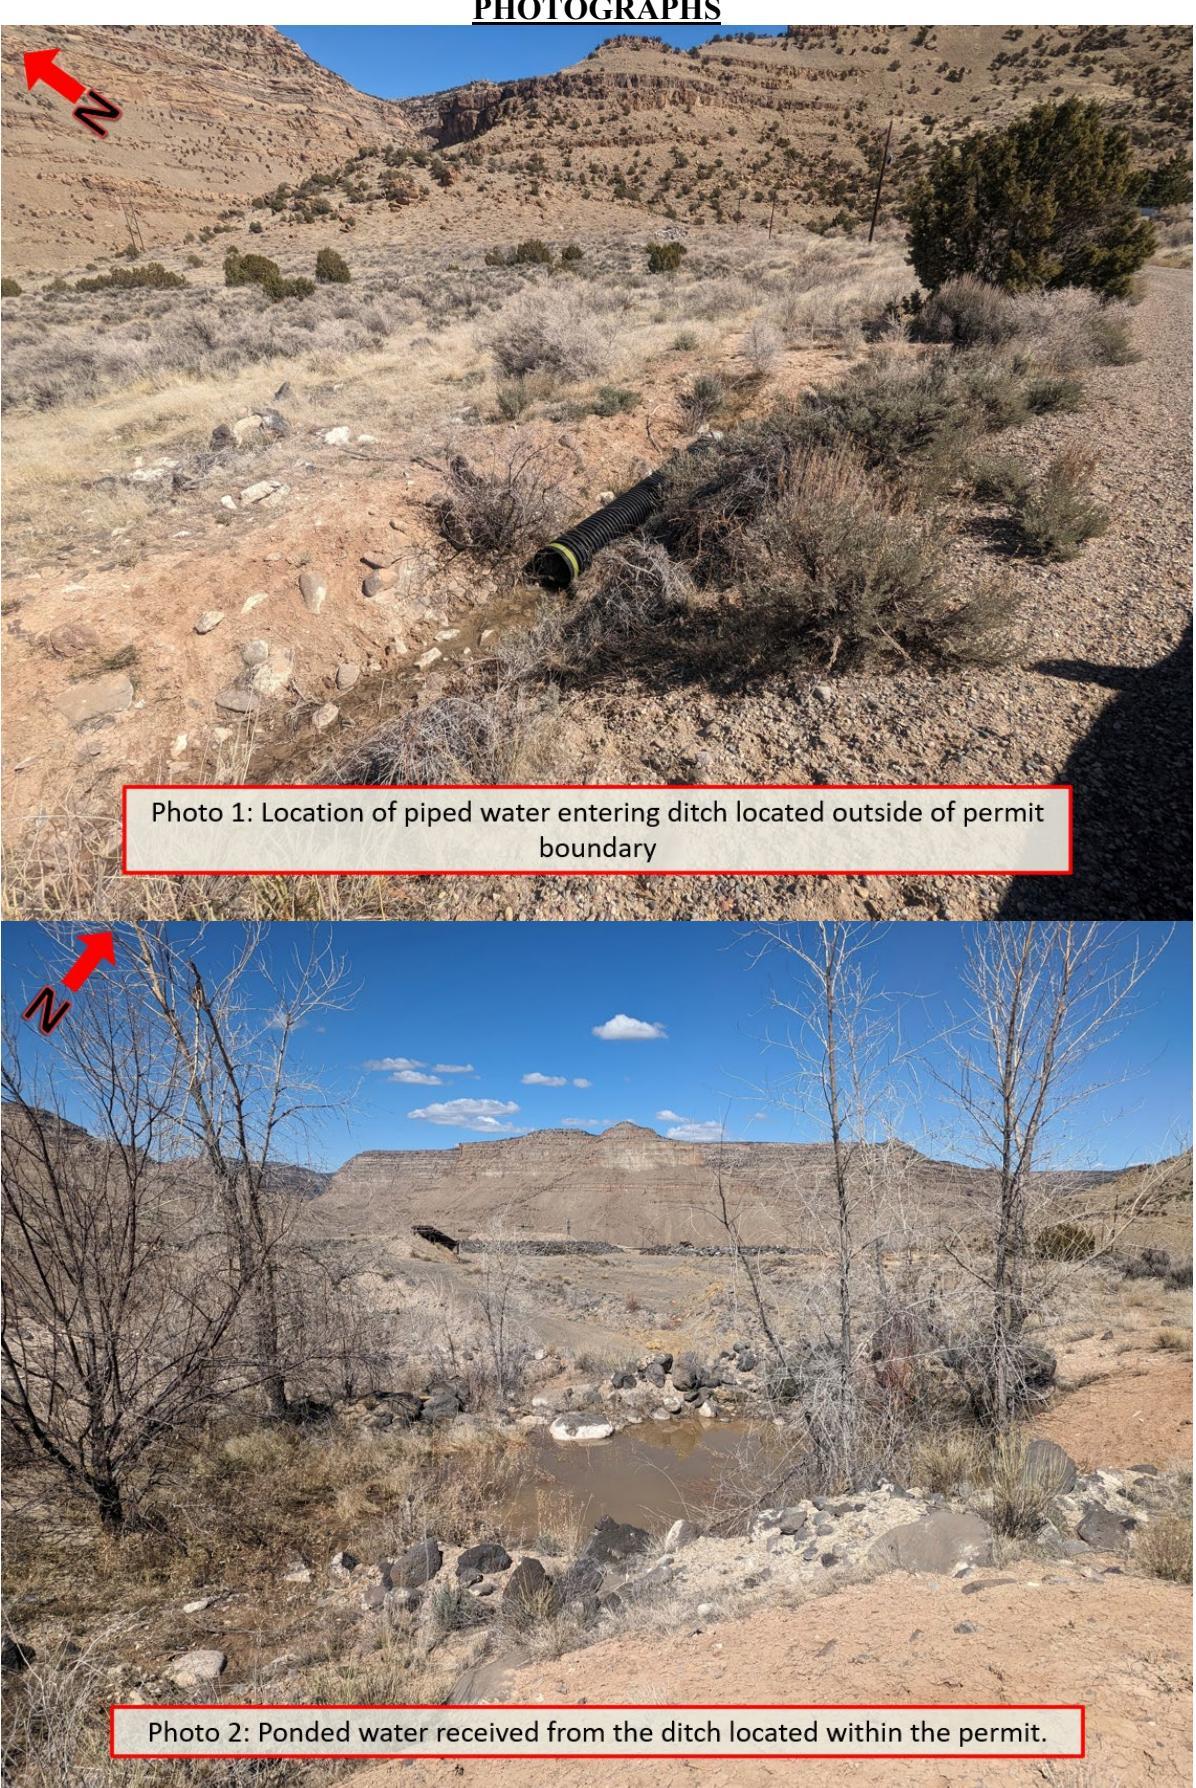
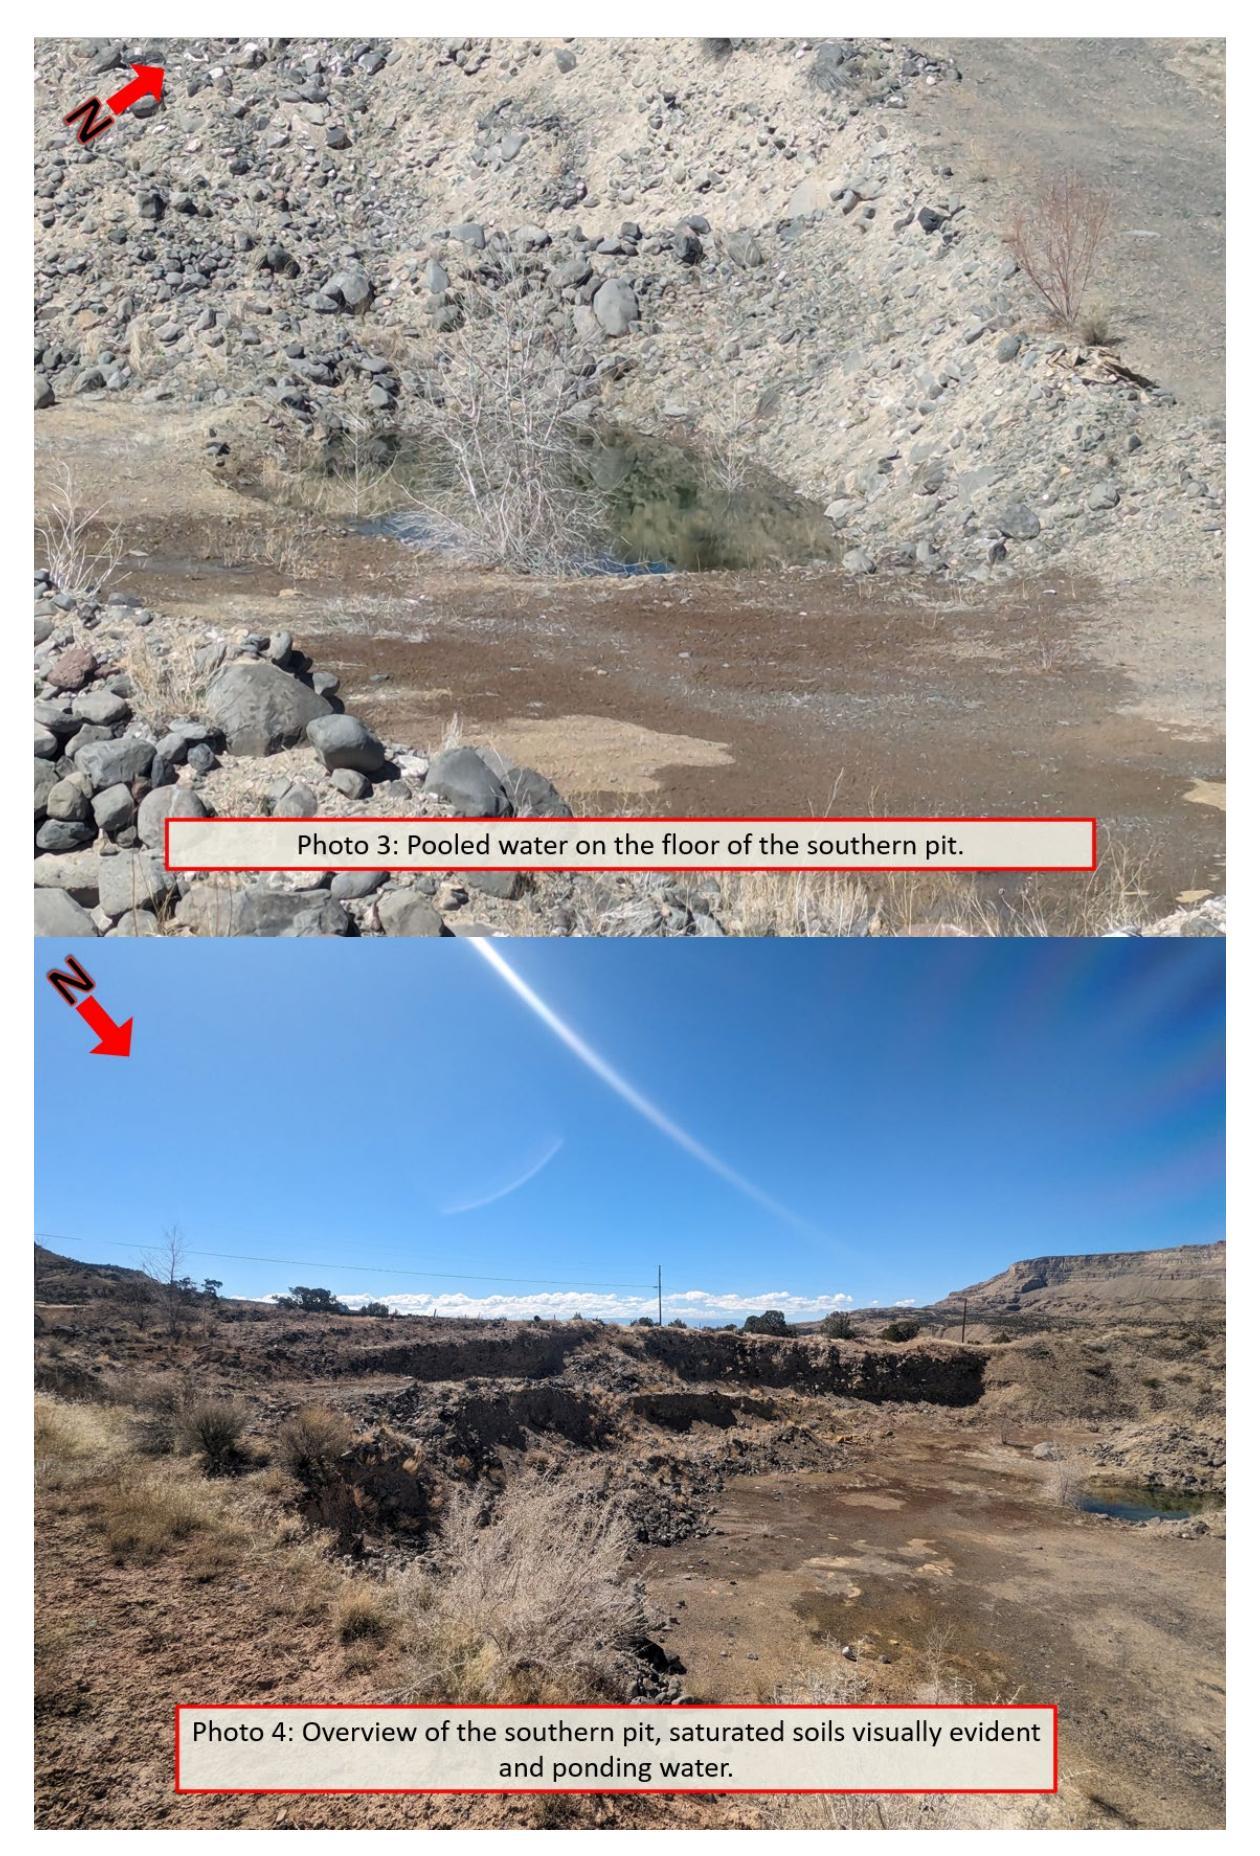
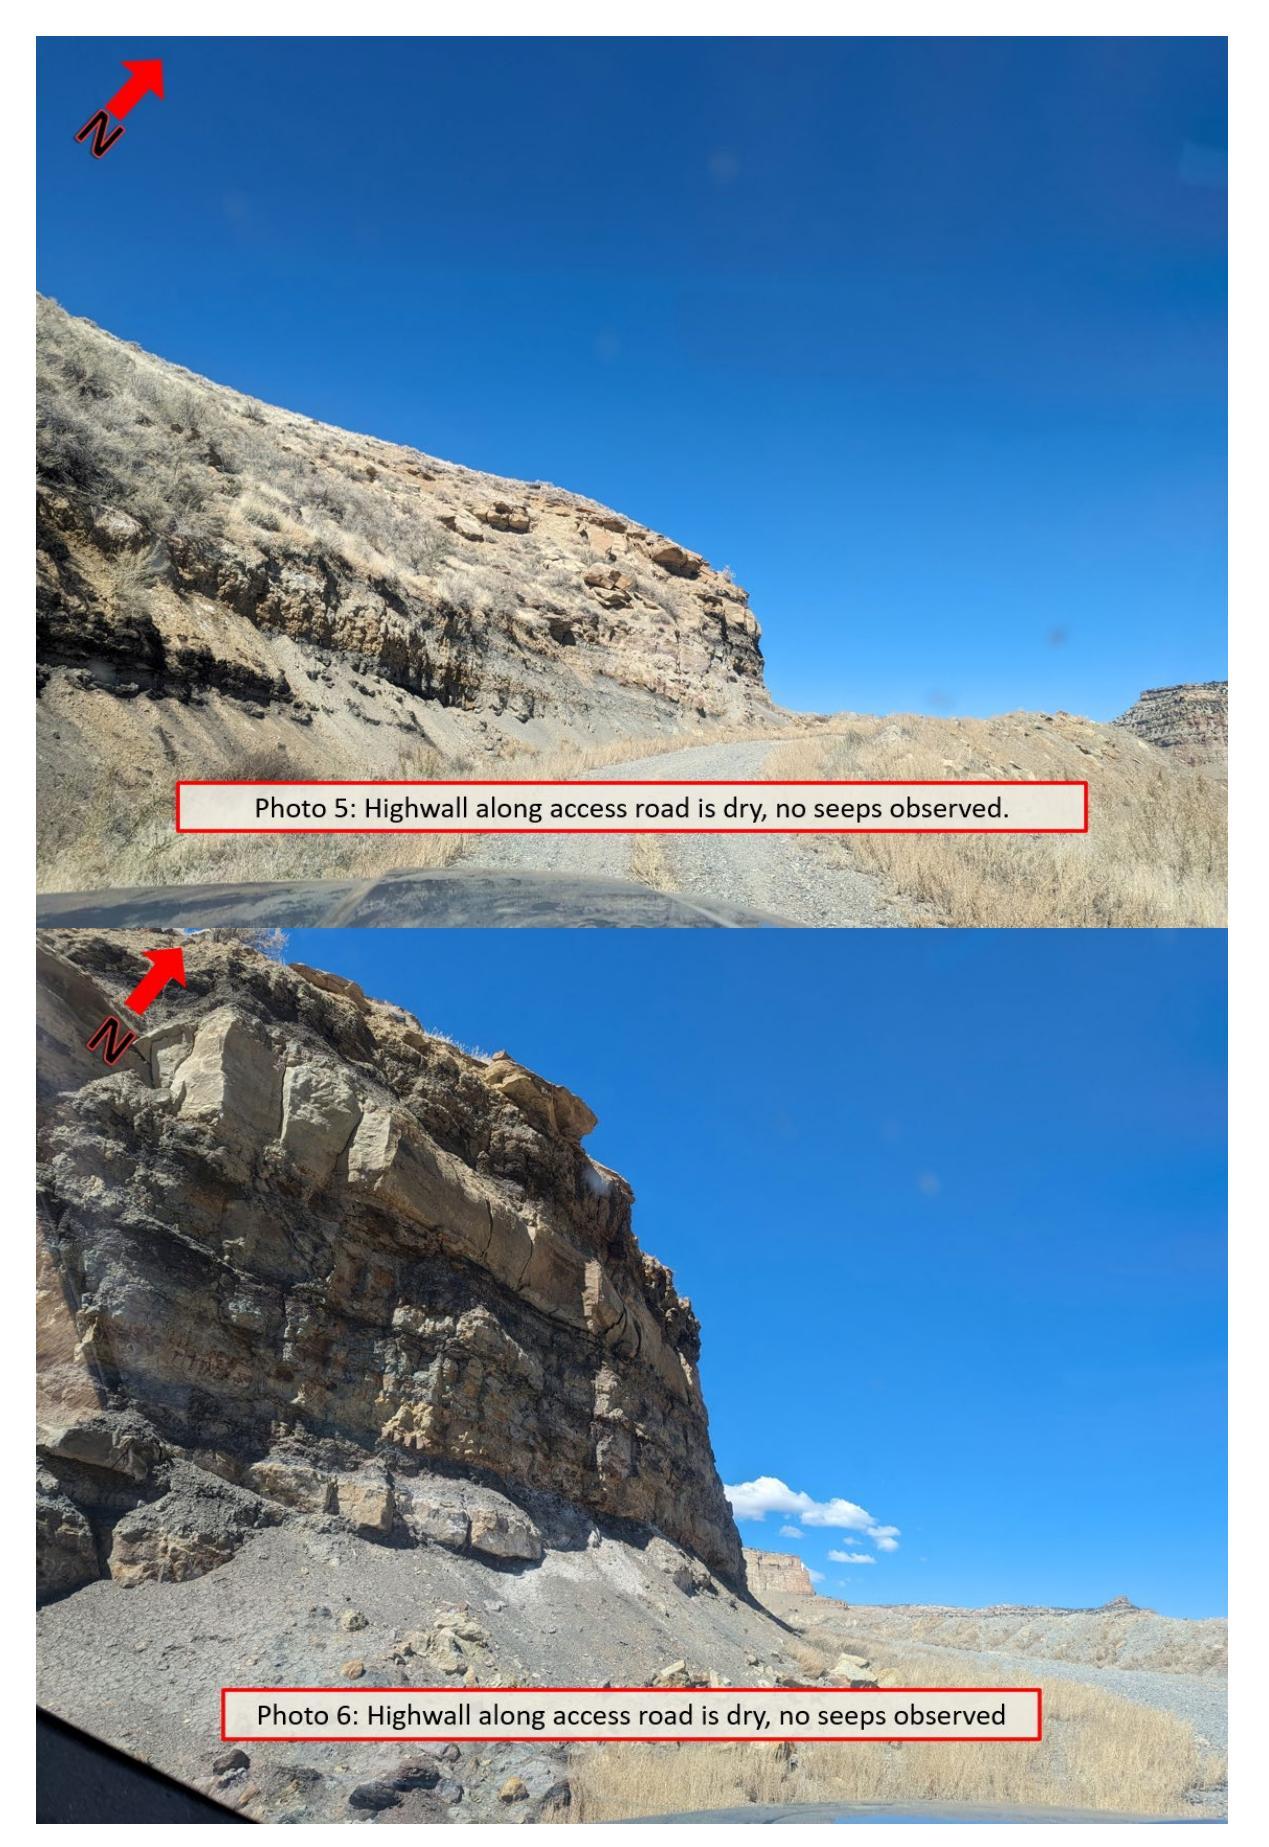
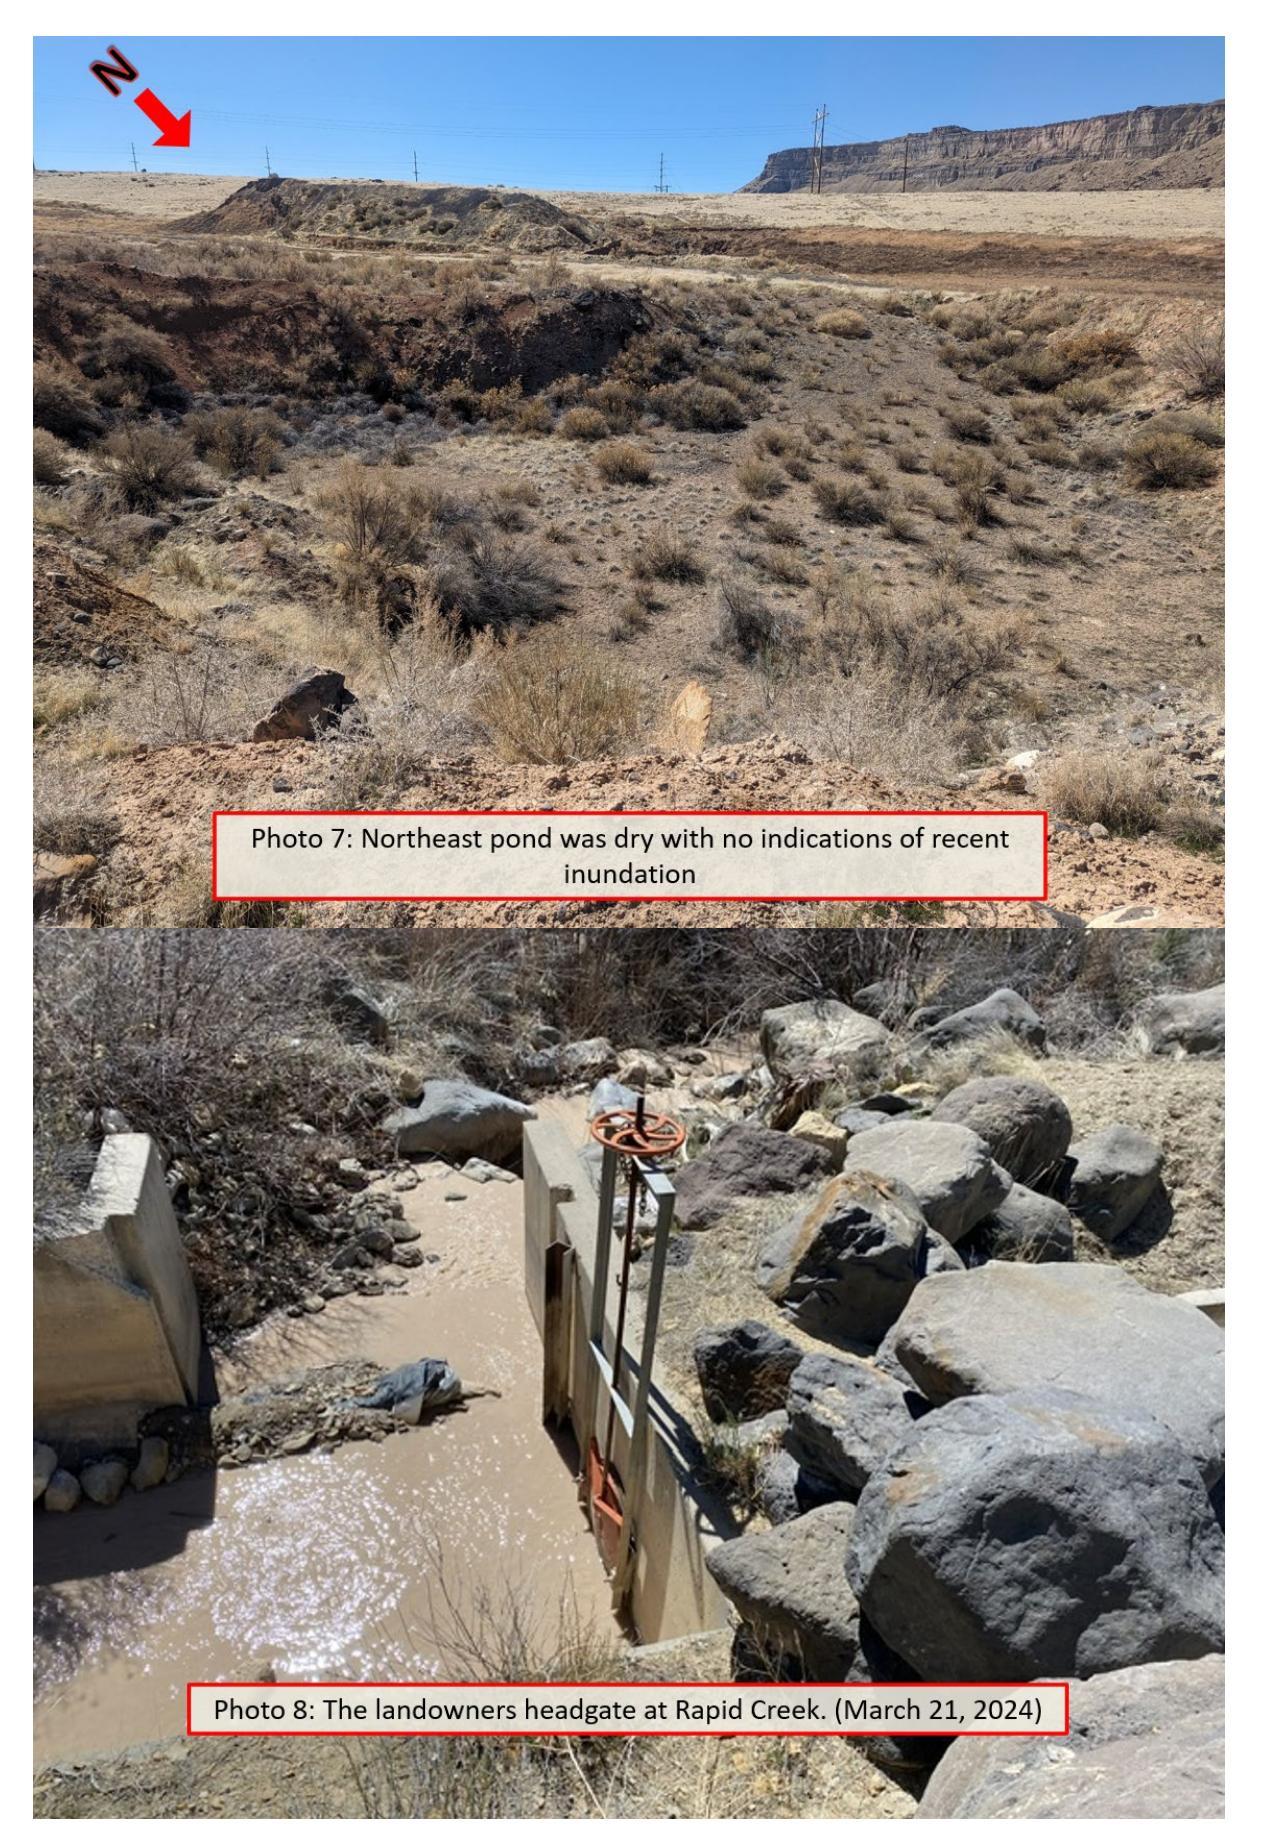
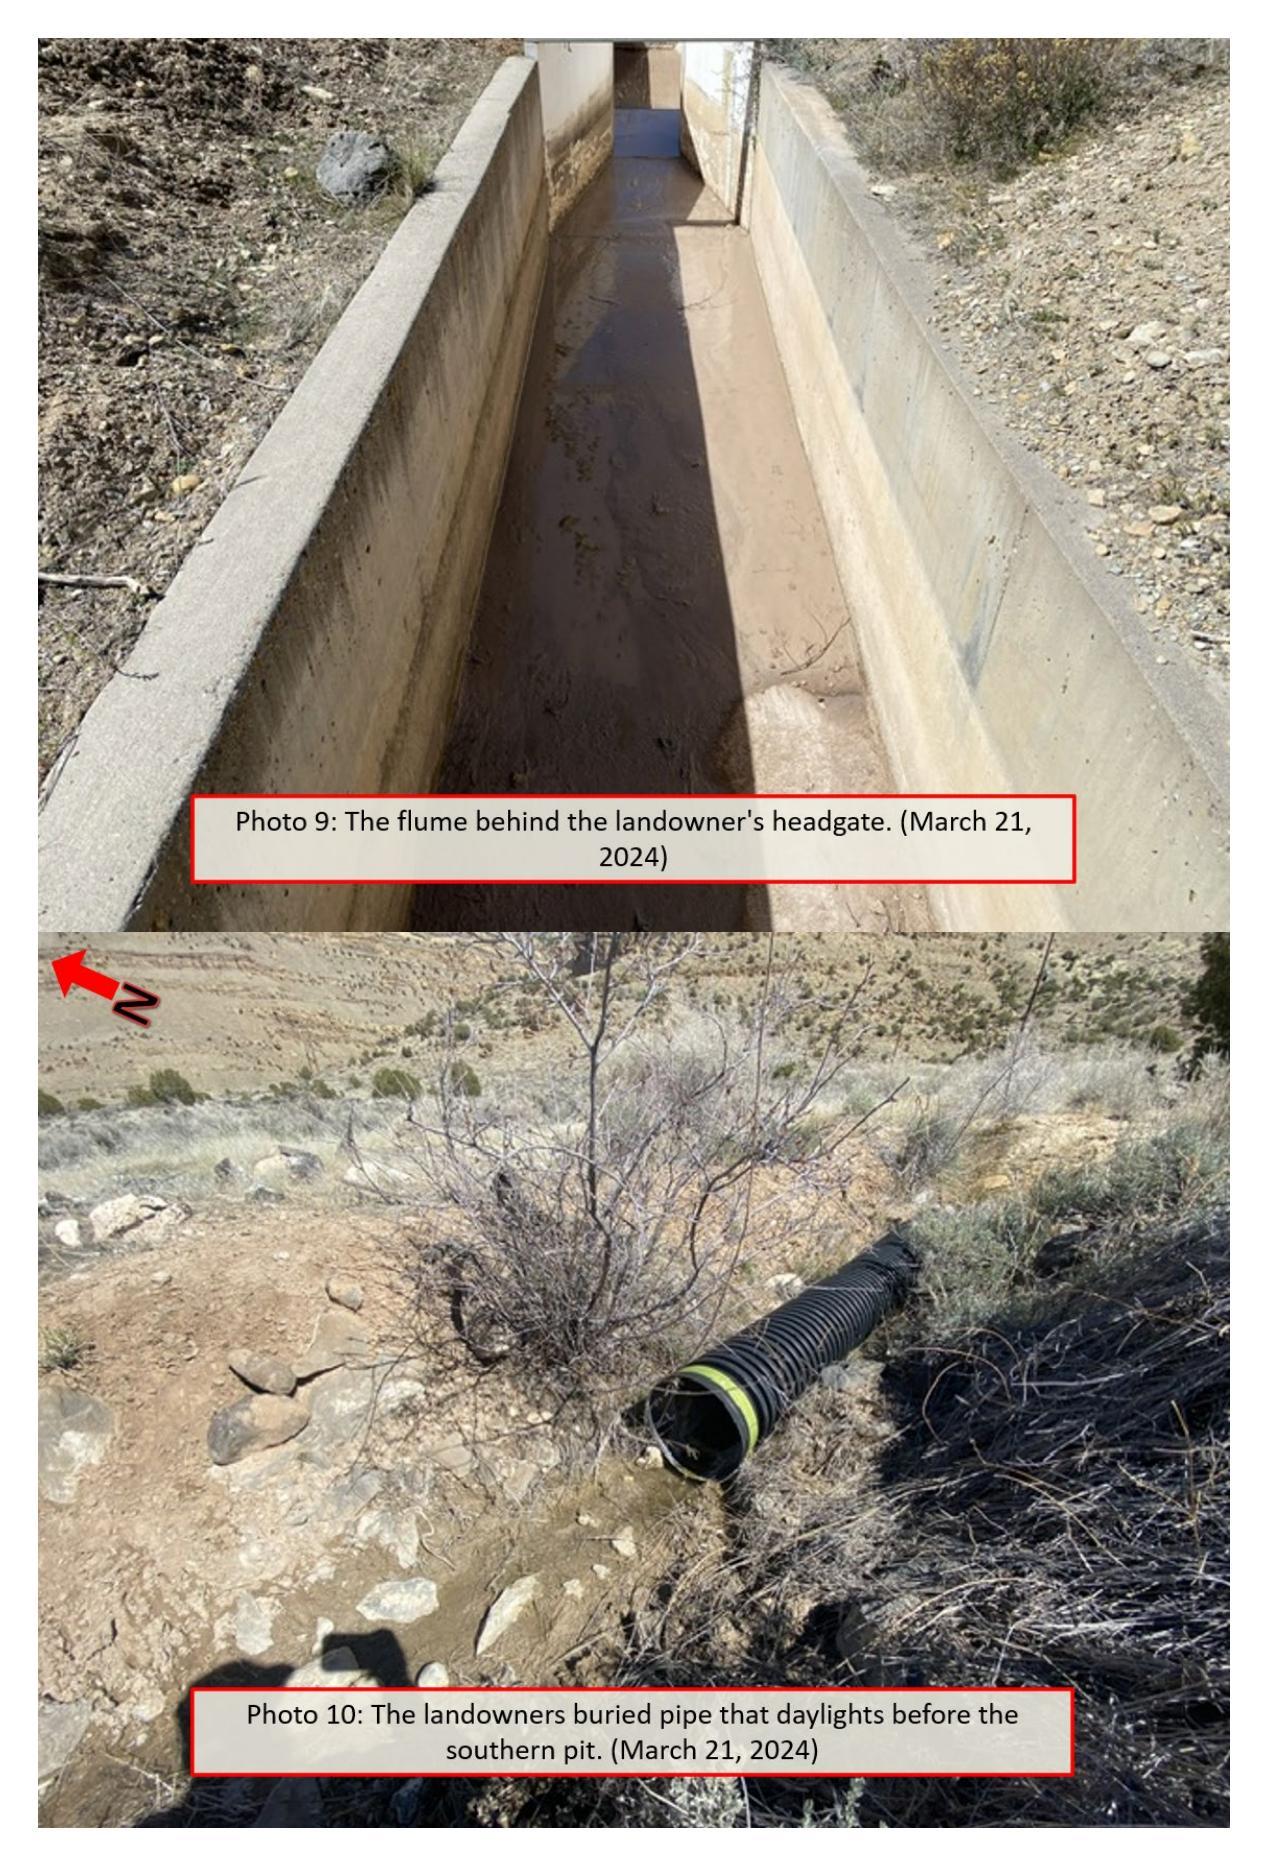
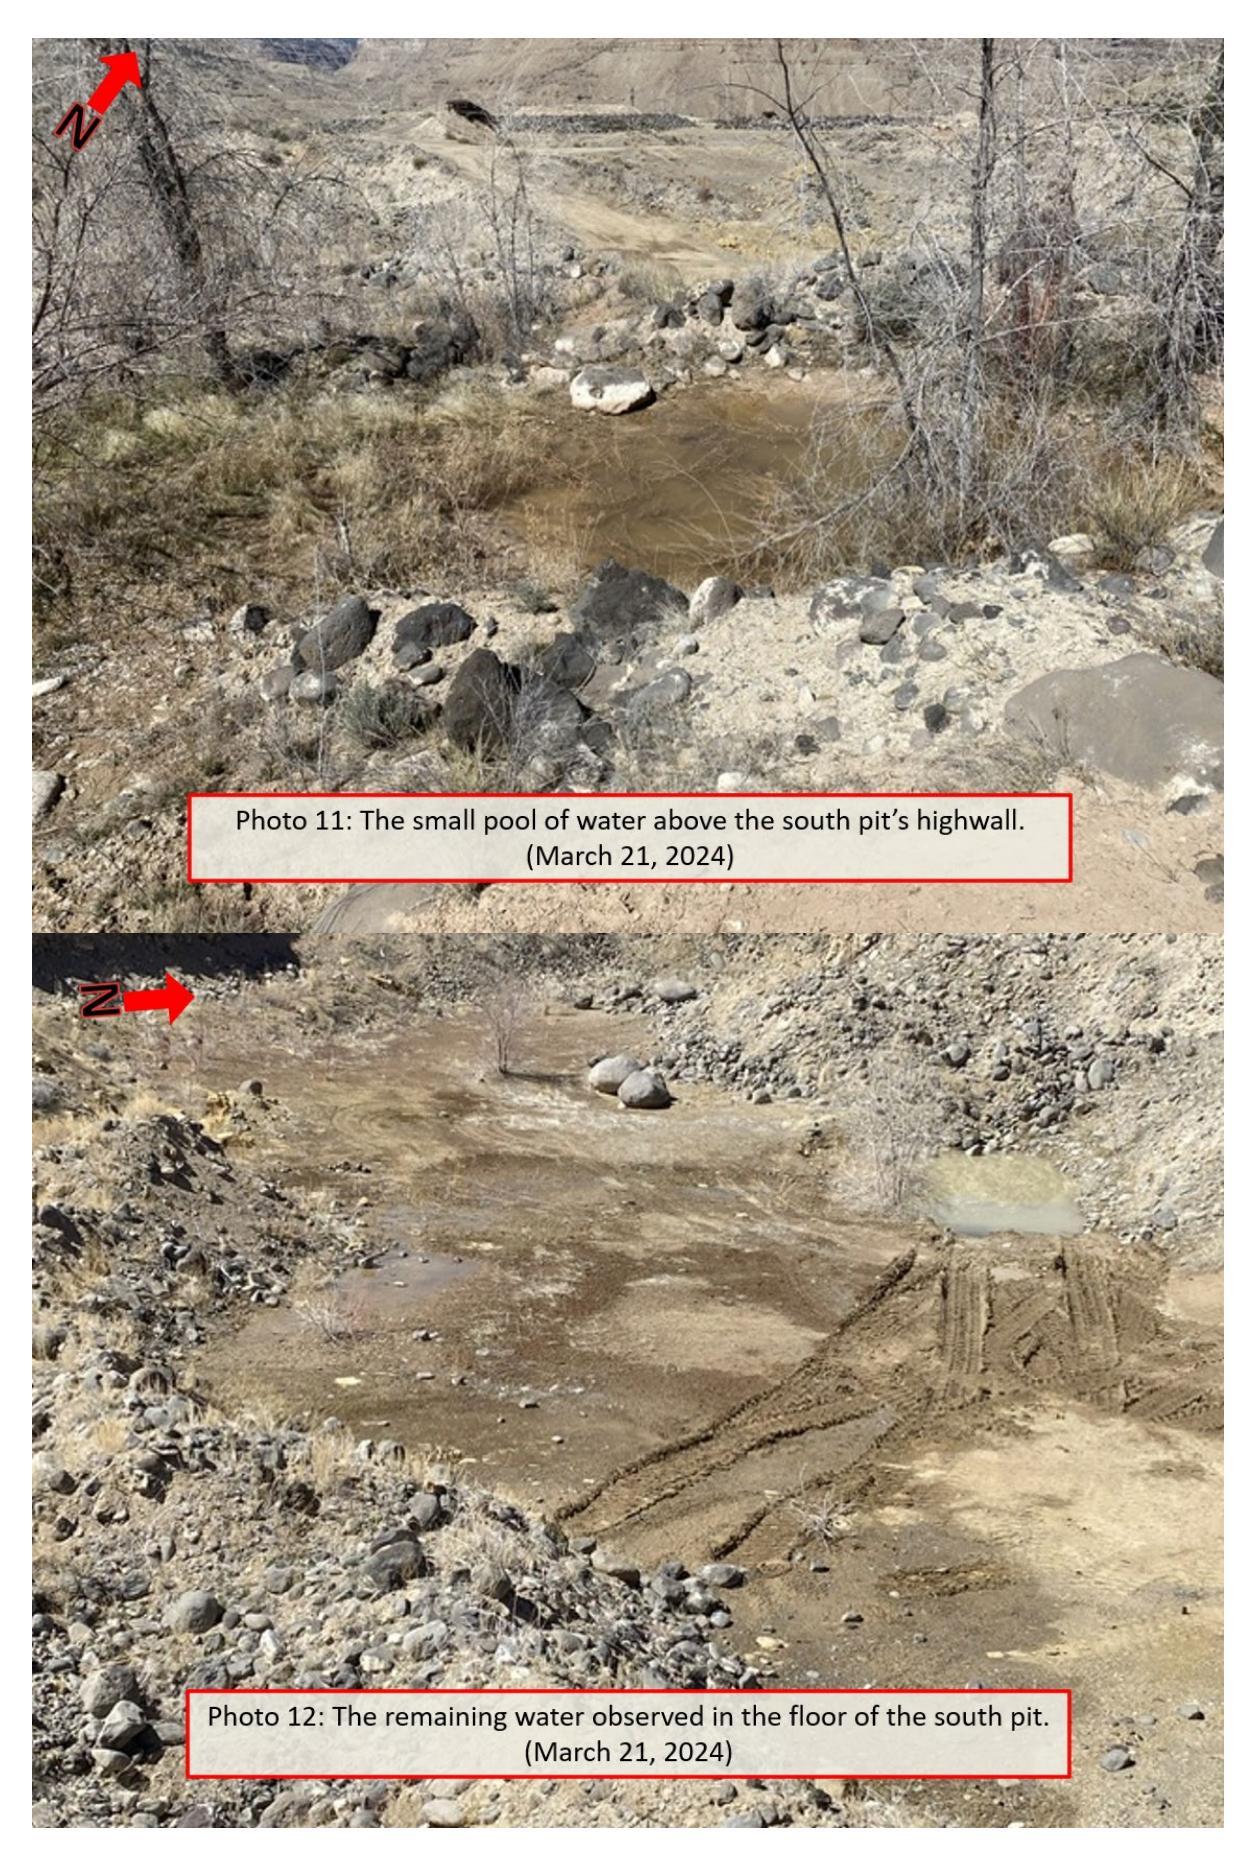
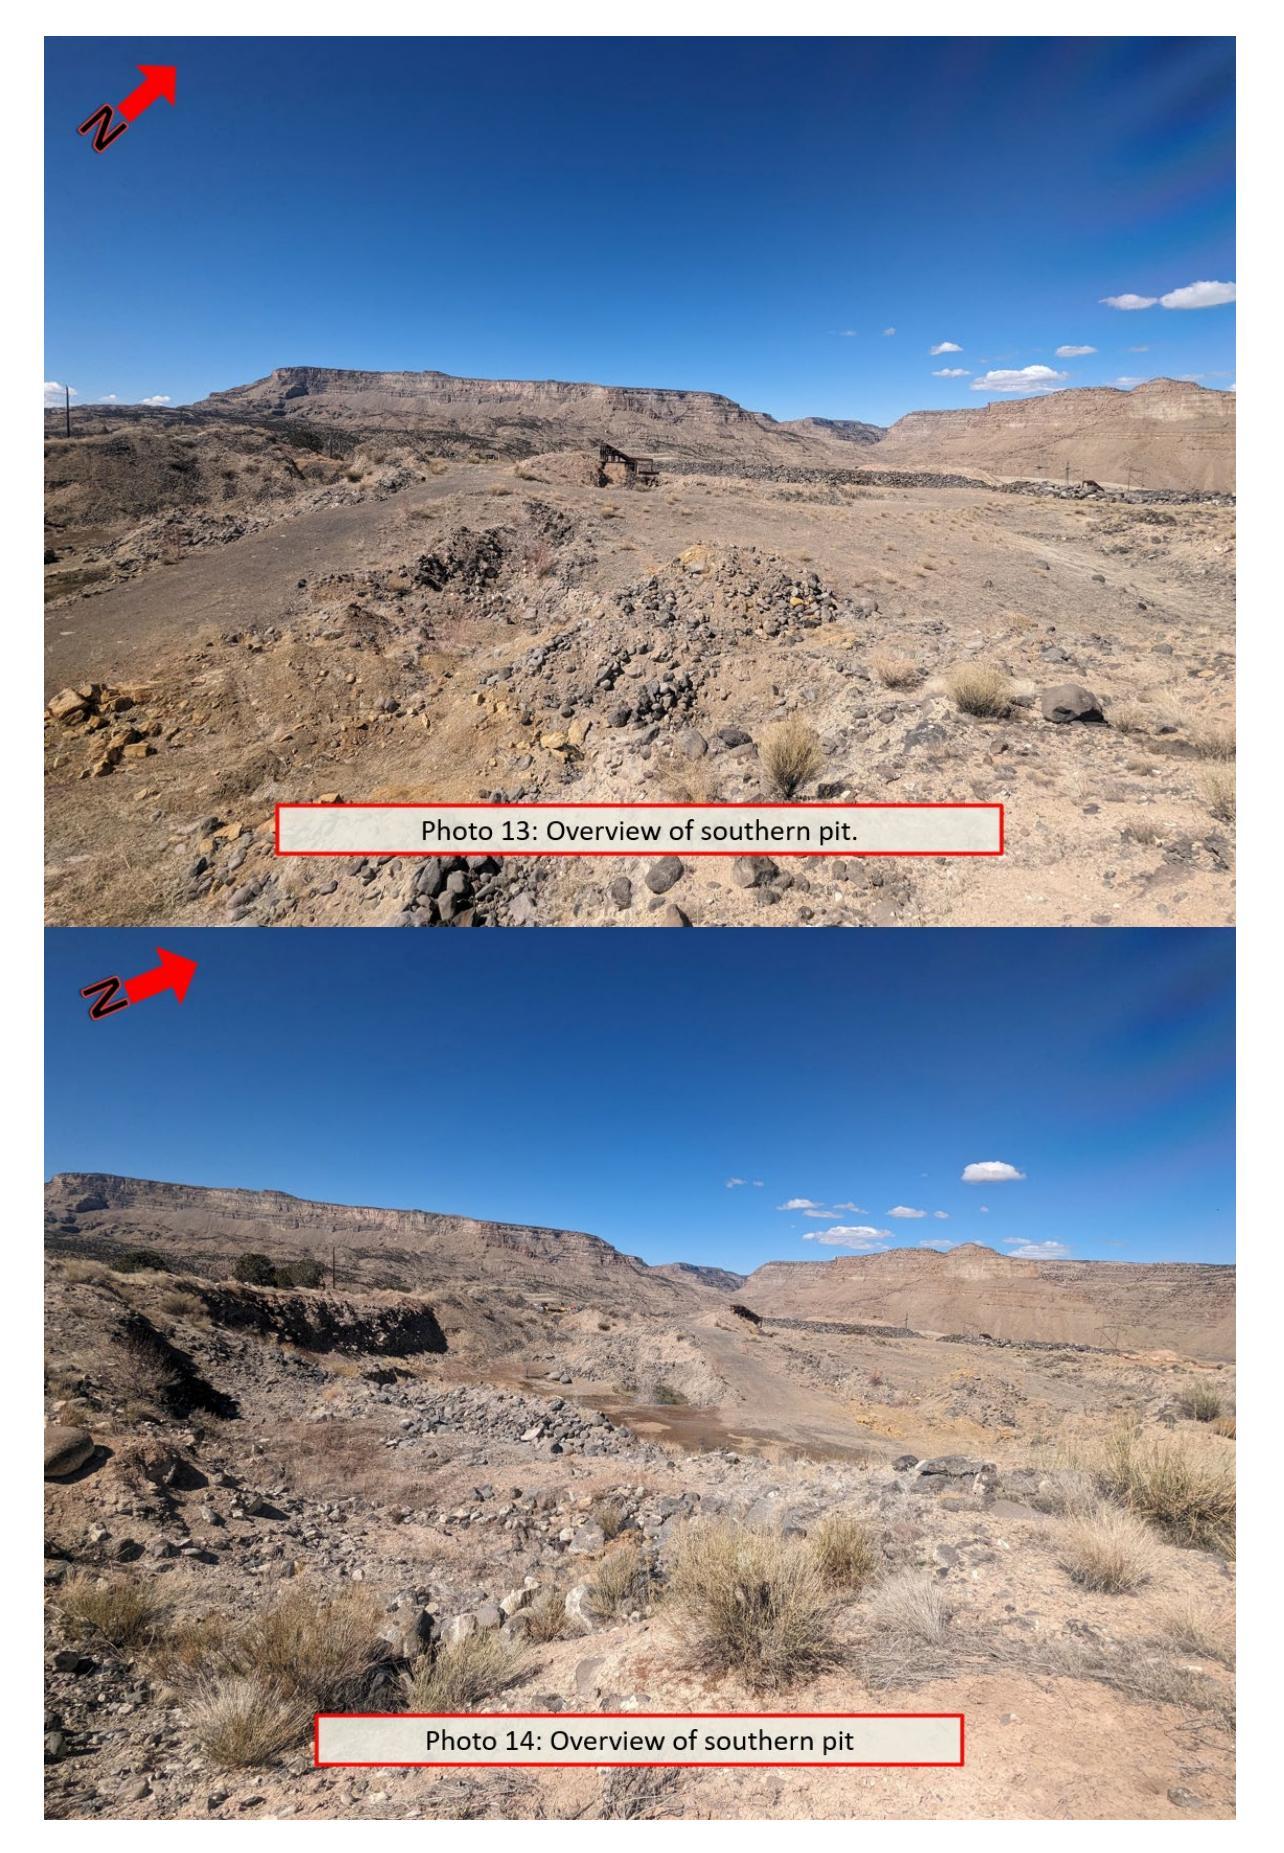
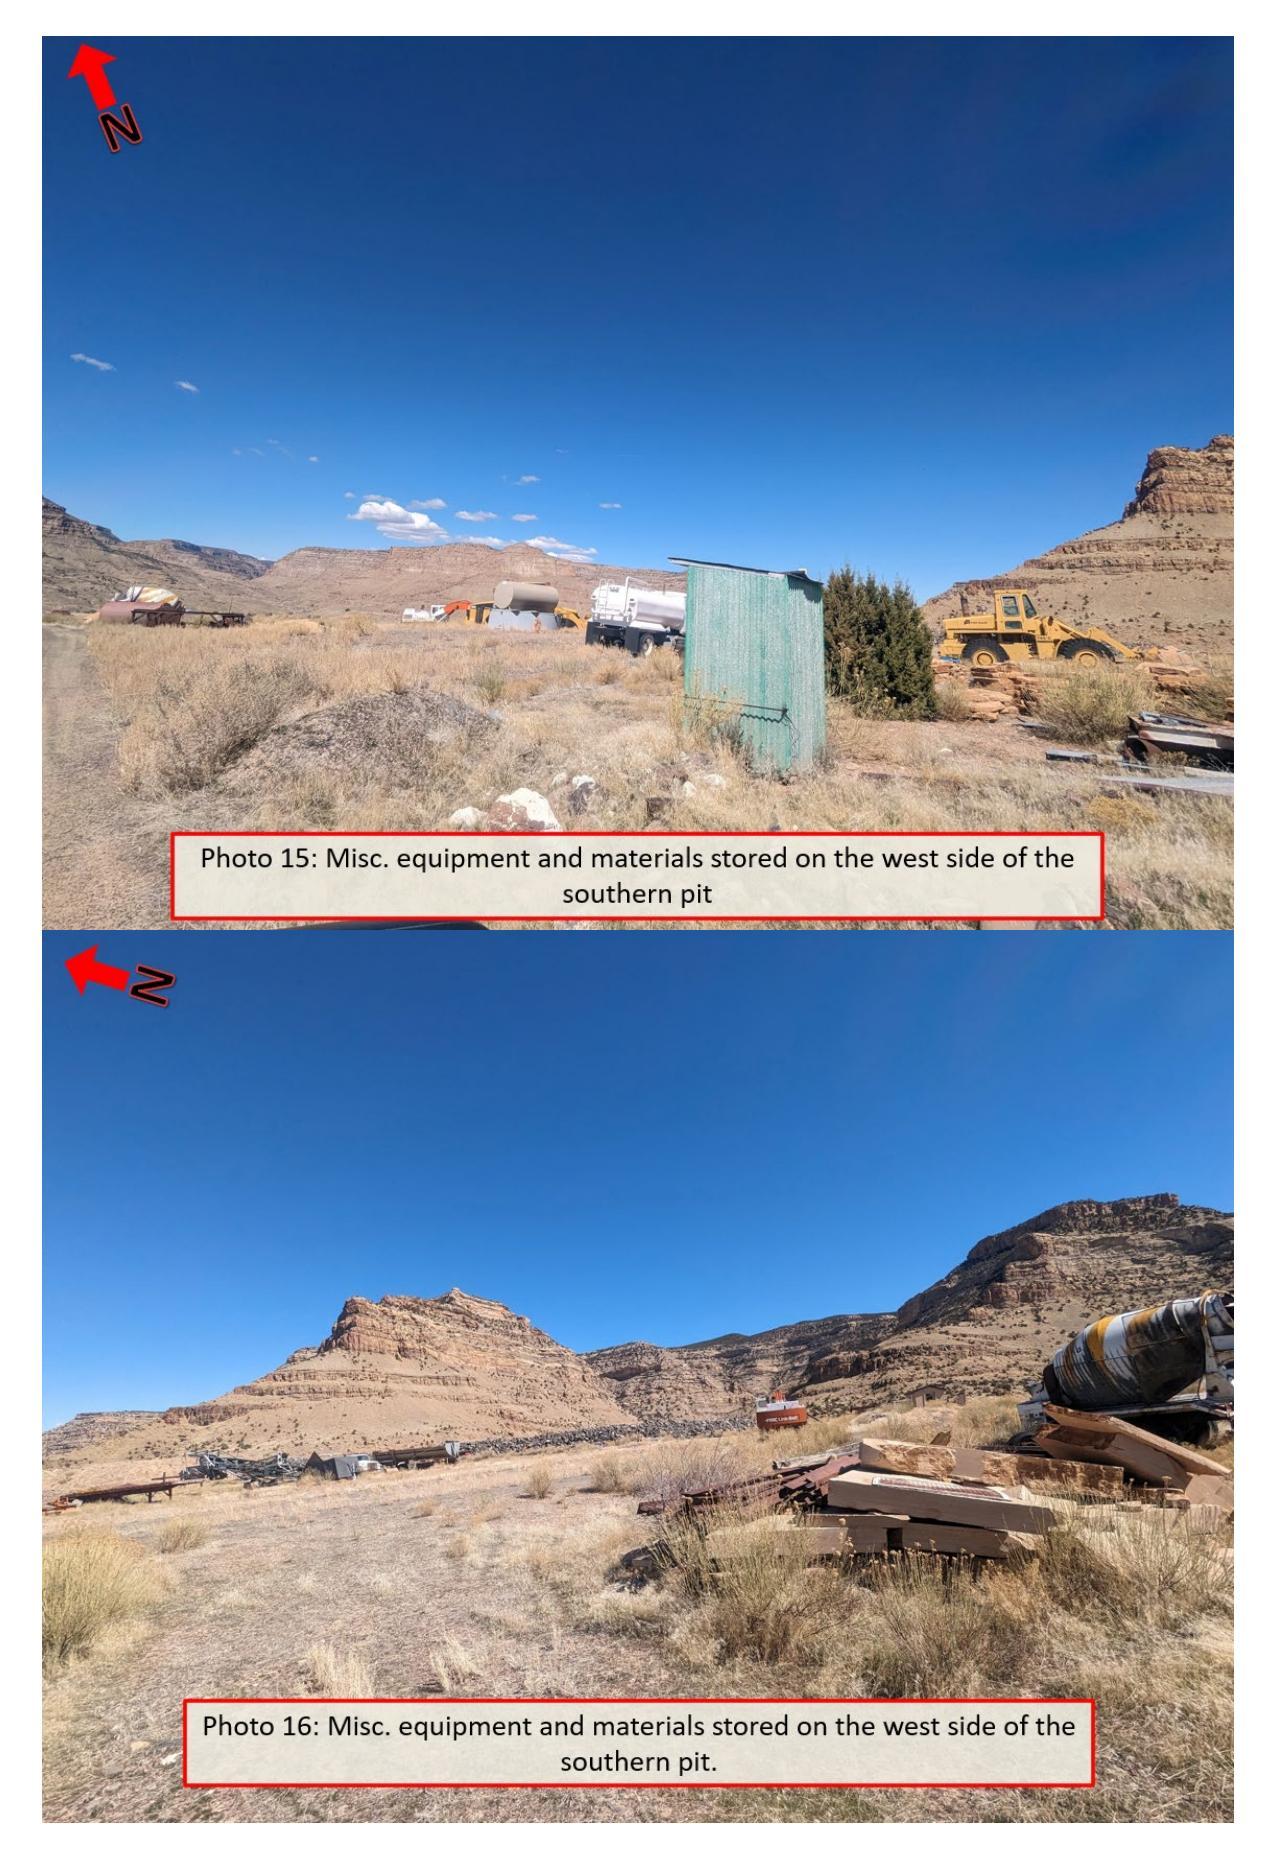
Water was observed discharging from a buried pipe* then being conveyed via an earthen ditch into the permit boundary ** (Photo 1). Water was estimated to be flowing at less than 30 gallons per minute. The discharging water resulted in ponding of water in two places within the southern pit area (Photos 2 and 3). Water infiltrated from the upper pool through the highwall and into the southern pit. The depth of the impounded water was not measured. Saturated soils on the southern pit floor were visually evident as the result of water flowing into the pit (Photo 4). The source of the water was believed to be from Rapid Creek above the Martin Crawford Ditch.

The Division drove down to the Cameo entrance. No water was observed infiltrating through the hillside along the access road (Photos 5 and 6). Additionally, all drainageways in the bottom were dry. The remaining northeast pit was observed to be dry with no evidence of recent inundation (Photo 7). No run-off of any kind was observed on site aside from the water discharging into the south pit.

The Division contacted the Division of Water Resources (DWR) on March 19, 2024 in an effort to obtain additional information regarding the Landowner's water diversion system from Rapid Creek. The Division explained the observations taken in the field and estimated that the water may have been coming from a buried pipeline that received water from the landowner's headgate at Rapid Creek. Brian Sewell of DWR offered to meet the Division in the field on March 21, 2024, to investigate the source of the water that was entering the south pit. The Division started the inspection on March 21st at Rapid Creek. The Division observed fresh ATV tracks at the headgate's location and that the headgate was closed (Photo 8). The flume behind the headgate was damp and muddy, indicating that there had been recent flow through the landowner's diversion inlet (Photo 9). No water was observed flowing in the flume. The ATV tracks were observed following the landowner's buried water line up to the south pit. The pipe feeding into the open ditch and into the pit was almost dry (Photo 10). A small amount of water was observed trickling out of the pipe. Brian Sewell and the Division agreed that the water was likely residual flow as gravity flushes the remaining water out of the buried pipe. The level of water in the small, ponded area above the south pit floor appeared to have decreased since the March 19th inspection (Photo 12).

There appears to be no changes to stockpiles or highwall configurations since the previous inspection. The site was inactive at the time of the inspection. Several pieces of equipment and miscellaneous materials are on site on the west side of the southern pit. Several stockpiles remain on site at both the north and southern pits with no recent evidence of excavation. There were no vehicle/equipment tracks surrounding the processing area or pit floor to indicate recent activity. (Photos 13 -17)

Staff observed two areas that were previously reclaimed. The first was the backfilled northwest pit. The previously inundated pit has been backfilled and sloped on the north side. Some highwalls remain on the south end. Little to no desirable vegetation was observed (Photo 18). Similarly, the area from where the northern irrigation line was removed has been reclaimed. Though vegetation is dense it is almost entirely Cheatgrass (Photo 19).

Per the conditions of the permit, Exhibit G, no groundwater exists, and no dewatering is necessary. Additionally, no water will be applied with the exception of dust suppression via tuck. The water in the pits is not from existing groundwater or the result of a recent stormwater event. The Operator was directed via email to immediately turn off all water and provide the Division with photo documentation that water is no longer being discharged into the permit boundary (email enclosed).

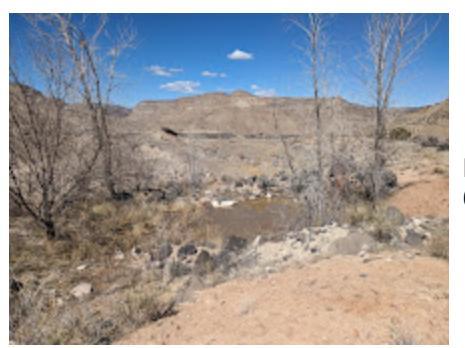
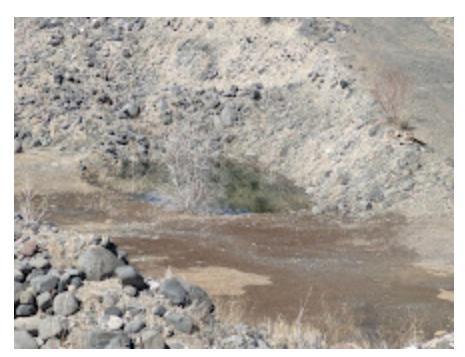
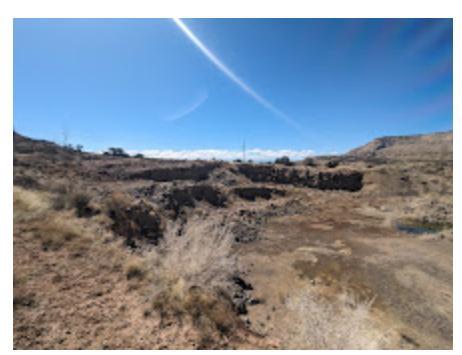
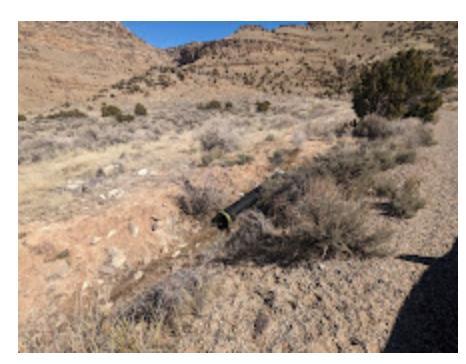
Earlier today the Division was notified that there was exposed groundwater at the Western Slope Flagstone Quarry No. 2. The Division conducted an inspection and observed piped water discharging into the southern pit within the DRMS permit boundary (M-1996-076). Per the conditions of the permit, Exhibit G, no groundwater exists and no dewatering is necessary. Additionally no water will be applied with the exception of dust suppression via tuck. The groundwater in the pits is not from existing groundwater or the result of a recent stormwater event. Water being applied and retained on site is a violation of a permit condition. The water being directed through the pipe and discharging into the pit needs to cease immediately. Please provide the Division with photo documentation that the water is no longer flowing into the southern pit. As well as, provide additional documentation when all of the impounded water has infiltrated.
