To:	Jerald Schnabel	From:	Paul Kos
	Castle Aggregate		Denver, CO 80202
File:	February 2024 Monitoring Summary	Date:	March 31, 2024

Reference: February 2024 Geotechnical Monitoring Summary Pikeview Quarry

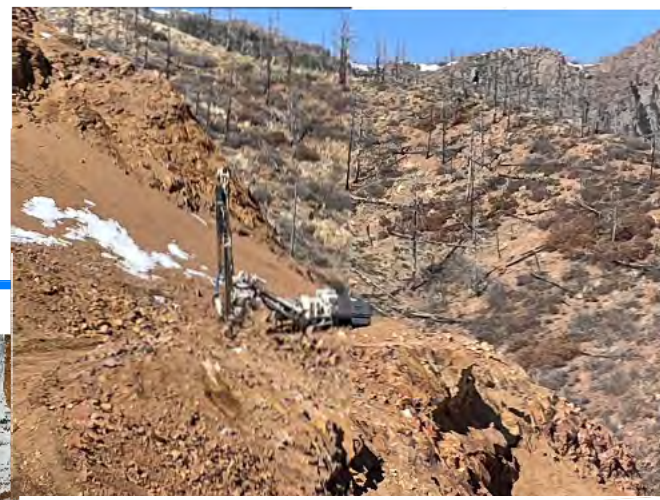
4.DRILL RIG PREPARING FOR BLASTING.

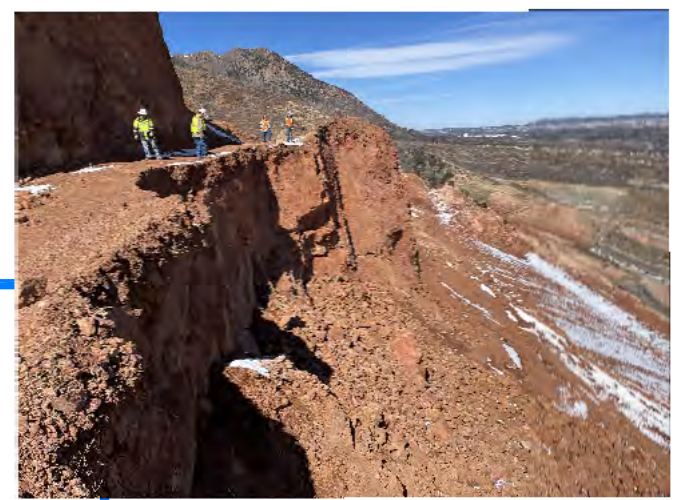
3. CLOSED ACCESS ROAD WITH DETERIORATED BENCH. ALSO, AREA TO BE BLASTED.

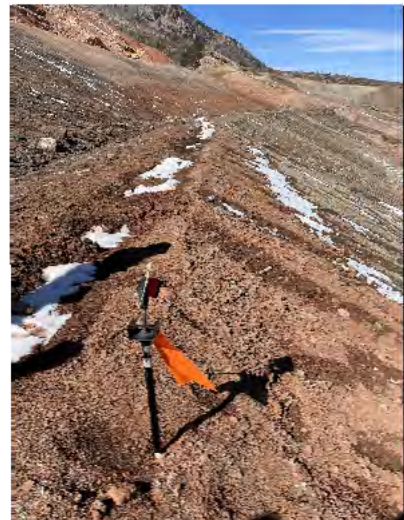
7. NEW BENCH PRISM SETTLING.
