GV-06 Monitoring - 4/3

PHOTOGRAPHIC LOG

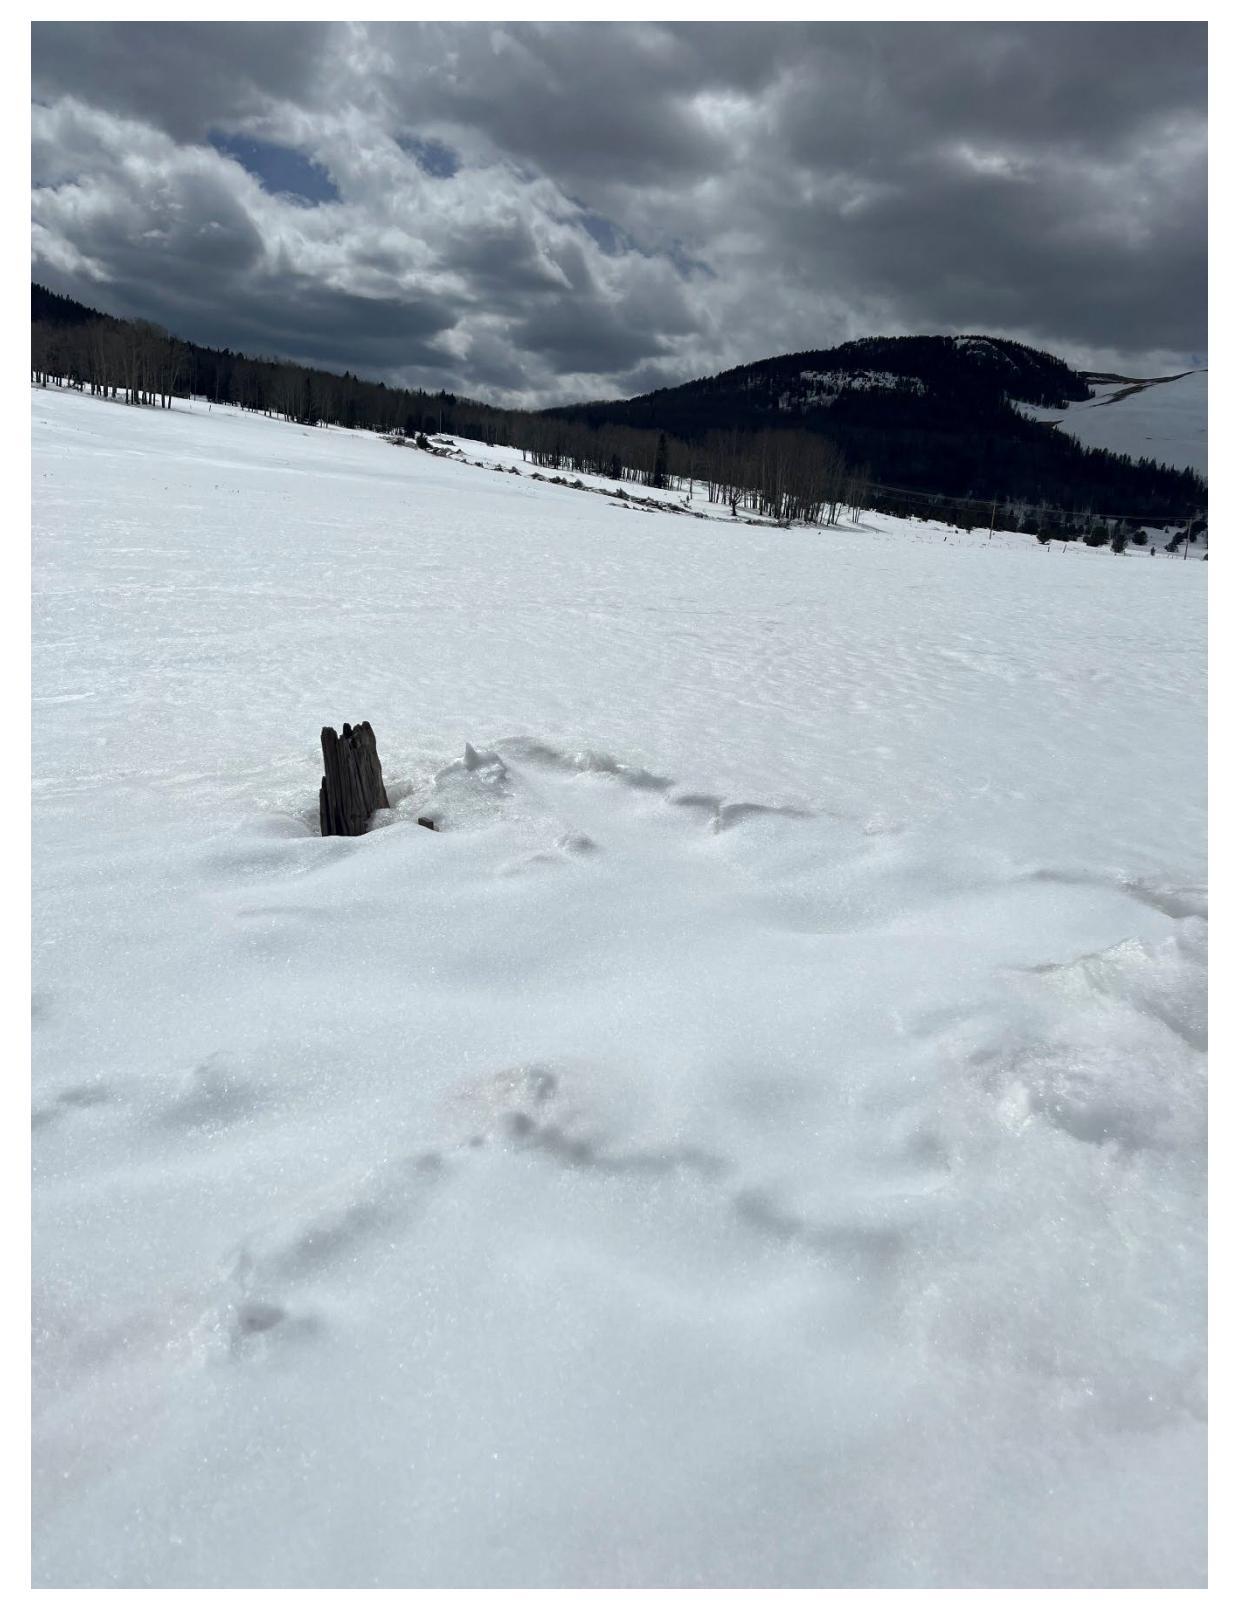
Photograph 1: View of the GV-06 surface water monitoring location, looking southwest. Photo taken 4/3/2024 at approximately 14:00 MDT.

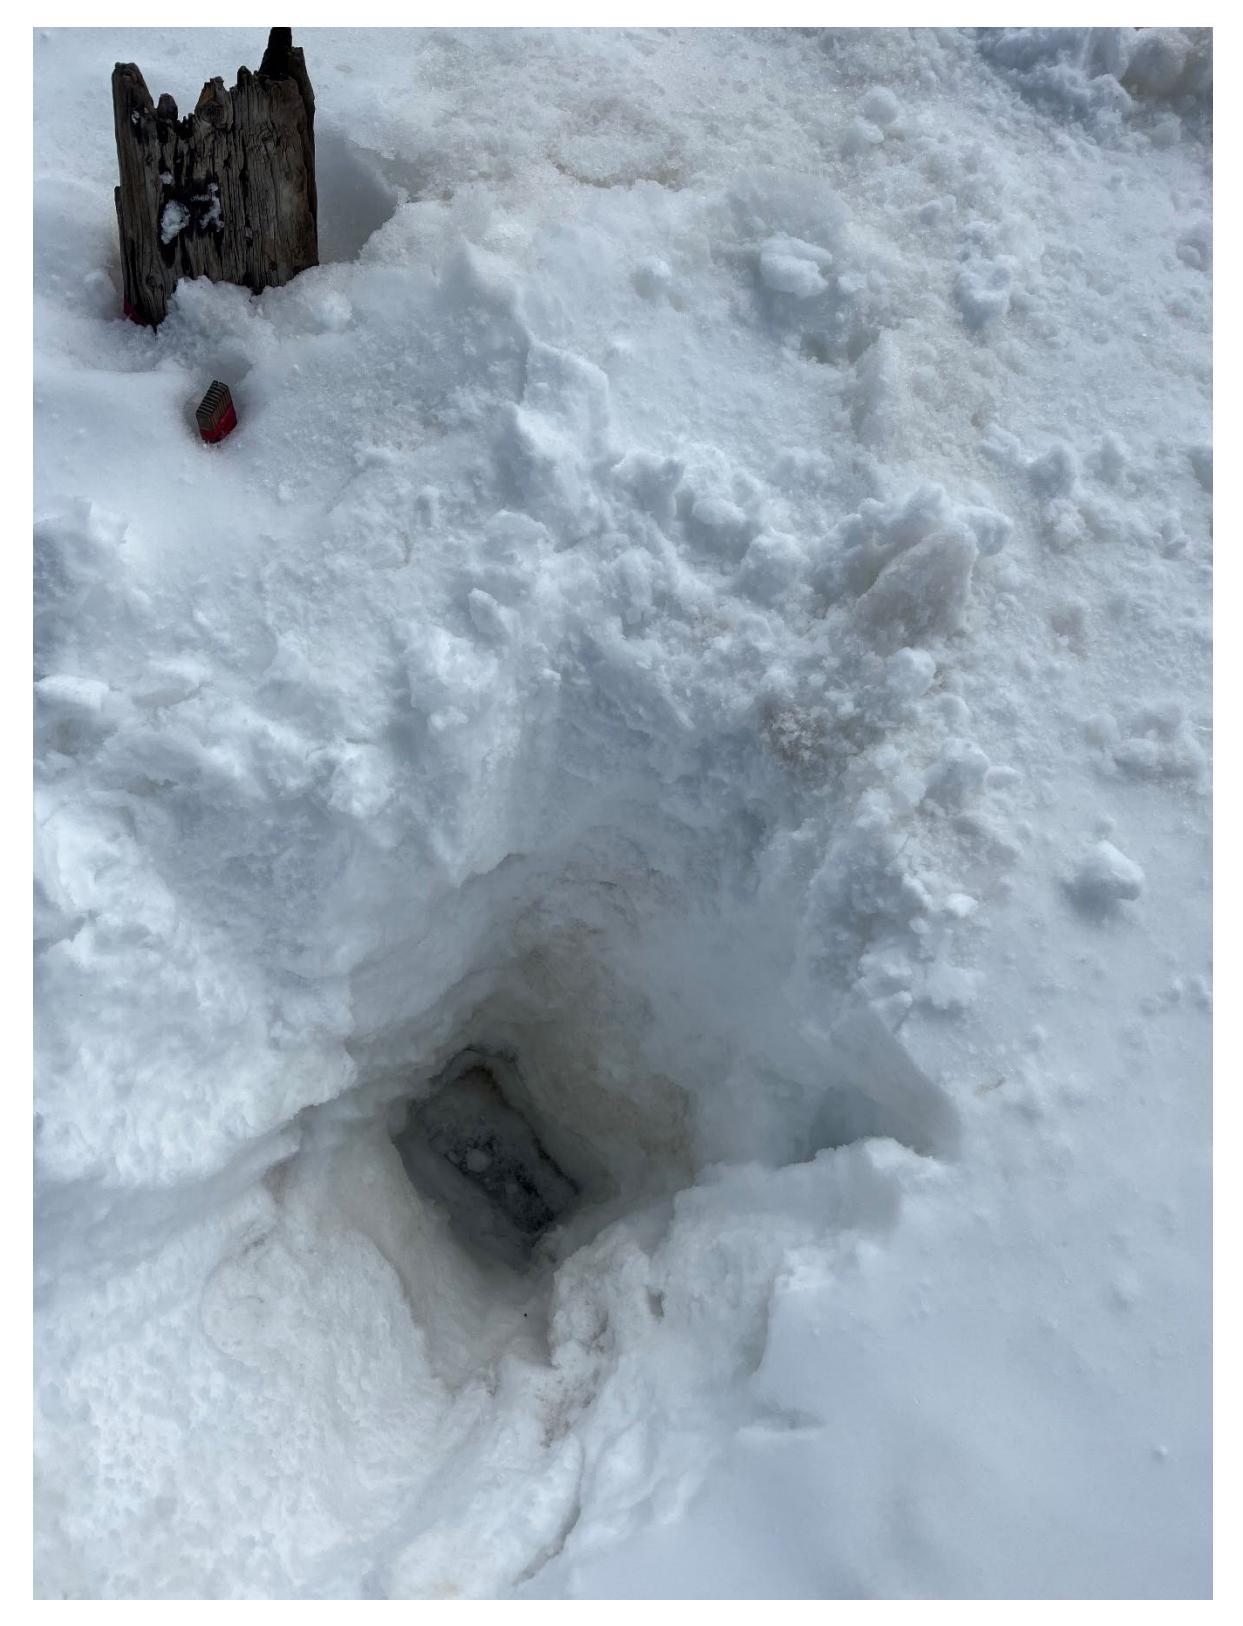
Photograph 2: View of the GV-06 surface water monitoring location after removal of snow. Photo taken 4/3/2024 at approximately 14:00 MDT.

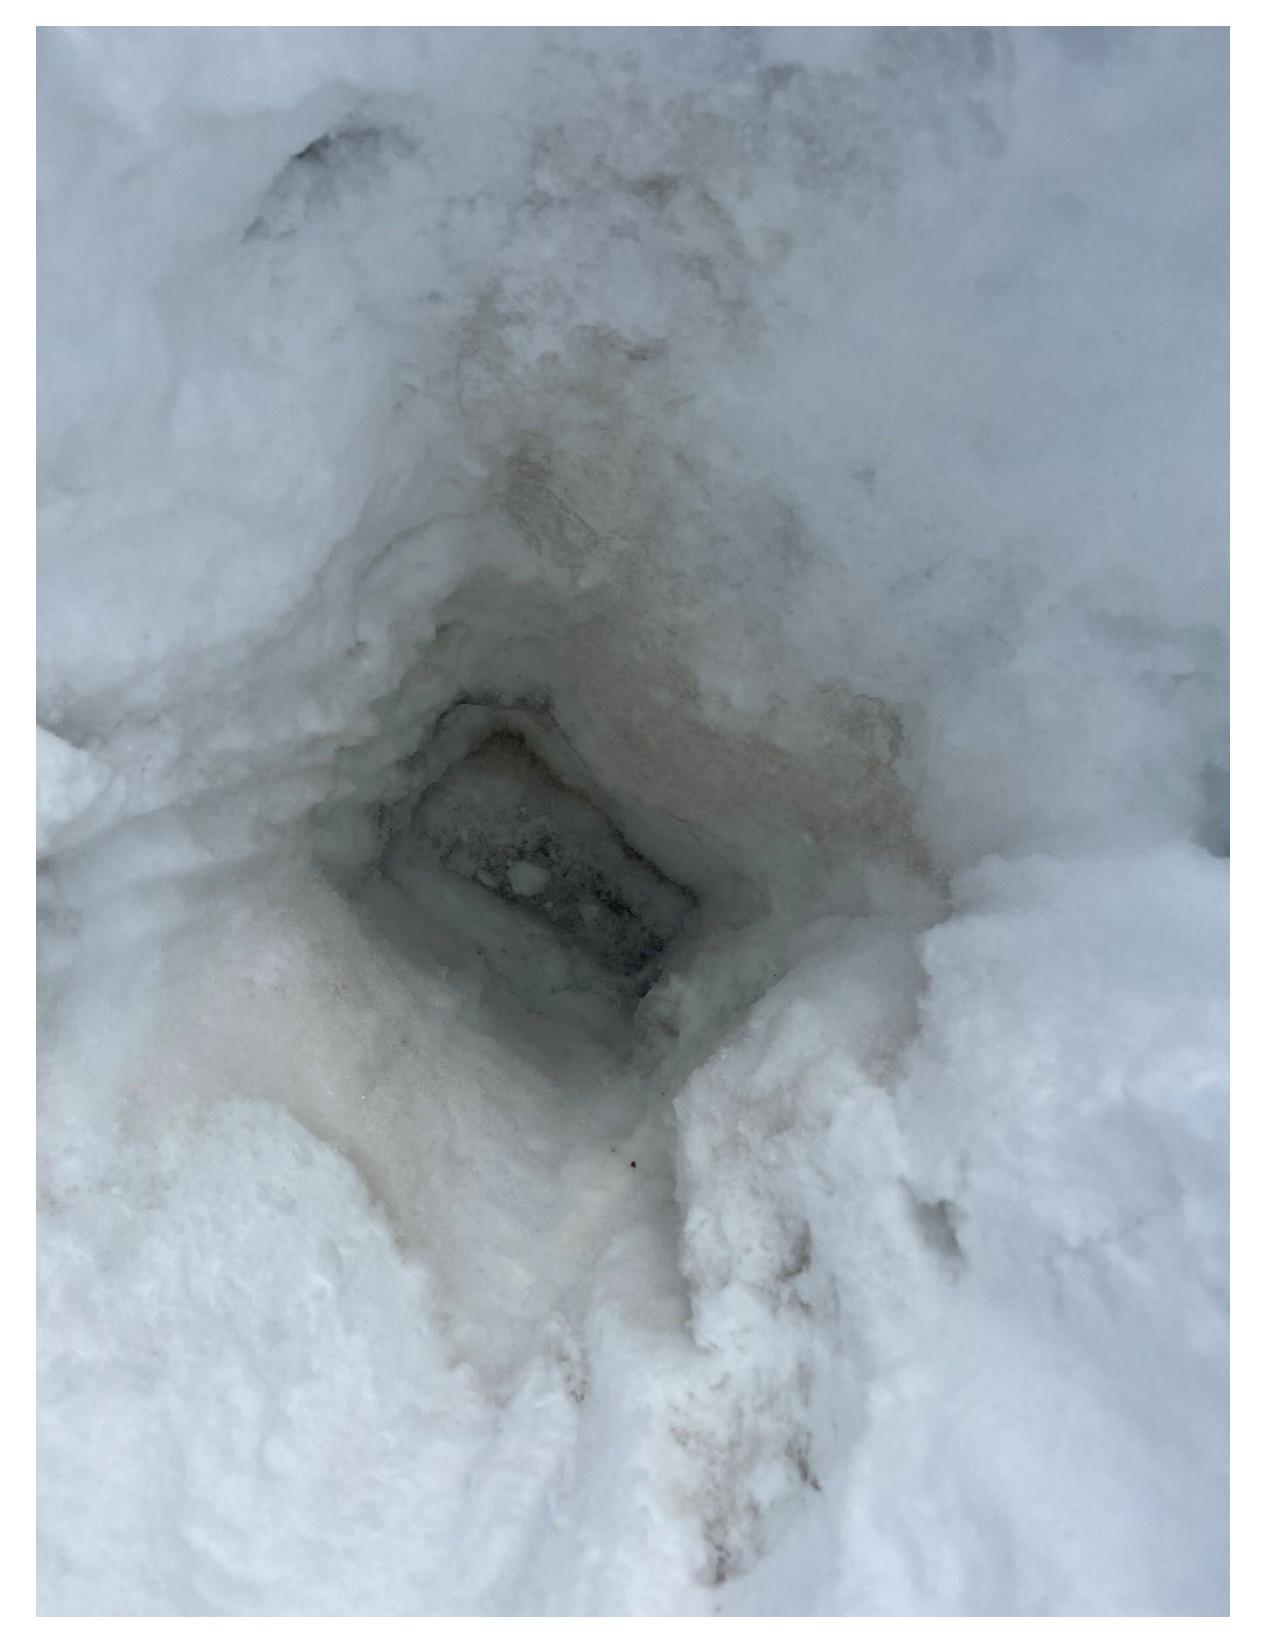
Photograph 3: View of the GV-06 surface water monitoring location after snow and ice was removed. No flowing water was observed at the location. Photo taken 4/3/2024 at approximately 14:00 MDT.

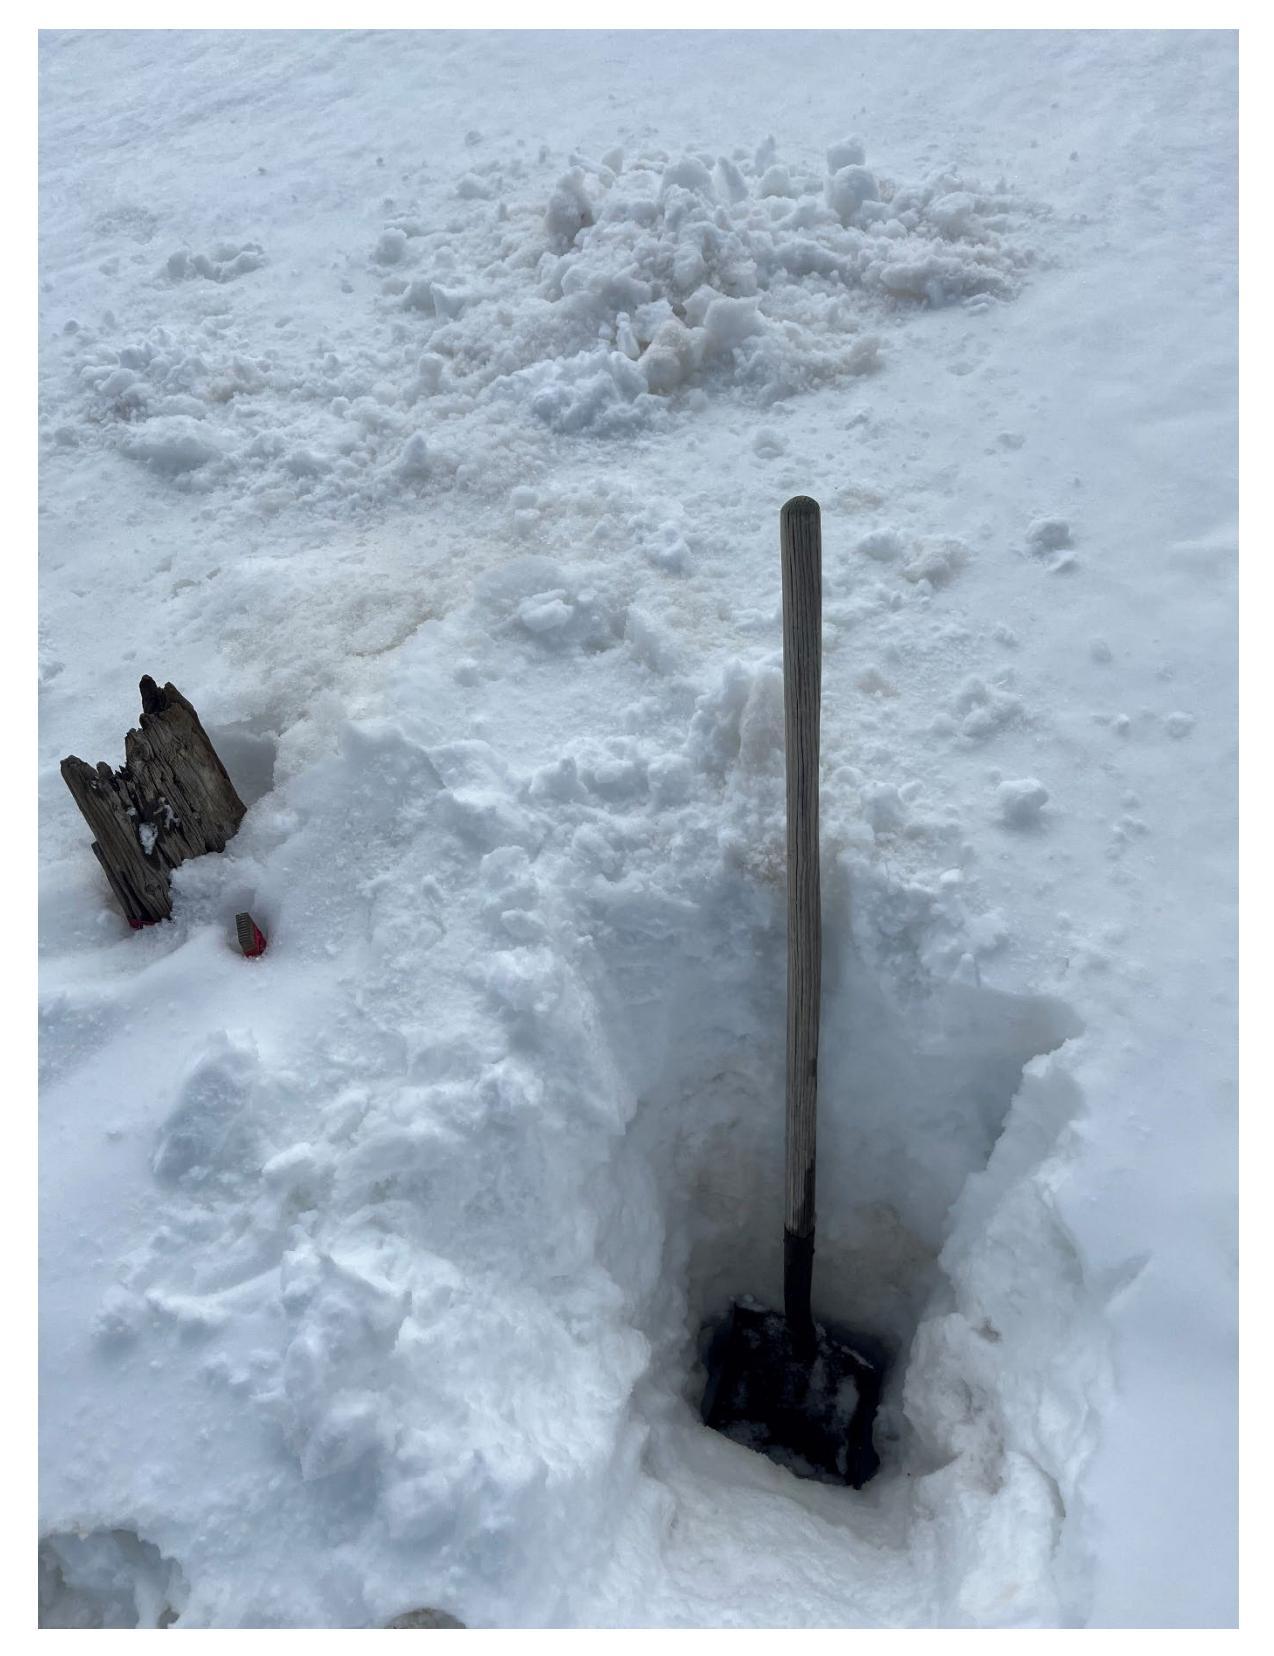
Photograph 4: View of the GV-06 surface water monitoring location showing the depth of snow. Photo taken 4/3/2024 at approximately 14:00 MDT.
