MINERALS PROGRAM INSPECTION REPORT PHONE: (303) 866-3567

MINE NAME:		MINE/PROSPECTING ID#:	MINERAL:	COUNTY:
Horton Gravel Pit		M-1985-135	Sand and gravel	Larimer
INSPECTION TYPE:		WEATHER: Clear	INSP. DATE:	INSP. TIME:
Monitoring			April 9, 2024	09:00
OPERATOR:		OPERATOR REPRESENTATIVE:	TYPE OF OPERATION:	
Larimer County		Todd Juergens	112c - Construction Regular Operation	
REASON FOR INSPECTION:		BOND CALCULATION TYPE:	BOND AMOUNT:	
Normal I&E Program		NA	NA – County Government	
DATE OF COMPLAINT:		POST INSP. CONTACTS:	JOINT INSP. AGENCY:	
NA		None	None	
INSPECTOR(S):	INSPECTOR'S SIGNATURE:		SIGNATURE DATE:	
Nikie Gagnon			May 14, 2024	
	A	ikie Gagnon

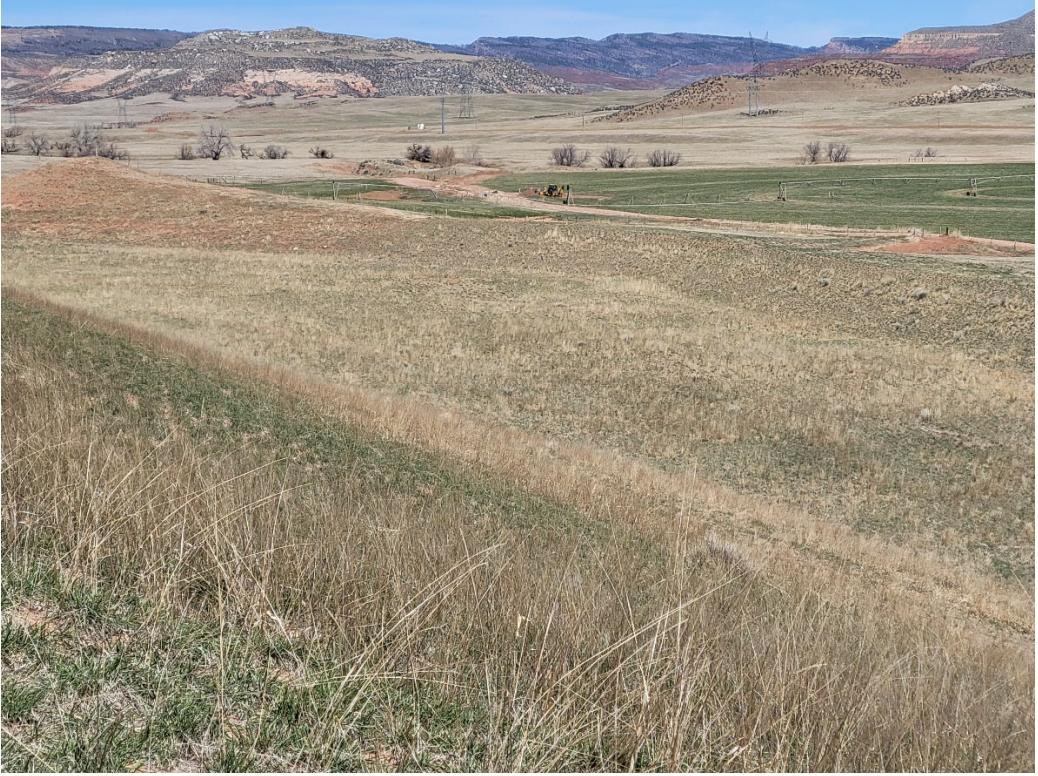
The mine site is split into two distinct areas. Cell A is on the east side and Cell B is on the west side of the permit area. A buried petroleum line bisects the two cells. Cell A was mined first and is in reclamation. The slopes are graded to 3H:1V. According to Mr. Juergens, the site has not been mined in a few years, however, the County plans to mine the west side of the permit area in the future.

Photo 1: View of reclaimed Cell A on the eastern side of the permit area.

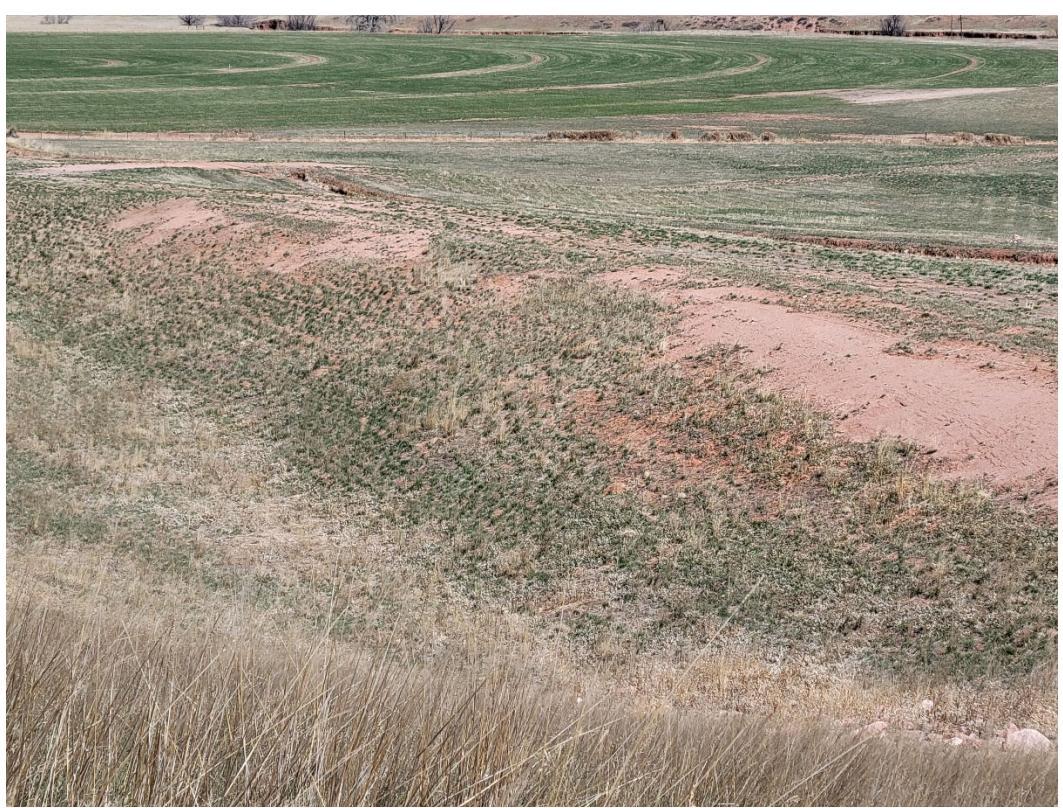
The Division observed a 26-acre reclaimed pit on the eastern side of the permit area. Native grasses are established on the pit floor and on the slopes. Generally, the grasses are uniformly established across the pit and this area is capable of regeneration. The Division observed some bare spots on the top of the northern side and in the northwestern corner. The pit was dry during this inspection and no evidence of standing water was noted.

Photo 2: View of patchy vegetation along top of slope in Cell A.

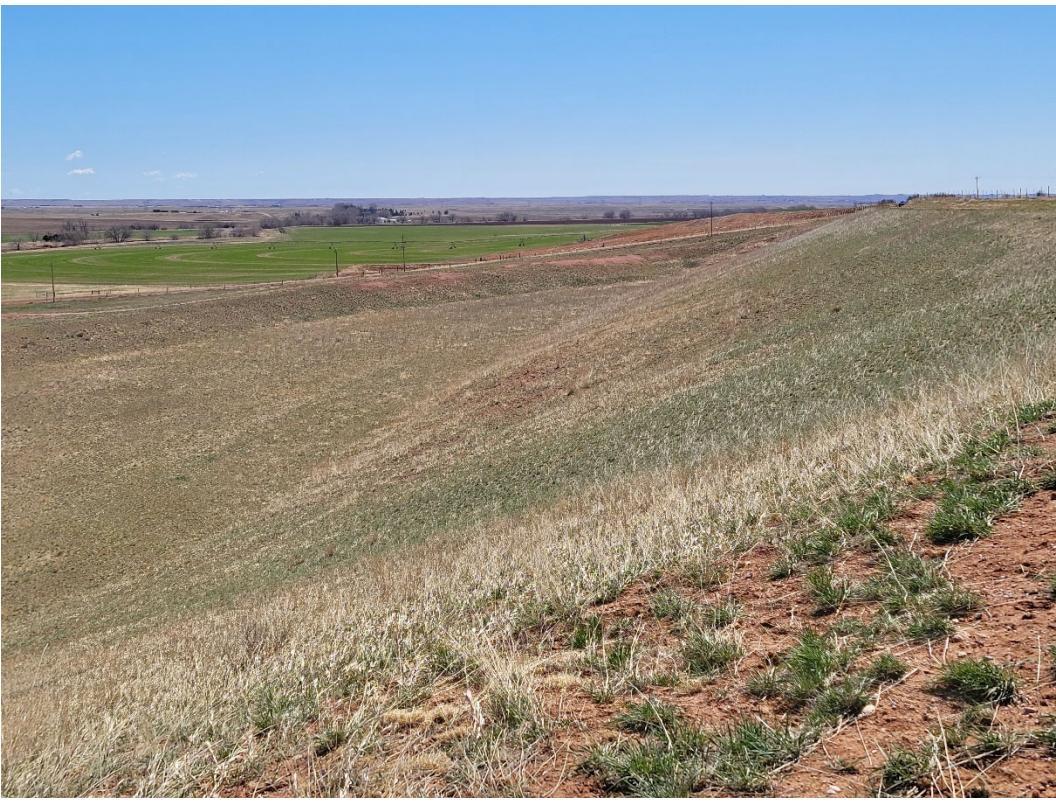
Photo 3: Side view of vegetated slope in Cell A.

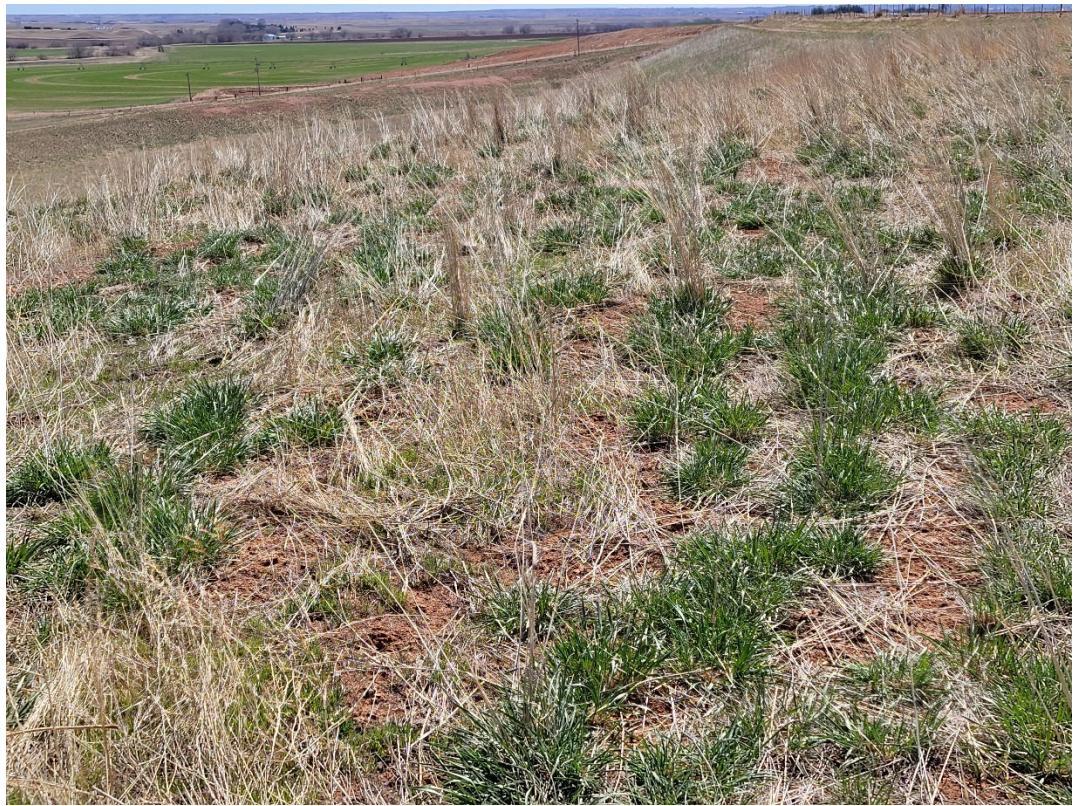
Photo 4: Area reseeded at top of southern slope in Cell A.

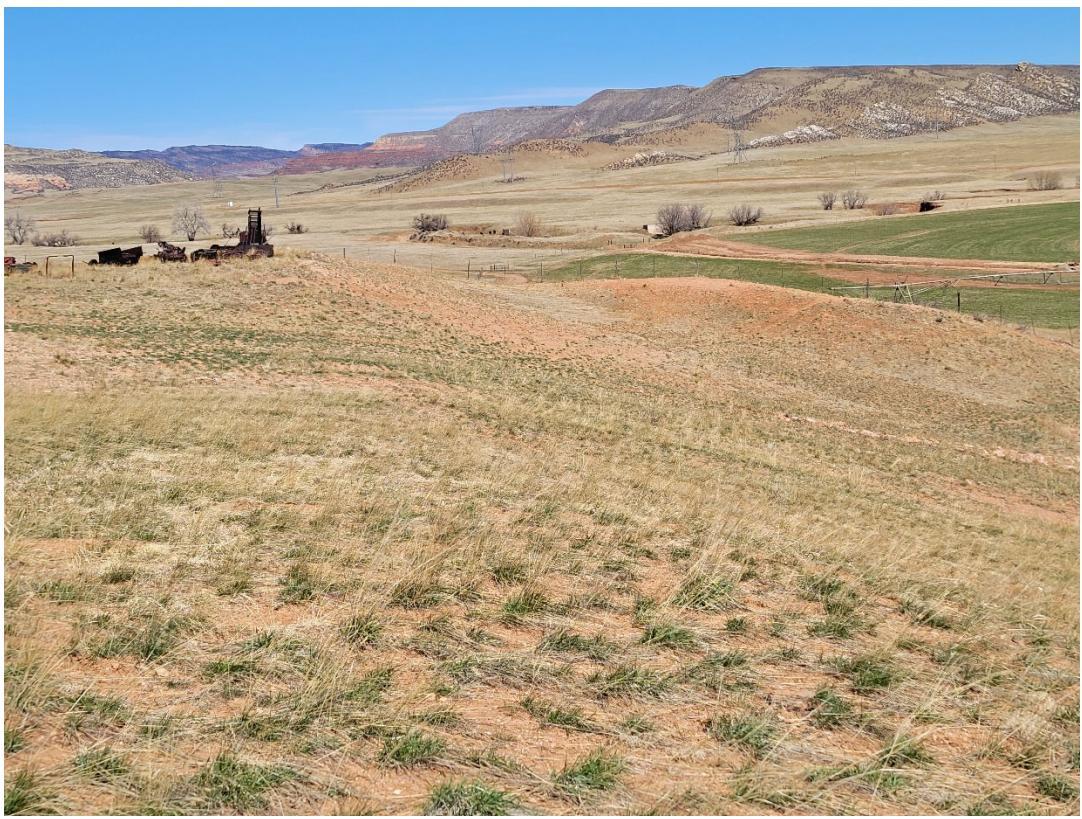
Photo 5: View looking northwest between the two cells.

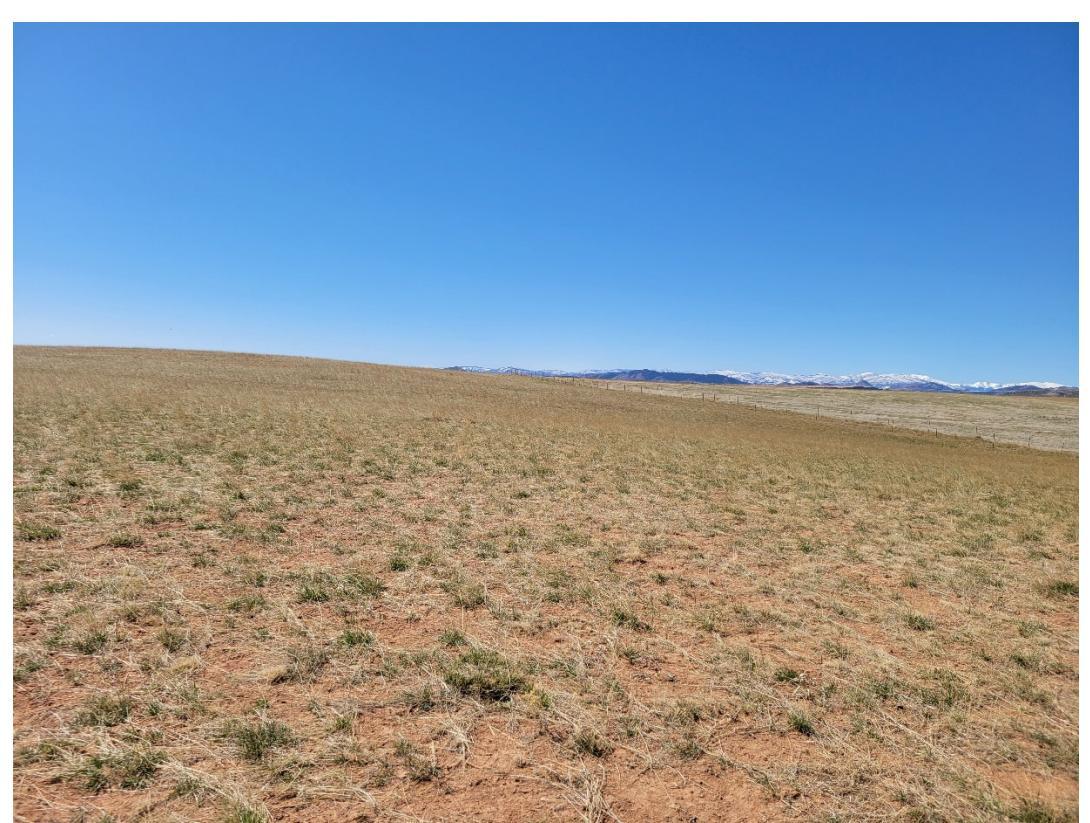
The western 15 acres in Cell B has not been mined and is occasionally used for grazing. The Division observed a small staging area on the southern boundary between the two cells. Culvert piping and concrete structures are stored in the staging area.

Photo 6: View looking north across the undisturbed portion in Cell B.

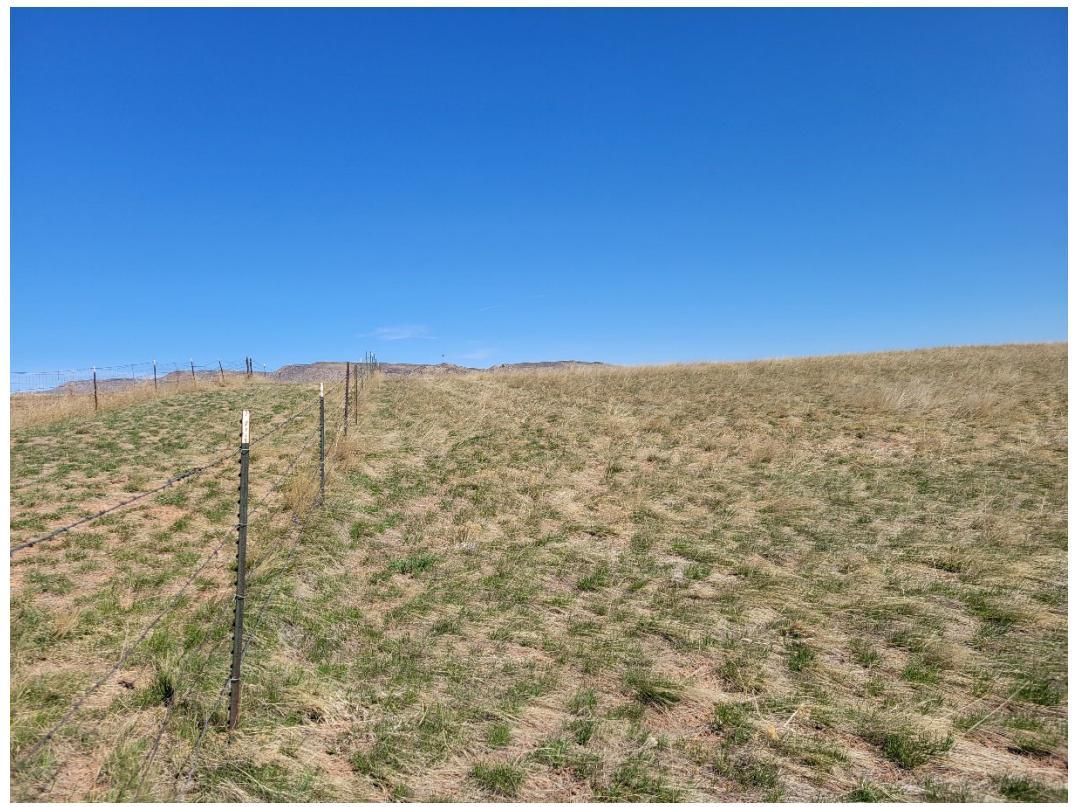
Photo 7: View looking down the southern boundary in Cell B.

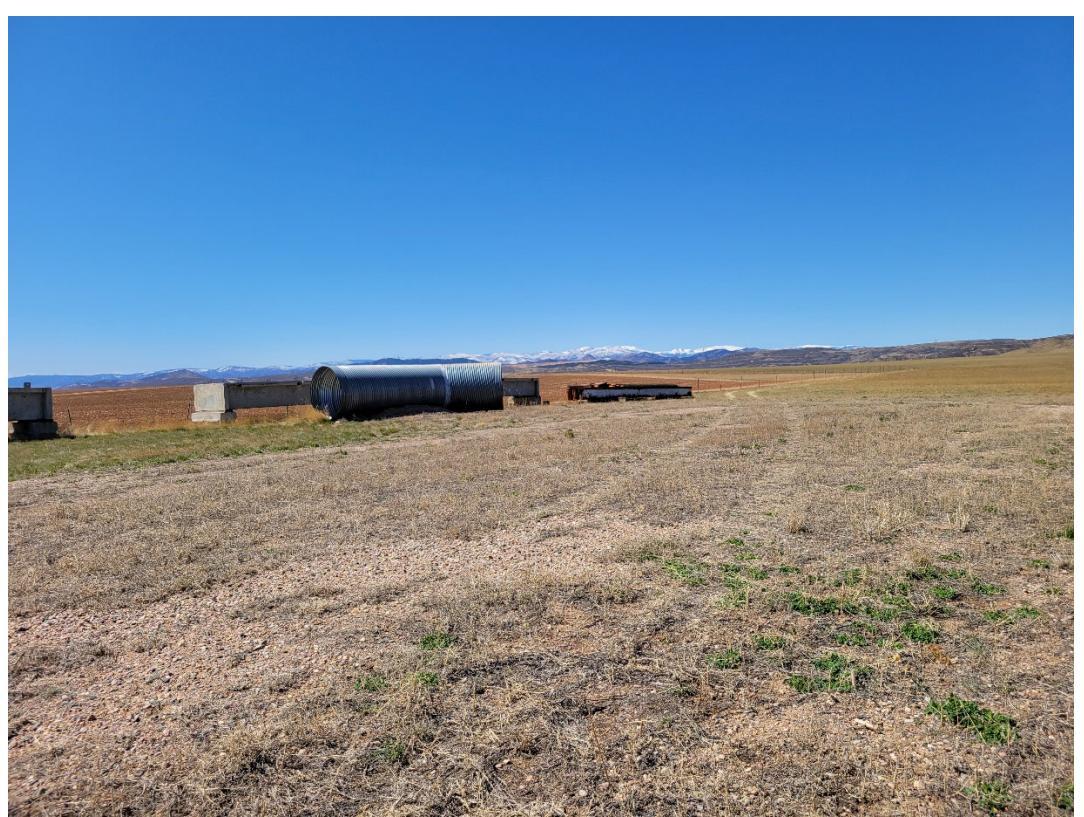
Photo 8: Staging area between the two cells along the southern boundary.

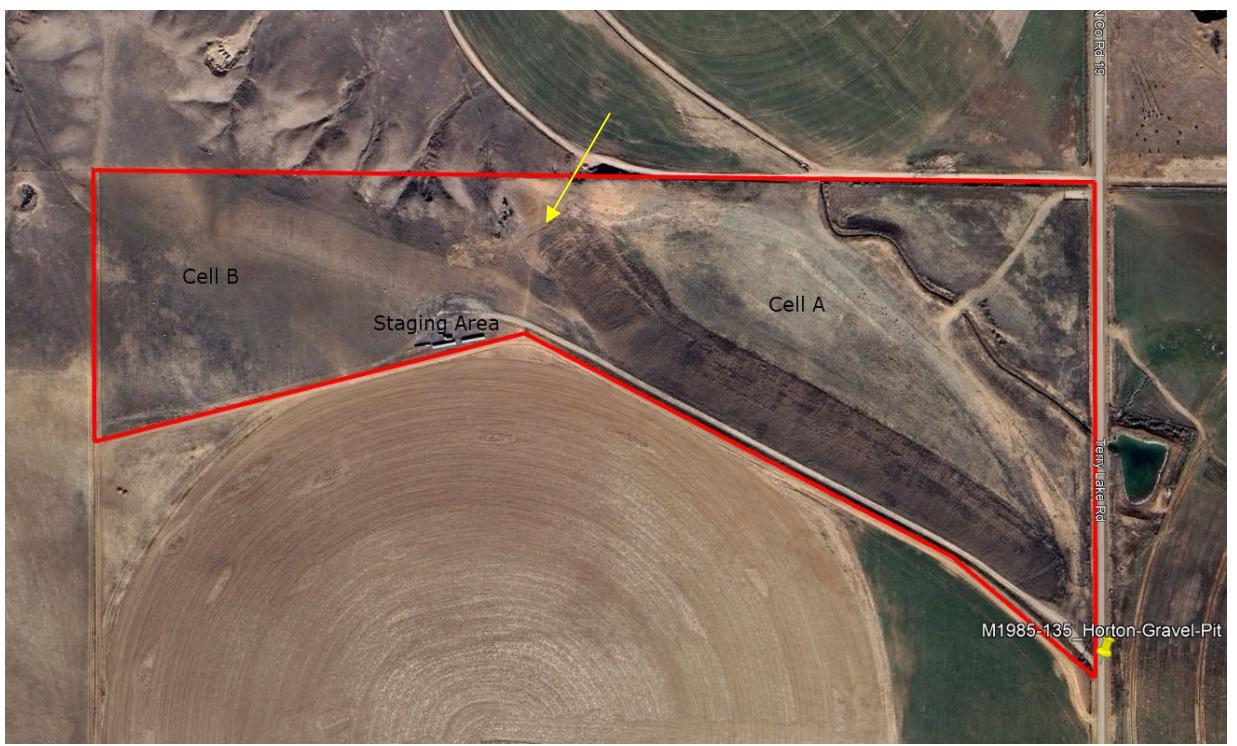
Figure 1: Approximate Permit Boundary. Google Earth imagery dated 11/11/2022. Yellow arrow points to the high point where the petroleum pipeline runs between the two cells.
