Re: Sandy Acres Pit, DRMS Permit No. M-1980-110 Technical Revision 6 (TR6) additional information

RE: Hendersen Development / Sandy Acres, Permit No. M-1980-110, Technical Revision (TR-06), Response to Request for Additional Information

| To: | File |
|---|--|
| Subject: | E-470 Public Highway Authority- Sandy Acres Pit - Ground Water Monitoring Plan |

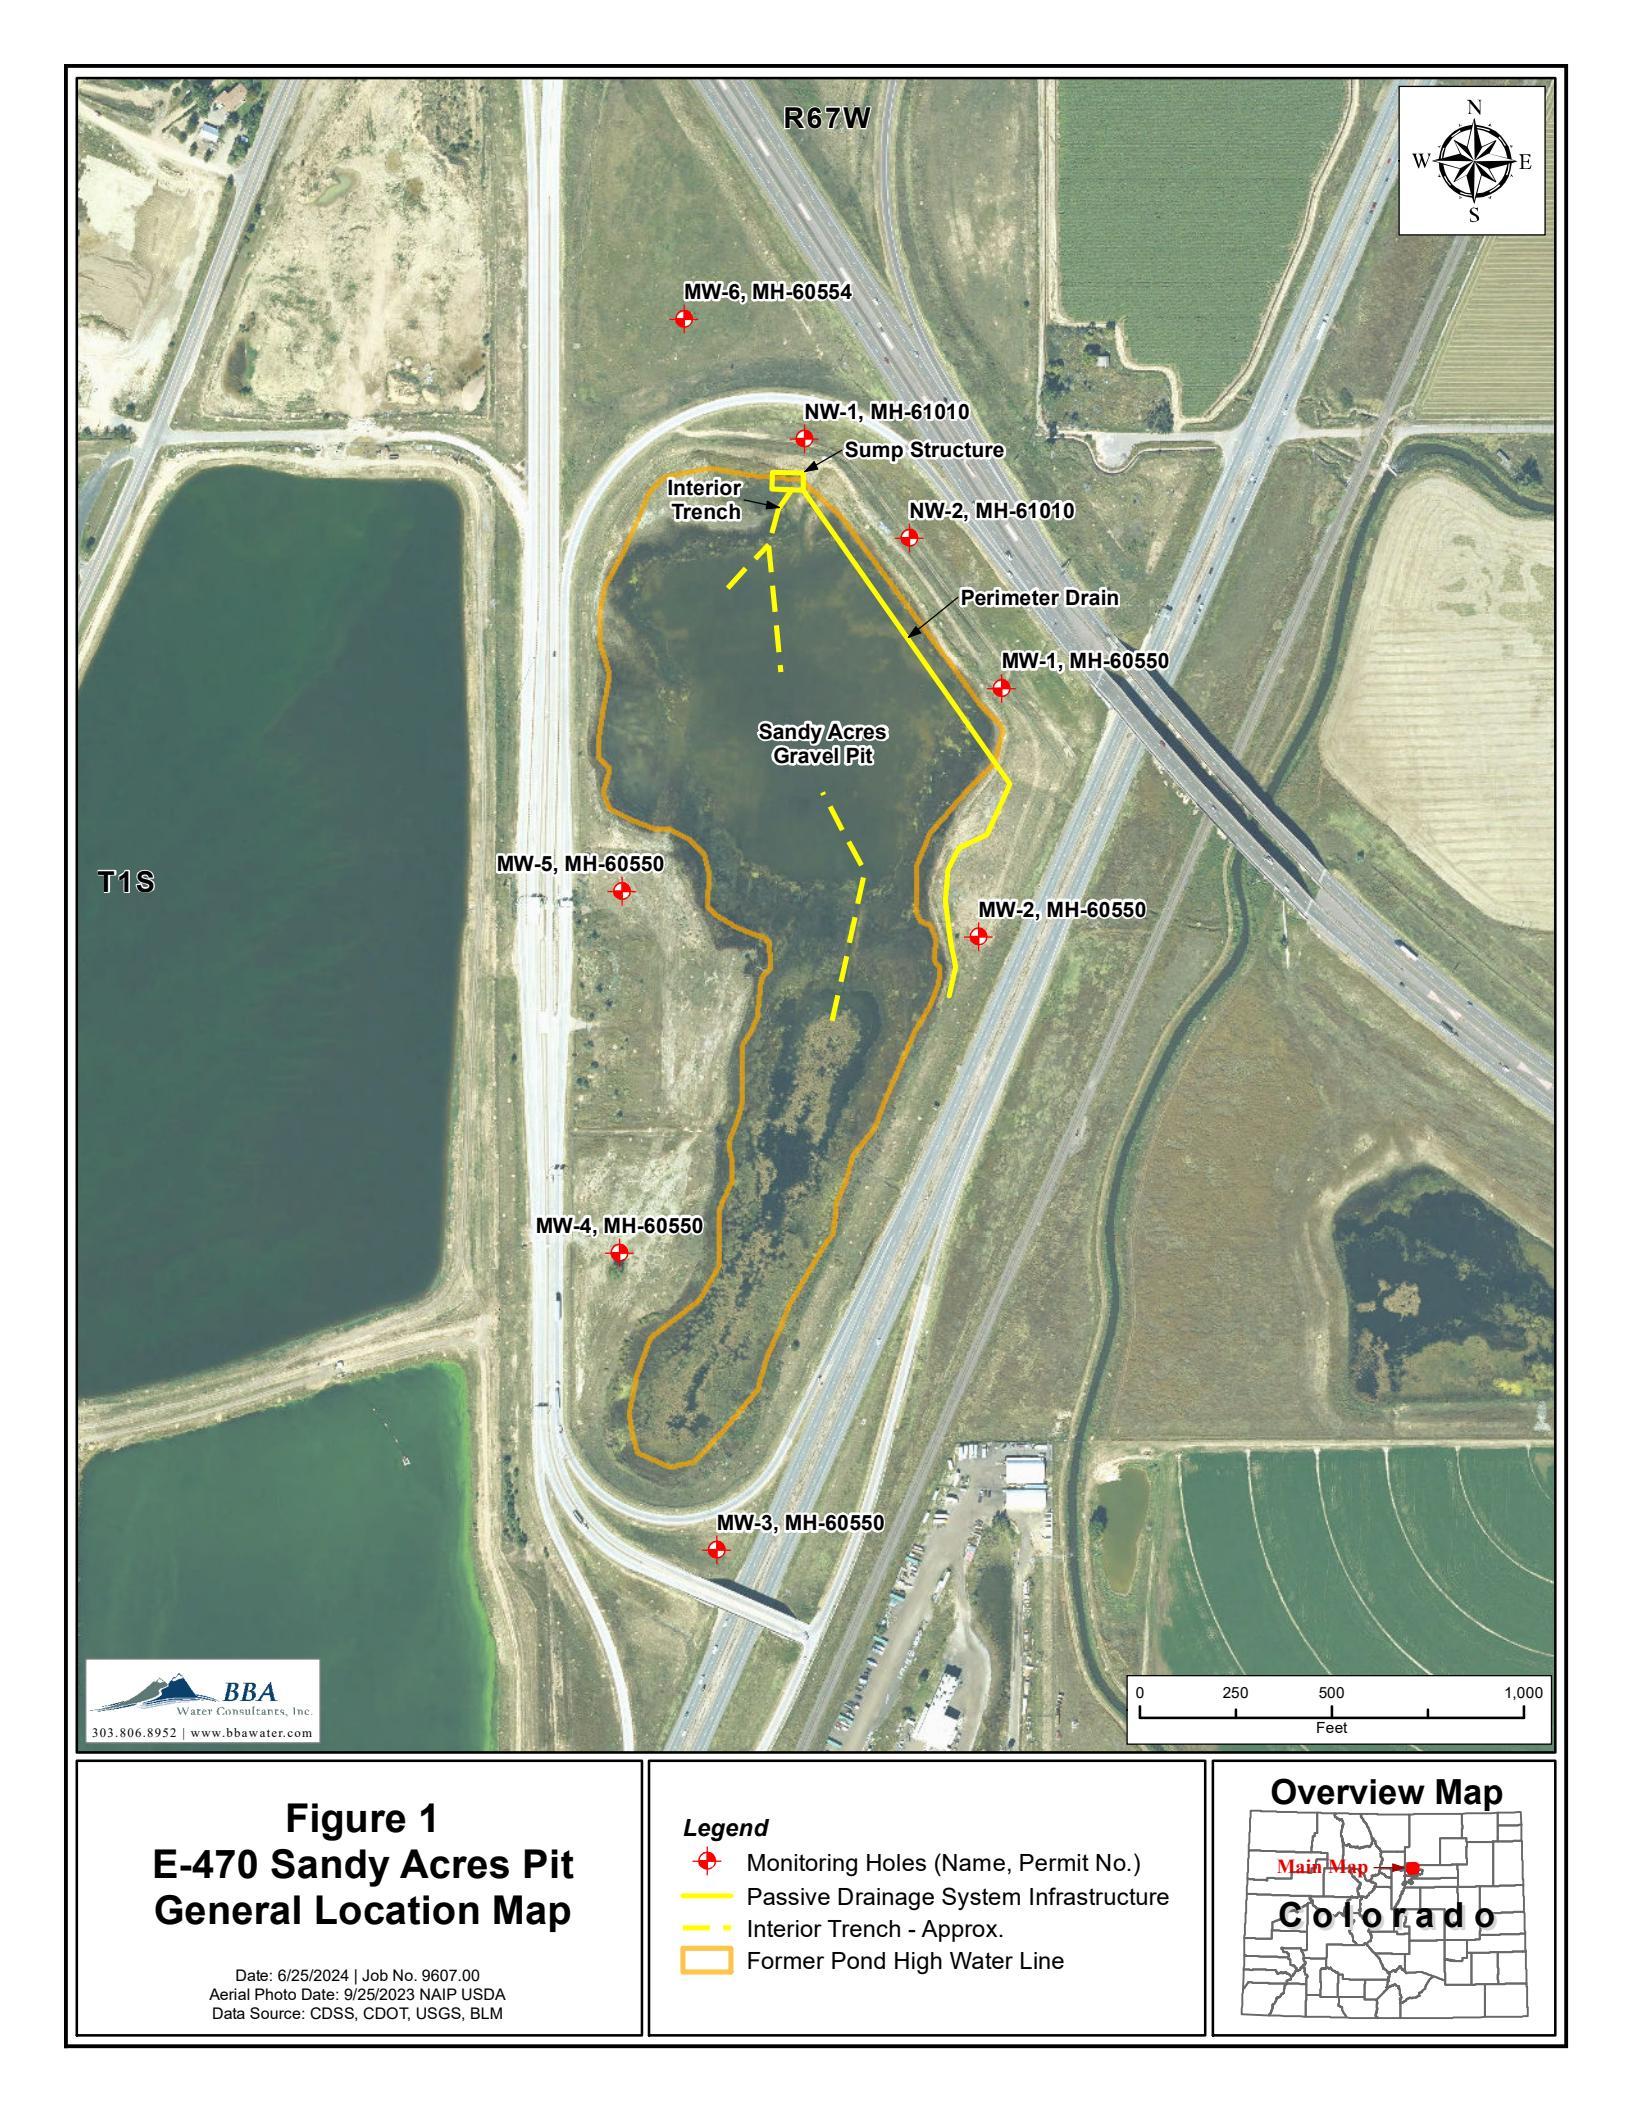
The location of the initial trenching, the sump structure and the extended / connected trenching along with the interior ditch efforts have been presented in the attached Figure 1. A cross section of the drainage system trench construction is provided in the attached Figure 2.

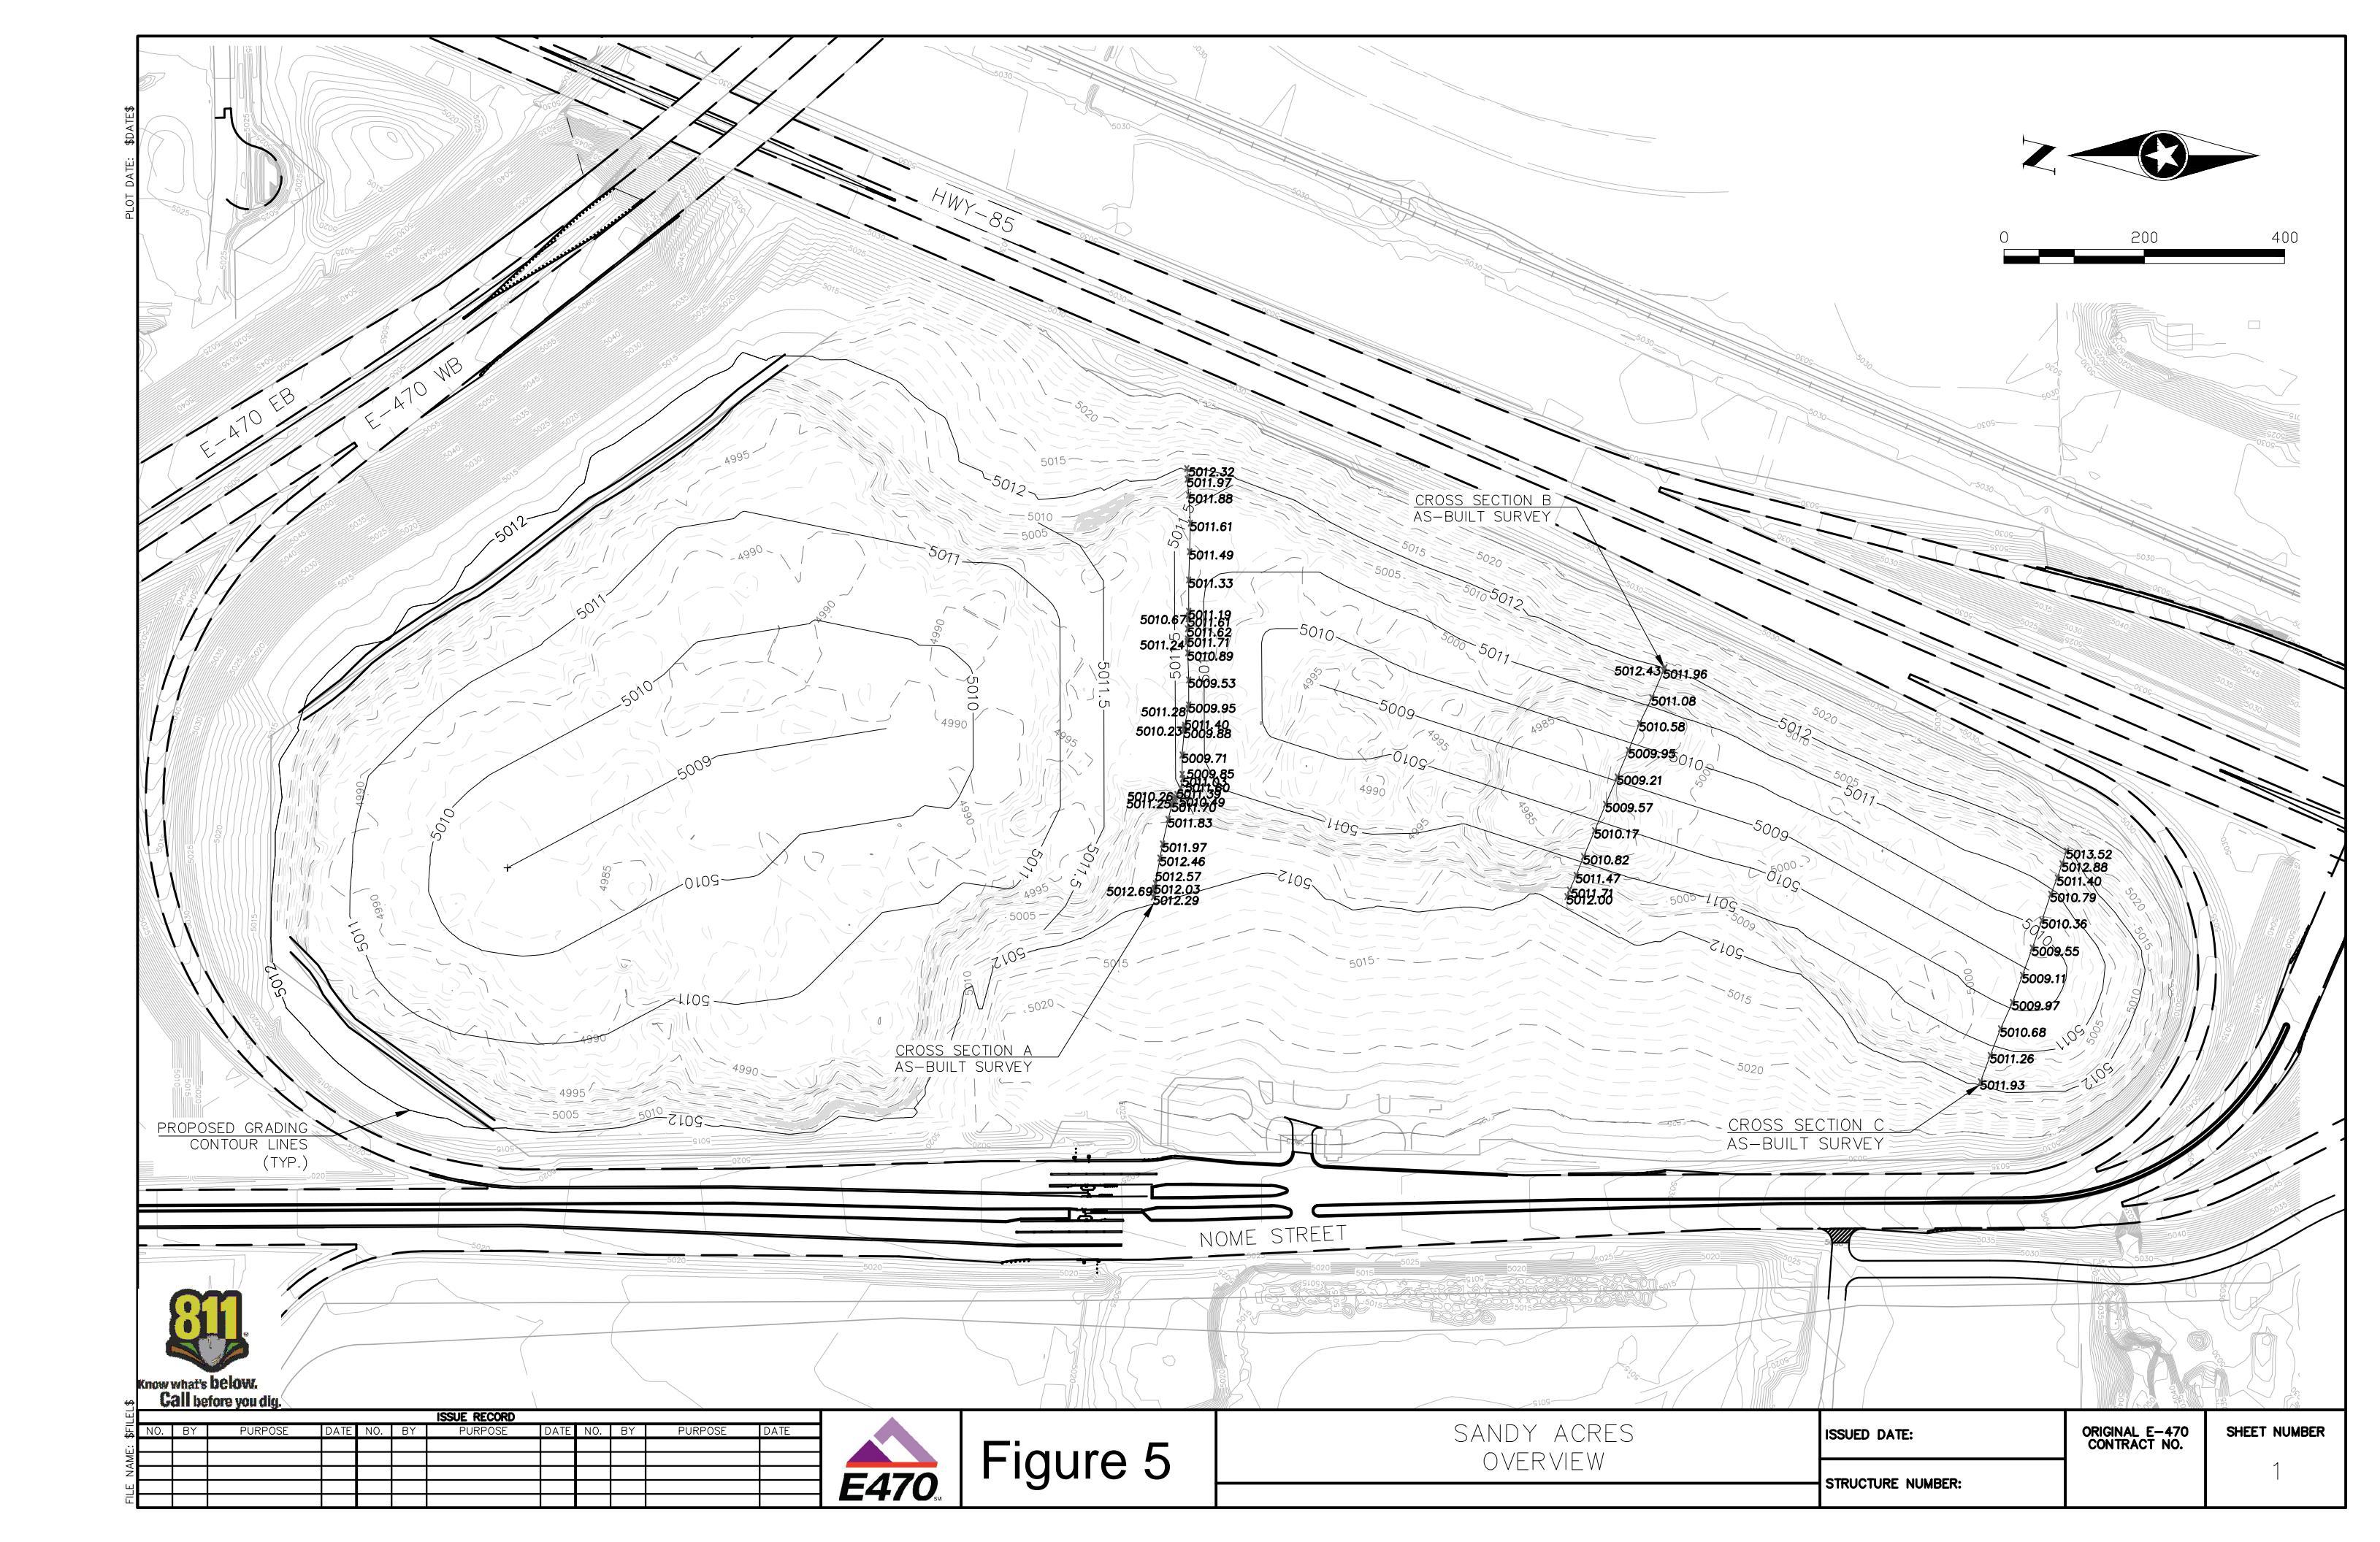
| 5040 | | | 504 | C |
|---|---|---|---|---|
| Herein <td><b>E470</b> Figure 5 </td> <td>CROSS SECTIONS</td> <td>STRUCTURE NUMBER:</td> <td>2</td> | <b>E470</b> Figure 5 | CROSS SECTIONS | STRUCTURE NUMBER: | 2 |

The general location map that presents both the proposed and as-built pit backfill elevations has been represented as the attached Figure 5. As indicated in the attached figure, the as-built elevations are at least the proposed elevation of 5012 feet at the edges of the pit and at least the proposed elevation of 5009 feet in the center of the pit. Accordingly, based on the information that has been provided by E-470 for our review, the pit backfill was installed in accordance with the proposed grading plan.

The original reclamation plan that proposed the pit backfilling submitted in Amendment Application AM-06 on March 4, 2014 identified a minimum backfill elevation of 5006.5 feet. On April 9, 2014, the reclamation plan was updated in a Resubmittal of Amendment Application AM-06 to identify a minimum backfill elevation of 5009 feet. The 5009-foot elevation was based on installing fill to an elevation a minimum of 2 feet above the static water level elevation. Based on our review of the available information, we understand that the static water level elevation identified at the time of the amendment application was 5006.5 feet and the revision of the pit backfill elevation to 5009 feet allowed for variation of the fill elevation of approximately 0.25 feet with an additional 0.25 feet of elevation to ensure the minimum 2-foot depth above the static water level elevatic water level elevation was achieved.
