MINERALS PROGRAM INSPECTION REPORT PHONE: (303) 866-3567

MINE NAME:	MINE/PROSPECTING ID#:	MINERAL:	COUNTY:
T Bone Stone Quarry	M-2004-030	Stone	Boulder
INSPECTION TYPE:	WEATHER: Cloudy	INSP. DATE:	INSP. TIME:
Surety-Related Inspection		July 26, 2024	11:30
OPERATOR:	OPERATOR REPRESENTATIVE:	TYPE OF OPERA	TION:
T Bone Stone, Inc.	Bill Tenore	112c - Construction	Regular Operation
REASON FOR INSPECTION:	BOND CALCULATION TYPE:	BOND AMOUNT:	
High Priority	Complete	\$48,274.00	
DATE OF COMPLAINT:	POST INSP. CONTACTS:	JOINT INSP. AGE	NCY:
NA	None	None	
INSPECTOR(S):	INSPECTOR'S SIGNATURE:	SIGNATURE DAT	Έ:
Patrick Lennberg	Patrick Lg	August 16, 2024

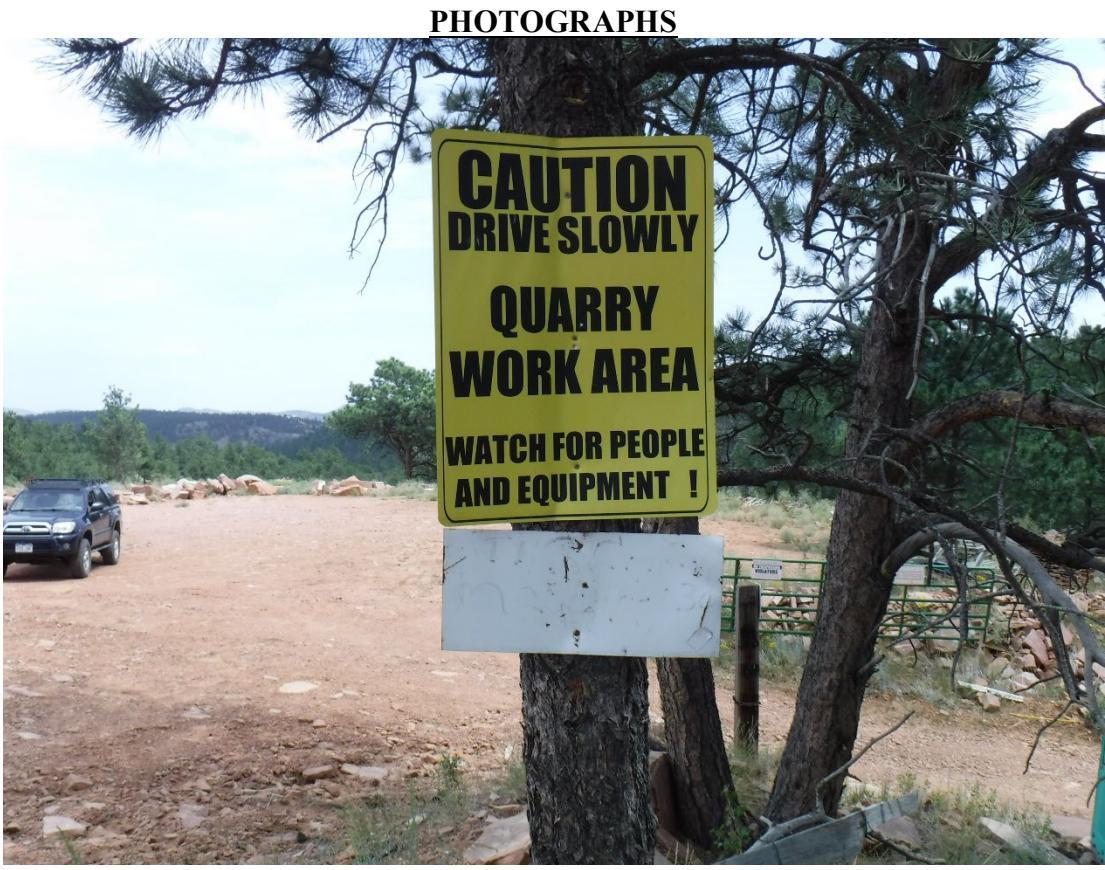
This is a 112c operation permitted for 25 acres. The affected acreage is 25 acres but only 14.5 acres are to be disturbed at any one time. The maximum depth of mining is limited to 50 feet. The permit is to mine sandstone for building materials and decorative use. The mine is located on property owned by William Tenore and Roberta McLeod Tenore. The mine is located in Boulder County. The site entrance is located approximately 3 miles north of Lyons, CO. The approved post-mining land use is rangeland. A faded mine sign was posted at the mine entrance pursuant to Rule 3.1.12.

Photo 1: Faded mine sign at the primary mine entrance

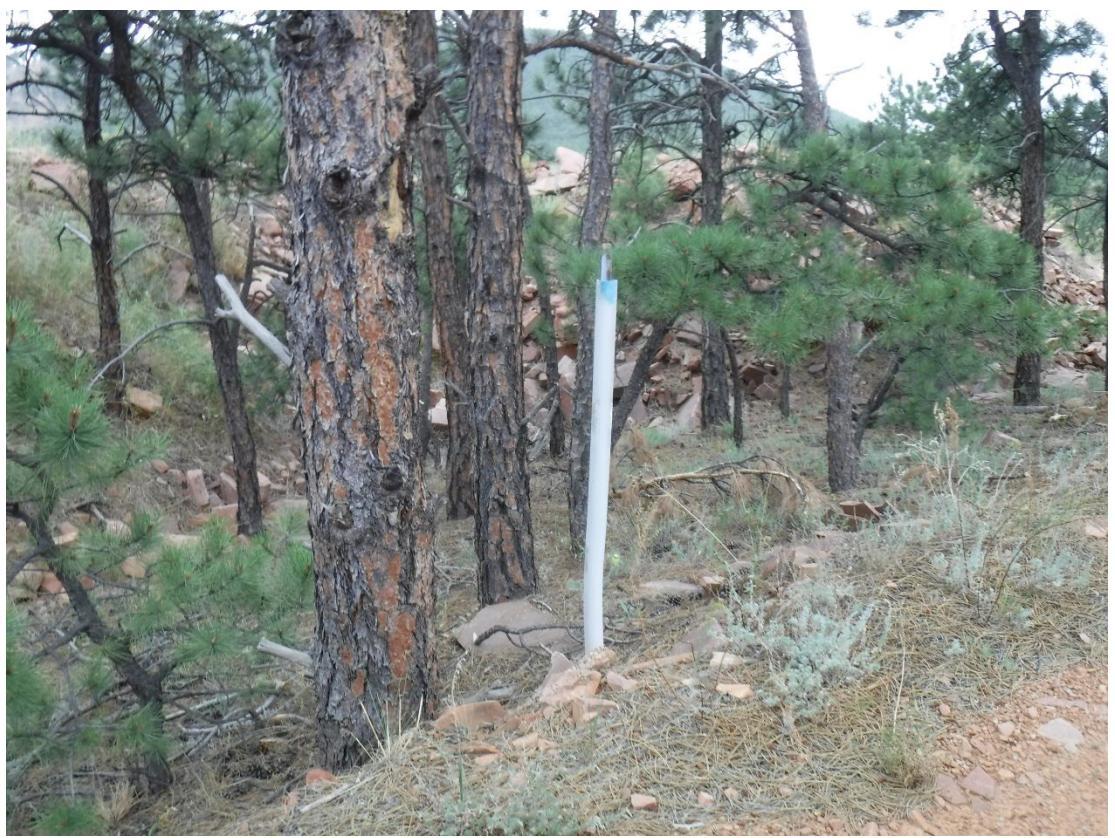
Photo 2: Typical permit boundary marker

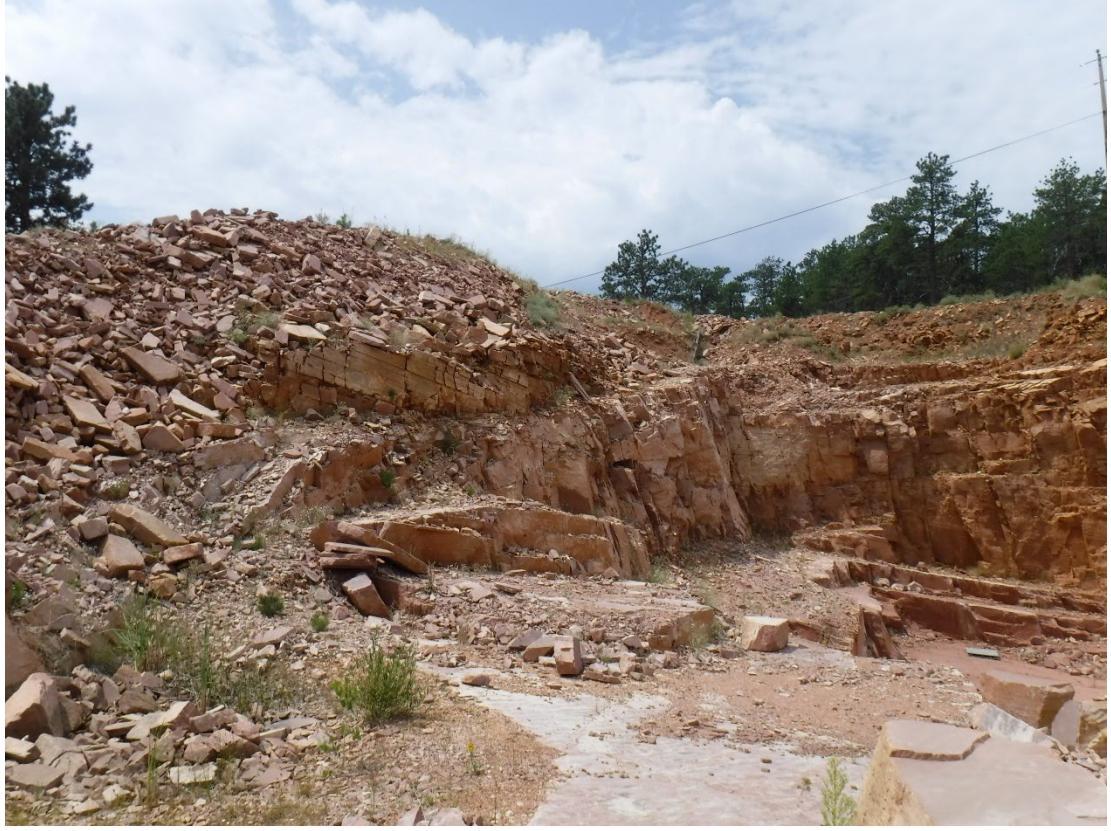
Photo 3: Quarry area located in the NW corner of the permit area, south wall

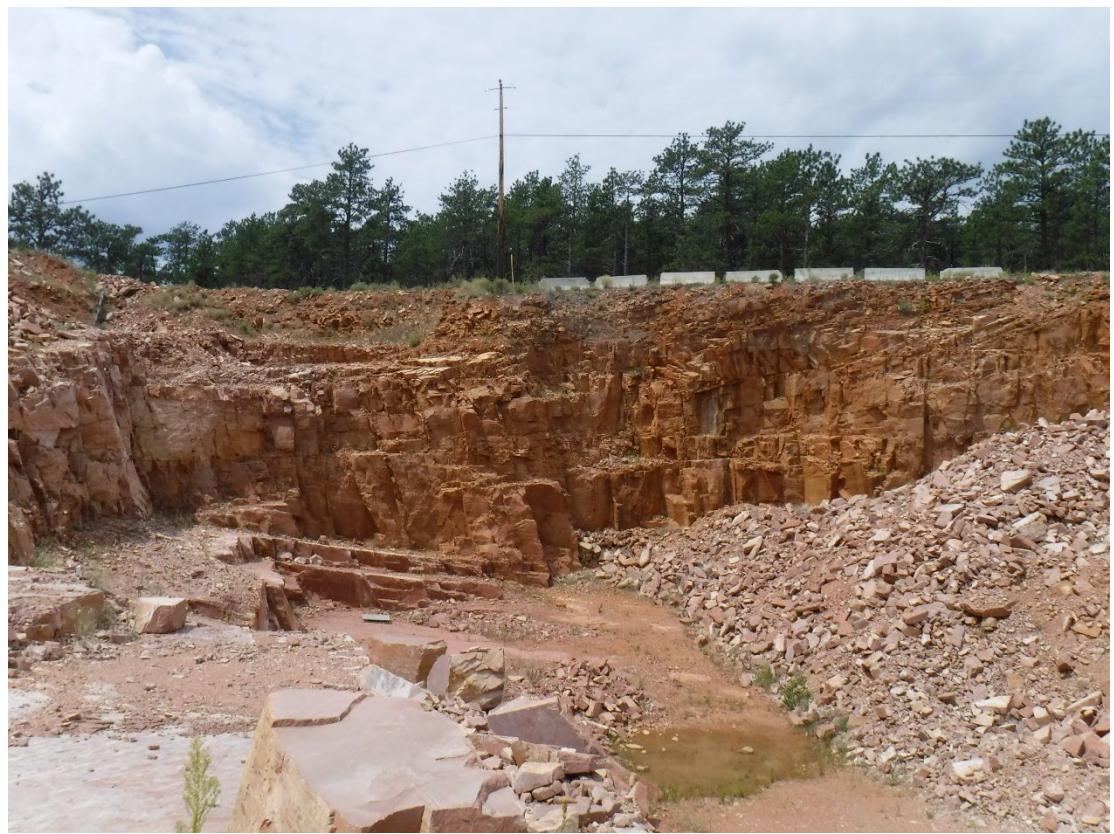
Photo 4: Quarry area located in the NW corner of the permit area, middle portion of area

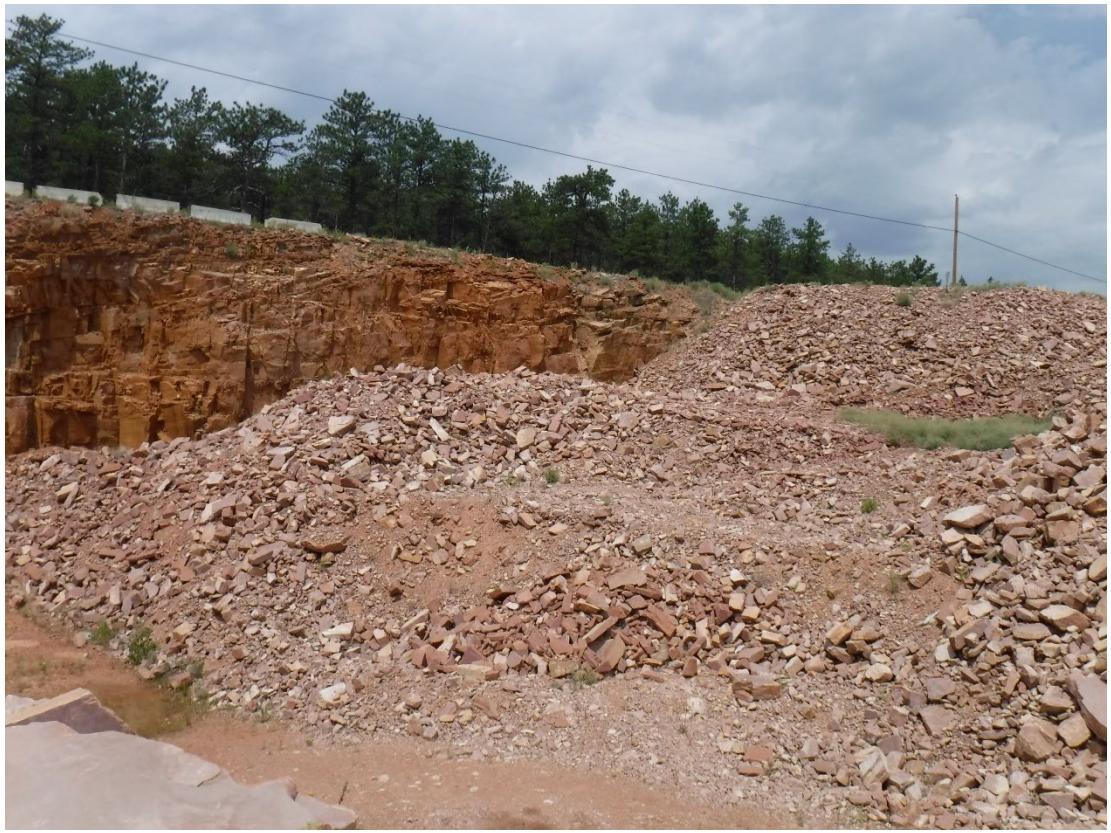
Photo 5: Overburden stockpile adjacent to quarry area located in the NW corner of the permit area, looking NW

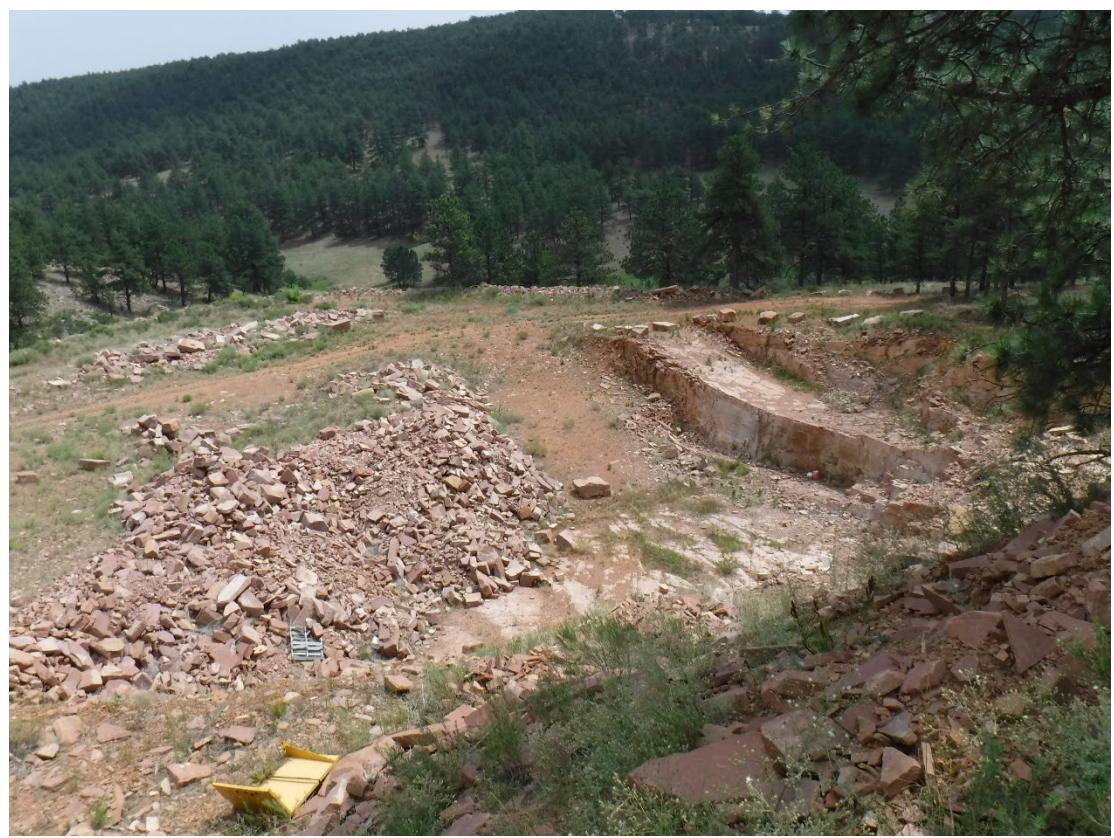
Photo 6: Looking down into the east quarry area in the NE portion of the permit area

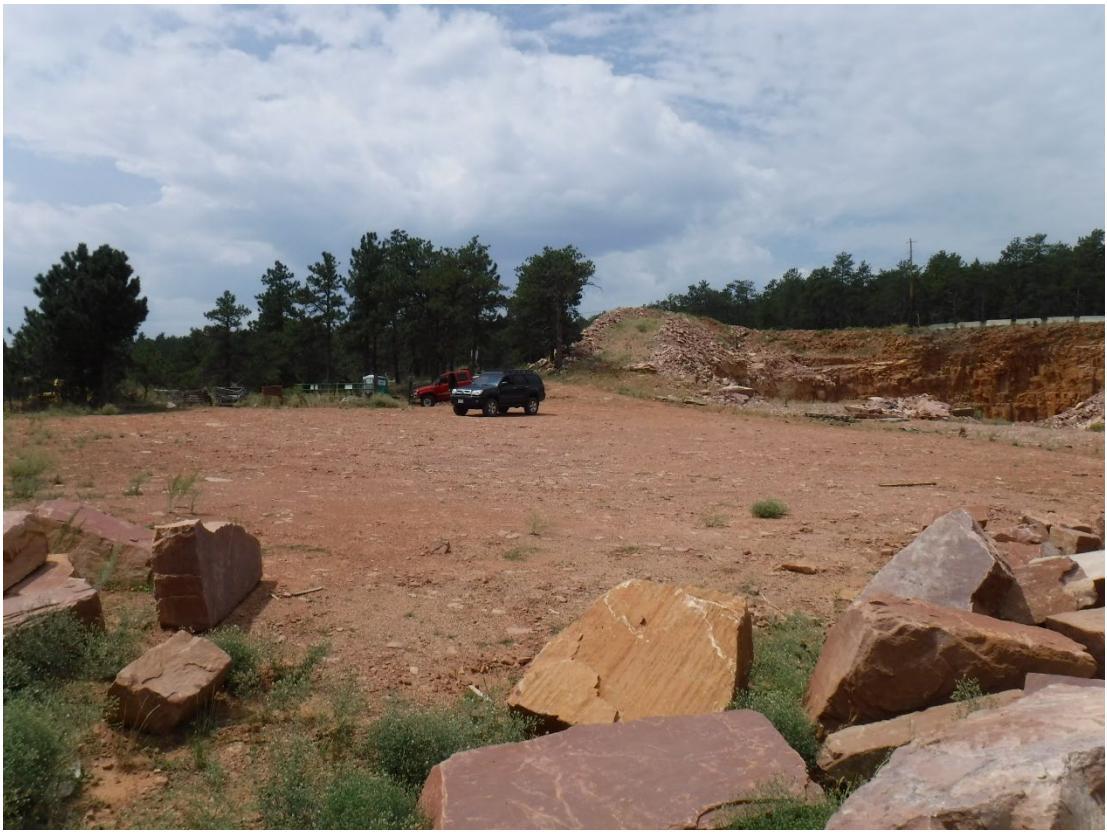
Photo 7: Equipment and material storage area in the north central portion of the permit area

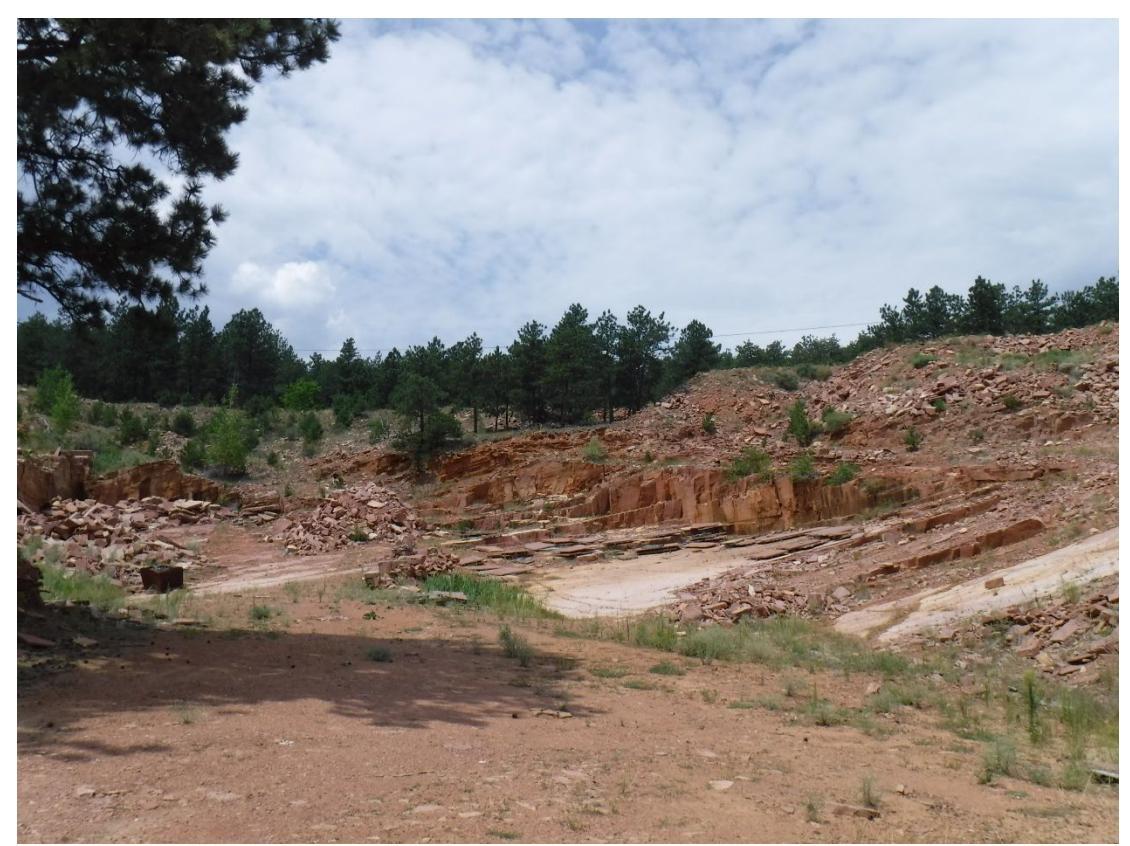
Photo 8: Quarry area in the central portion of the permit area

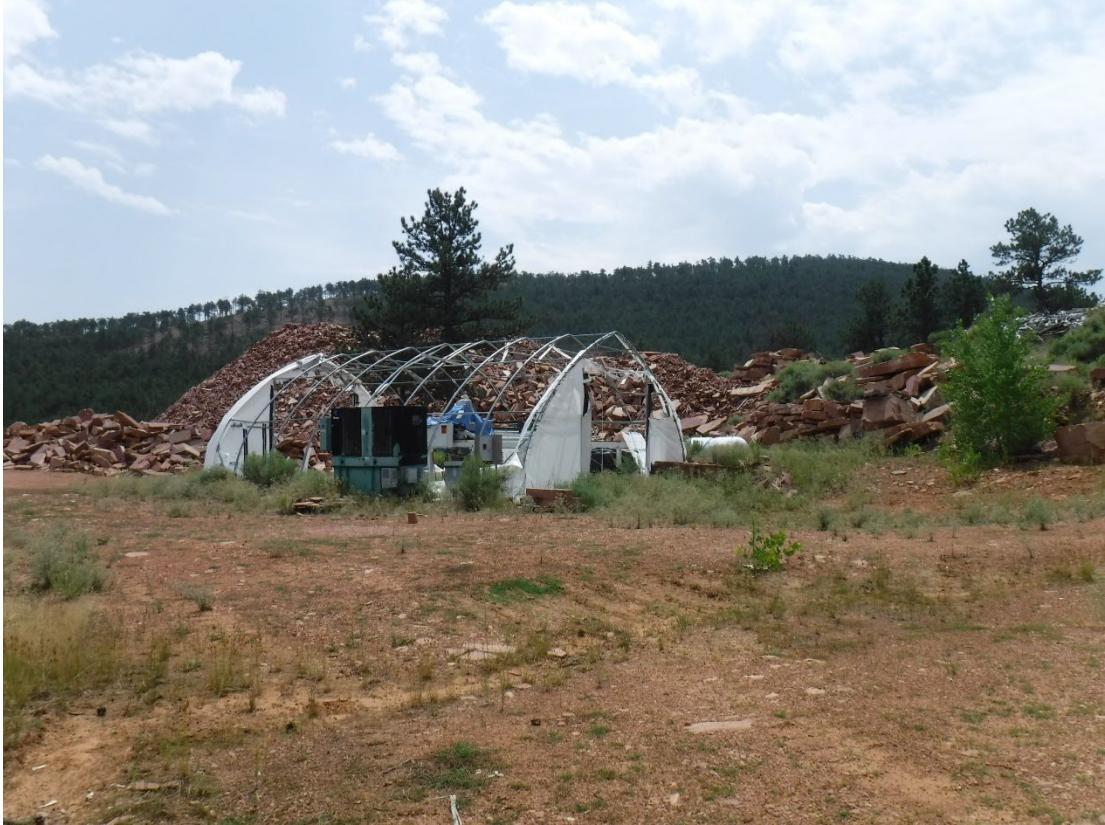
Photo 9: Dilapidated shelter with overburden stockpile behind it

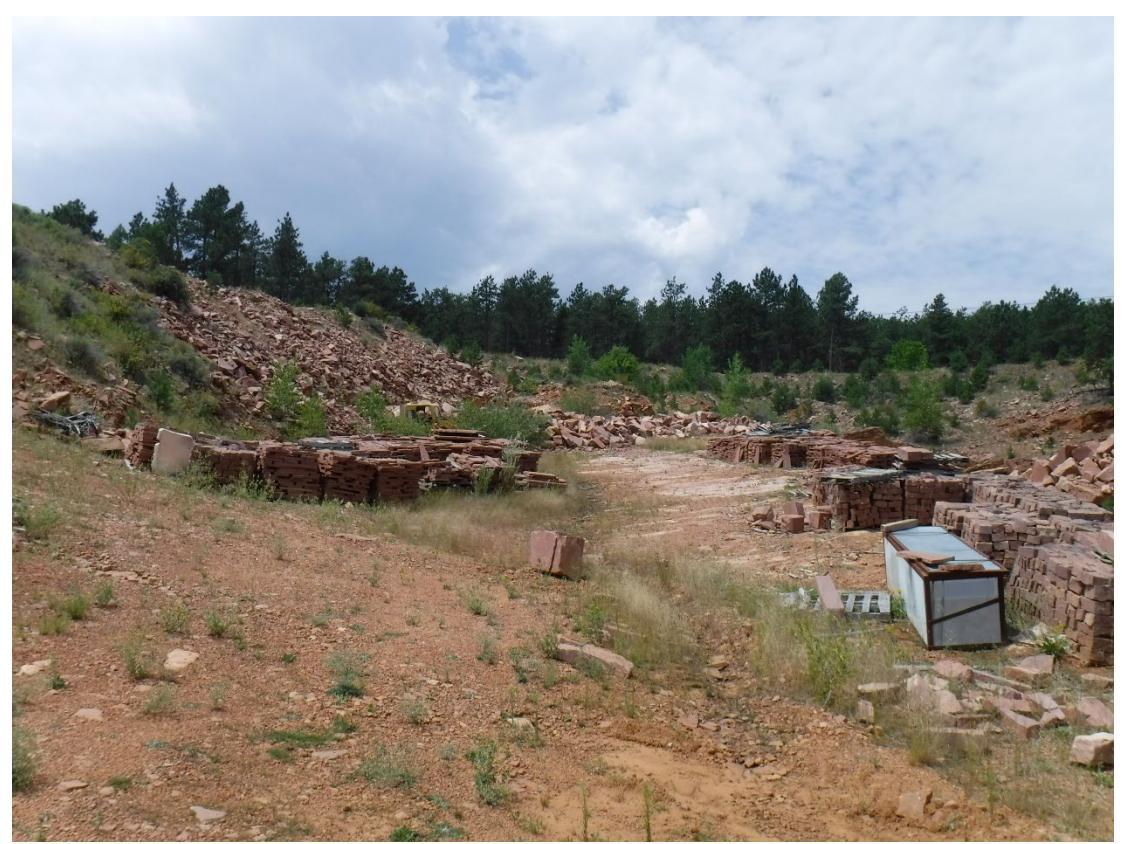
Photo 10: Marketable and overburden material along southern highwall of central quarry area

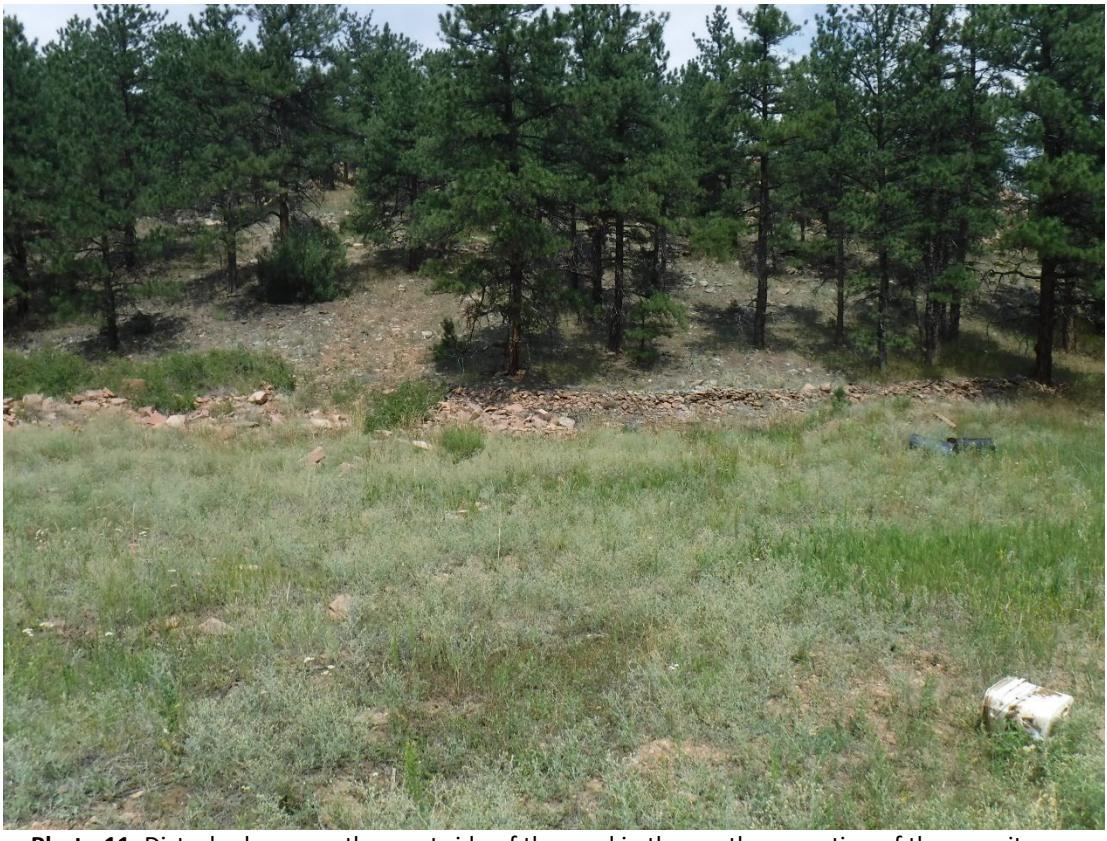
Photo 11: Disturbed area on the west side of the road in the southern portion of the permit area

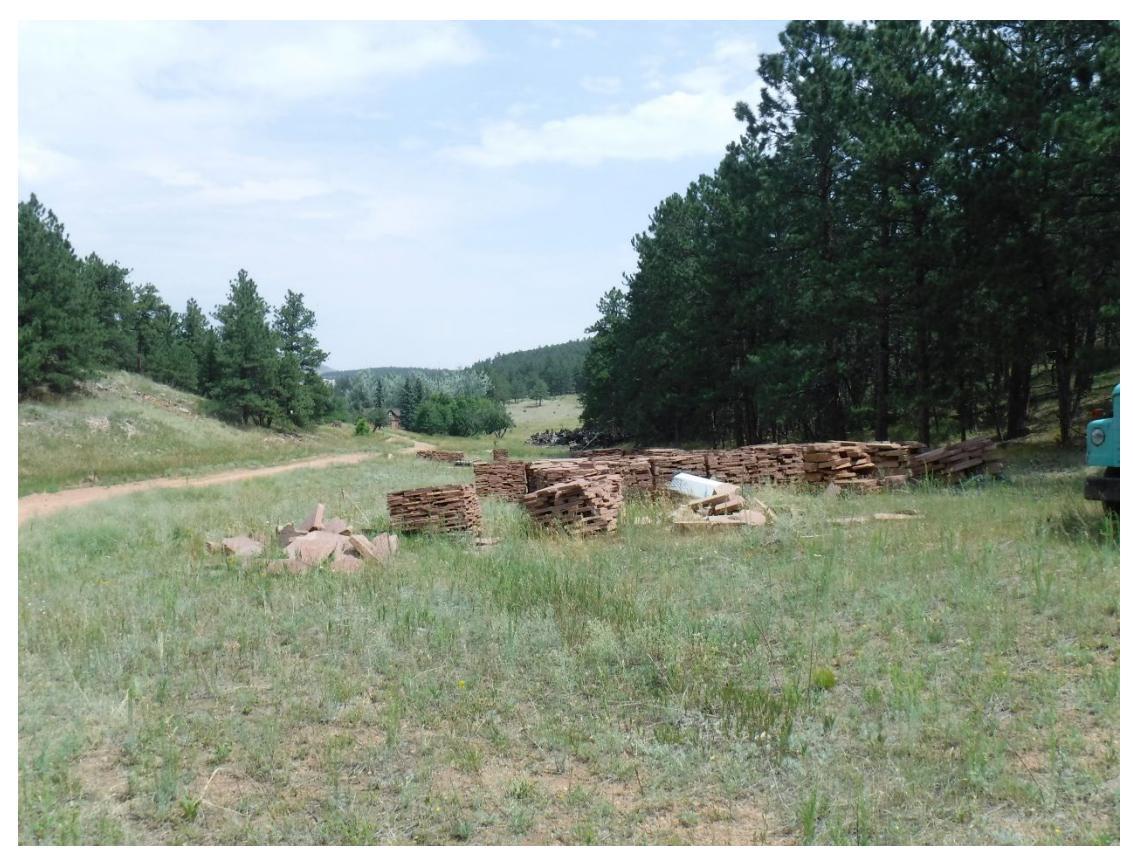
Photo 12: Disturbed area on the east side of the road in the southern portion of the permit area

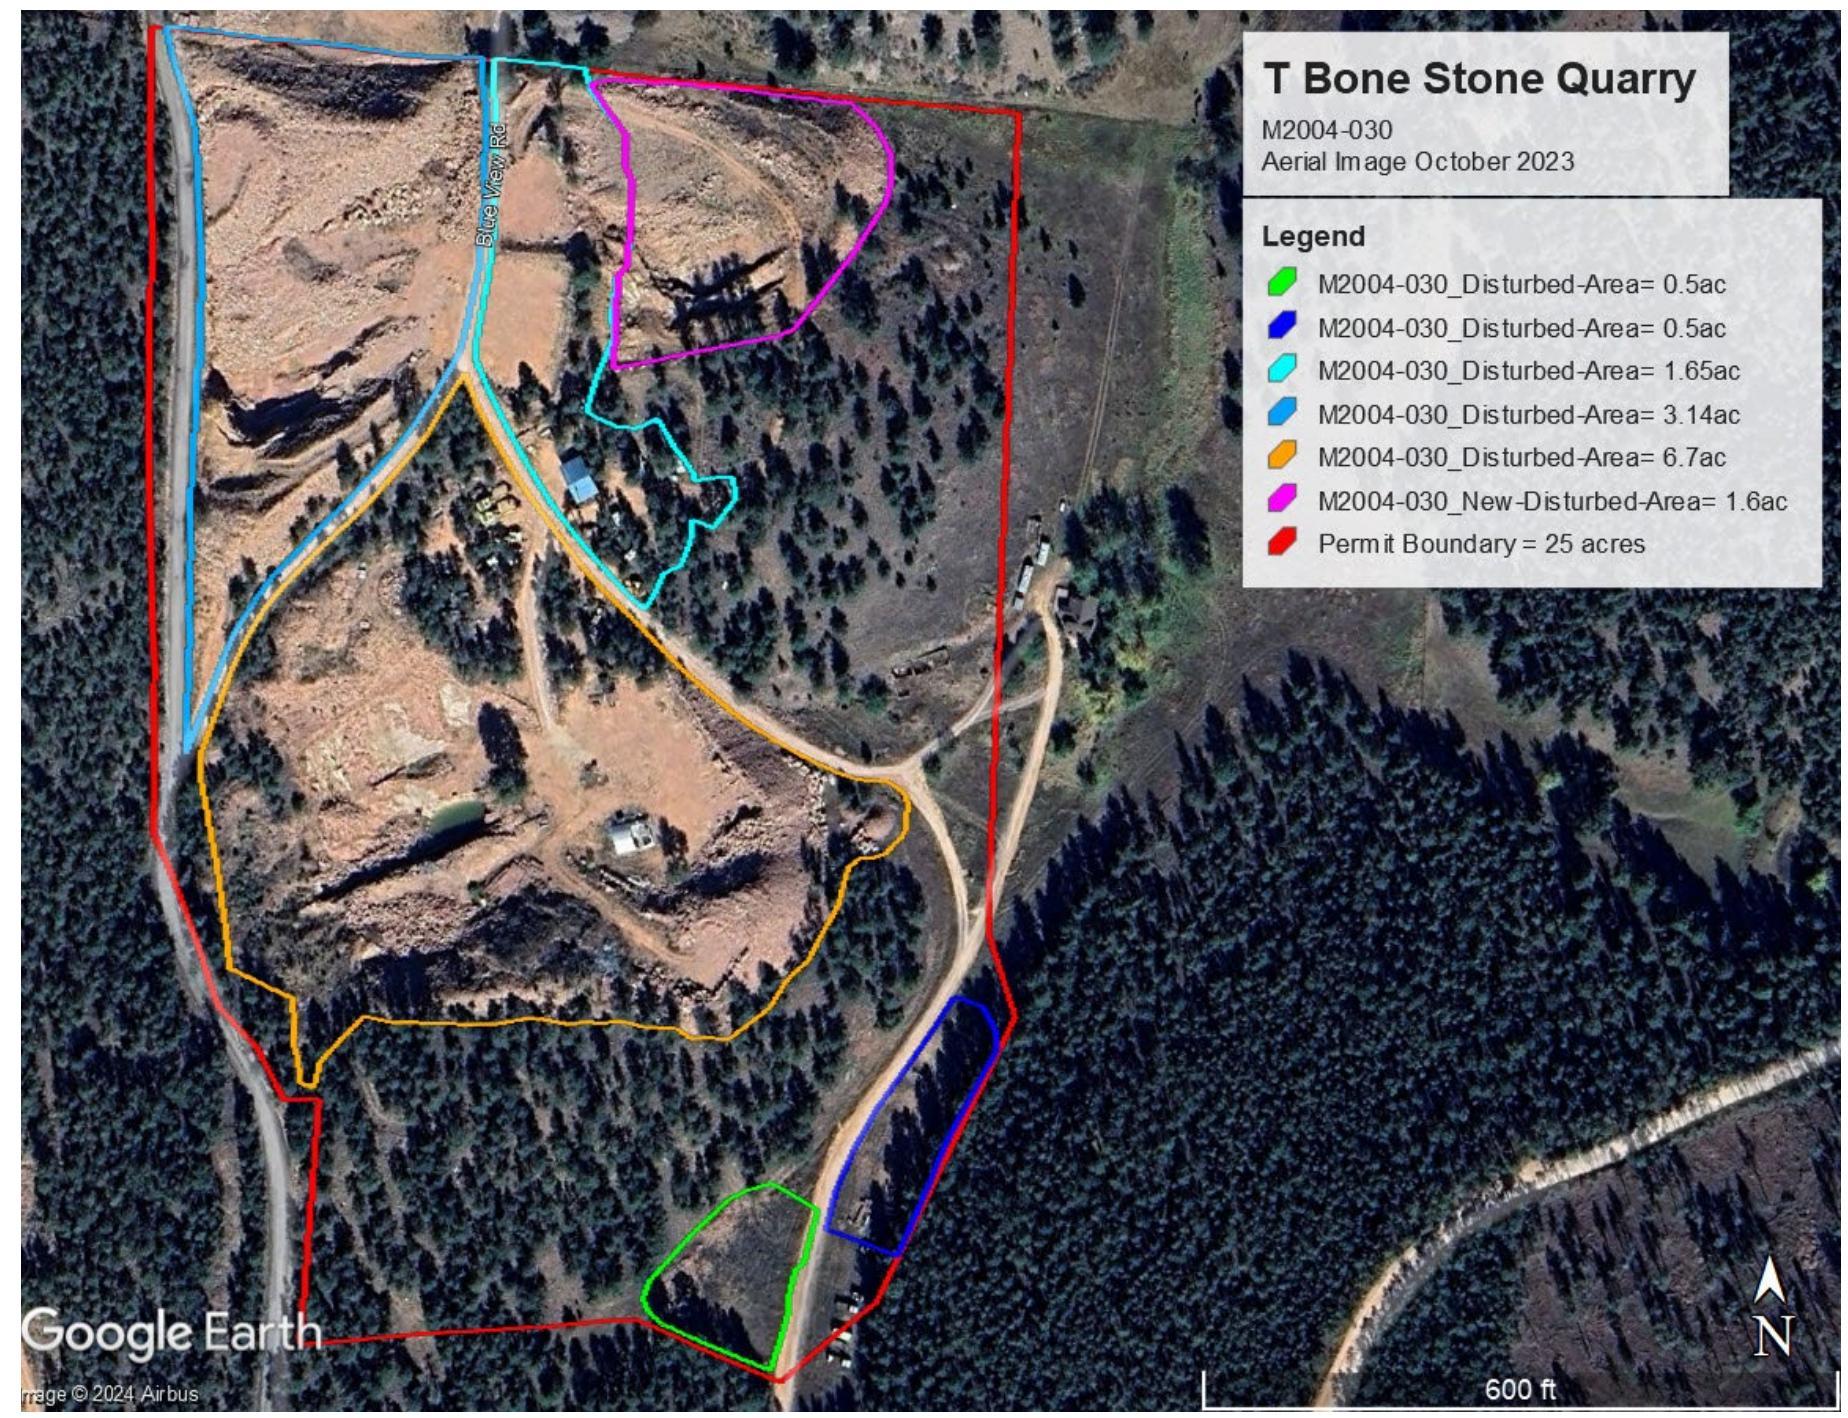
There are three quarry areas, the southern quarry, outlined in orange (site map located at the end of photos below), is approximately 6.7 acres in size and includes the processing area. The north quarry, outlined in blue, is approximately 3.1 acres and the eastern quarry, outlined in purple is 1.6 acres in size. The south quarry is approximately 15 feet deep with overburden stockpiled along its northern and southern edges. Approximately 400 feet of highwall ranging from 3-15 feet in height exist in the south quarry. The north quarry is approximately 30 feet deep with overburden stockpiled along its northern and southern edges. Approximately

There are two areas, totaling 1 acre, located in the southeastern part of the permit boundary that have/are being used to store palletized product. The area in green has been reclaimed and has native vegetation becoming established. The area in dark blue contains stored material.
