MINERALS PROGRAM INSPECTION REPORT PHONE: (303) 866-3567

MINE NAME:	MI	MINE/PROSPECTING ID#:		RAL:	COUNTY:	
Well Field Pit	M-1	M-1984-154		nd gravel	Prowers	
INSPECTION TYPE:		INSPECTOR(S):		DATE:	INSP. TIME:	
Surety Release Inspection	Urs	Ursula Armstrong, Amy Eschberger		ber 24, 2024	1:21 pm	
OPERATOR:	OP	OPERATOR REPRESENTATIVE: T		TYPE OF OPERATION:		
City of Lamar	Patr	Patrick Mason, Michael Machone 110 - Construction Limited Impact		-		
REASON FOR INSPECTION:		BOND CALCULATION TYPE:		BOND AMOUNT:		
Surety Release Requested		None		\$0.00		
DATE OF COMPLAINT:		POST INSP. CONTACTS:		JOINT INSP. AGENCY:		
NA		None		None		
WEATHER:	INSPE	INSPECTOR'S SIGNATURE:		SIGNATURE DATE:		
Clear	V	Vunta Hours		October 1, 2024

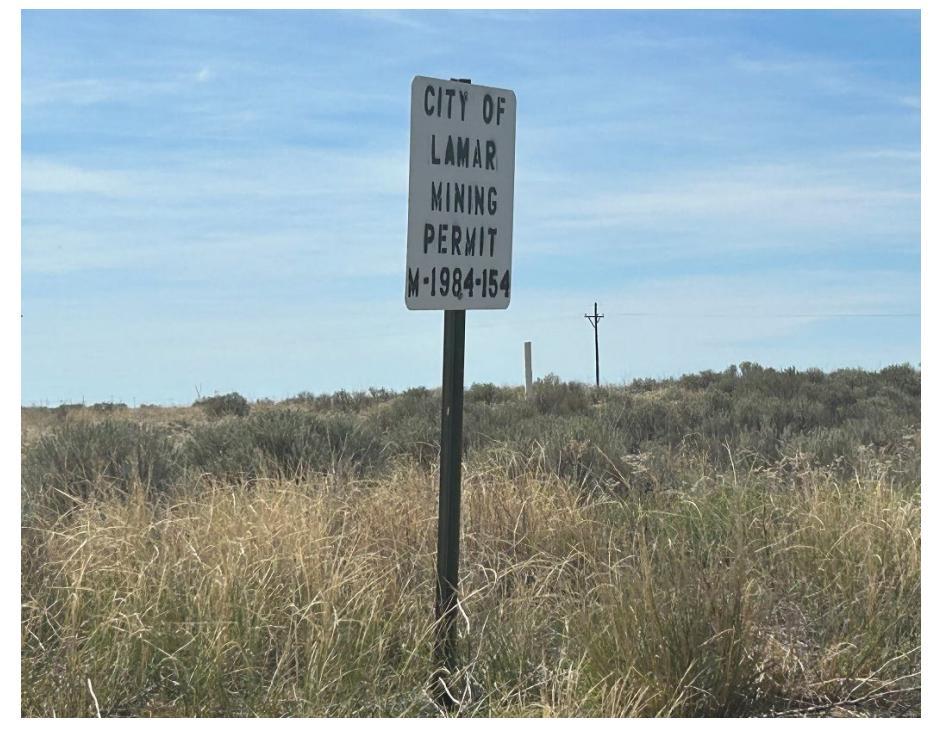
Photo 1. Mine identification sign located at entrance of the site.

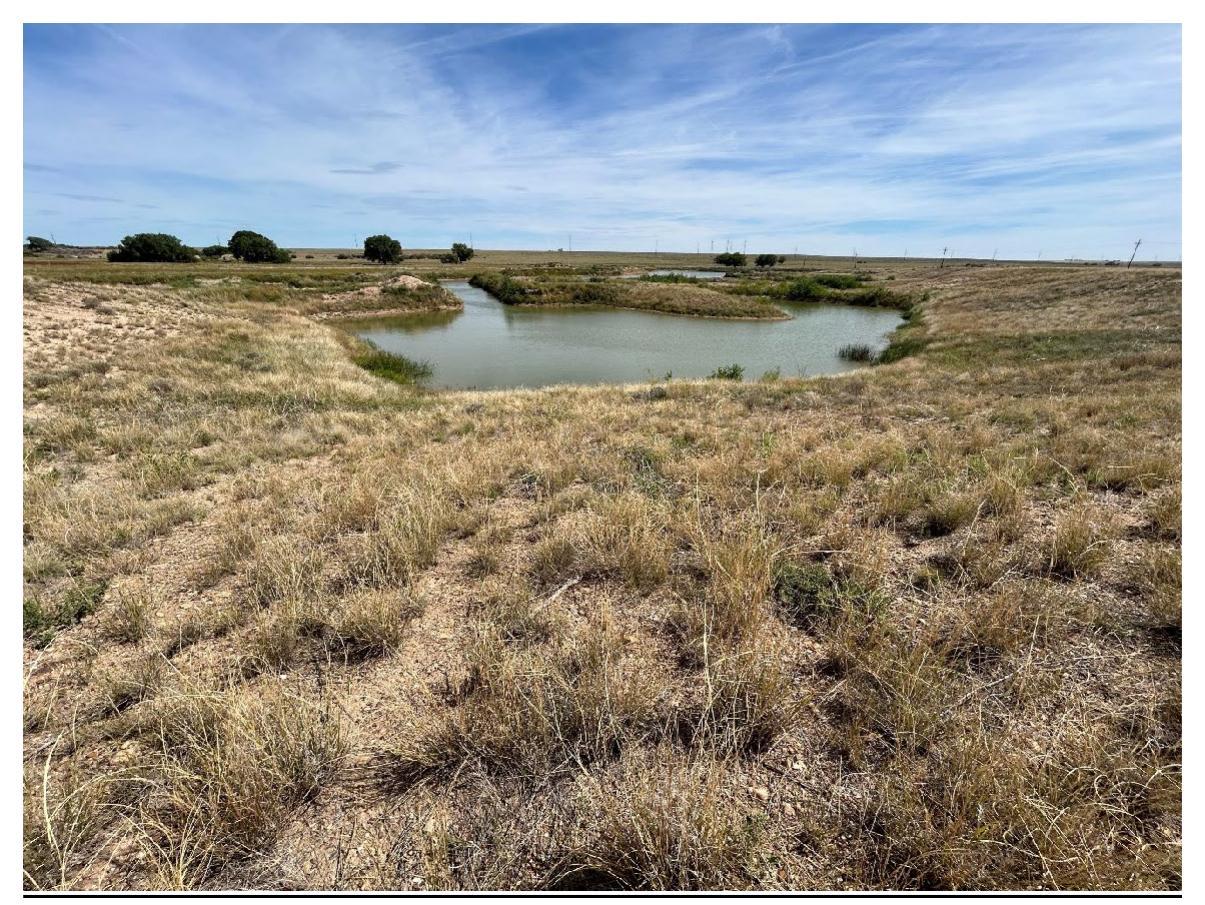
Photo 2. View looking east at the northern portion of the permit area showing slopes graded 3H:1V or flatter with good vegetative cover.

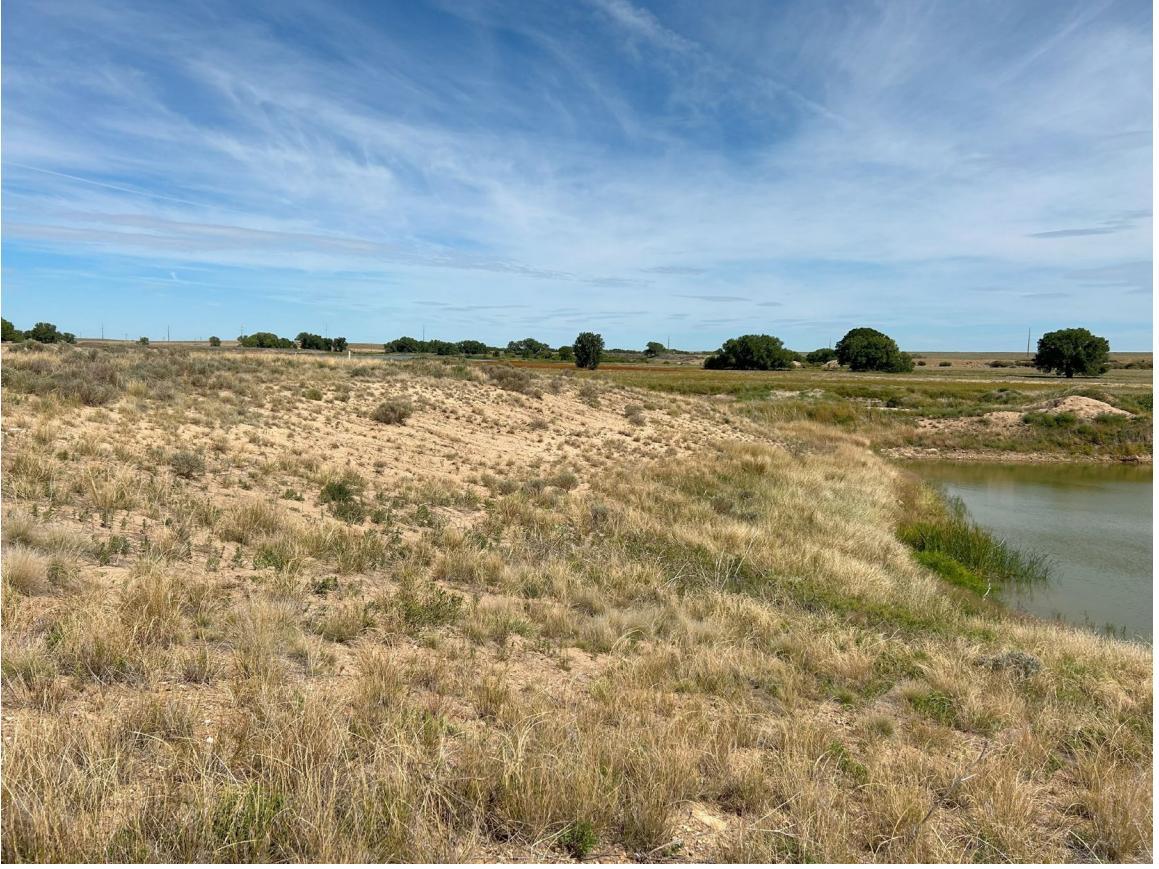
Photo 3. View looking northeast at the northern embankment, showing slopes graded 3H:1V or flatter with good vegetative cover. Minor erosional rilling observed in the central area.

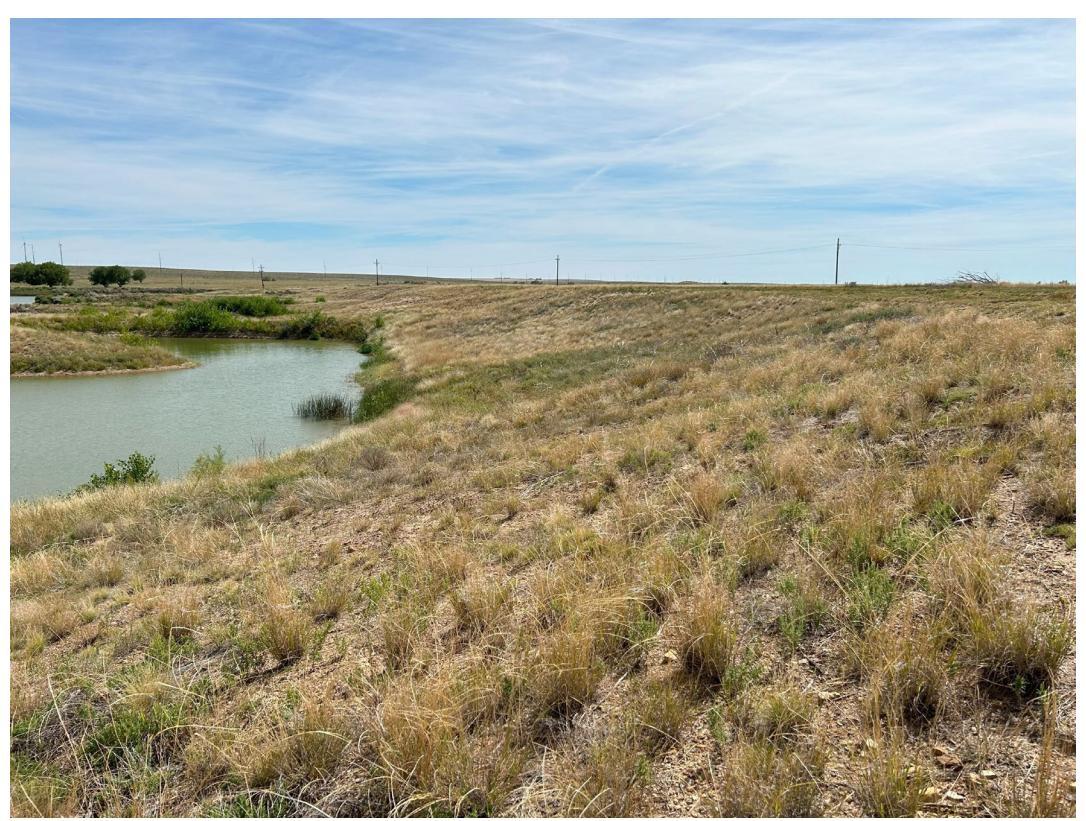
Photo 4. View looking south across the northwestern portion of the permit area, showing slopes graded 3H:1V or flatter with good vegetative cover.

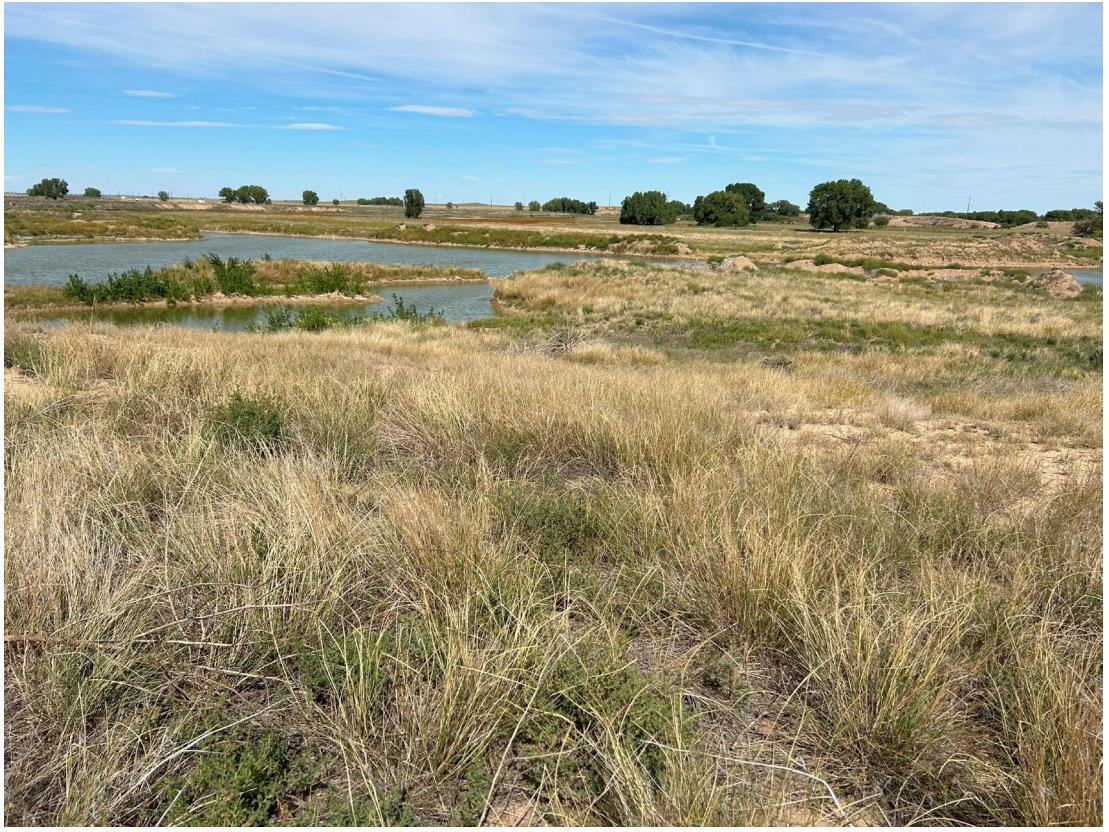
Photo 5. View looking east across central portion of permit area, showing slopes graded 3H:1V or flatter with good vegetative cover.

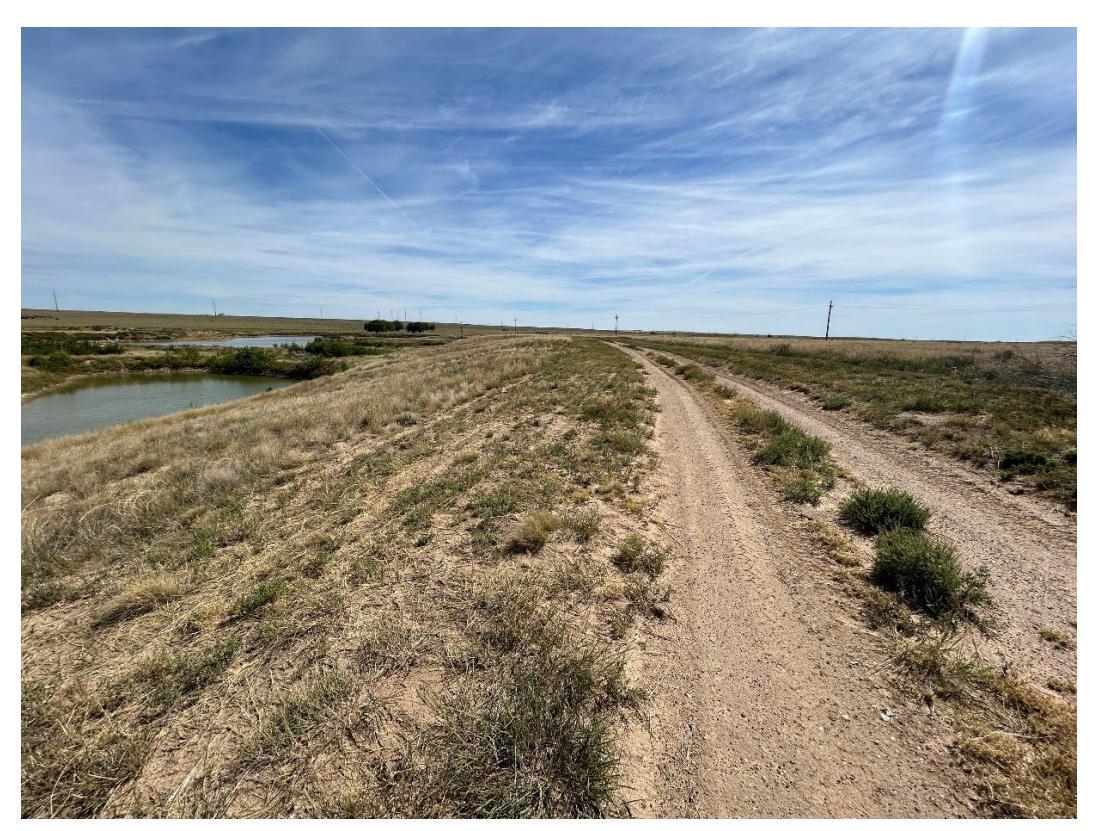
Photo 6. View looking south across western portion of permit area, showing slopes graded 3H:1V or flatter with good vegetative cover.

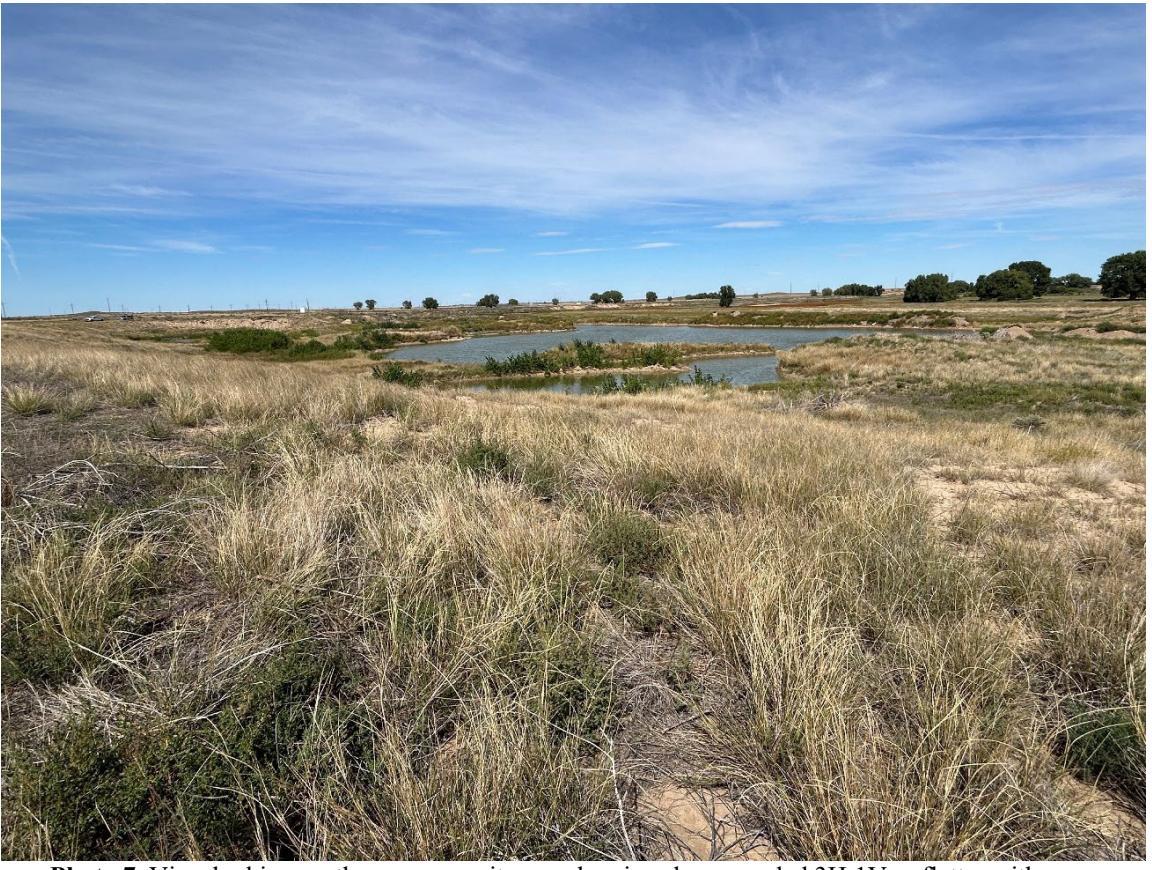
Photo 7. View looking north across permit area, showing slopes graded 3H:1V or flatter with good vegetative cover.

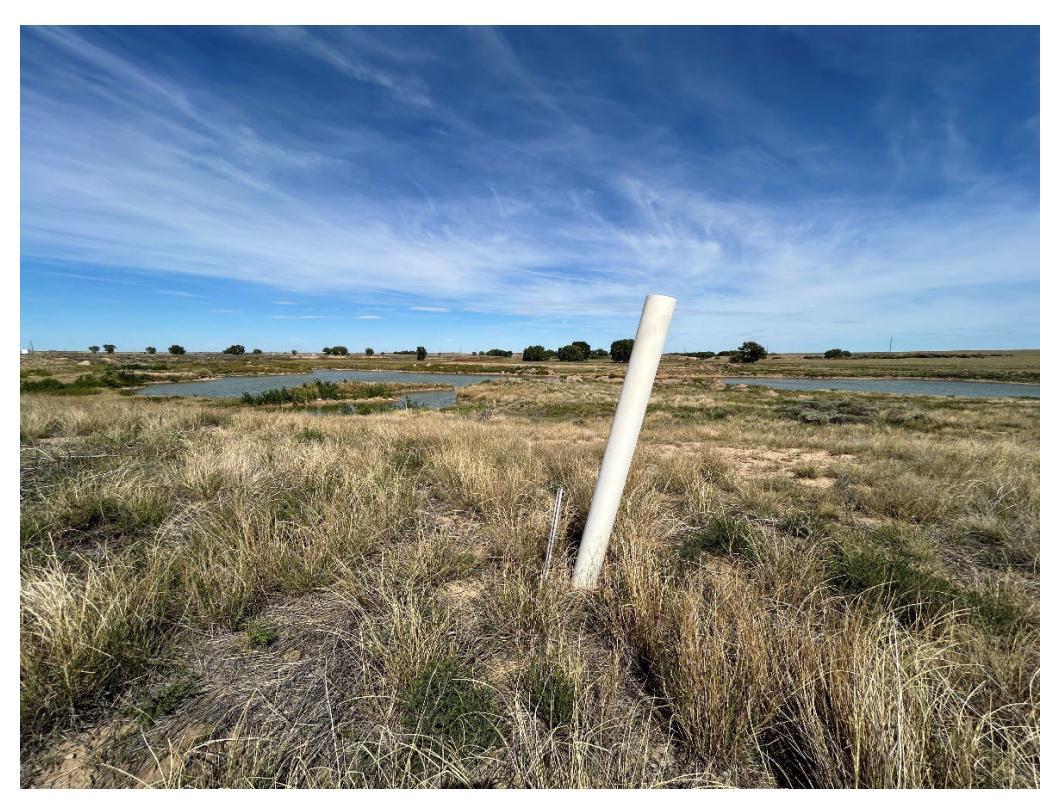
Photo 8. View looking north across permit area, showing slopes graded 3H:1V or flatter with good vegetative cover. Note white pole marking southwestern corner of permit boundary.
