# M2008037 Emma Load Mine Inspection Report

## MINERALS PROGRAM INSPECTION REPORT PHONE: (303) 866-3567

MINE NAME:		MINE/PROSPECTING ID#:	MINERAL:	COUNTY:	
Emma Lode MS#7261		M-2008-037	Silver, gold, copper,	Clear Creek	
			lead and zinc		
<b>INSPECTION TYPE:</b>		WEATHER: Clear	INSP. DATE:	INSP. TIME:	
Monitoring			September 13, 2024	11:00	
OPERATOR:		<b>OPERATOR REPRESENTATIVE:</b>	TYPE OF OPERATION:		
Venture Resources, Inc.		Mason Drake	110(2) - Hard Rock Limited Impact		
<b>REASON FOR INSPECTION:</b>		BOND CALCULATION TYPE:	BOND AMOUNT:		
Normal I&E Program		Complete Bond	\$6,050.00		
DATE OF COMPLAINT:		POST INSP. CONTACTS:	JOINT INSP. AGENCY:		
NA		None	None		
INSPECTOR(S):	INSPECTOR'S SIGNATURE:		SIGNATURE DATE:		
Nikie Gagnon			October 10, 2024		
	Ai	Kie Gagnon

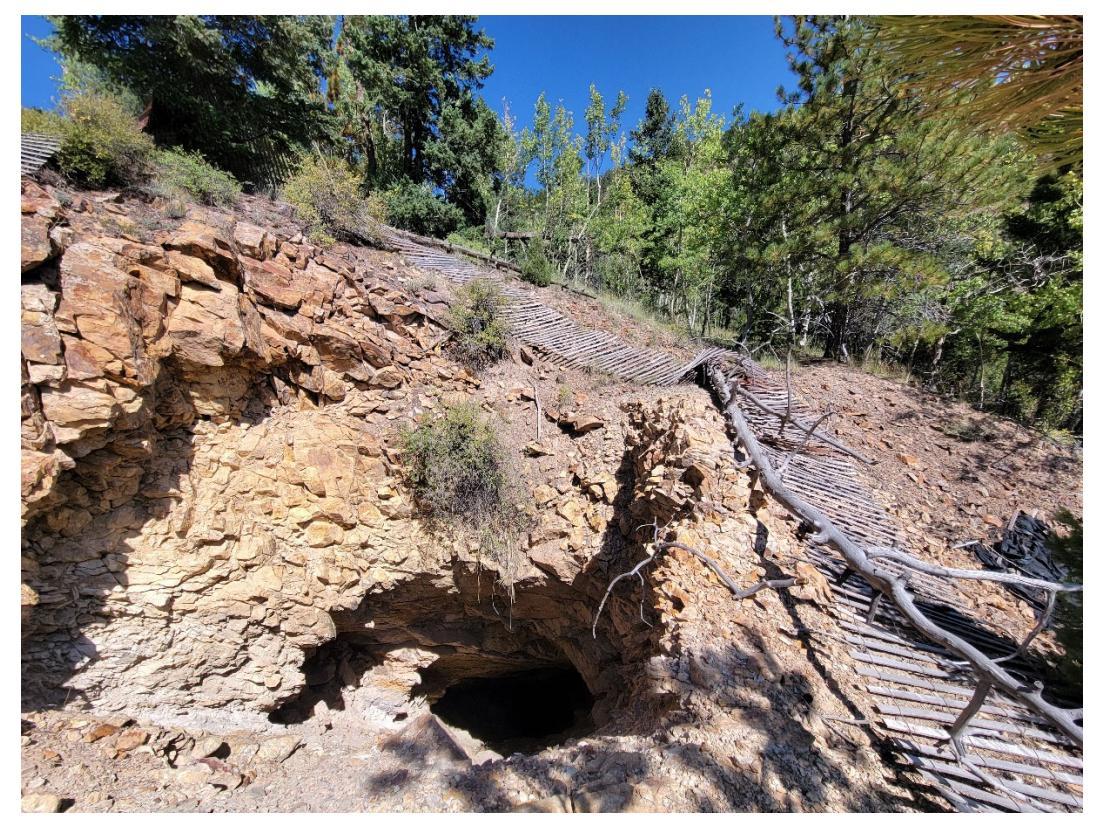
**PROBLEM 1:** The Garland Shaft is not safeguarded from unauthorized entry into the mine. This is a problem pursuant to Rule 3.1.5(6) for failure to close or safeguard the shaft.

The existing/historic disturbance consists of an open shaft (Garland Shaft) connecting to the Dove's Nest Mine. The opening is approximately 3 feet tall x 8 feet wide. The approved mining plan states that a shaft collar/enclosure would be constructed immediately upon the commencement of mining. As of the date of this inspection, no mining disturbance has occurred at the site and the Operator has not installed the shaft collar. In 2017, Technical Revision 2 was approved by the Division to address safety around the Garland Shaft and authorized the installation of a fence around the perimeter of the shaft and the posting of No Trespassing and Danger Keep Out signs. During this inspection, the Division observed a wood picket fence laying on the ground around the shaft. Pursuant to Rule 3.1.5(6), adits and shafts should be closed, and where practicable, backfilled and graded in a manner consistent with the post-mining land use. This has been cited as Problem #1 above and requires corrective action by the Operator.

Photo 1: View of opening to Garland Shaft.

**CORRECTIVE ACTIONS:** The Operator shall replace the fence around the shaft and reinstall the Mine and safeguarding signs on the enclosure.

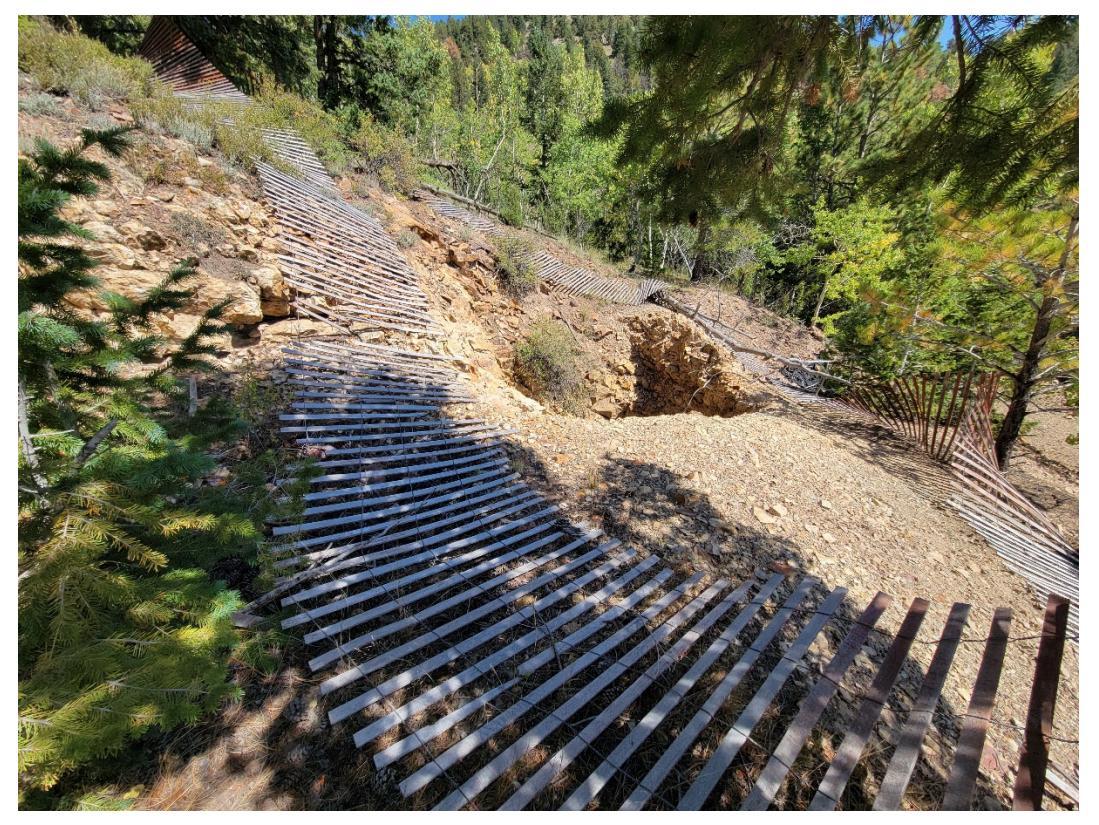
Photo 2: View of security fence on the ground around the shaft.

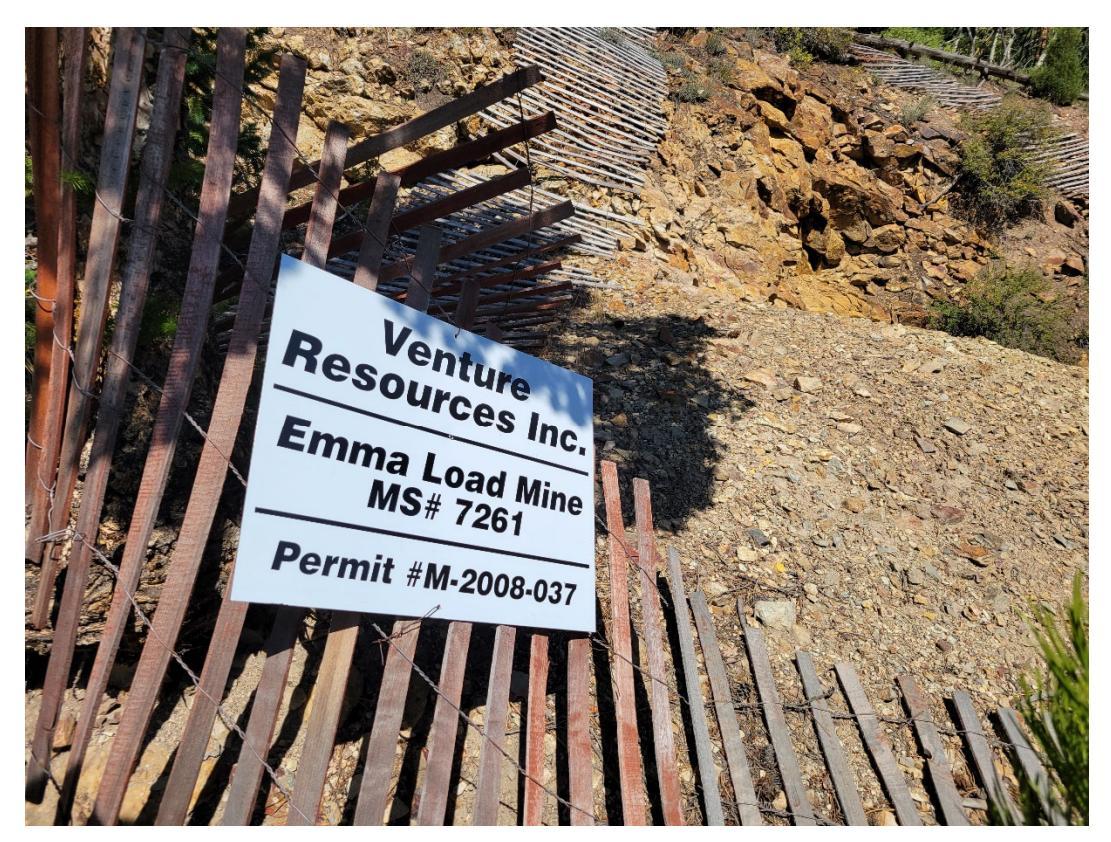
Photo 3: Mine sign posted on the security fence observed on the ground.

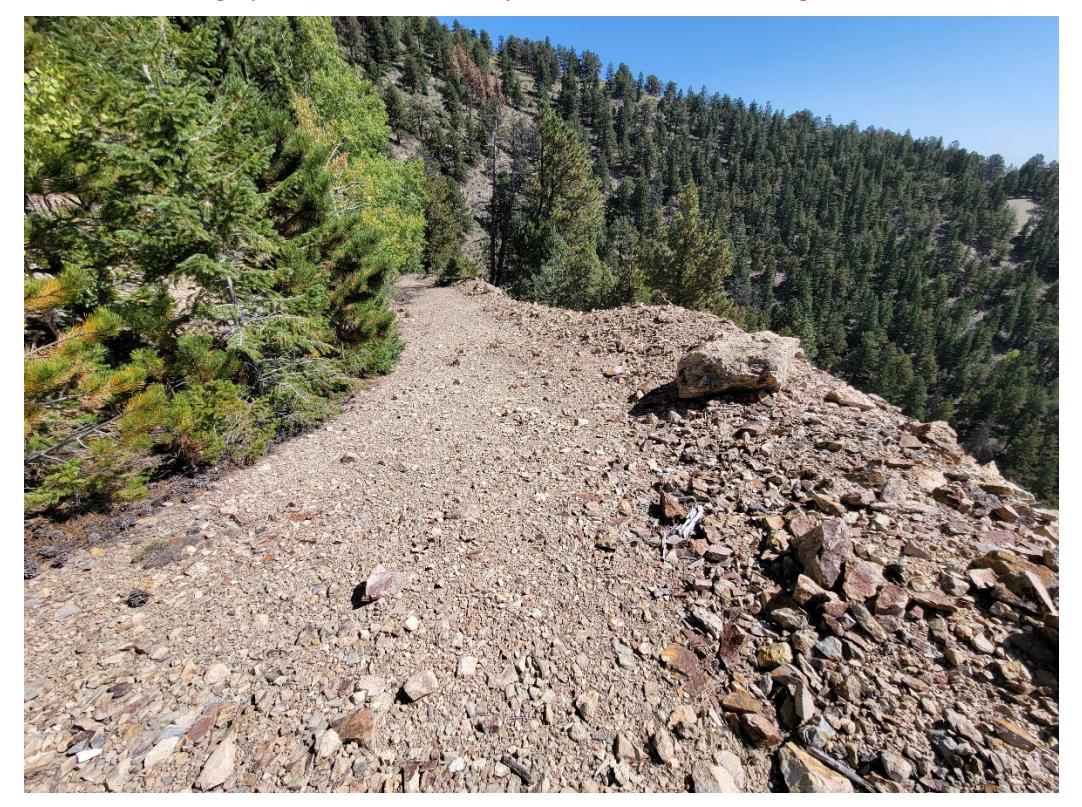
Photo 4: Access road to the Garland Shaft.
