MINERALS PROGRAM INSPECTION REPORT PHONE: (303) 866-3567

MINE NAME:	MINE/PROSPECTING ID#:	MINERAL:	COUNTY:
JH Sand & Gravel Pit #1	M-1979-131	Sand and gravel	Crowley
INSPECTION TYPE:	WEATHER:	INSP. DATE:	INSP. TIME:
Surety-Related Inspection	Cloudy	August 21, 2024	11:30
OPERATOR:	OPERATOR REPRESENTATIVE:	TYPE OF OPERATION:	
JH Sand & Gravel, LLC	Jim McCuistion and Gerald Korinek	112c - Construction Regular Operation	
REASON FOR INSPECTION:	BOND CALCULATION TYPE:	BOND AMOUNT:	
Surety Related	None	\$77,365.00	
DATE OF COMPLAINT:	POST INSP. CONTACTS:	JOINT INSP. AGE	NCY:
NA	None	None	
INSPECTOR(S):	INSPECTOR'S SIGNATURE:	SIGNATURE DATE:	
Jocelyn Carter	Jon Rato	October 10, 2024

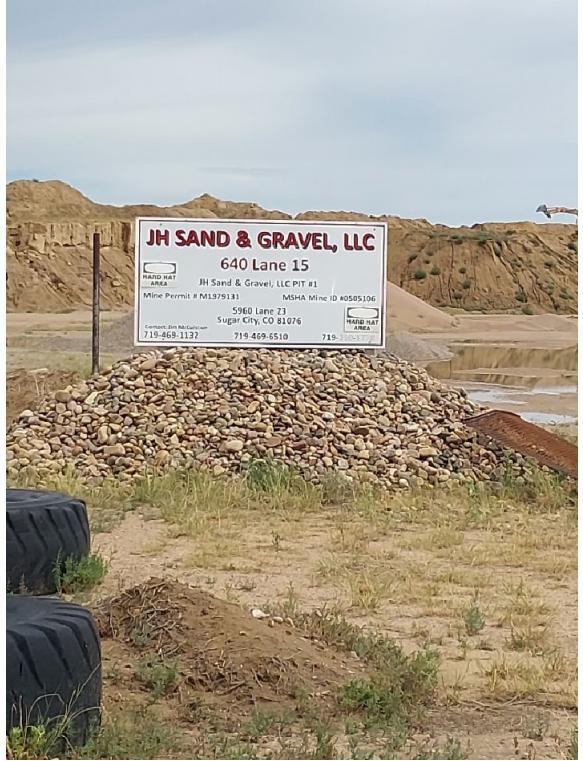
There is a sign posted at the entrance of the pit area as required by Rule 3.1.12(1) (see Photo #1). The permit boundary markers were verified (see Photos #2 and #3), there were a few markers that were no longer in place on Mr. Gerald and Norman Korinek's property. The missing markers are not considered an issue at this time as they would need to be removed based on the proposed permit boundary after the approval of the submitted AR-1.

Photo #1: Mine sign posted at pit entrance per Rule 3.1.12(1).

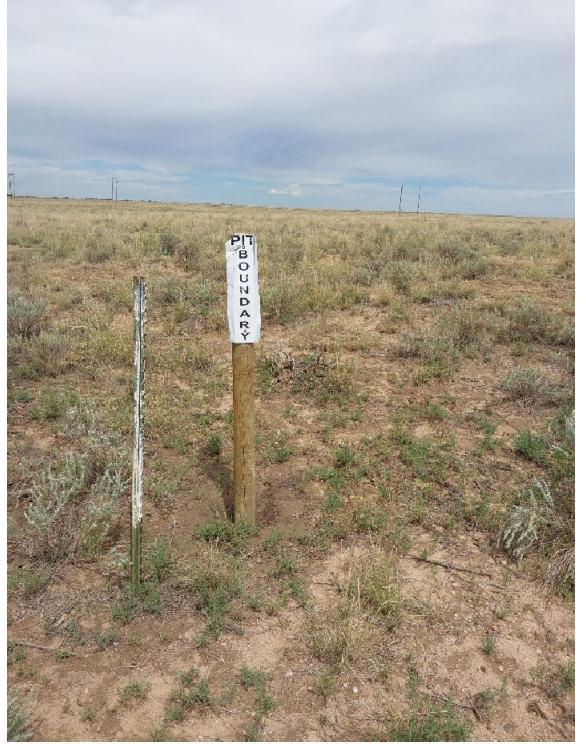
Photo #2: Permit boundary marker located in the northwest corner of the permit area, looking northwest.

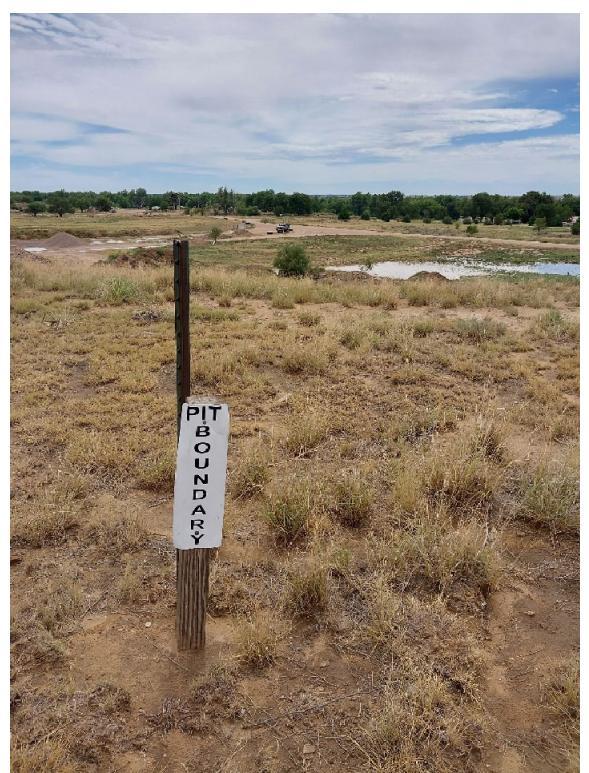
There was some standing water observed in the active pit area, given the recent storms in the area, the standing water is not considered an issue by the Division (see Photo #3).

Photo #3: Permit boundary marker located along County Lane 15 on the west section of the permit boundary, looking east southeast. Active pit area can be seen in the background with several pools of standing water from recent storm events.

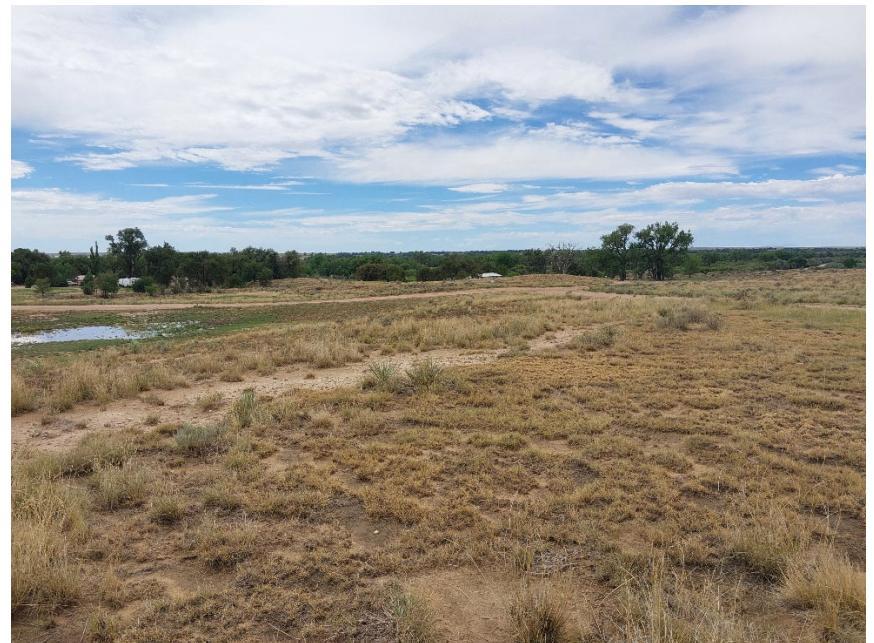
County Lane 15 runs north-south along the west side of the permit area and County Lane 13 runs east-west along the south portion of the permit area, both roads appeared to be in good condition with no issues (see Photos #4, #5, #6, and #12).

There were no noxious weeds observed on site in the areas that are being requested to be released. The vegetation on the lands being requested for release appeared to be well vegetated and includes some wooded vegetation (see Photos #4 - #13).

Photo #4: View from the lower west permit boundary area looking southeast at the land owned by Quarter Circle LT, Inc north of County Lane 13 that is proposed to be released.

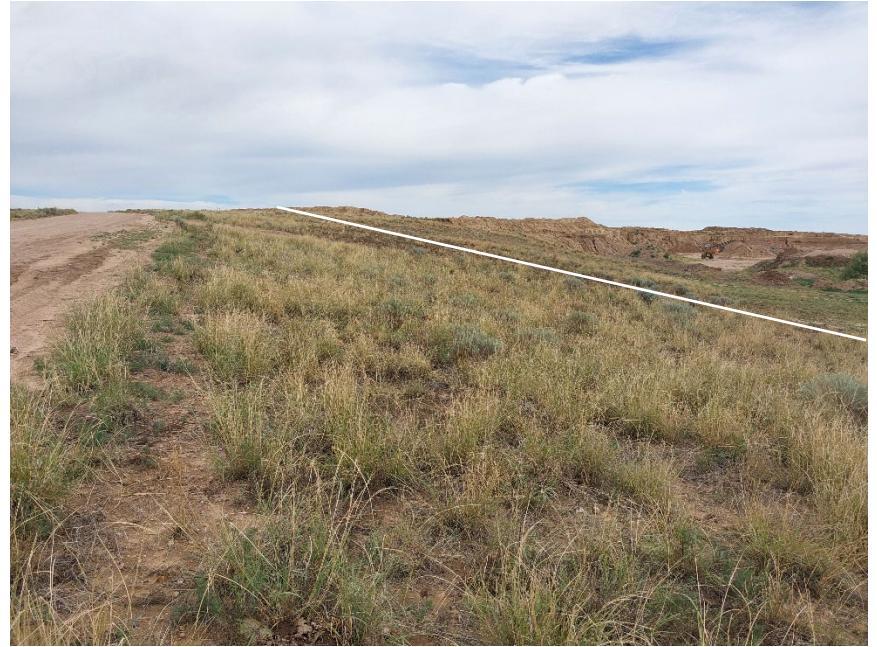
Photo #5: View of the permit area from the lower west portion of the permit boundary along County Lane 15 (seen on the left side) looking northeast at the section of land owned by Quarter Circle LT, Inc proposed for release located west of the active pit area, between the white line (approximate location) and the road.

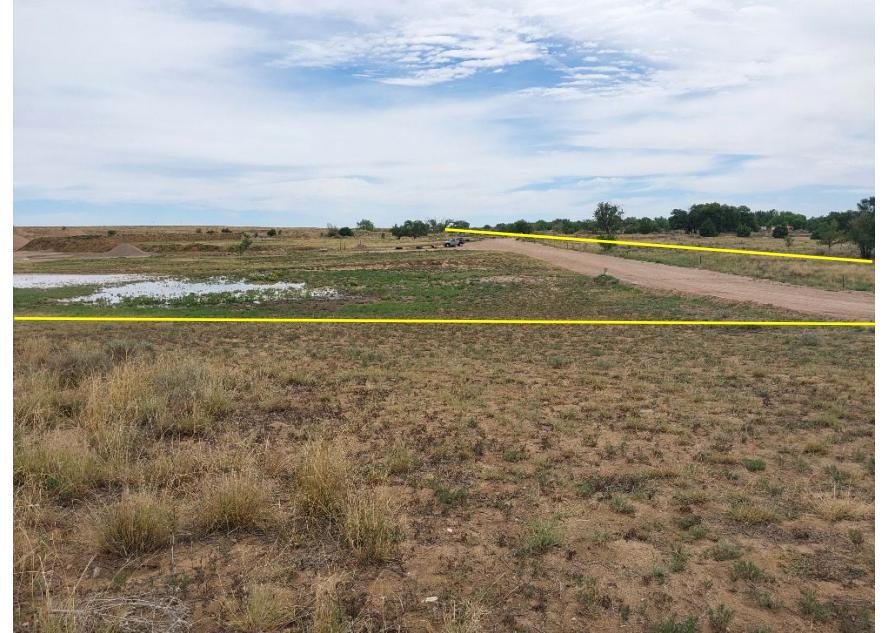
Photo #6: View from lower west portion of the permit area looking east at portions of land that are proposed for release. The yellow lines represent to approximate locations of the new permit boundary; land below the bottom line (owned by Quarte Circle LT, Inc) and above the top line (owned by Mr. Gerald and Norma Korinek) are proposed for release.

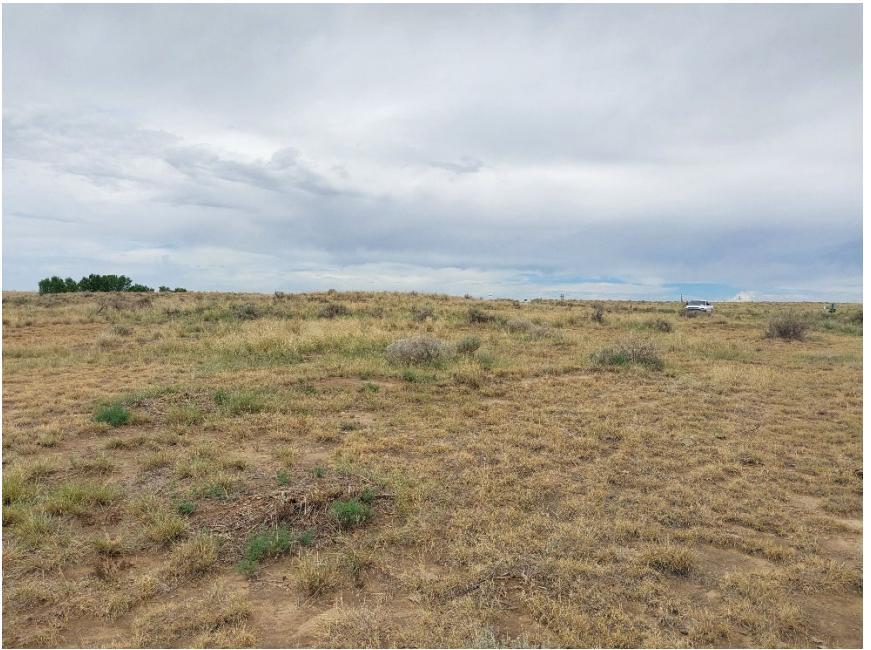
Photo #7: View of the lands located on Quarter Circle LT, Inc property in the southwest corner of the permit area, looking northwest.

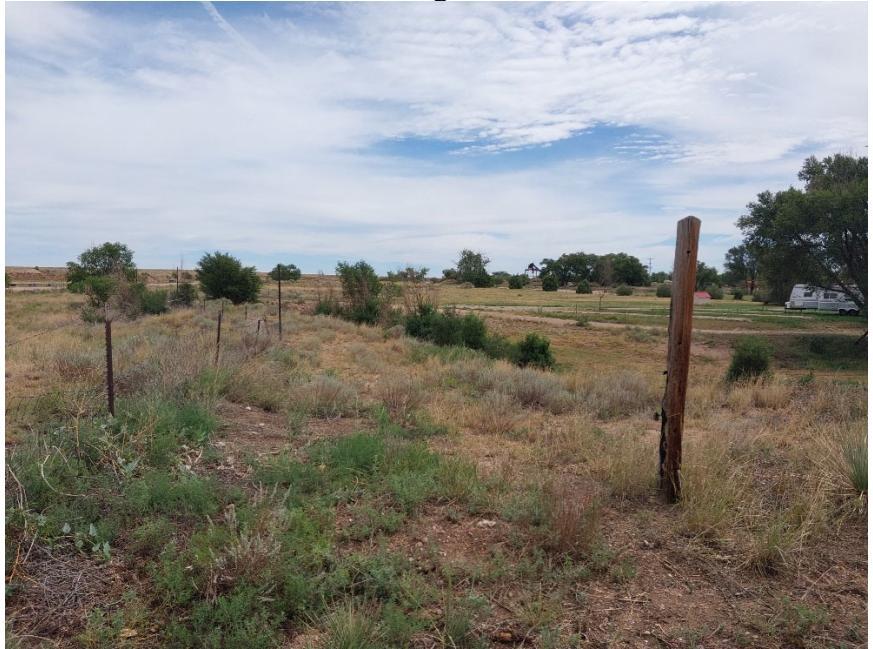
Lands owned by Mr. Korinek that are within the permit boundary have some equipment, implements, materials, some pre-law disturbances, and a small structure on site (see Photos #8 - #11, #13, and #14). When asked about his satisfaction with the reclamation of the area during the inspection, Mr. Korinek stated that he is happy with the conditions and does not object to the lands being released from the permit area.

Photo #8: View of the lands located on Mr. Gerald and Norma Korinek's property in the southwest corner of the permit area, looking east.

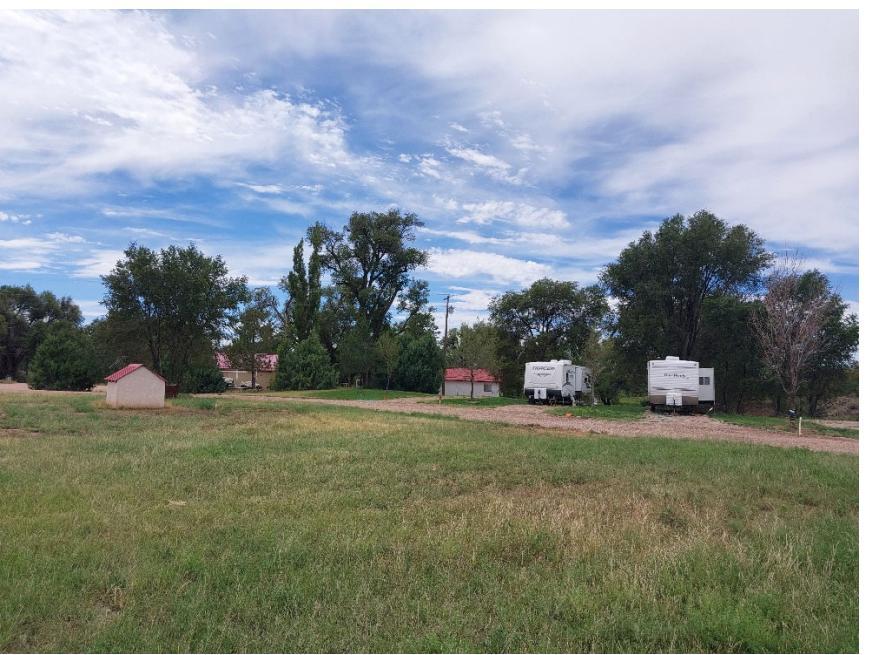
Photo #9: View of the lands located on Mr. Gerald and Norma Korinek's property in the southwest corner of the permit area, looking south.

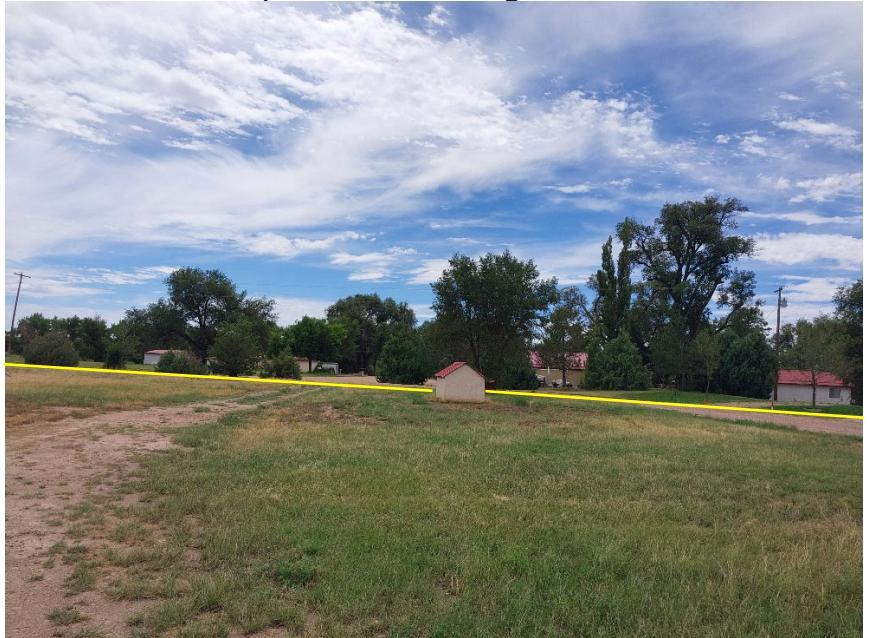
Photo #10: View of the lands located on Mr. Gerald and Norma Korinek's property in the southwest corner of the permit area, looking southeast. Lands below the yellow line are proposed for release.

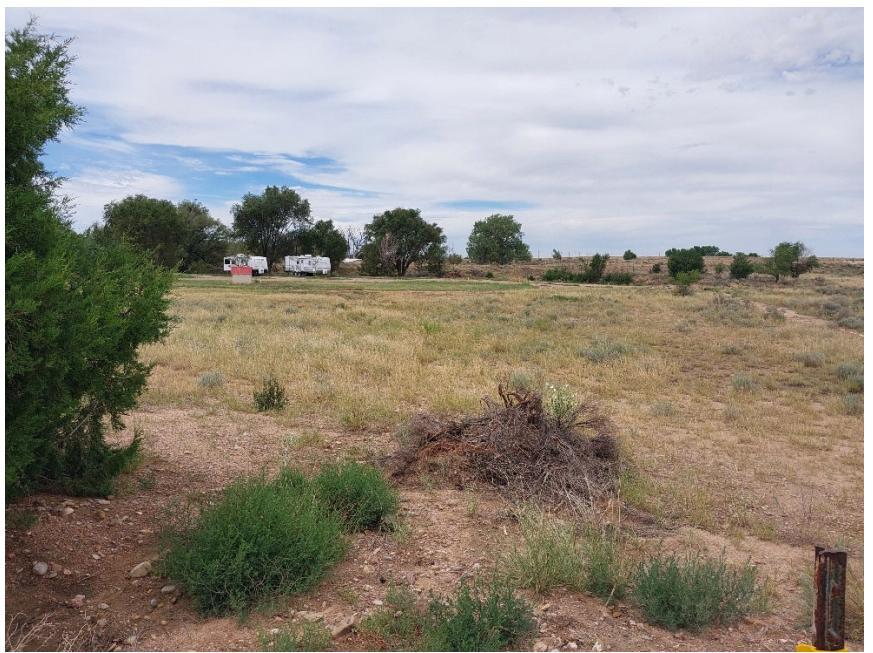
Photo #11: View of the lands located on Mr. Gerald and Norma Korinek's property in the southwest corner of the permit area, looking west from the east property line.

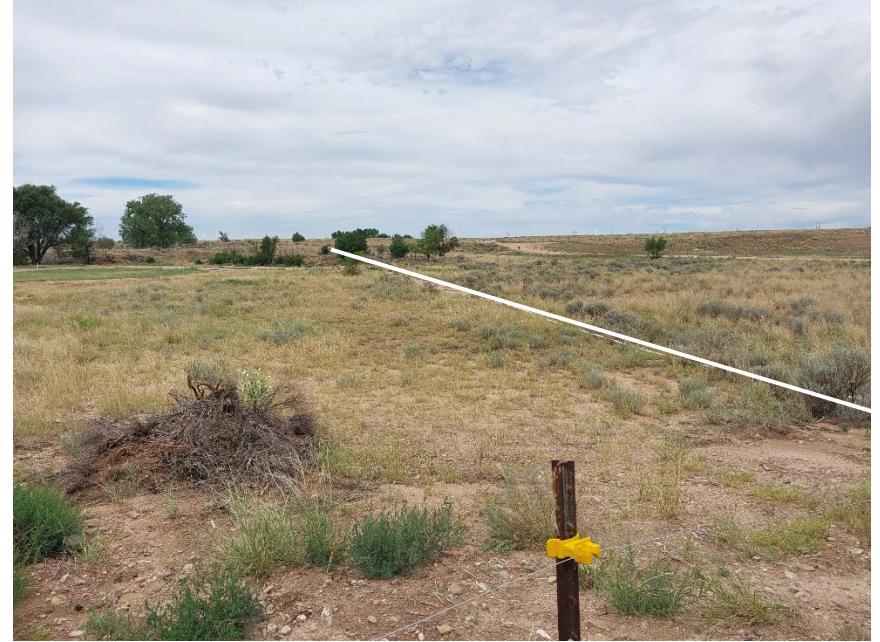
Photo #12: View of the lands located on Mr. Gerald and Norma Korinek's property in the southwest corner of the permit area, looking west from the east property line. County Lane 13 can be seen on the right side of the photo, the area to the left of the while line is proposed for release.

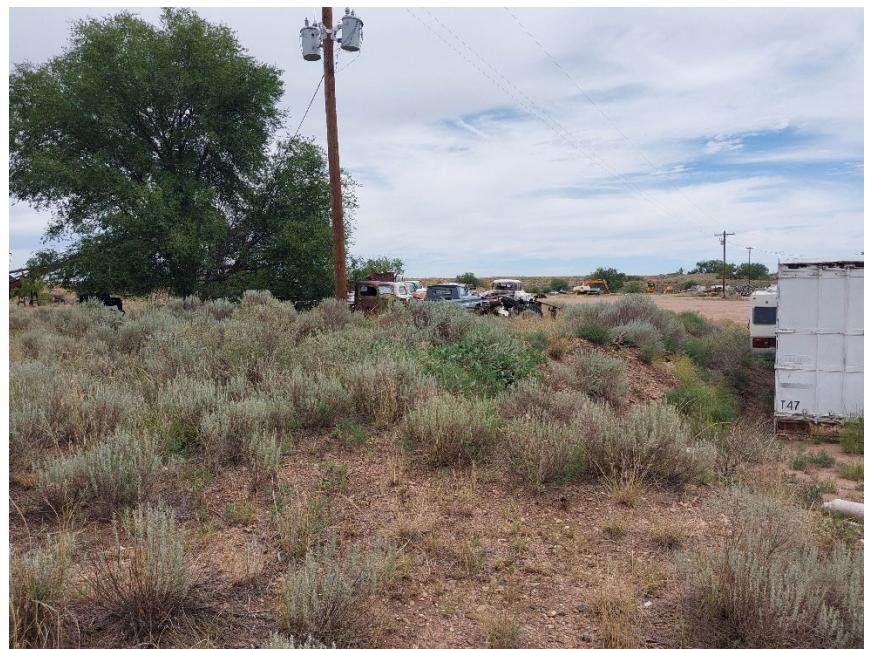
Photo #13: View of lands located on Mr. Gerald and Norma Korinek's property, looking to the northeast from the west portion of the permit boundary. Equipment that can be associated with mining can be seen in the photo.

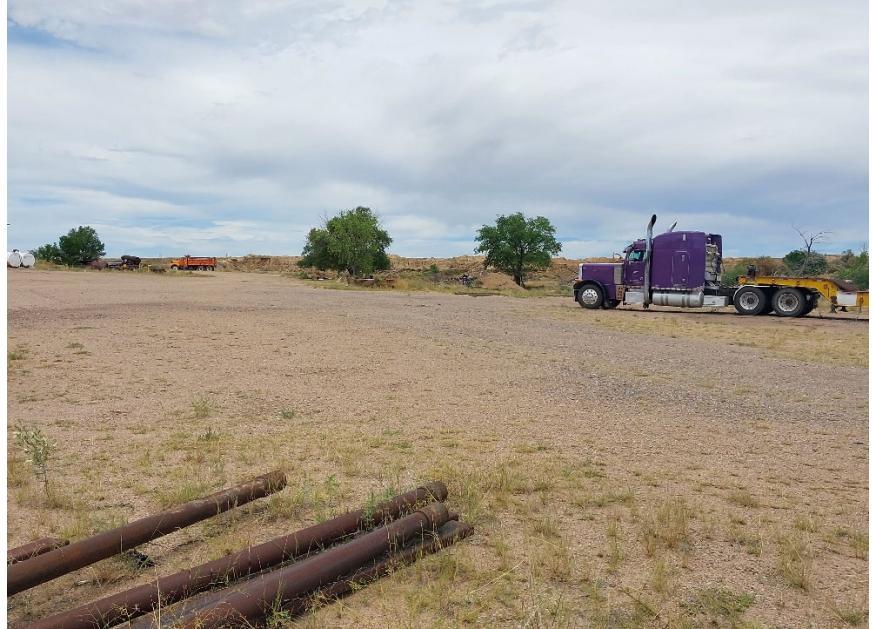
Photo #14: View of lands located on Mr. Gerald and Norma Korinek's property, looking north from the southeastern portion of the permit area. Materials and equipment that can be associated with mining can be seen in the photo.

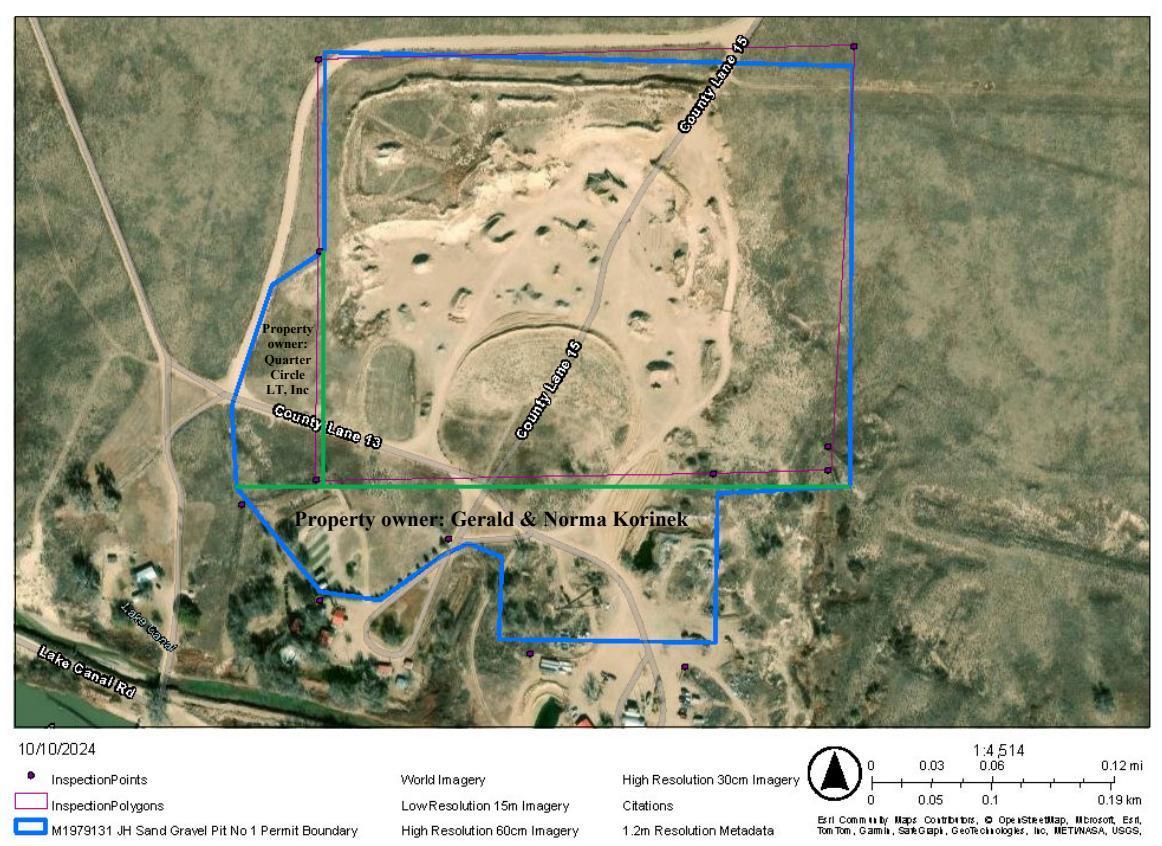
Inspection map showing current permit boundary in blue, approximate proposed permit boundary in purple inspected polygon, purple inspection points mark where permit or property boundaries were verified. The green lines indicate the approximate property boundary lines
