## **Firestone Gravel Inspection Report**

### MINERALS PROGRAM INSPECTION REPORT PHONE: (303) 866-3567

MINE NAME:		MINE/PROSPECTING ID#:	MINERAL:	COUNTY:
Firestone Gravel Resource		M-1996-052	Sand and gravel	Weld
<b>INSPECTION TYPE:</b>		WEATHER: Clear	INSP. DATE:	INSP. TIME:
Monitoring			October 17, 2024	10:00
OPERATOR:		<b>OPERATOR REPRESENTATIVE:</b>	<b>TYPE OF OPERATION:</b>	
L. G. Everist, Incorporated		Lynn Shults	112c - Construction Regular Operation	
<b>REASON FOR INSPECTION:</b>		BOND CALCULATION TYPE:	BOND AMOUNT:	
Normal I&E Program		Complete Bond	\$1,454,400.00	
DATE OF COMPLAINT:		POST INSP. CONTACTS:	JOINT INSP. AGENCY:	
NA		None	None	
INSPECTOR(S):	INSPECTOR'S SIGNATURE:		SIGNATURE DATE:	
Nikie Gagnon			December 13, 2024	
Chris Girardi	1	· · · · ·		
	U4	ikie Gagnon		
		0

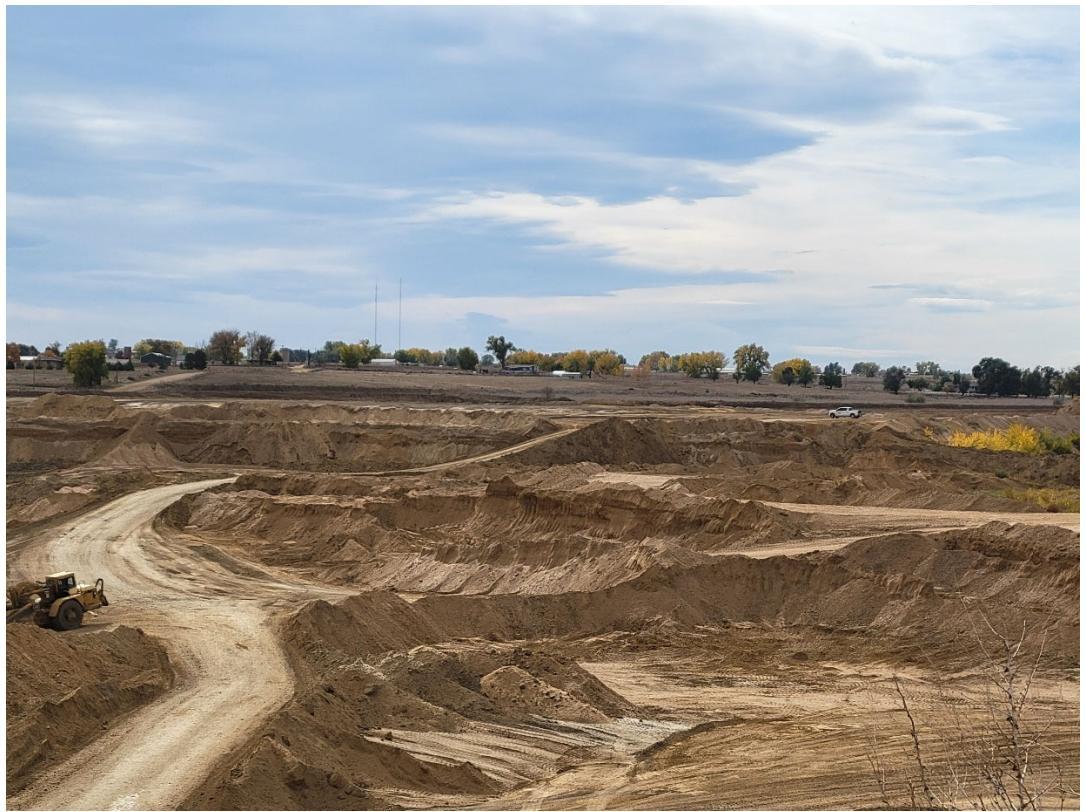
Photo 1: Looking south at the active mining in the northern portion of Area 3.

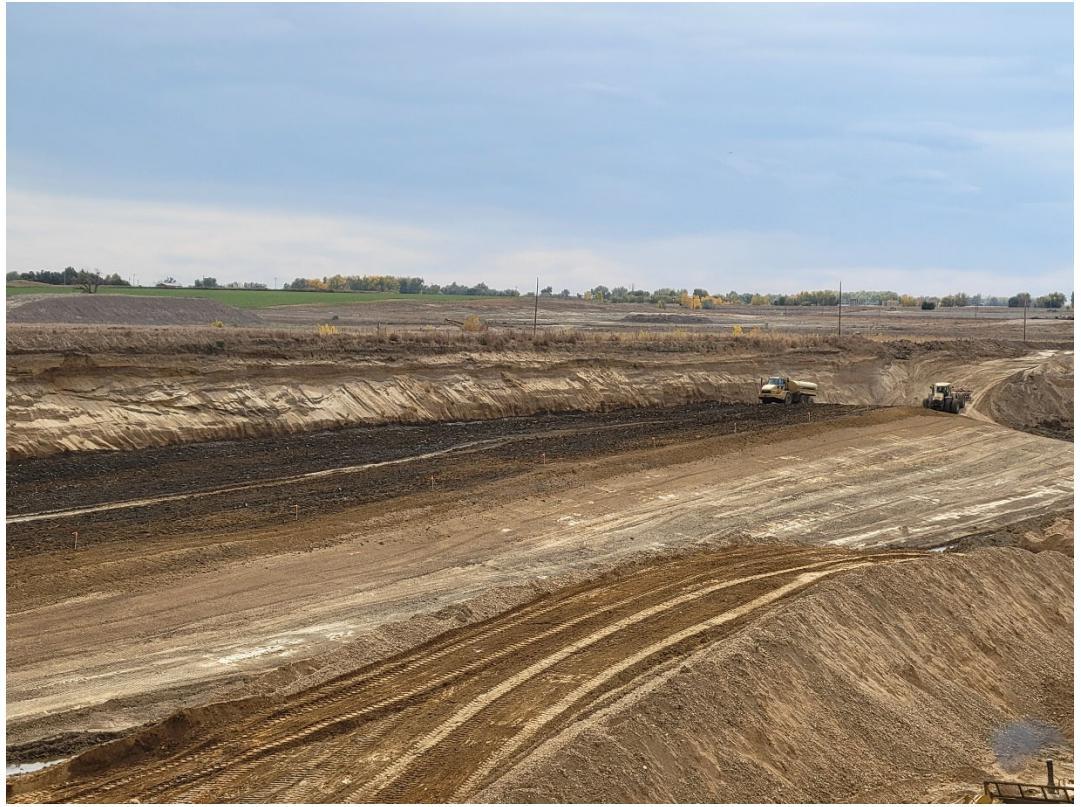
Photo 2: Looking southeast at placement of clay lining in the northeastern corner of Area 3.

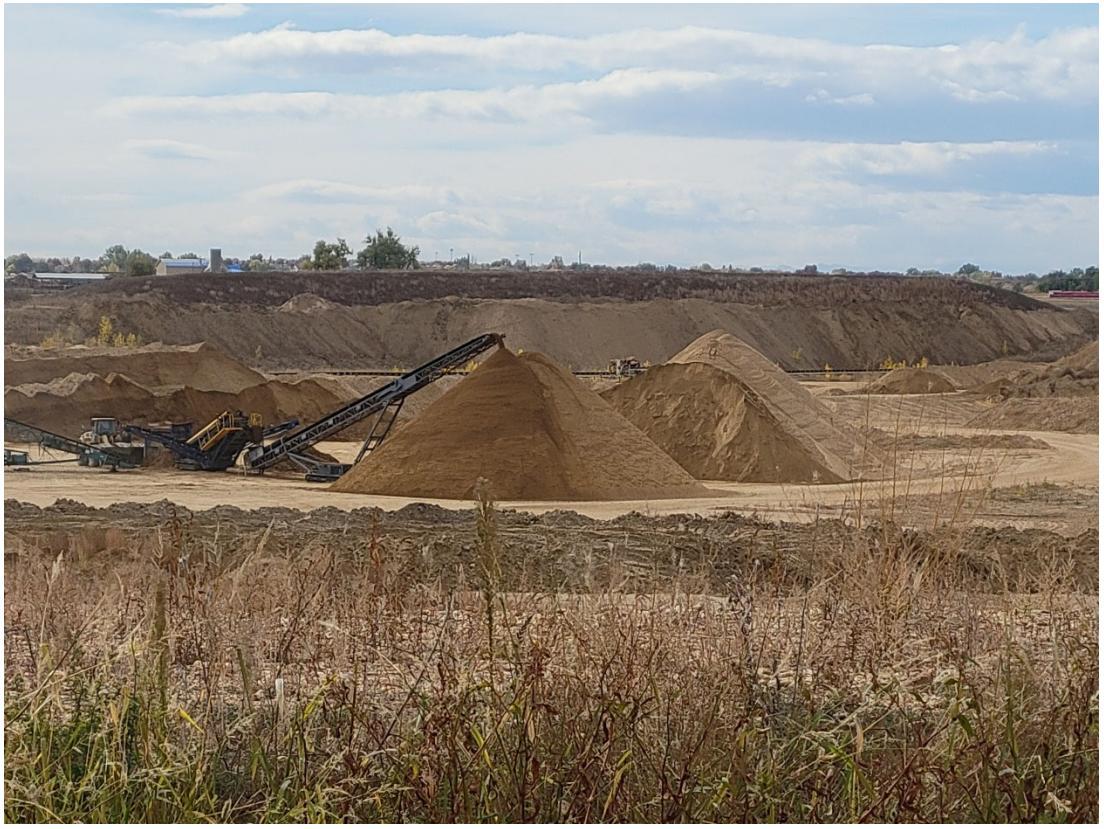
Photo 3: Stockpiles of product in the active mining area.

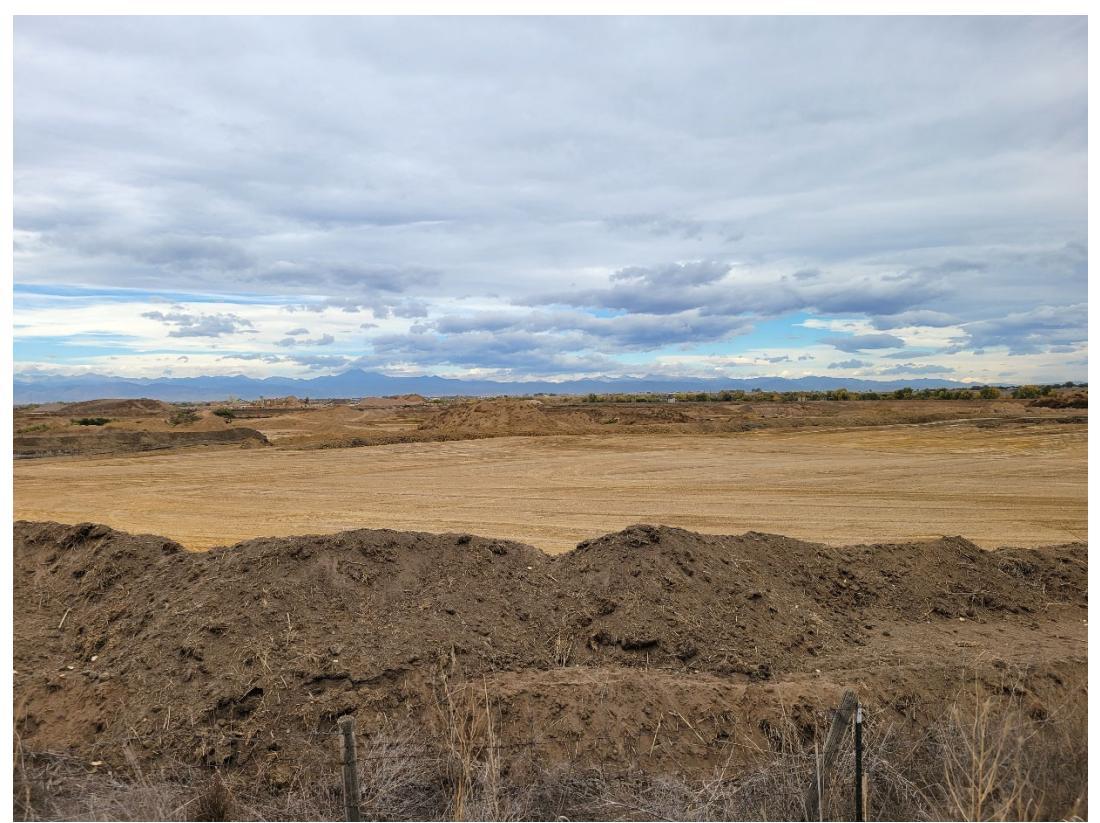
Photo 4: Looking at recently cleared area prepped for mining in the southeast portion of Area 3.

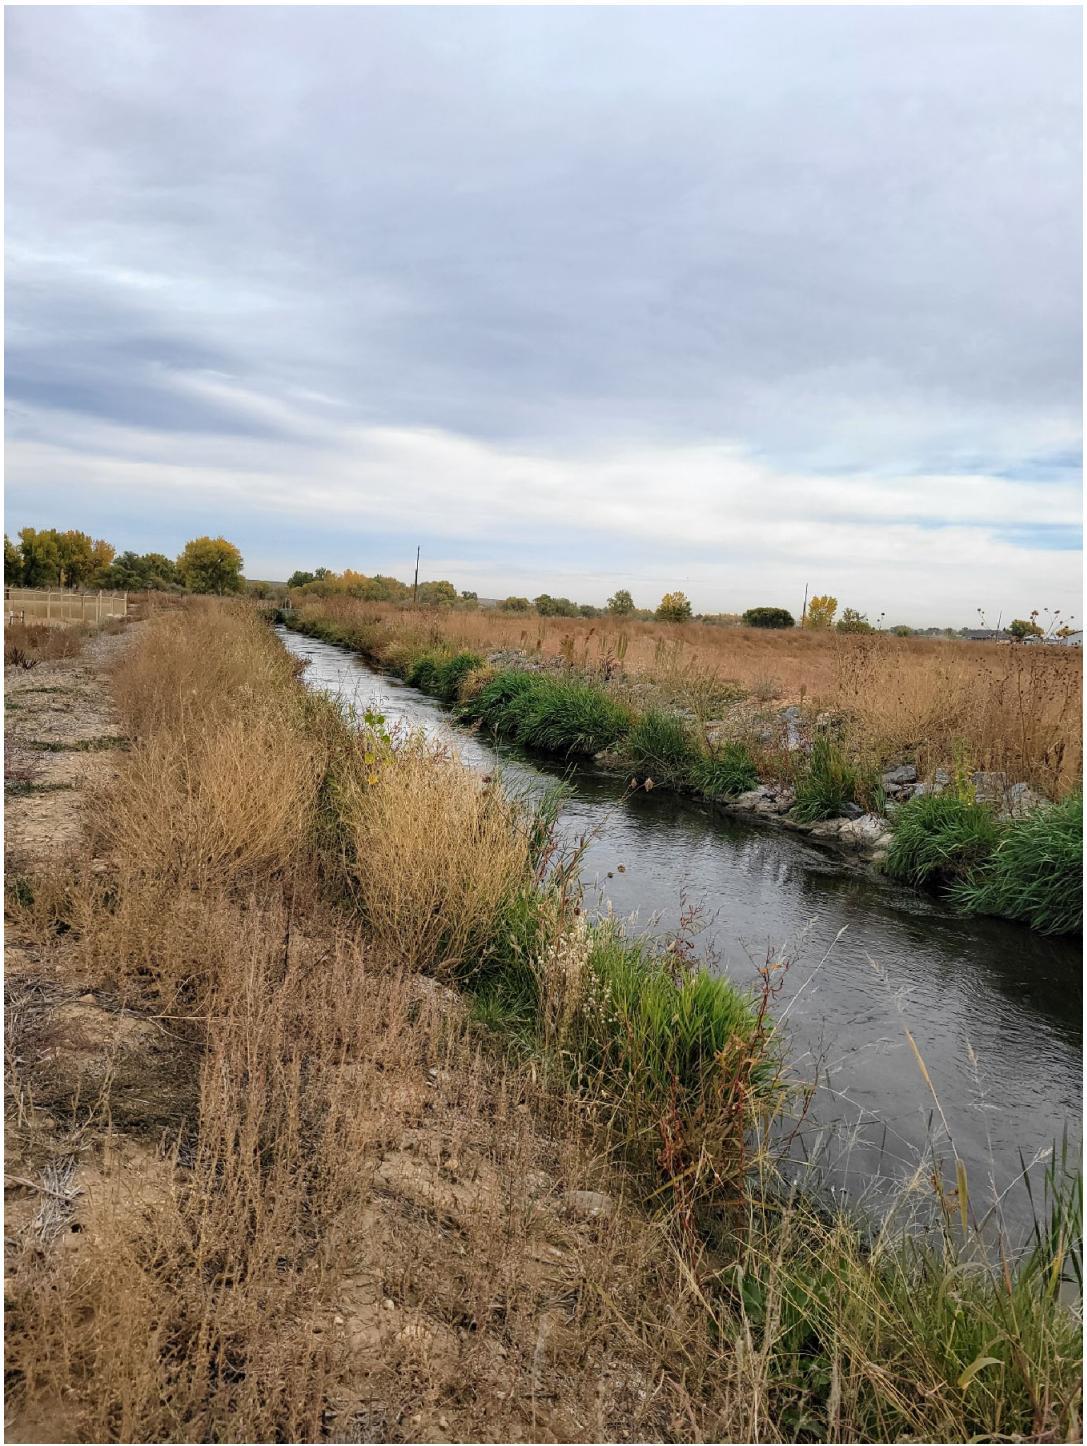
The Division approved Technical Revision 2 in August 2023. This revision authorized the relocation of the Last Chance Ditch from the center of the mine site to run along the northern perimeter. During the inspection, the Division observed the settling ponds in the northwest corner of the mine site and the relocated Last Chance Ditch (Photo 5). Water is collected in a trench in the Area 3 and pumped to the settling ponds. The operator utilizes the water for processing. The Division observed water discharging to the Last Chance Ditch (Photo 6). The Division reviewed the CDPHE records and confirmed that the operator has an active discharge permit No. 3696447A. Additionally, the Operator has an active well permit and provided a copy of the current Substitute Water Supply Plan for the period January 1, 2024 to January 1 2025 to the Division. The plan covers depletions for exposure of 20.9 acres. The Operator has an active groundwater monitoring plan. During this inspection, the Division observed eight groundwater monitoring wells around the exterior of the site.

Photo 5: Relocated Last Chance ditch on the north end of the site.

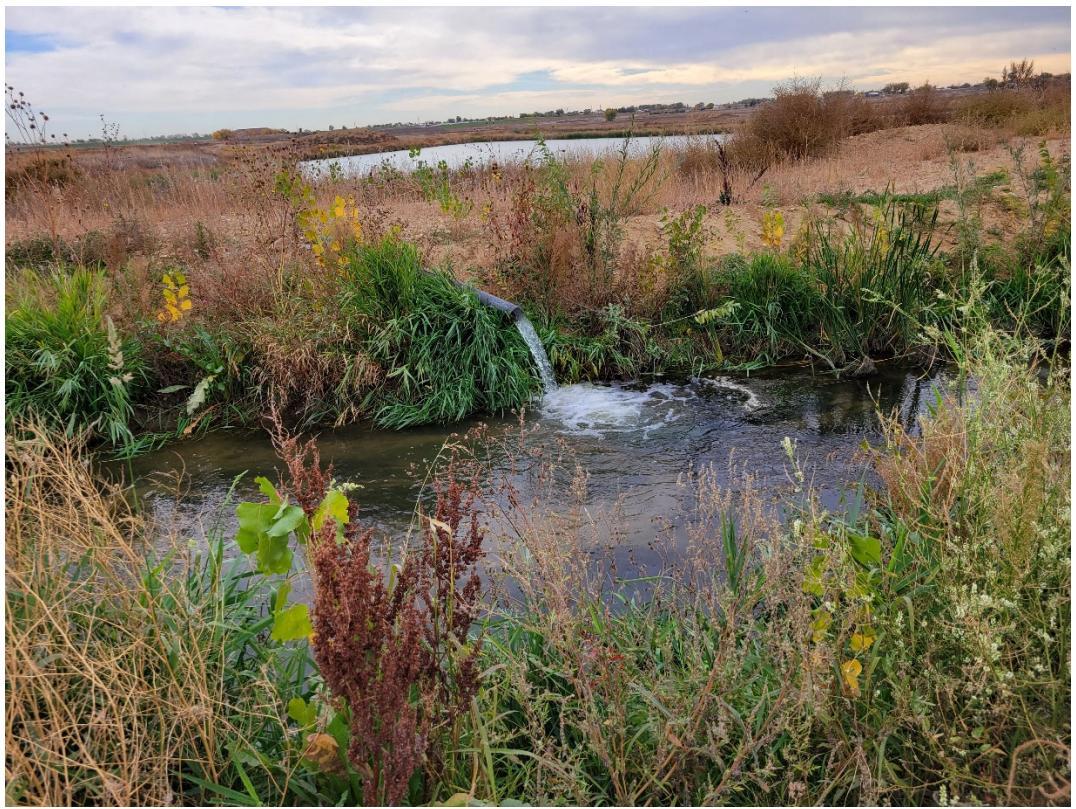
Photo 6: Water discharging into Last Chance ditch in the northwest corner of the site.

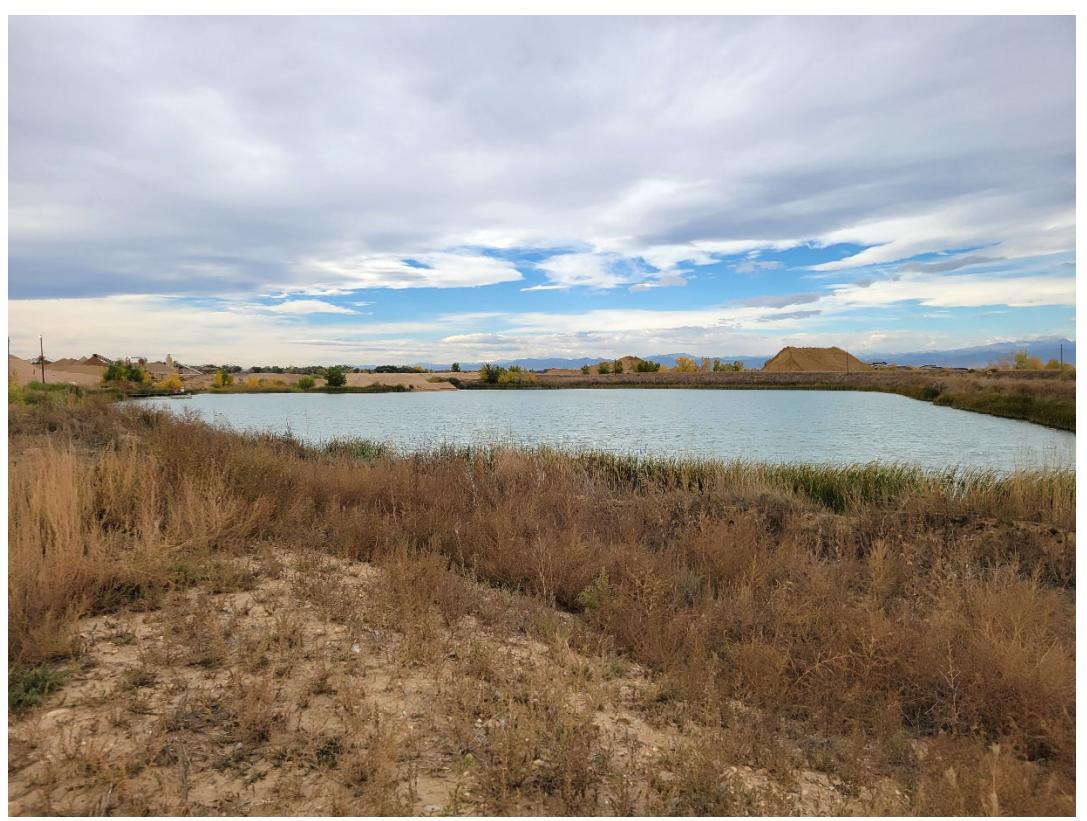
Photo 7: Pond adjacent to the plant area in the northwest corner of the mining area.

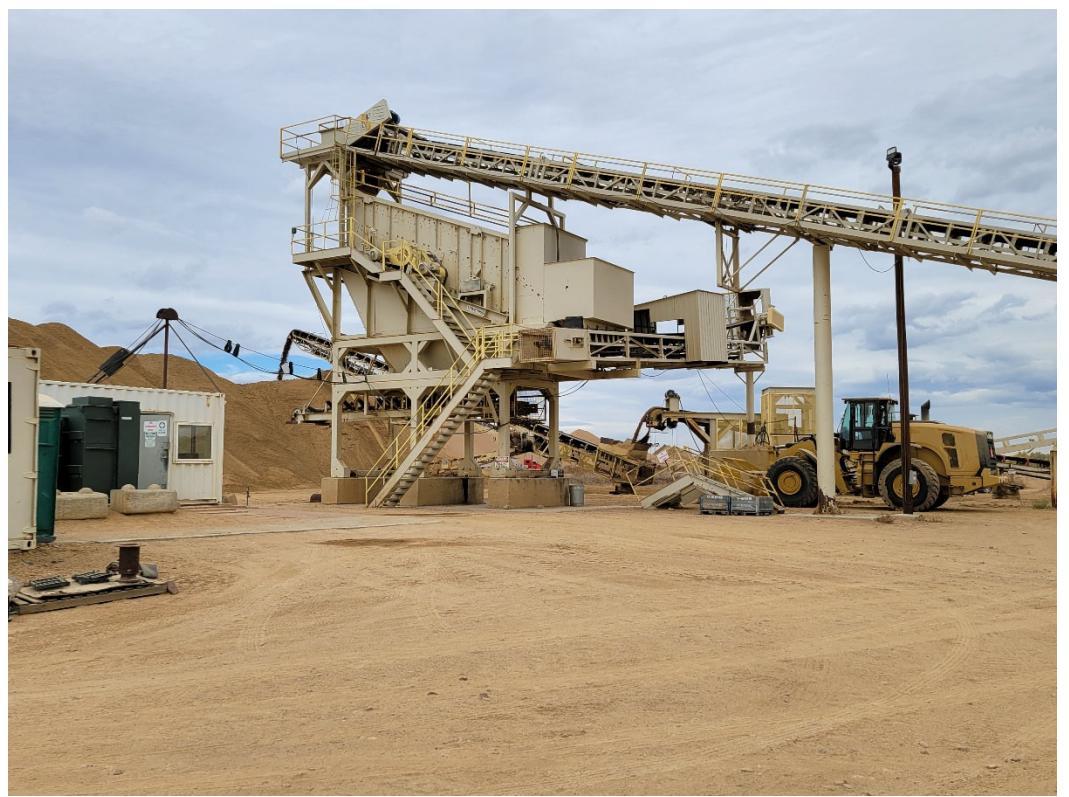
The mine site is split into 3 areas. Mining began in Area 1 in the southwest corner of the property and moved north and east over the years. The plant site is located within Area 2 on the northwest side of the permit area (Photo 8) and stockpiles are staged in the southwest corner of Area 3 along with a boneyard. Active mining is occurring in the northern part of Area 3. According to the operator, mining in the northern section of Area 3 is nearing completion and the northern perimeter has been backfilled and sloped to 3H:1V. During the inspection, the Division observed equipment in the northeast corner of Area 3 placing and compacting the clay liner (Photo 2). The operator plans to continue concurrent reclamation as they mine to the south in Area 3. Once mining is complete, Area 3 will be reclaimed to a 266-acre lake. Upland areas will be reclaimed to rangeland.

Photo 8: Processing equipment in Area 2.

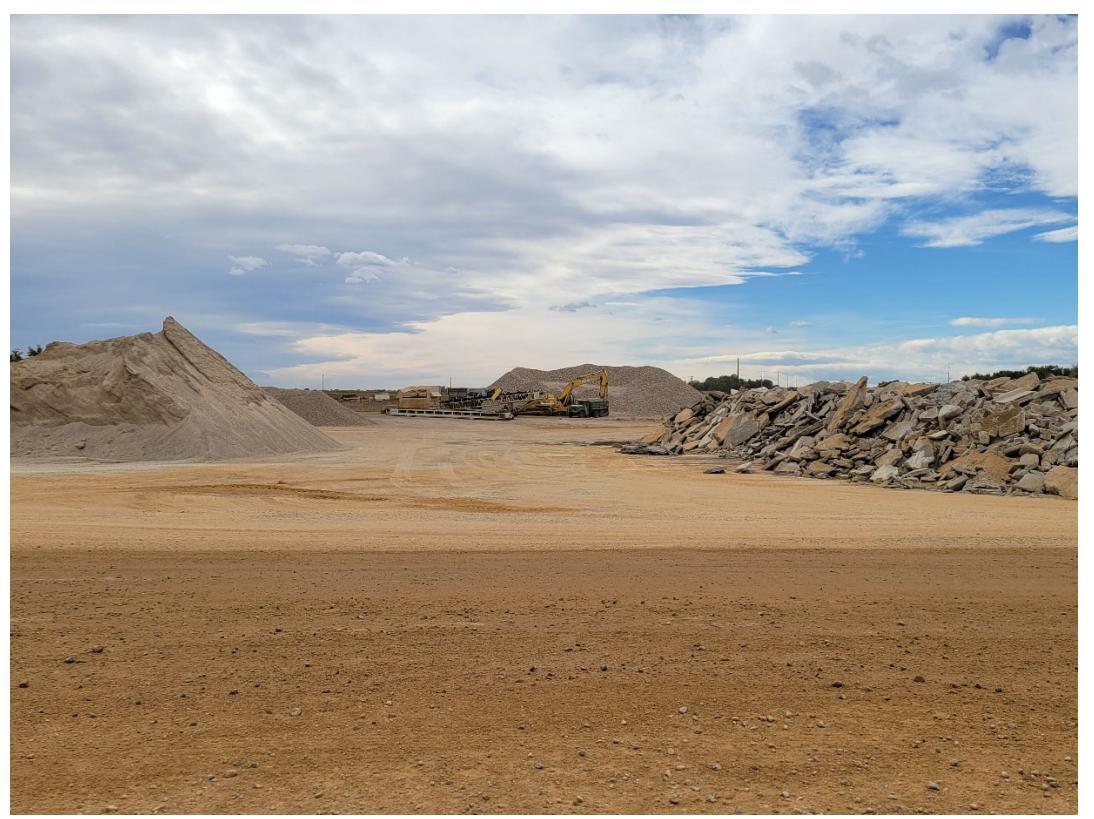
Photo 9: Stockpile area in the southwest corner of Area 3.

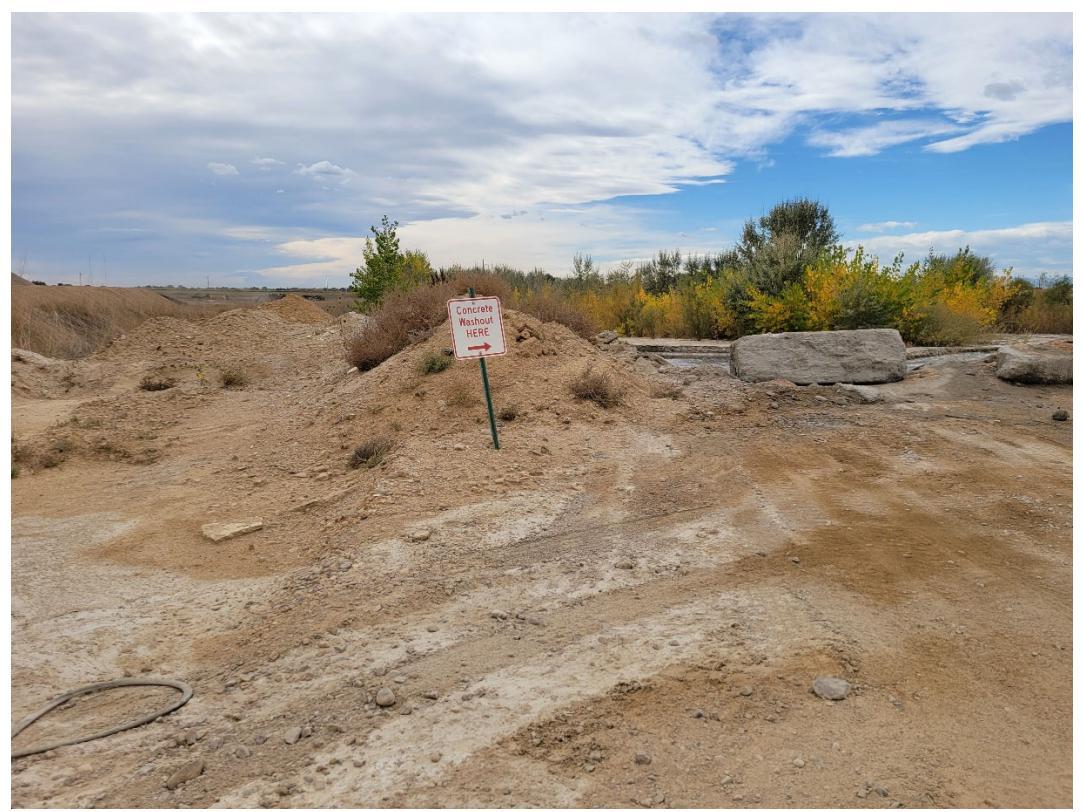
Photo 10: Concrete wash area adjacent to the processing plant.

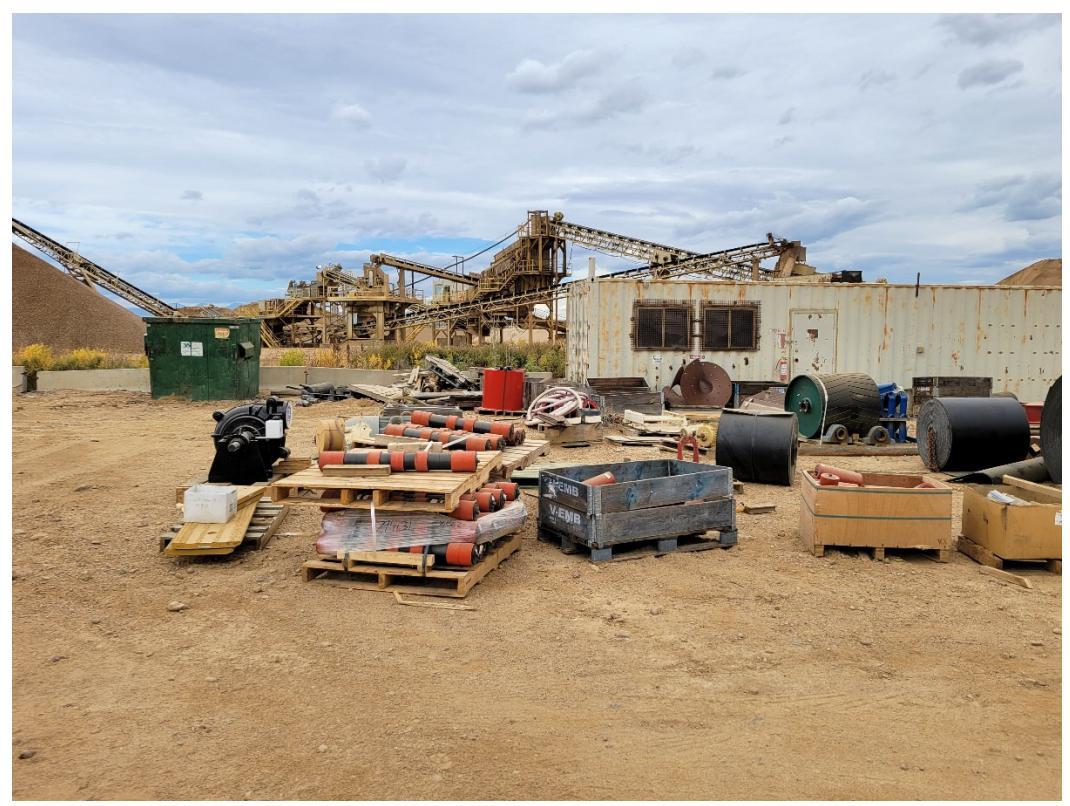
Photo 11: Equipment storage area adjacent to the processing plant.

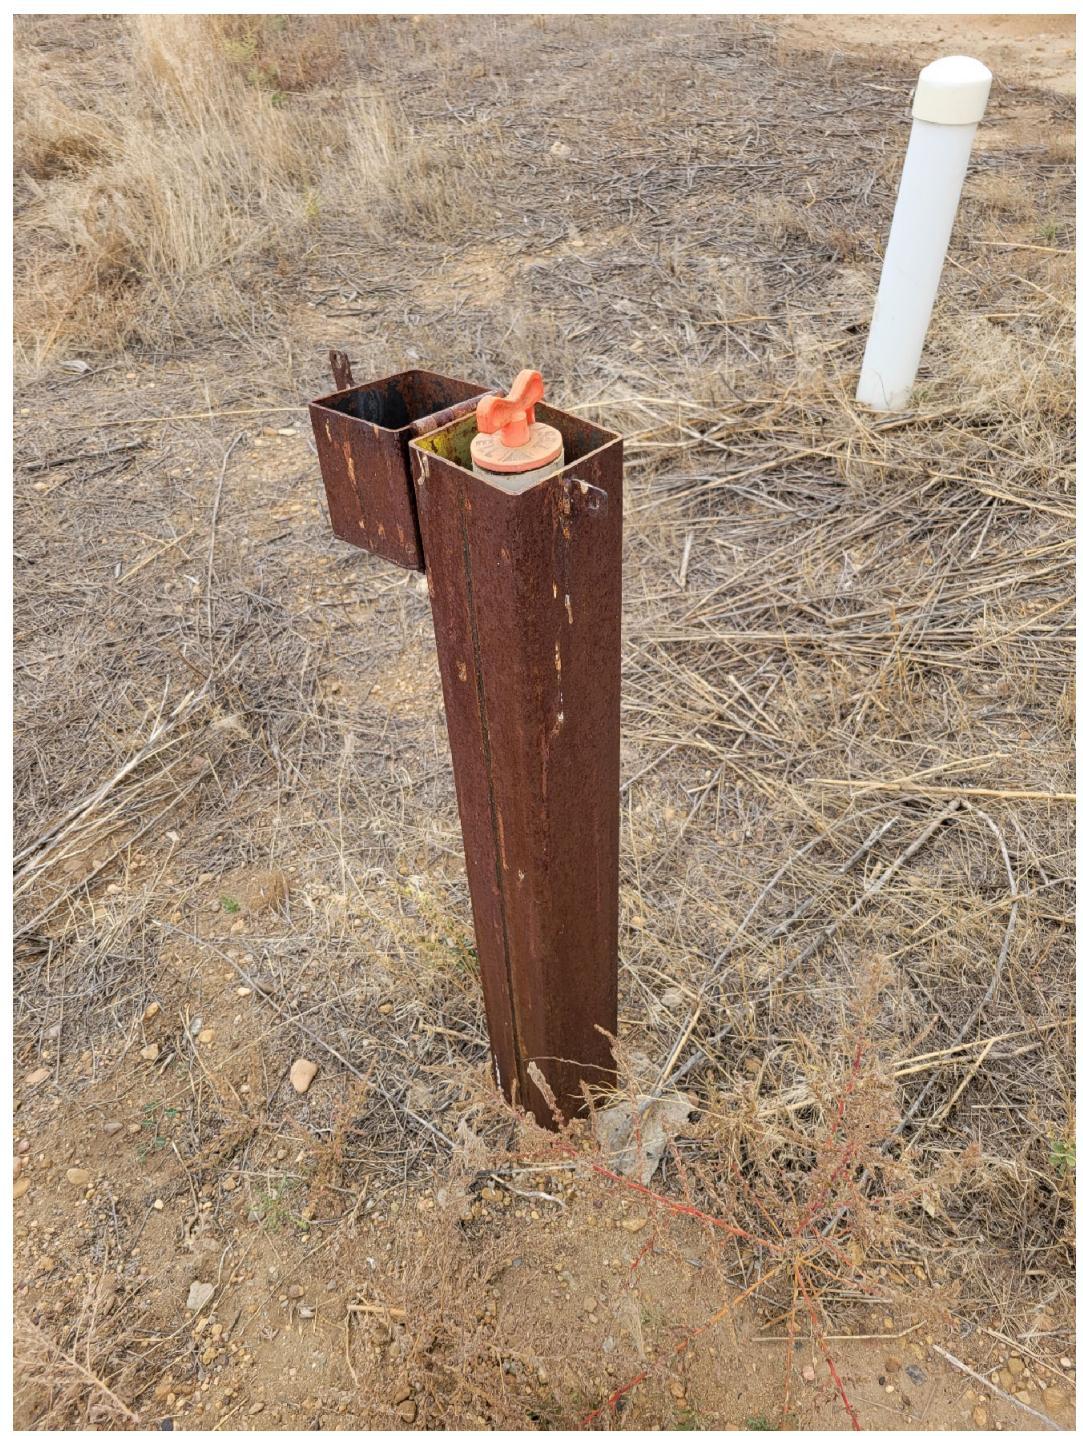
Photo 12: Groundwater monitoring well on Accord's property outside the northern permit boundary.

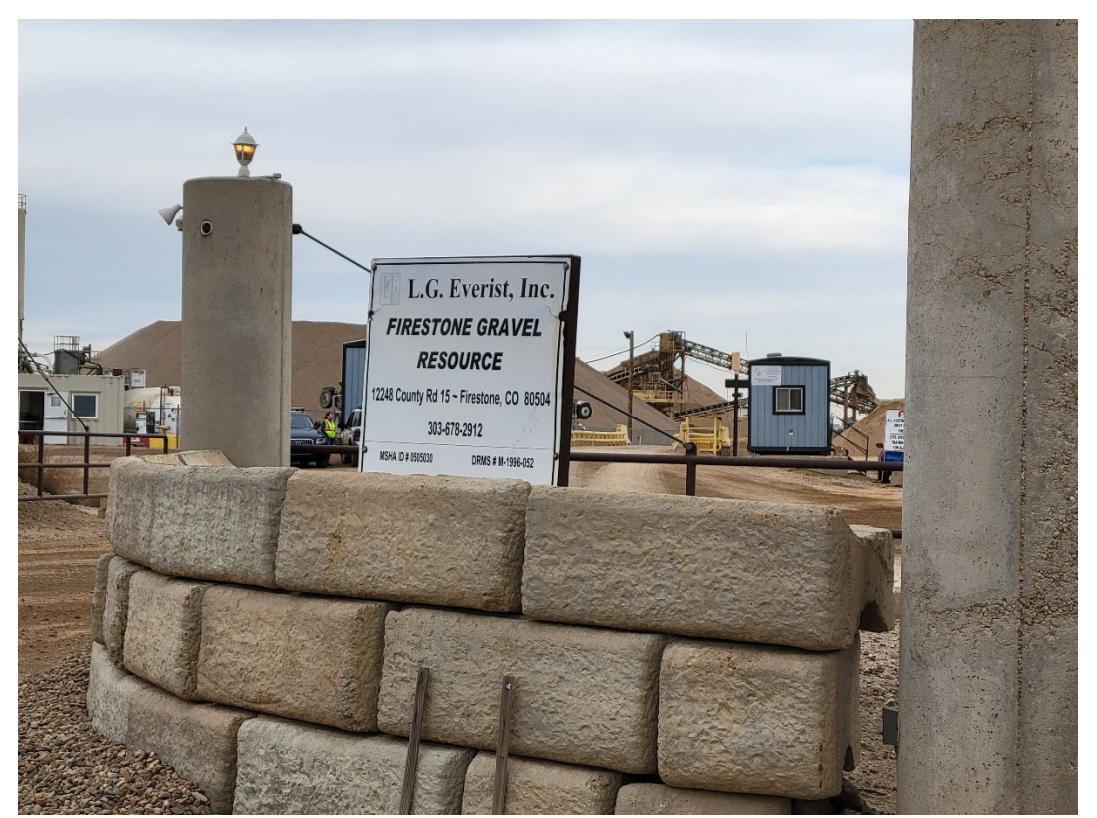
A mine sign was posted at the entrances to the site as required by Rule 3.1.12(1) (Photo 13). A barbed wire fence is installed around the perimeter of the site and mine notices were observed posted on fence.

Photo 13: Mine sign posted at the entrance to the site in Area 2.
