MINERALS PROGRAM INSPECTION REPORT PHONE: (303) 866-3567

MINE NAME:		MINE/PROSPECTING ID#:	MINERAL:	COUNTY:
Sprague Scraper Service Pit		M-2005-032	Gravel, sand and clay	Washington
INSPECTION TYPE:		WEATHER: Cloudy	INSP. DATE:	INSP. TIME:
Monitoring			December 9, 2024	09:30
OPERATOR:		OPERATOR REPRESENTATIVE:	TYPE OF OPERATION:	
JC Farms Inc			110c - Construction Limited Impact	
REASON FOR INSPECTION:		BOND CALCULATION TYPE:	BOND AMOUNT:	
Normal I&E Program			\$33,000.00	
DATE OF COMPLAINT:		POST INSP. CONTACTS:	JOINT INSP. AGENCY:	
NA		None	None	
INSPECTOR(S):	INSPECTOR'S SIGNATURE:		SIGNATURE DATE:	
Ben Hammar			January 7, 2025	
	Ellman

PERMIT #: M-2005-032 INSPECTOR'S INITIALS: BEH INSPECTION DATE: December 9, 2024

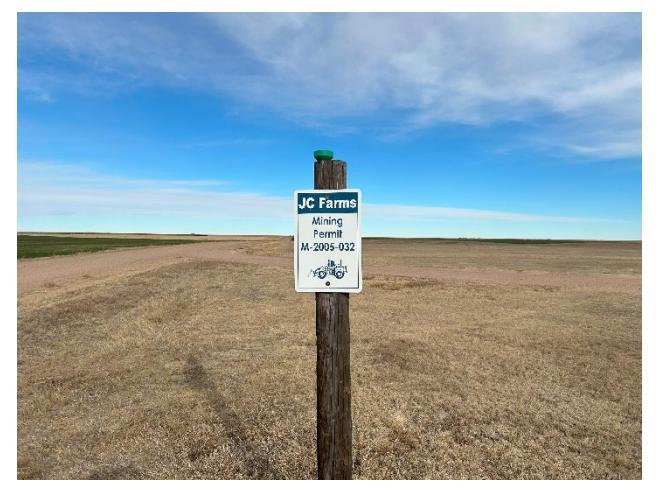
The site was inactive at the time of this inspection, but per conversation with the operator it has been consistently utilized. The site identification sign was clearly posted near the mine entrance, and all site boundaries were well maintained and clearly marked.

Photo 1: Posted site identification sign.

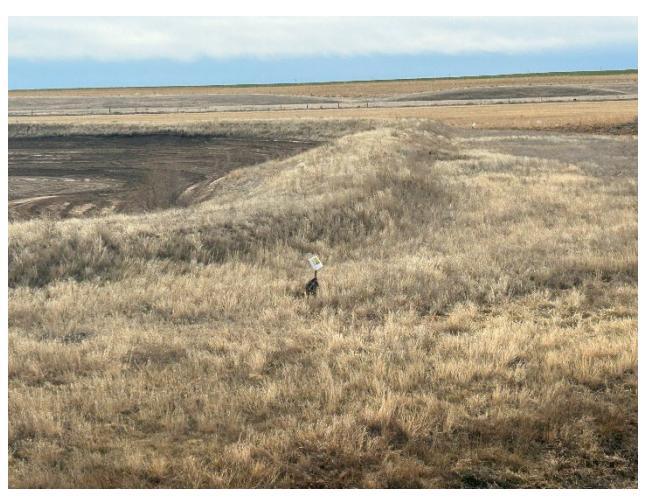
Topsoil piles were well seeded, stable, and arranged into a berm along the southern and western pit boundaries. No signs of erosion were found during this inspection, and the pit appeared to be actively maintained and under regular use. Some standing water was present, however this was likely due to a recent rainfall event that occurred within the area.

Photo 2: Seeded topsoil berms and northwestern site marker

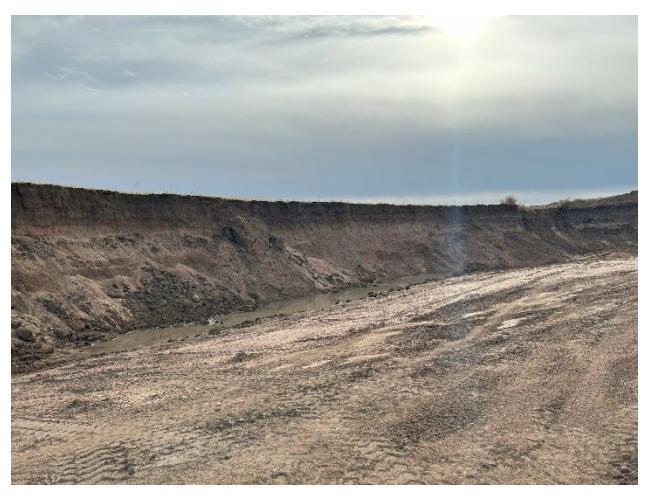
Photo 3: Highwall and water retained from recent storm event.

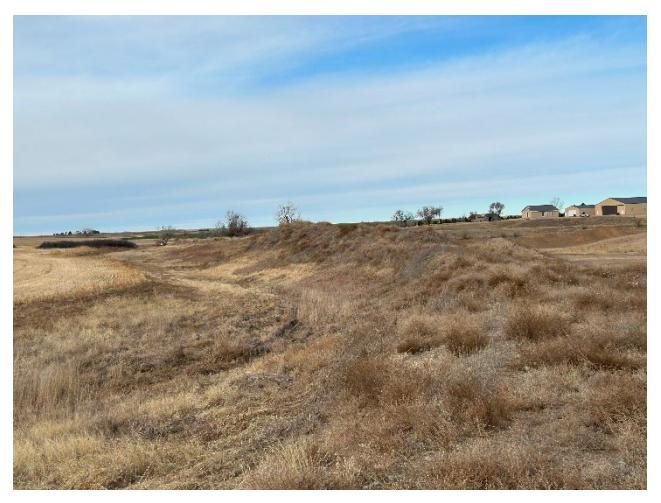
Photo 4: Southern boundary line and topsoil berm.

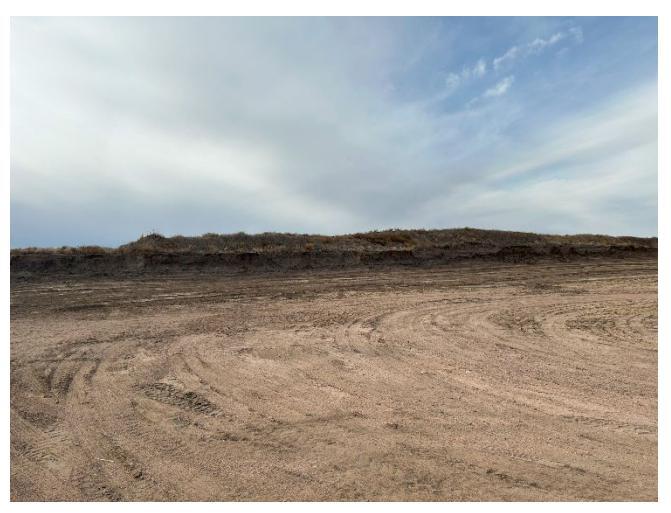
Photo 5: Pit floor and extended view of highwall.
