Comments received by the Division for the Seeley Reservoir Stockpiles M-2023-043 Application

RE: Seeley Reservoir Stockpiles, File No. M-2023-043 (Adequacy Review/Additional Application Comments)

**RE: Review of the Ogilvy Ditch Company
Structure Keirnes Land Company, LLC/Eagle
View Farms, LLC Weld County, Colorado**

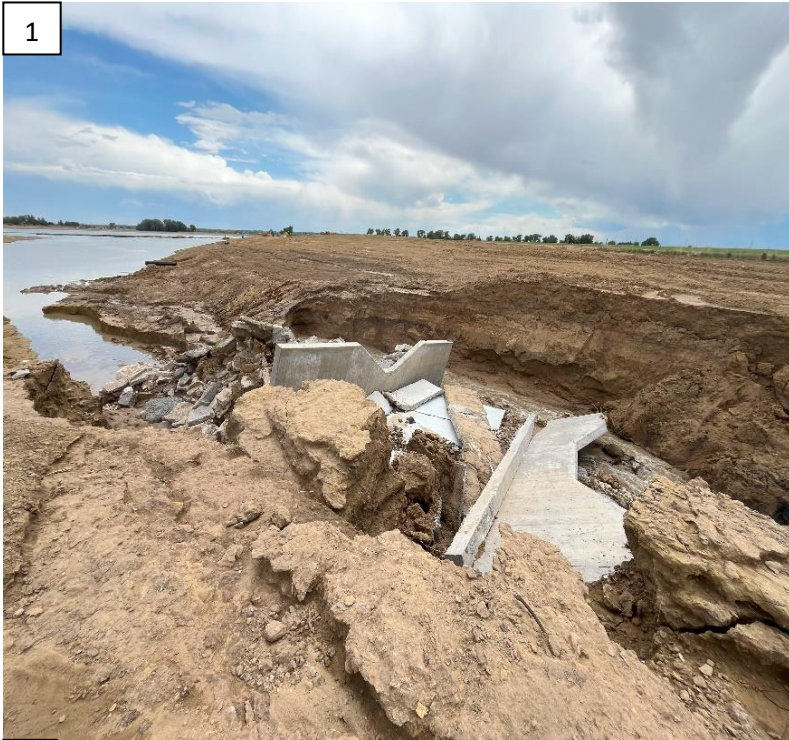
- Image 1 - Shows the first unapproved failed structure and damages caused, due to the non-engineering (as stamped engineered plans were nonexistent). Our general observations contradict the claimed cause of failure and we believe it was due to head wall pressure by damming up the historical flow of water.

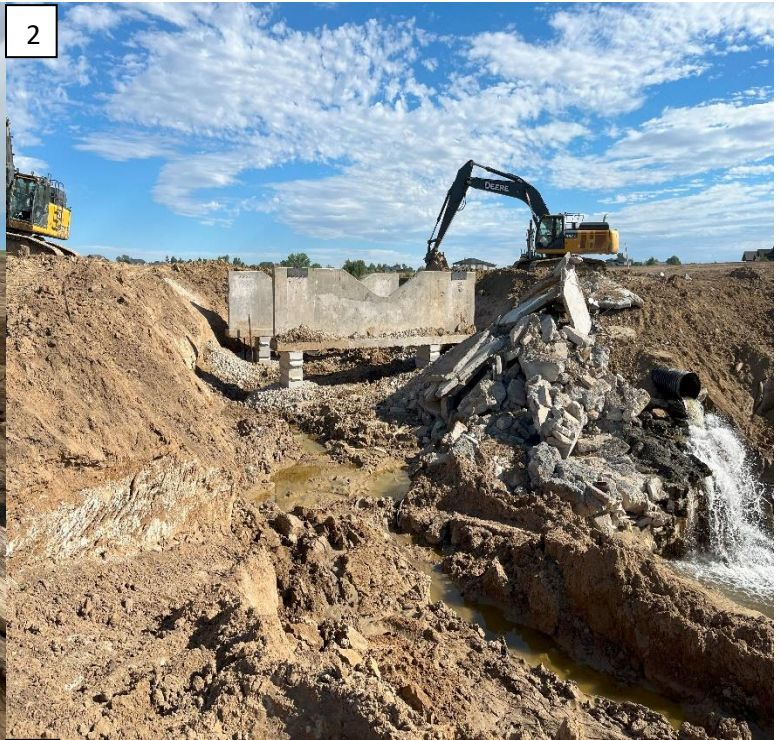
- Image 2 - Shows the 2nd structure utilizing the salvaged headwall set on crushed concrete, elevated 4ft +/- resting on concrete blocks (neither of these components are shown on engineered drawings), skewed/moved outside of the historical flowline.

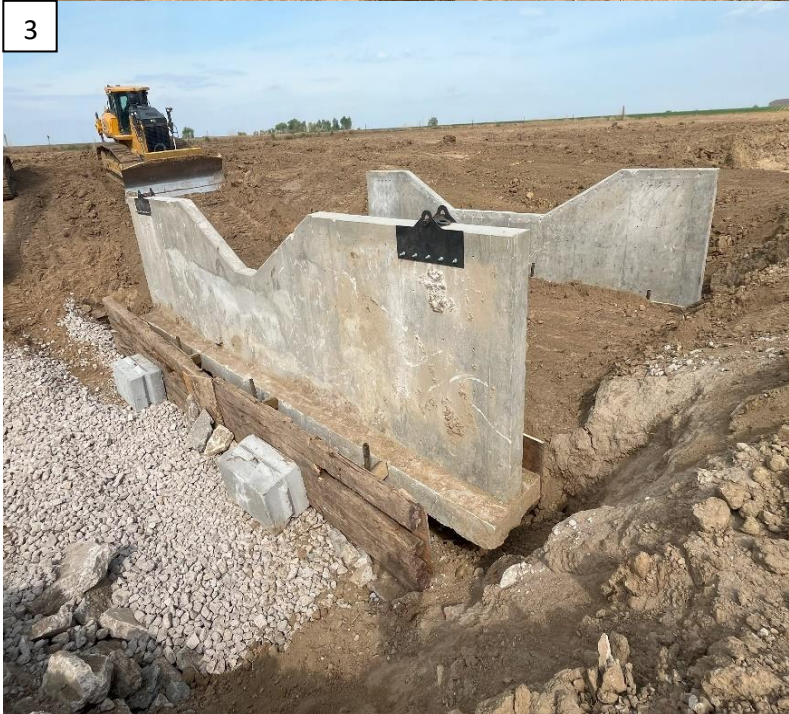
- Image 3 – Shows formed footers via railroad ties on top of crushed concrete, with no horizontal rebar or vertical rebar ties connecting the salvaged headwall.

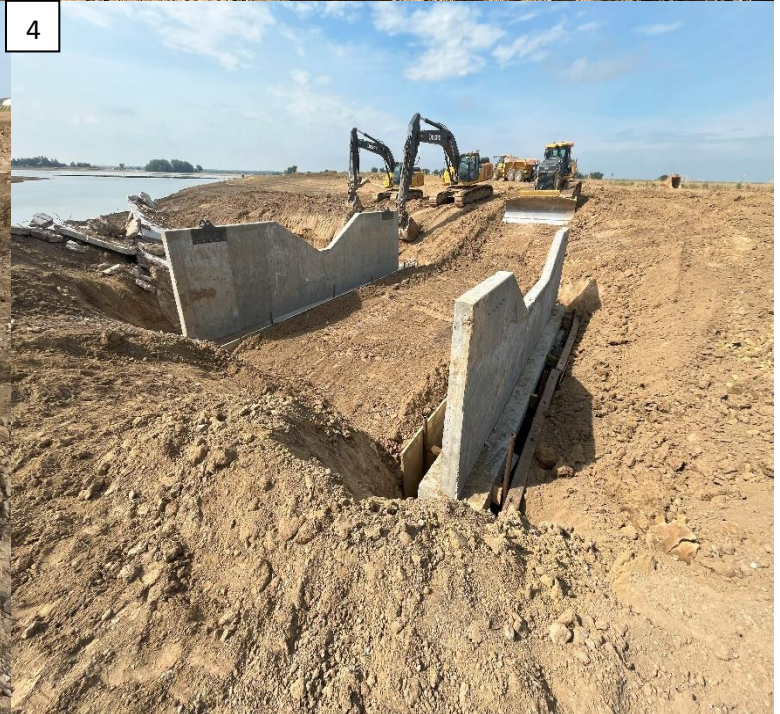
- Image 4 – Shows uncompacted back fill and no compaction test nor mechanical compaction were provided or verified.
- Image 5 – Shows the railroad tie forms left and backfilled in place and again no mechanical compaction were provided or verified.

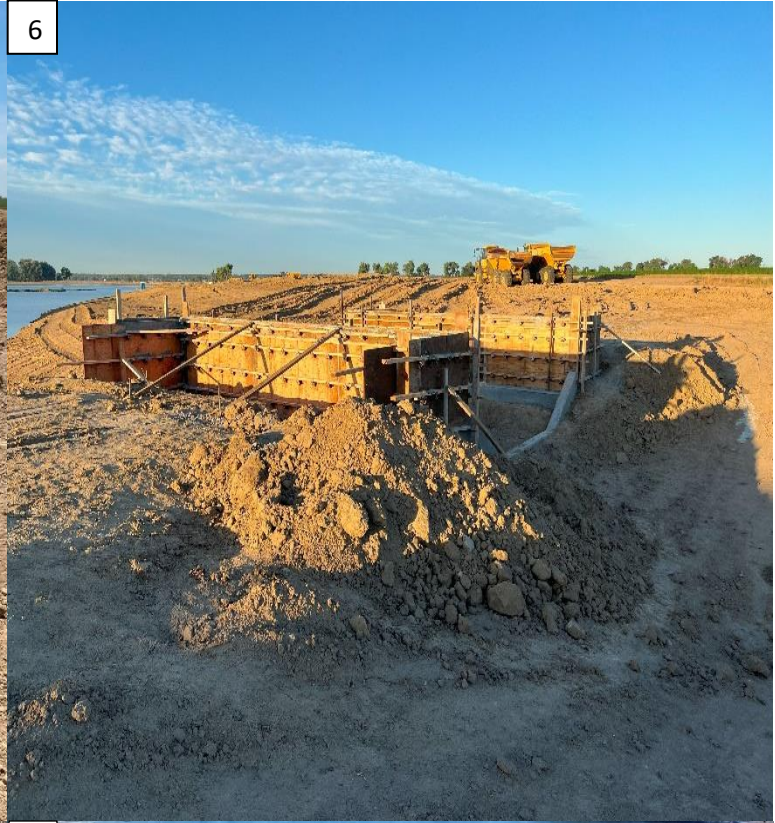
- Image 6 – Shows skewed forming of unneeded height on top of headwall making the overall height of the structure 11 ½ ft top to bottom.
- Image 7 – Shows historical flowline altered and moved west during construction (see Image 8 for historical context). It shows the new detained/impounded body of water footprint (5ft deep x 50ft wide x 1000 ft long). The gross magnitude of the structure (7ft + above HWL) and the impounded body of water upstream of the Seeley Lake Reservoir is not justifiable per our third party engineer.

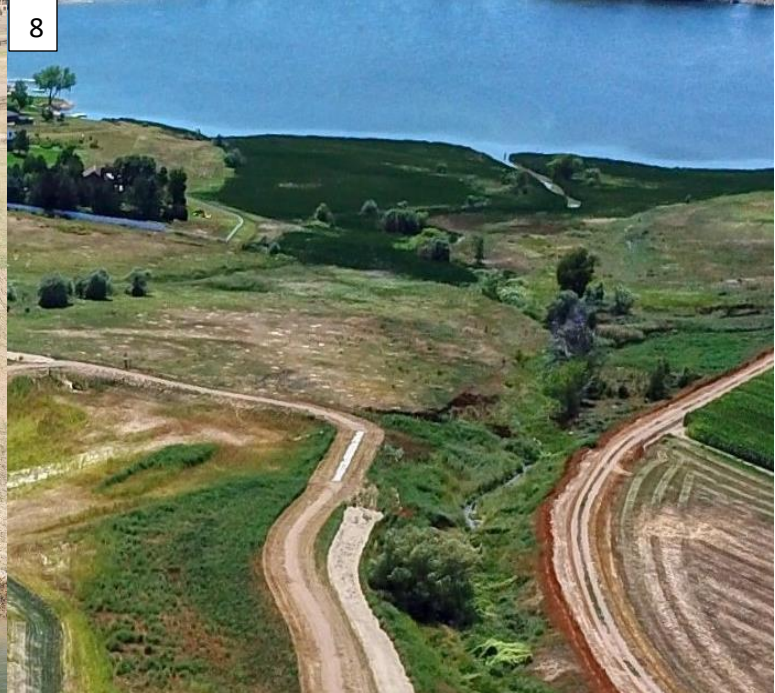
- Image 8 – Show the subject areas' historical positive flow of water down gradient to the Seeley Lake Reservoir, before creating the new detained body of water outside of the reservoirs original foot print shown in image 7.
