MINERALS PROGRAM INSPECTION REPORT PHONE: (303) 866-3567

MINE NAME:	MINE/PROSPECTING ID#:	MINERAL:	COUNTY:
Haynes Hereford Ranch Pit	M-2004-023	Sand and gravel	Phillips
INSPECTION TYPE:	WEATHER:	INSP. DATE:	INSP. TIME:
Monitoring	Cloudy	December 17, 2024	10:00
OPERATOR:	OPERATOR REPRESENTATIVE:	TYPE OF OPERATION:	
Phillips County	Kevin Scott, Ed Glennemeier, Dave	112c - Construction Regular Operation	
	Salyards		
REASON FOR INSPECTION:	BOND CALCULATION TYPE:	BOND AMOUNT:	
Normal I&E Program	None	\$0.00	
DATE OF COMPLAINT:	POST INSP. CONTACTS:	JOINT INSP. AGENCY:	
NA	None	None	
INSPECTOR(S):	INSPECTOR'S SIGNATURE:	SIGNATURE DAT	Е:
Joel Renfro	$\bigcirc 10$	January 22, 2025	
	Alkentre		
	Under the state

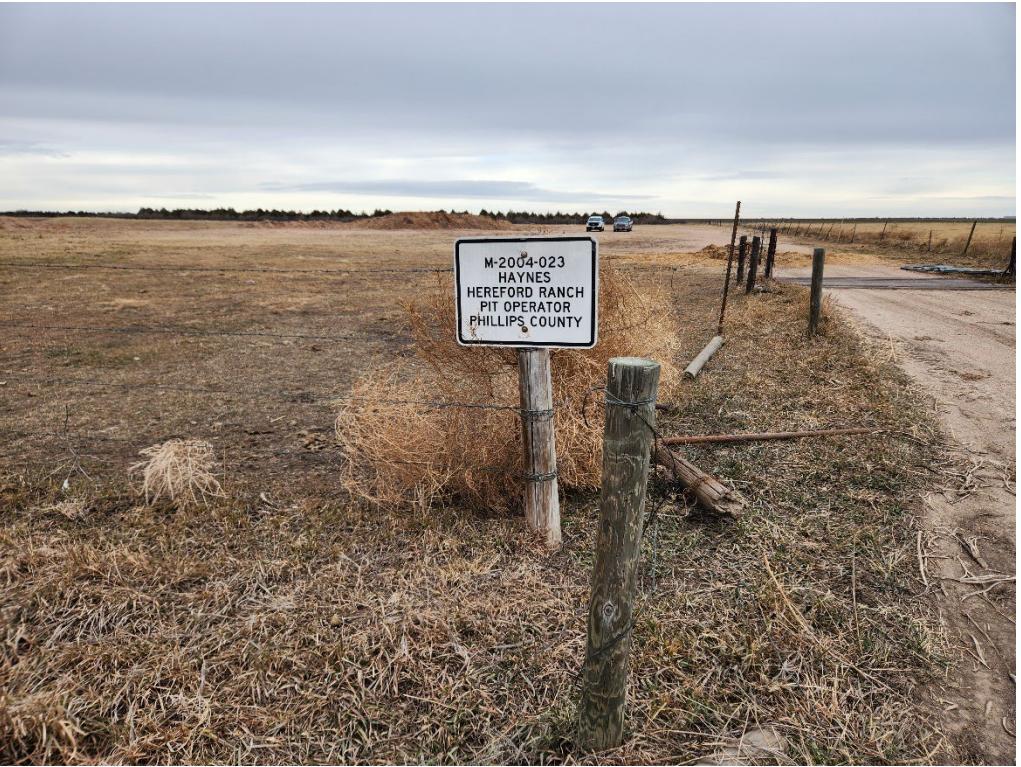
Photo 1. Mine entrance sign, looking north.

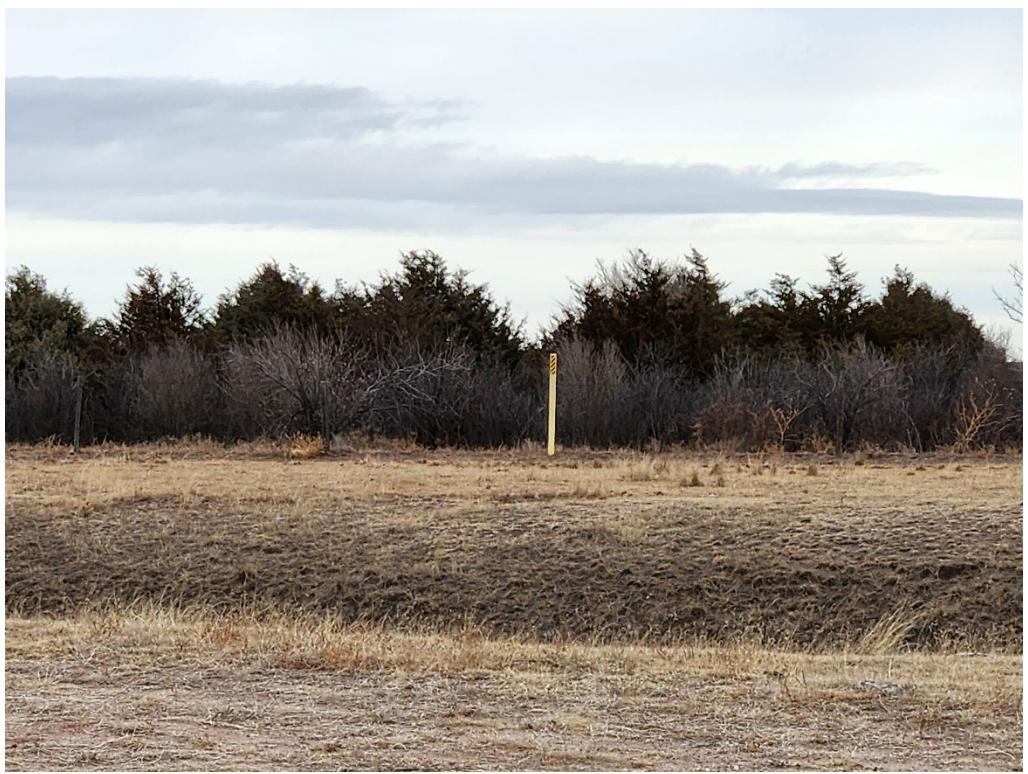
The permit boundary is along the intersection of Co Rd 33 and Co Rd. 24 connecting to a zig-zagged boundary that roughly follows the North Fork Frenchman Creek that runs through this site. The boundaries are marked with a fence along the roads and creek and corners are marked with bright red posts. The creek was dry at the time of inspection.

Photo 2. Permit boundary marker in the northeast of the site, looking north.

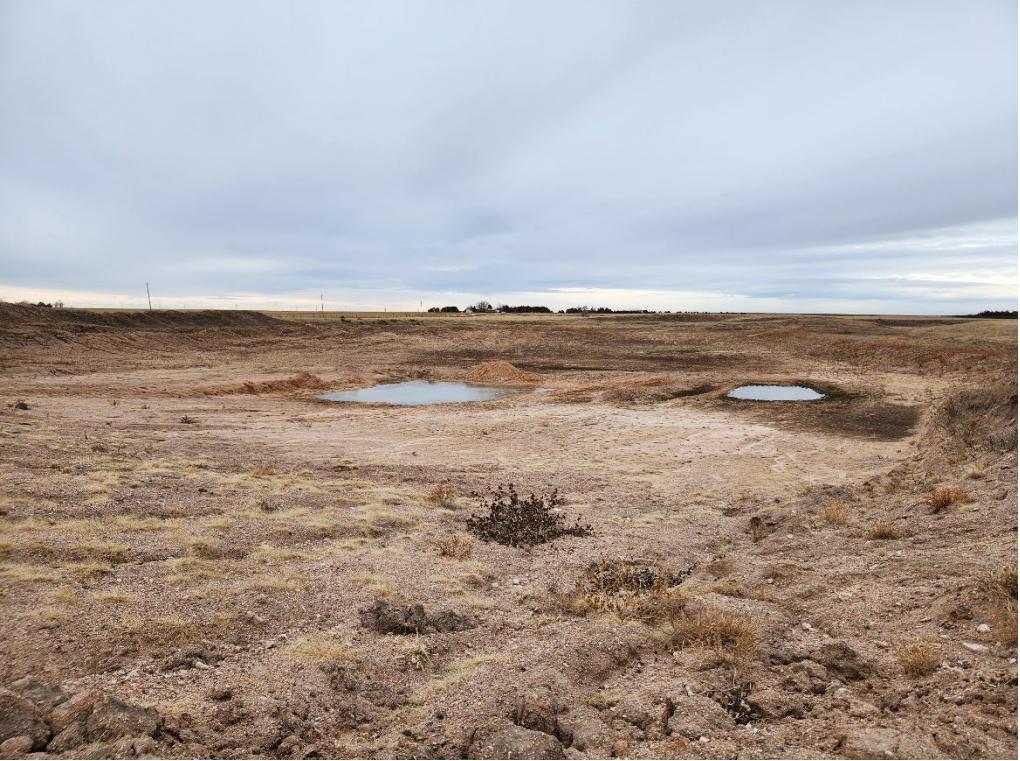
This site was last active in April 2024. Currently, there is a pit near the southeast corner of the site dug out with some material stockpiled to the north and east. Material is excavated and stockpiled, then used as needed for road maintenance. Currently, the only disturbance is in a pit dug out in the east with a stockpile of topsoil stored right above it. The operator plans to continue expanding the pit westward and reclaiming it as they move.

Photo 3. Open mining pit on site, looking west.

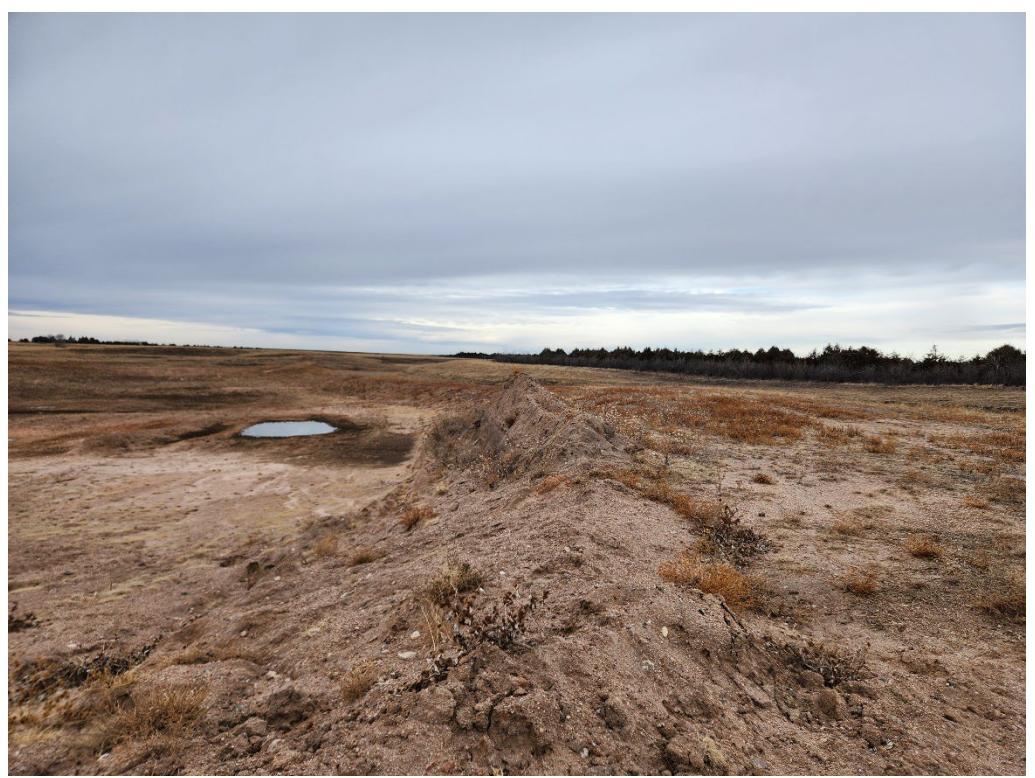
Photo 4. Topsoil stockpile, looking west.

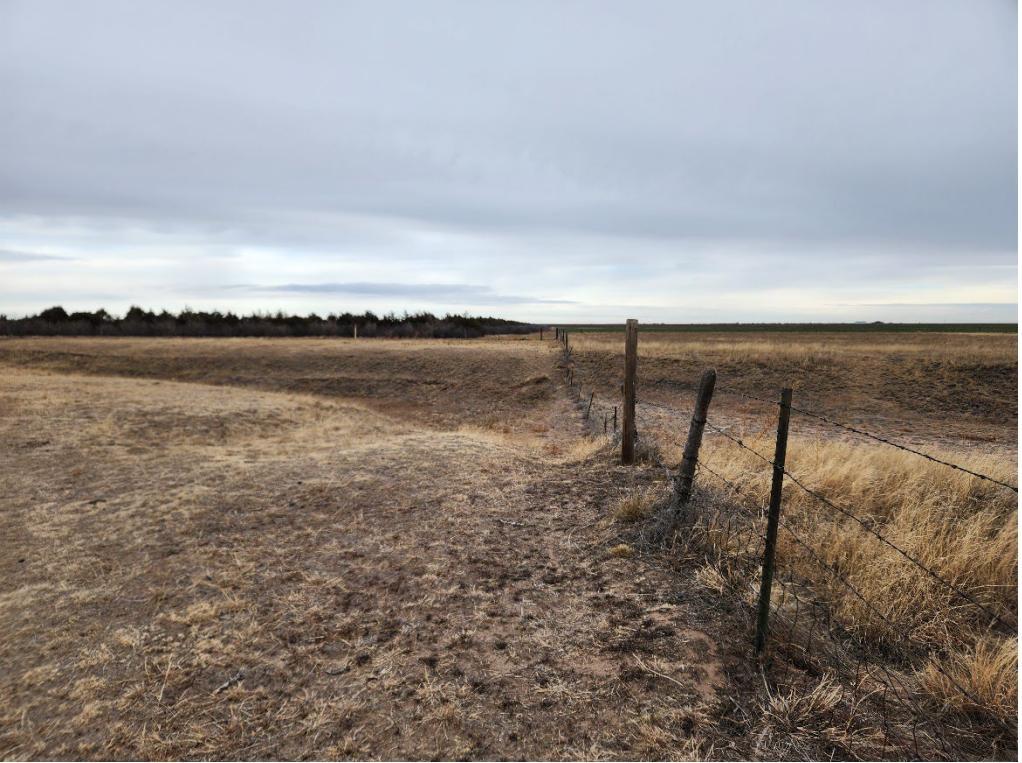
Photo 5. Eastern permit boundary, looking north.

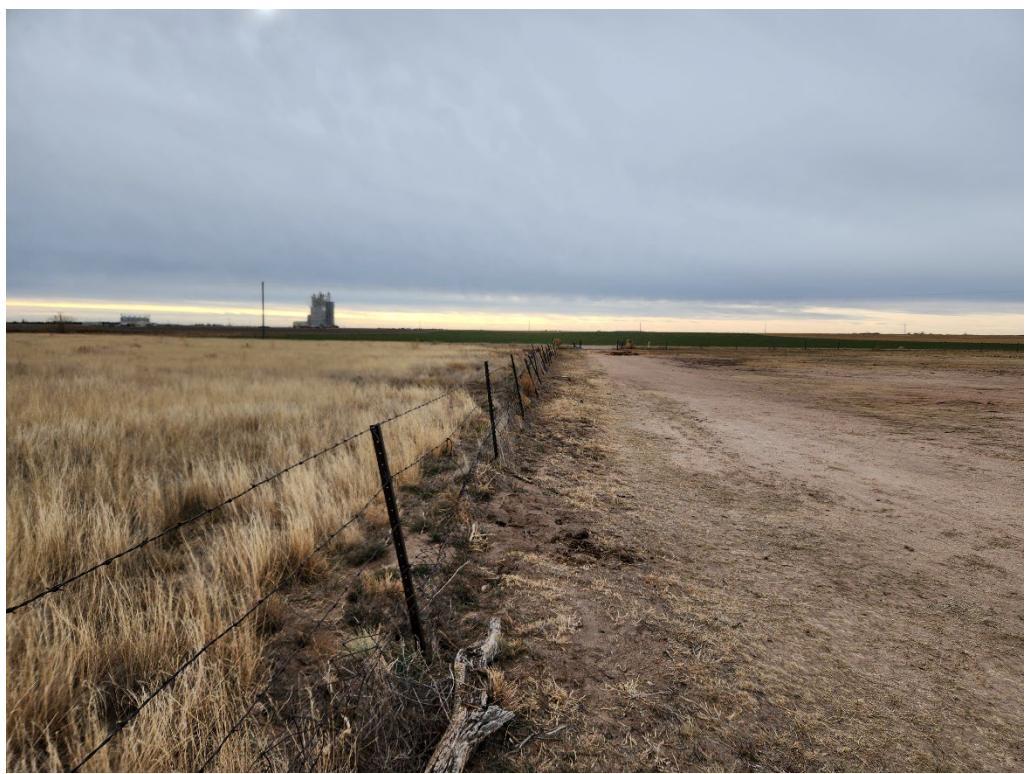
Photo 6. Eastern permit boundary, looking south.

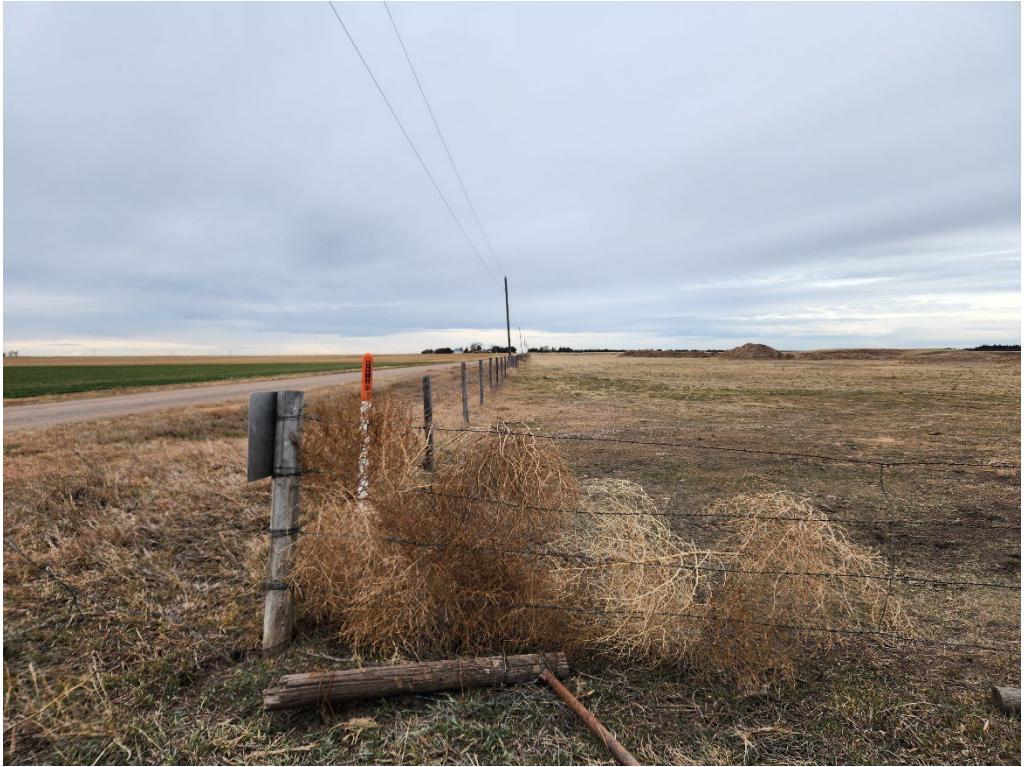
Photo 7. Southern permit boundary, looking west.

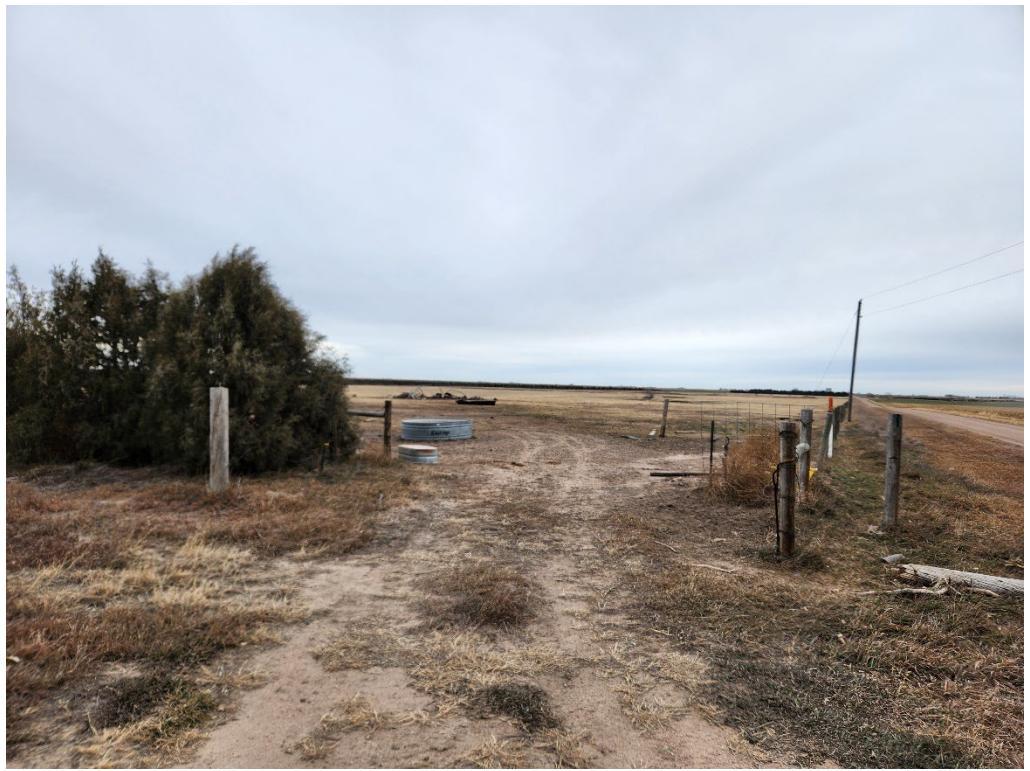
Photo 8. Southwest corner of the permit boundary, looking east

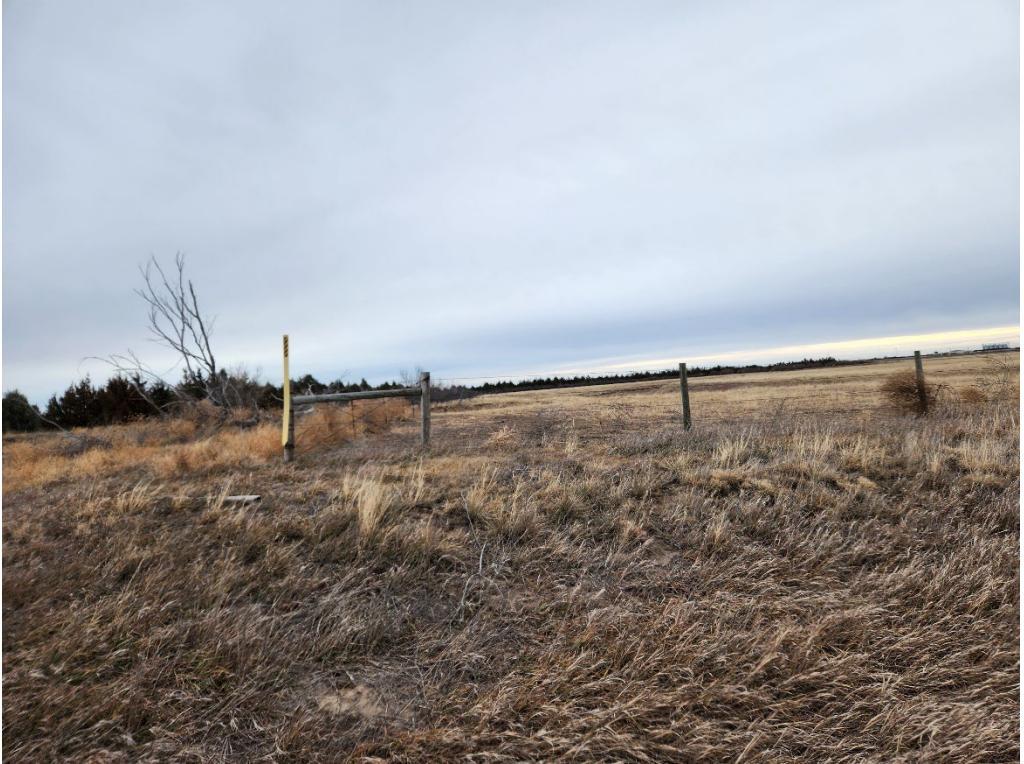
Photo 9. Northwest corner of the permit boundary, looking east.
