## MINERALS PROGRAM INSPECTION REPORT PHONE: (303) 866-3567

MINE NAME:	MINE/PROSPECTING ID#:	MINERAL:	COUNTY:
Patton Clay Mine	M-1998-067	Clay (general)	Fremont
<b>INSPECTION TYPE:</b>	WEATHER:	INSP. DATE:	INSP. TIME:
Surety Release Inspection	Windy	January 9, 2025	11:00
OPERATOR:	<b>OPERATOR REPRESENTATIVE:</b>	TYPE OF OPERATION:	
Summit Brick & Tile Co.	N/A	112c - Construction Regular Operation	
<b>REASON FOR INSPECTION:</b>	BOND CALCULATION TYPE:	BOND AMOUNT:	
Surety Release Requested	None	\$29,500.00	
DATE OF COMPLAINT:	POST INSP. CONTACTS:	JOINT INSP. AGENCY:	
NA	None	None	
INSPECTOR(S):	<b>INSPECTOR'S SIGNATURE:</b>	SIGNATURE DATE:	
Jocelyn Carter	Jone Rato	January 22, 2025

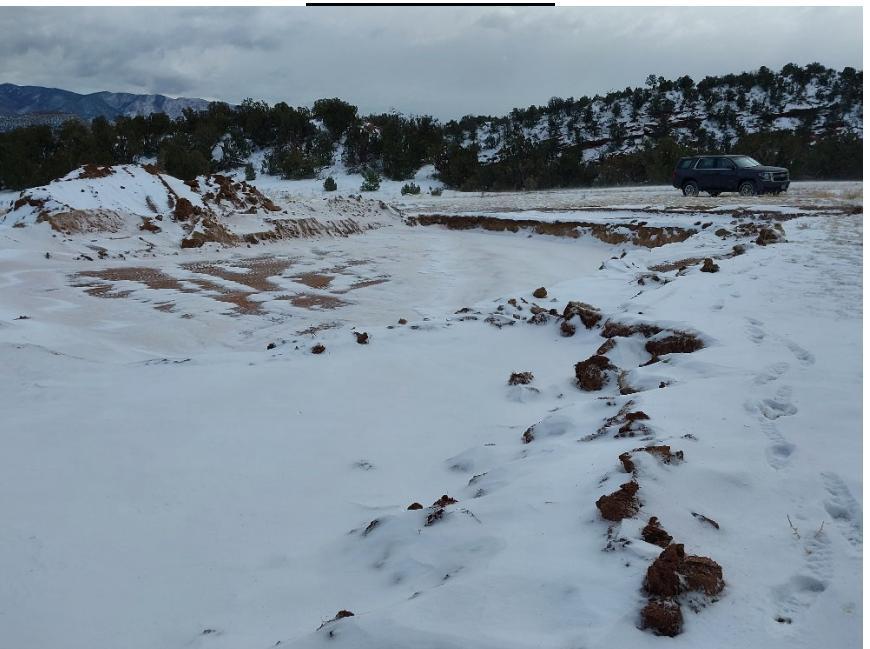
Photo #1: View of the excavation disturbance observed, looking to the southeast from the south portion of Area F.

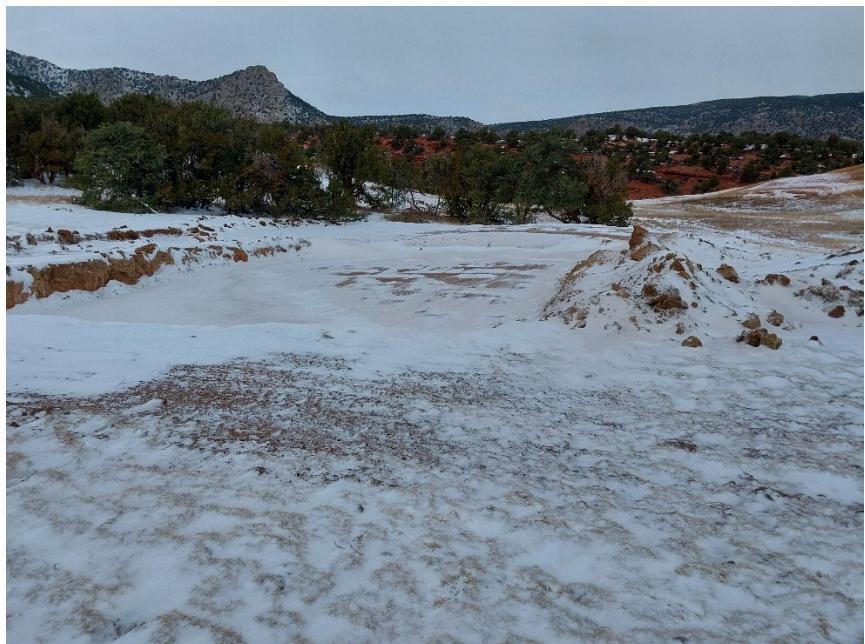
Photo #2: View of the excavation area observed, looking to the northwest from the southern portion of Area F.

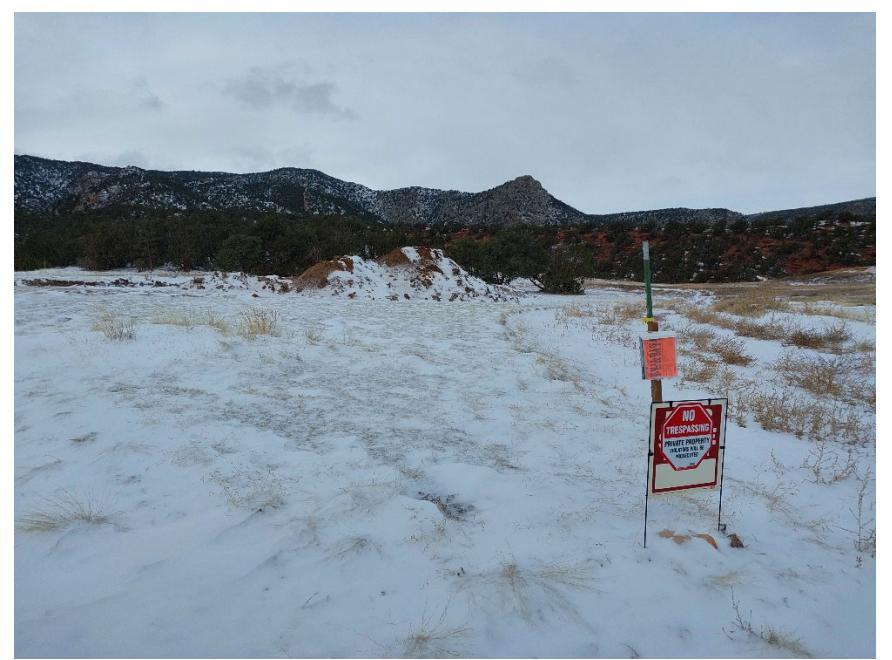
The Division does feel it is appropriate to approve the AR-1 application but will require the Operator to provide documentation from the landowner stating that the land disturbances observed during the January 9, 2025, site visit was not mine related. Given the assessment made by the Division on the October 9, 2024, site visit, the areas that have been disturbed by mining have been sufficiently reclaimed by the Operator.

Photo #3: View of the building permit observed on site with the excavated area and material seen beyond it to the left in the picture; looking to the northwest of the southern portion of Area F.

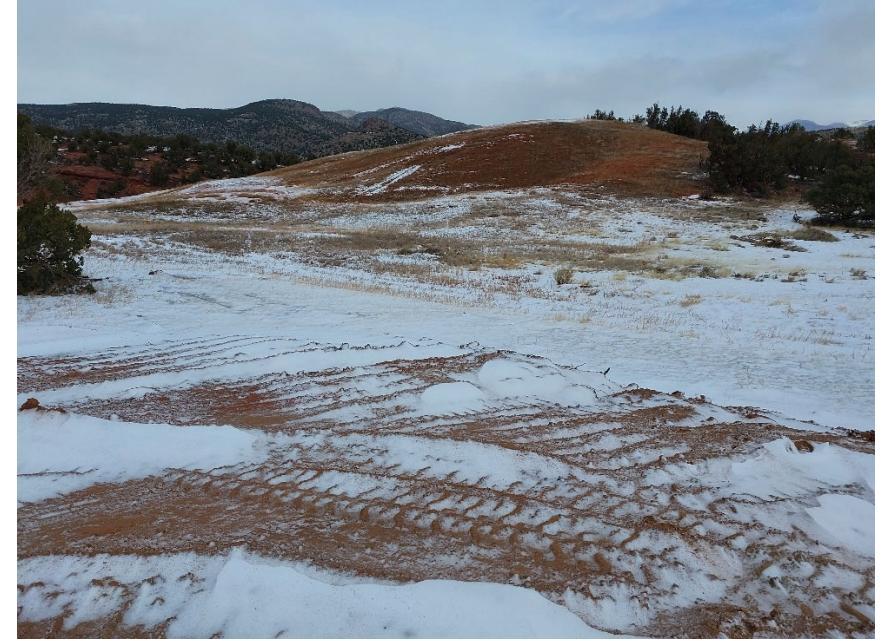
2021 with the most recent reclamation activity of seeding occurring in May of 2022. At the time of this inspection, the condition of the vegetation could not be adequately assessed due to the ground conditions and the presence of snow. However, when the site was visited on October 9, 2024, the re-vegetation appeared to be adequate with no issues regarding noxious weeds. There were no erosional issues that were observed during the October visit and the land appeared to be stable for use as rangeland.

Photo #4: View of the reclaimed hillside of the mining disturbance of Area F; the tracks that can be seen in the foreground are part of the excavated area near the posted building permit.

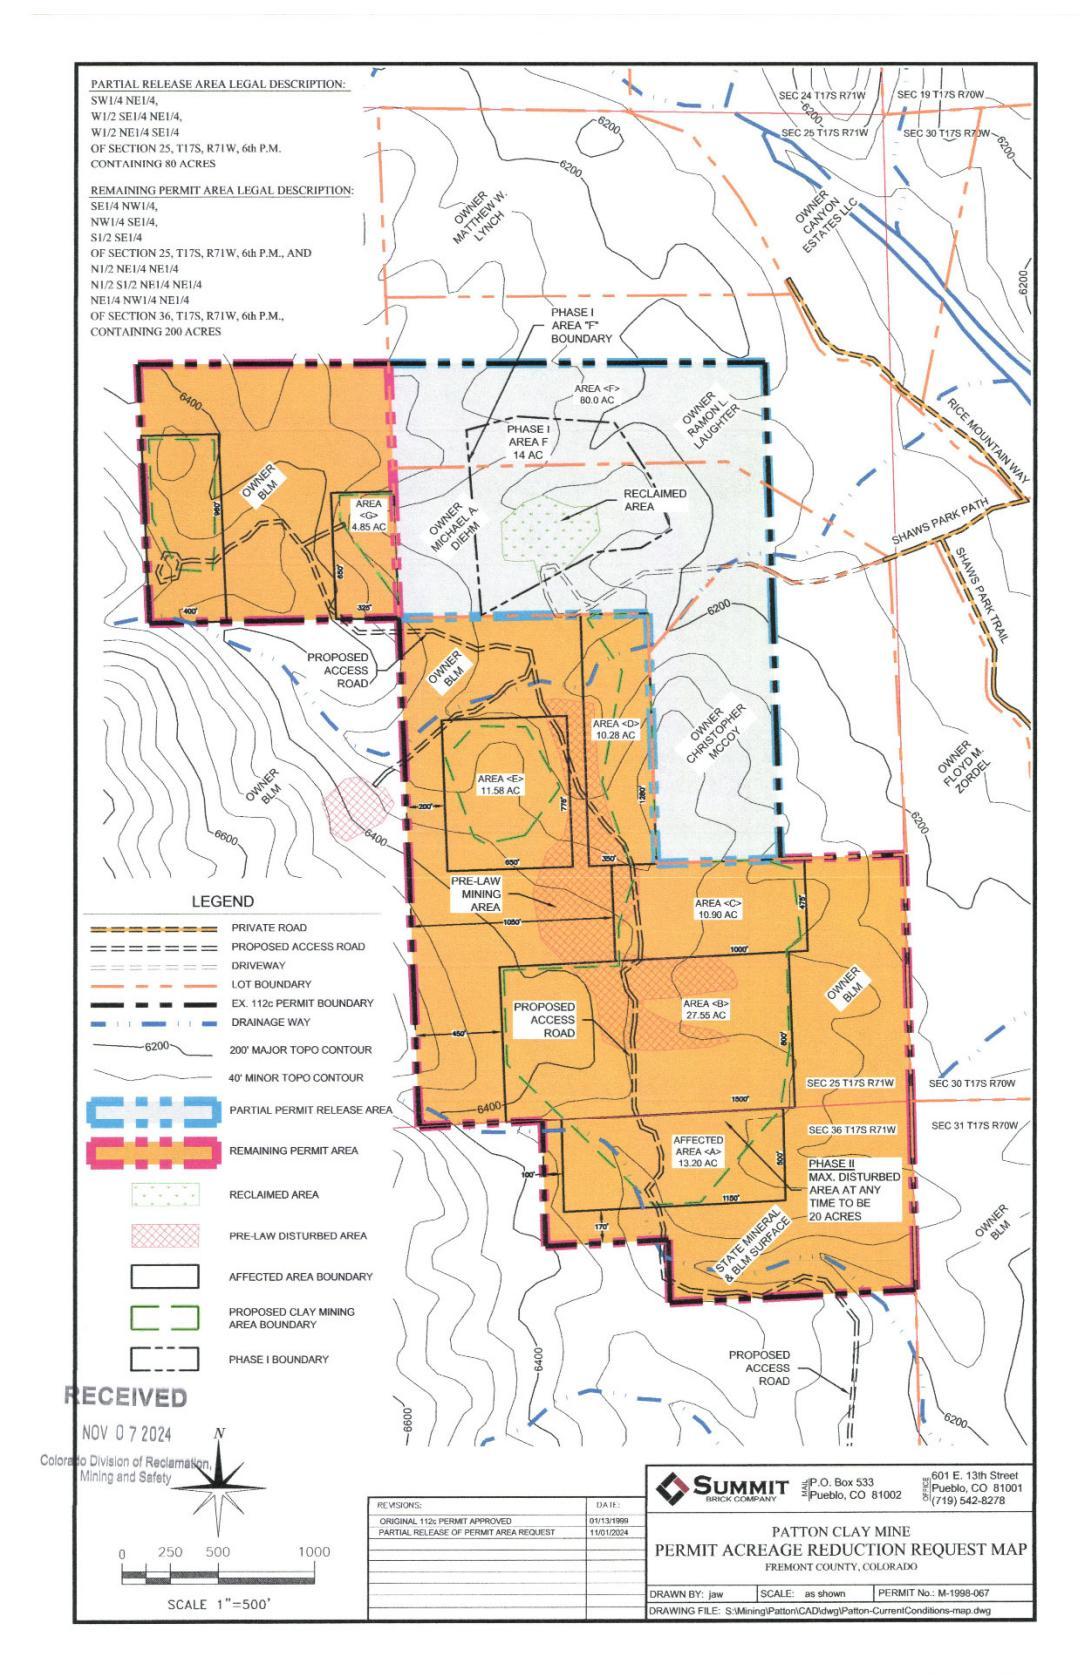
Map #2: The map that was submitted with the AR-1 application, for reference only.
