MINERALS PROGRAM INSPECTION REPORT PHONE: (303) 866-3567

MINE NAME:	MINE/PROSPECTING ID#:	MINERAL:	COUNTY:
90 Road Pit	M-2008-043	Sand and gravel	Montrose
INSPECTION TYPE:	WEATHER: Clear	INSP. DATE:	INSP. TIME:
Monitoring		February 5, 2025	12:30
OPERATOR:	OPERATOR REPRESENTATIVE:	TYPE OF OPERATION:	
Rocky Mountain Aggregate & Construction,	None	110c - Construction Limited Impact	
LLC			-

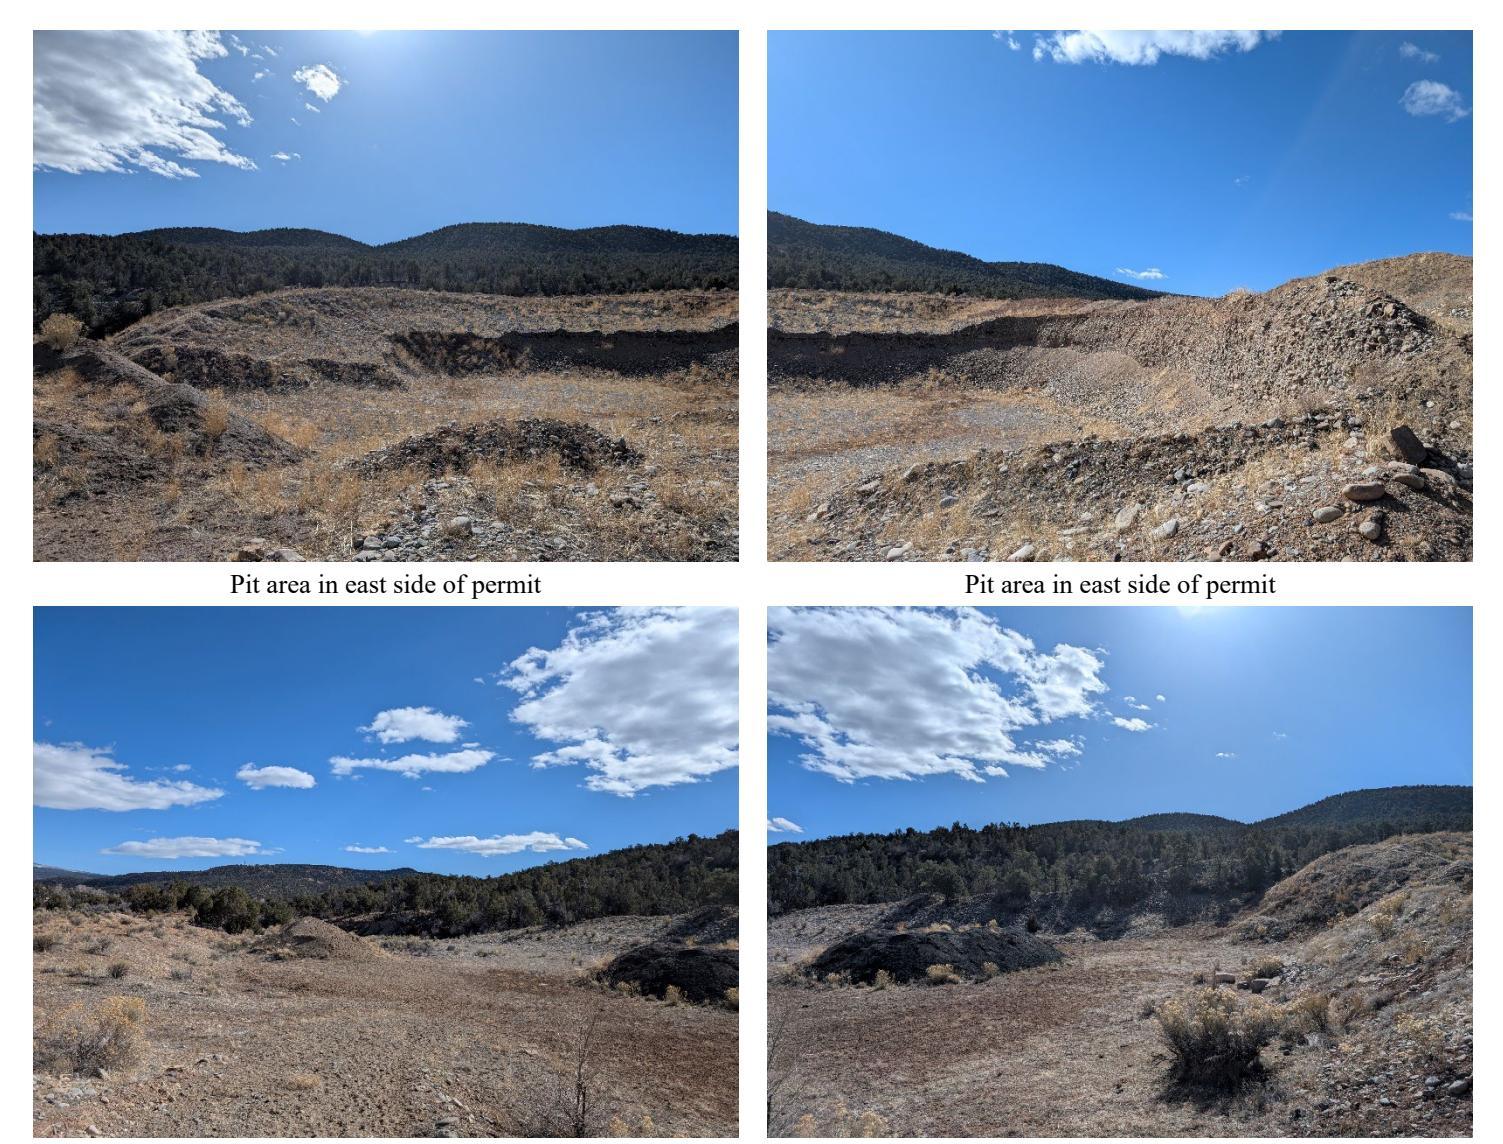
Small topsoil stockpile just near pit

Crushed asphalt stockpile near pit

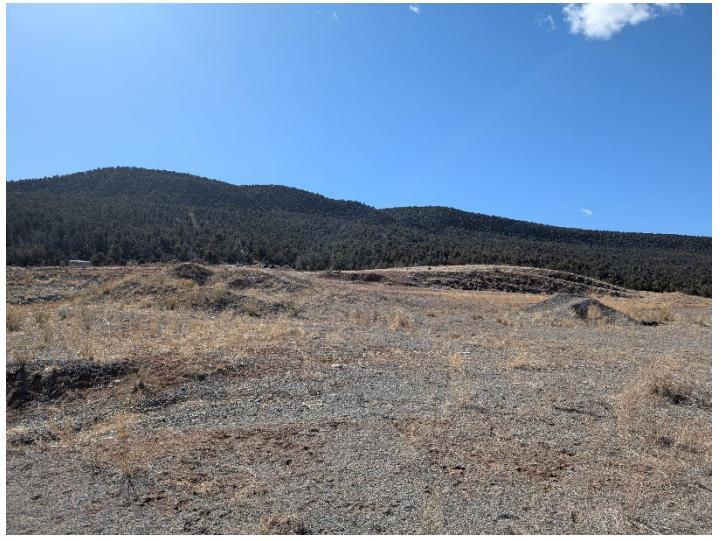
Stockpile area west of pit

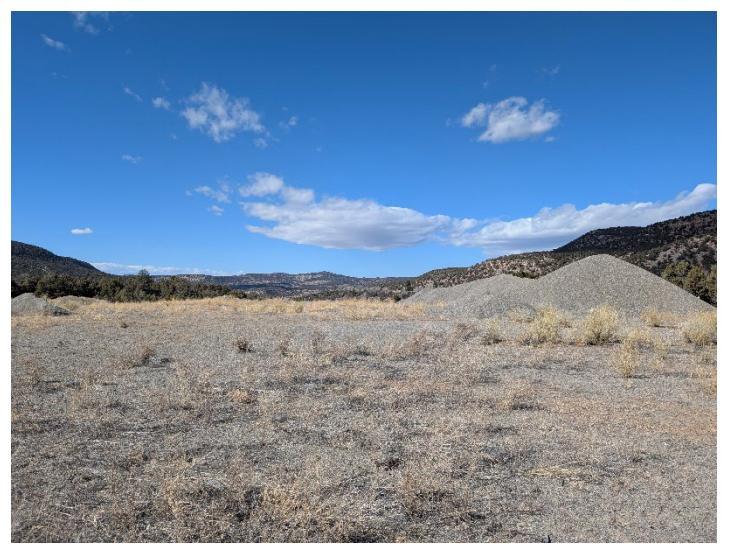
Stockpile area west of pit

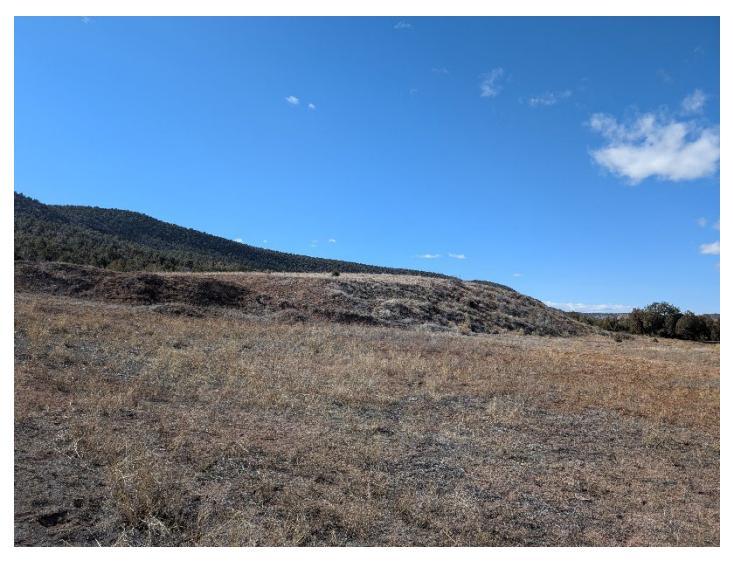
Overburden stockpile near site entrance

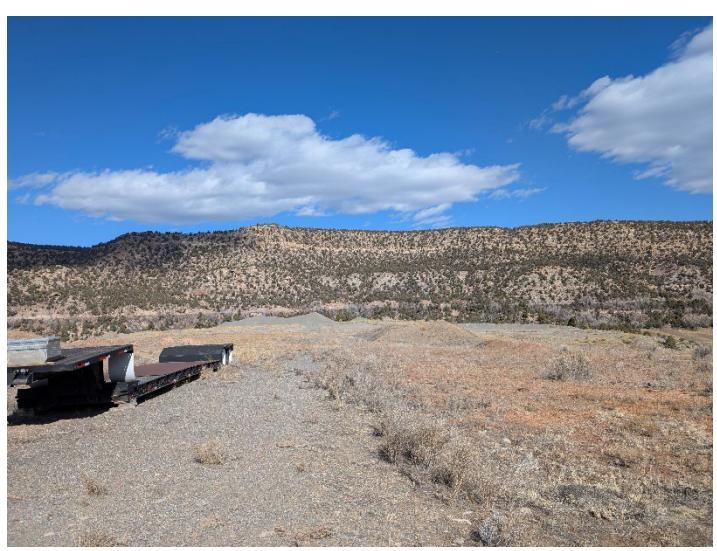
The mine identification sign was not posted at the entrance of the mine site. This is a problem for failure to post a mine identification sign as required by Section 3.1.12(1) of the rule. The Operator shall, at the entrance of the mine site, post a sign which shall be clearly visible from the access road, with a minimum size equaling one hundred and eighty-seven (187) square inches, such as eleven (11) inches in height and seventeen (17) inches in width, with appropriate font size, with the following: the name of the Operator, a statement that a reclamation permit for the operation has been issued by the Colorado Mined Land Reclamation Board; and the permit number. The operator shall submit photo documentation that a proper sign has been posted by April 11, 2025.

View from site entrance

CORRECTIVE ACTIONS: The operator shall, at the entrance of the mine site, post a sign which shall be clearly visible from the access road with the following: the name of the operator, a statement that a reclamation permit for the operation has been issued by the Colorado Mined Land Reclamation Board; and the permit number. The operator shall submit photo documentation that a proper sign has been posted by the corrective action date.
