MINERALS PROGRAM INSPECTION REPORT PHONE: (303) 866-3567

MINE NAME:		MINE/PROSPECTING ID#:	MINERAL:	COUNTY:
Cooley Reservoir & Fulton Wildlife Area		M-1999-034	Sand and gravel	Adams
INSPECTION TYPE:		WEATHER: Clear	INSP. DATE:	INSP. TIME:
Surety Release Inspection			March 28, 2025	10:30
OPERATOR:		OPERATOR REPRESENTATIVE:	TYPE OF OPERATION:	
Holcim - WCR, Inc.		Wyatt Webster, Holcim, and	112c - Construction Regular Operation	
		Jason Helms, City of Thornton		
REASON FOR INSPECTION:		BOND CALCULATION TYPE:	BOND AMOUNT:	
Surety Release Requested		None	\$1,510,800.00	
DATE OF COMPLAINT:		POST INSP. CONTACTS:	JOINT INSP. AGENCY:	
NA		None	None	
INSPECTOR(S):	INSPECTOR'S SIGNATURE:		SIGNATURE DATE:	
Nikie Gagnon			April 11, 2025	
	Aikie Gagnon

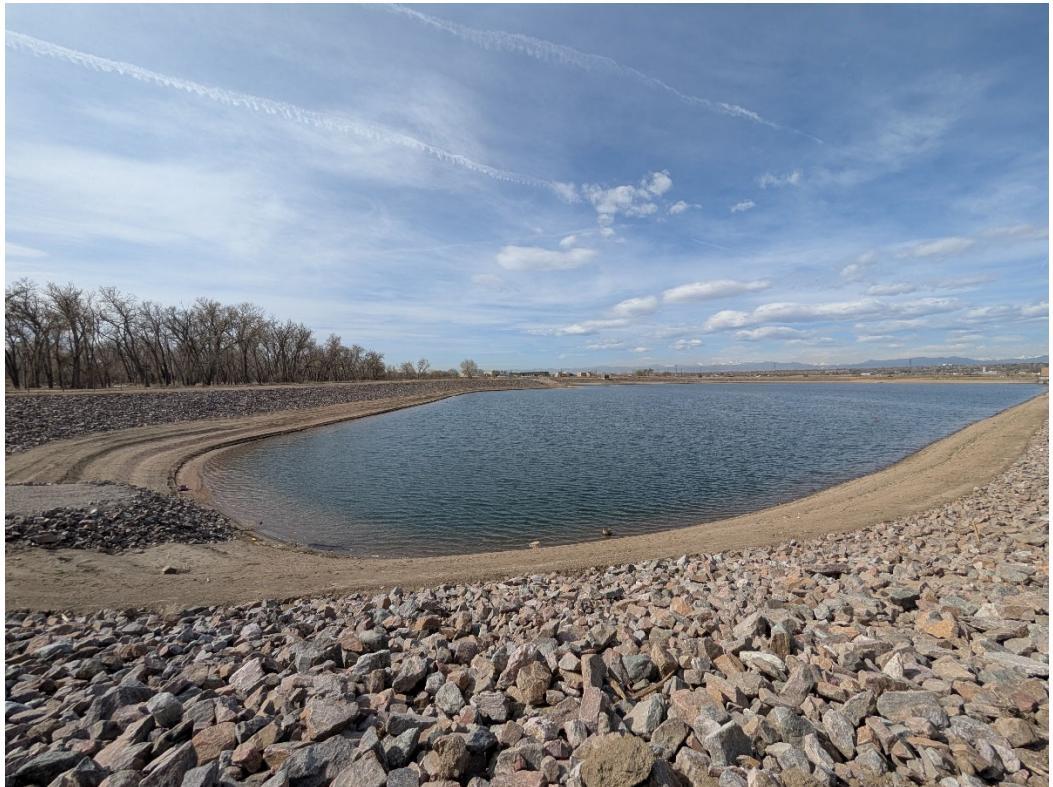
Photo 1: Looking from the northeast corner of the South Cell, rip rap placed above the water line on the eastern and northern slopes.

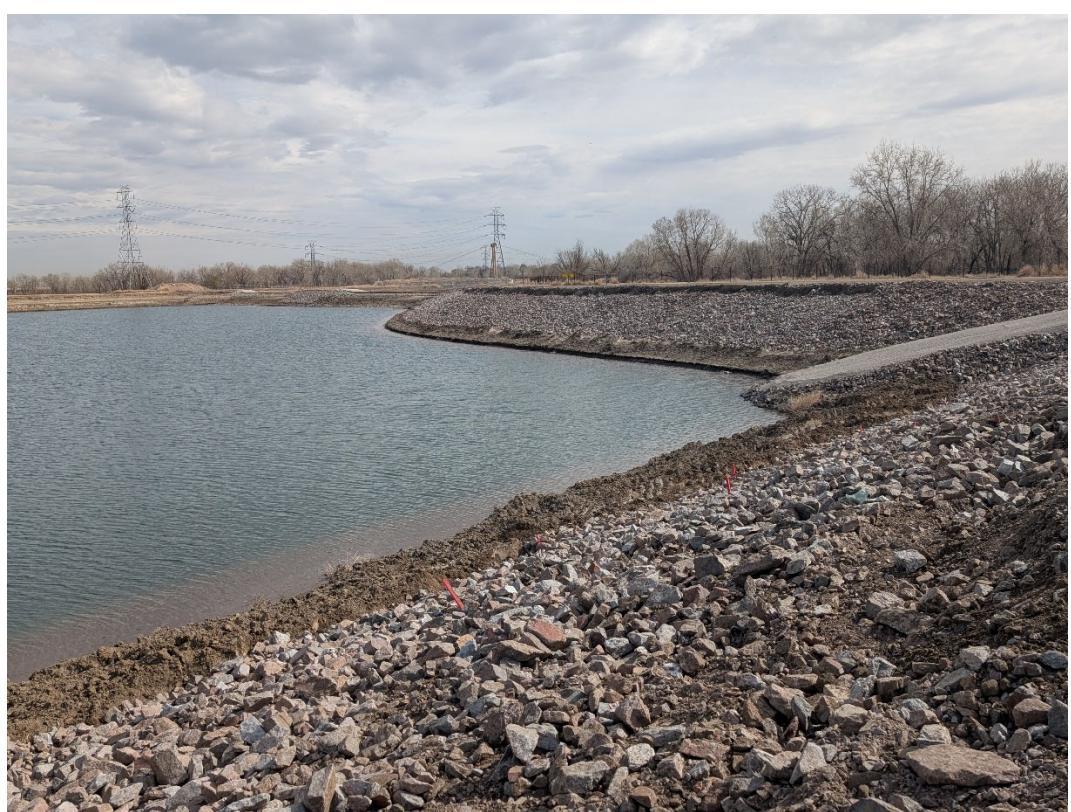
Photo 2: Looking from the southeast corner of the Middle Cell, rip rap placed above the water line on the southern and eastern slopes.

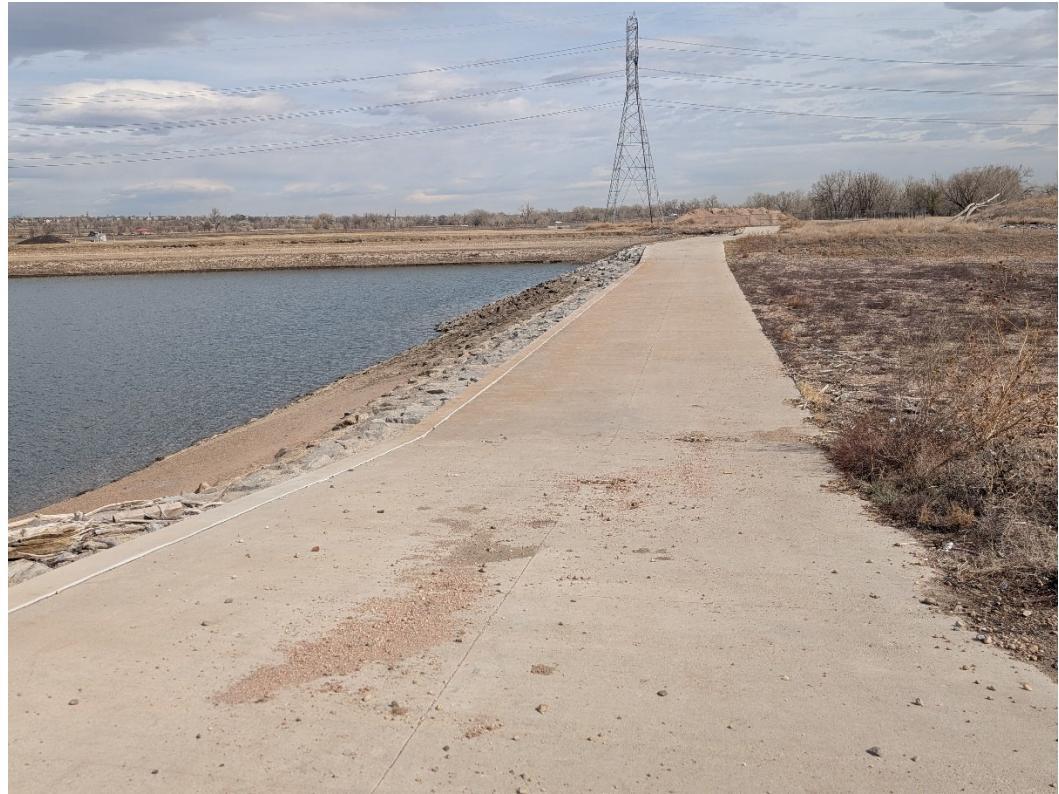
Photo 3: Looking across the repaired spillway on the western side of the Middle Cell.

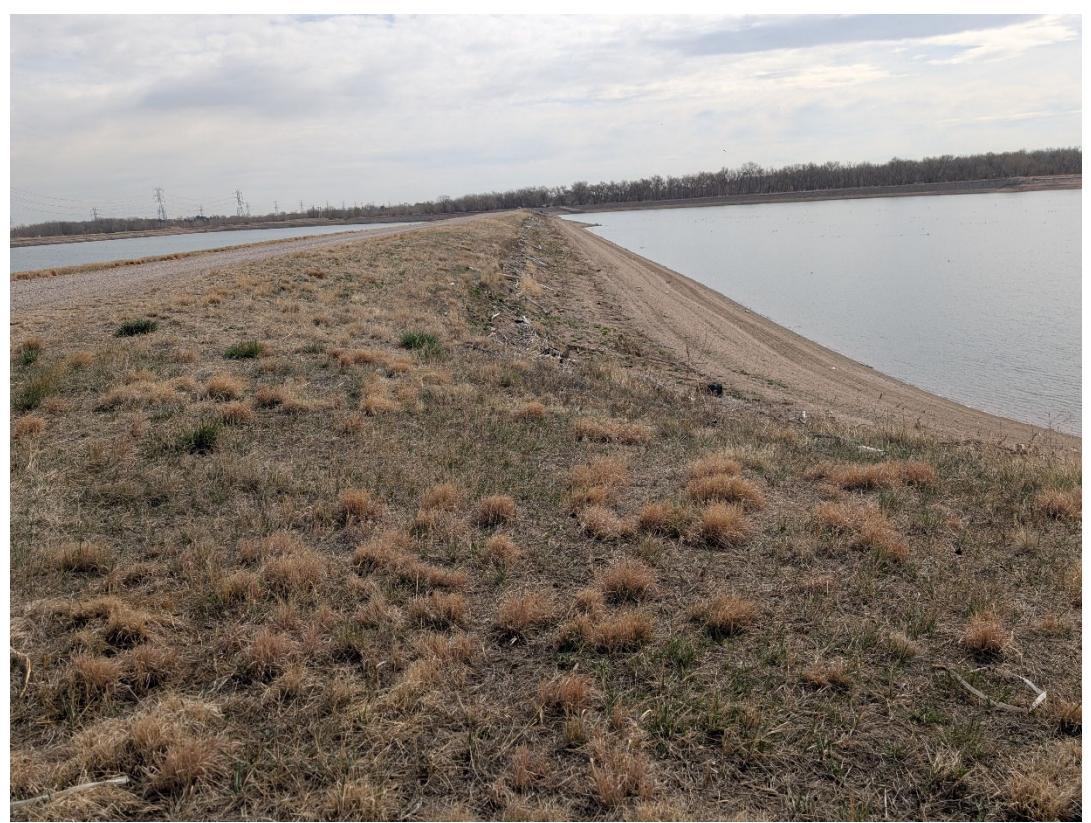
Photo 4: Looking at the slopes and vegetation on the northern side of the South Cell.

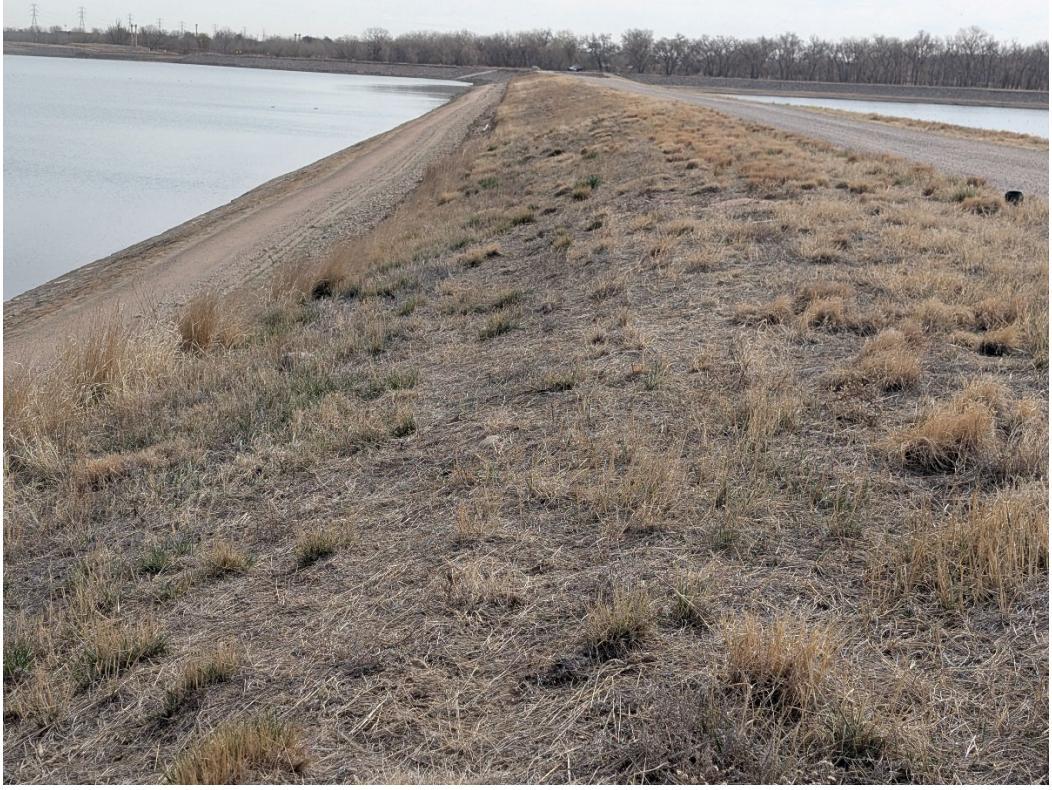
Photo 5: Looking at the slopes and vegetation on the southern side of the Middle Cell.

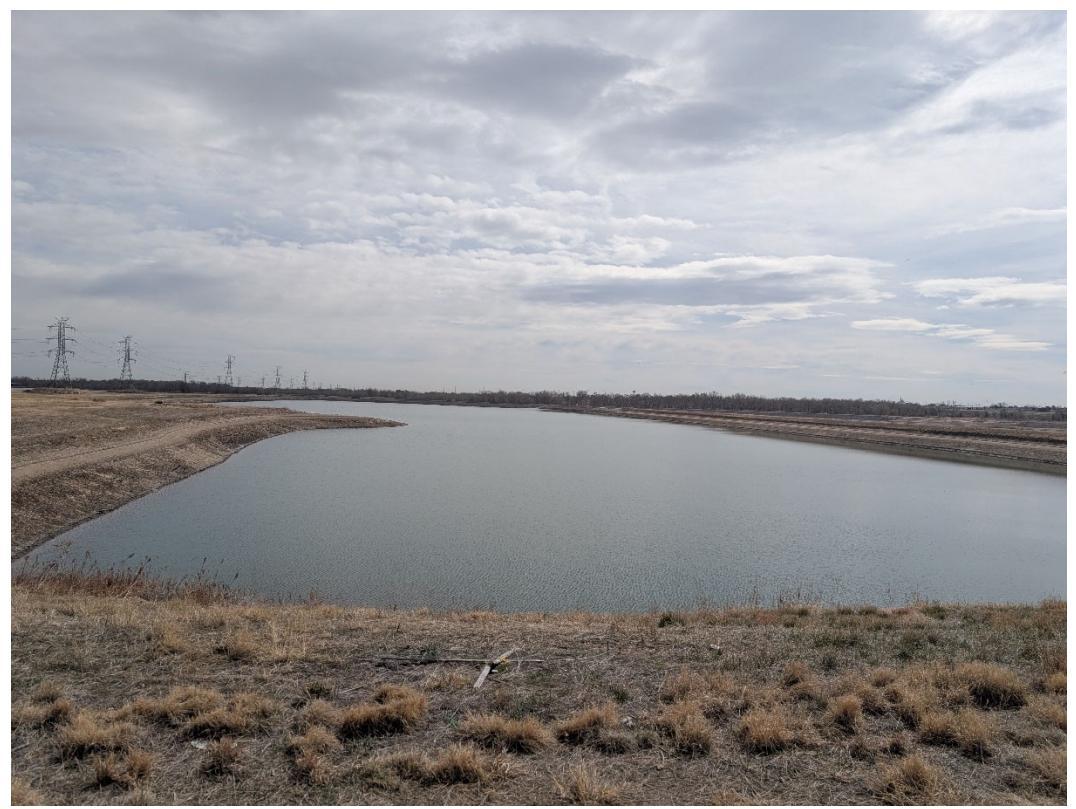
Photo 6: Looking at vegetation and sloping across the Middle Cell from the west end.

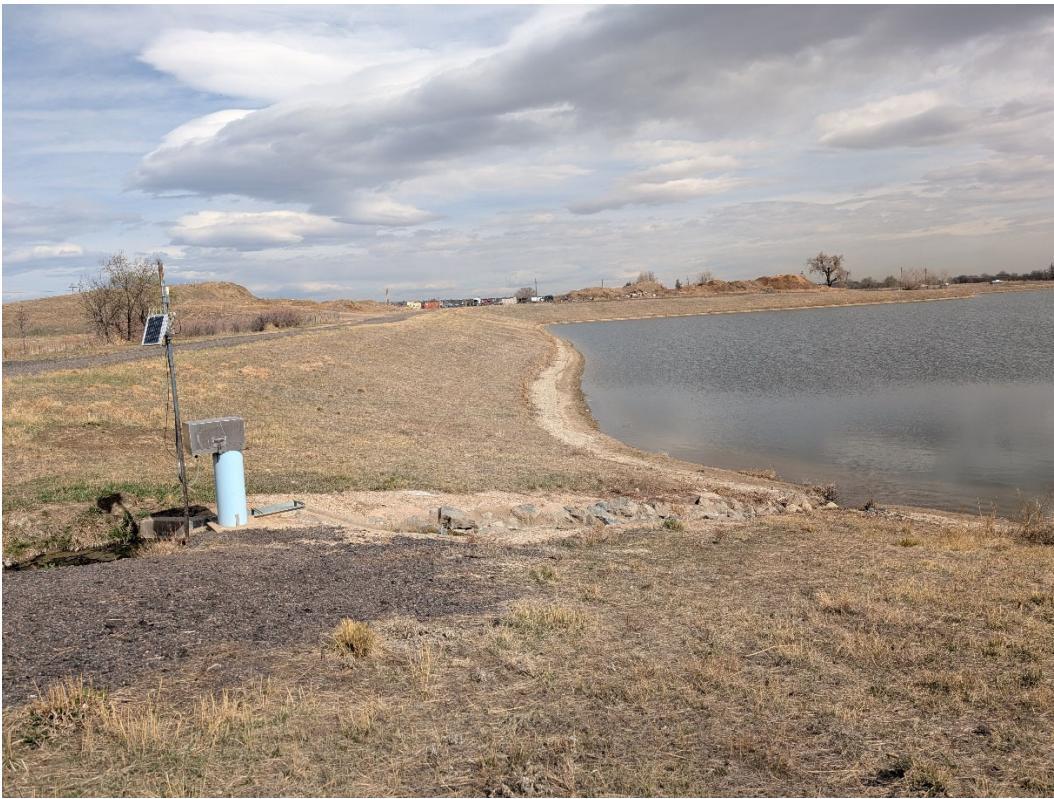
Photo 7: Looking at vegetation and sloping on the west end of the North Cell.

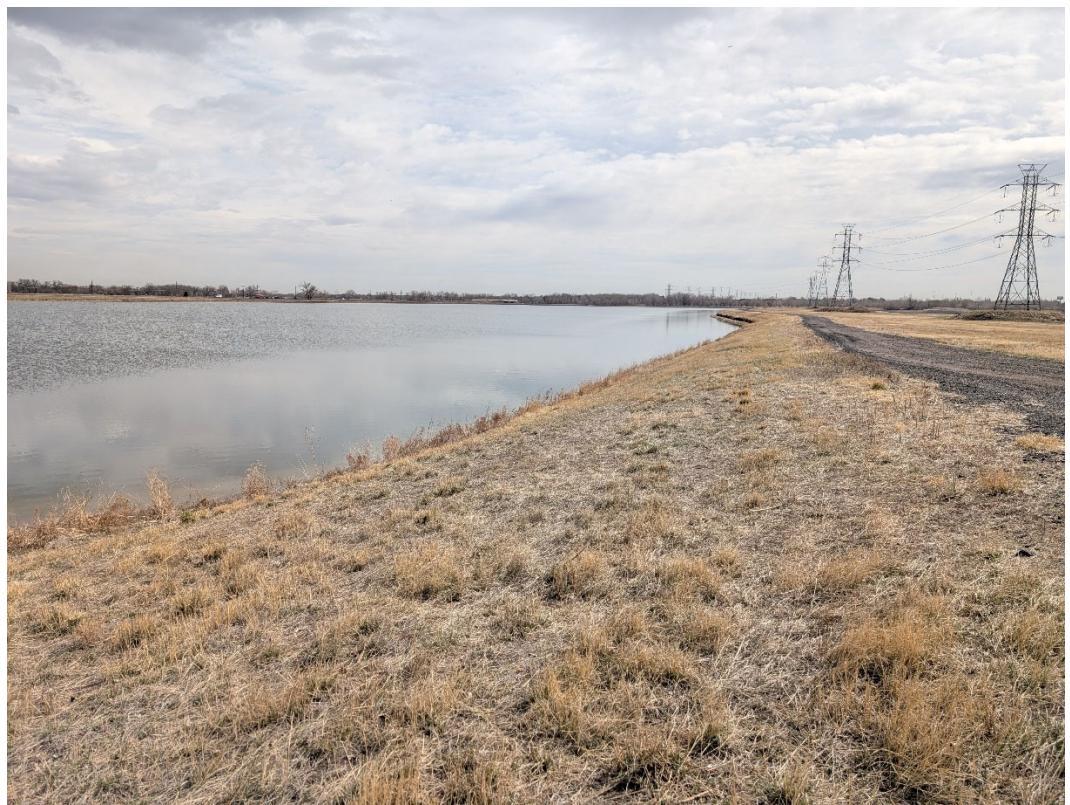
Photo 8: Looking at vegetation and sloping along the southern bank of the North Cell.

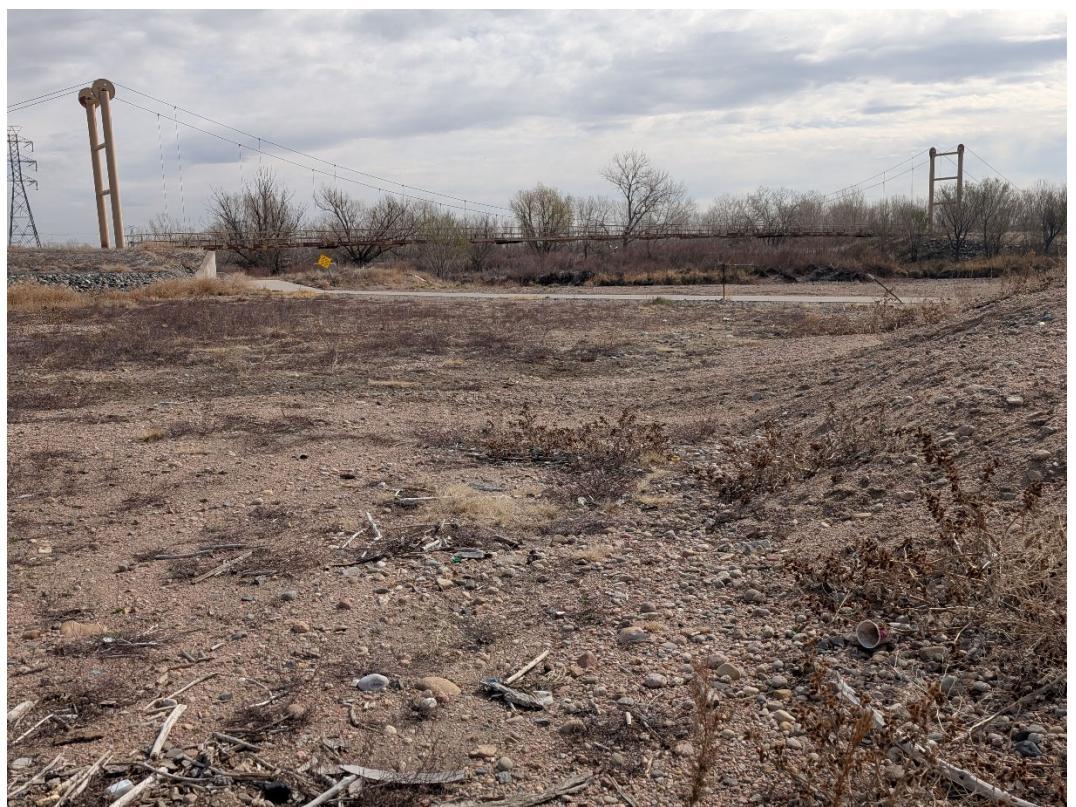
During the inspection, the Division observed a conveyor crossing the South Platte River from the east side of the permit area to the northeast corner of the Middle Cell, adjacent to the spillway. This conveyor will need to be removed prior to seeking a release of the east side of the permit area. After the inspection, the operator submitted new maps and revised the release area to leave the conveyor corridor in the remaining permit area. The acres for this release have been adjusted to 271.15 rather than the original request for 276.15 acres.

Photo 9: Standing in the spillway on the western side of the Middle Cell looking at the conveyor structure still in place across the South Platte River. The operator will need to remove this to release the east side of the permit area.
