MINERALS PROGRAM INSPECTION REPORT PHONE: (303) 866-3567

MINE NAME:	MINE/PROSPECTING ID#:	MINERAL:	COUNTY:
Olathe Pit	M-1984-108	Sand and gravel	Montrose
INSPECTION TYPE:	WEATHER:	INSP. DATE:	INSP. TIME:
Monitoring	Clear	April 2, 2025	14:00
OPERATOR:	OPERATOR REPRESENTATIVE:	TYPE OF OPERATION:	
Western Gravel, Inc.		110c - Construction Limited Impact

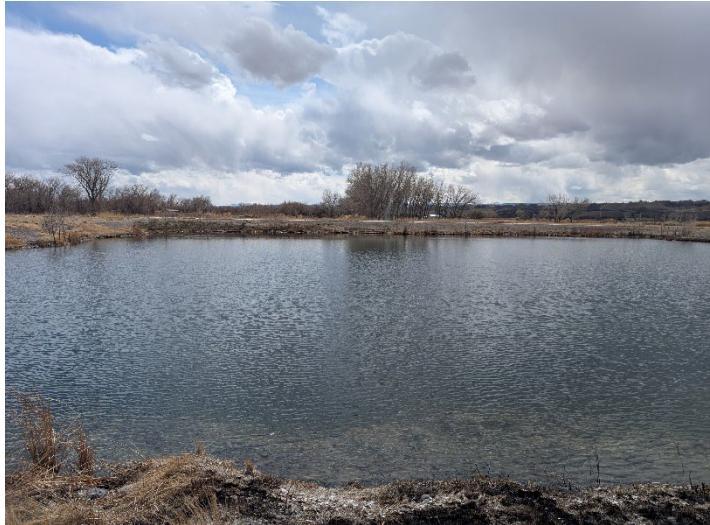
South Pond

PROBLEM/POSSIBLE VIOLATION: Problem: The site has been in final reclamation for greater than 5 years. The area around the south pond has not been adequately revegetated to meet the requirements of Rule 3.1.10. This is a possible violation of Rule 3.1.3 for failure to complete reclamation within 5 years.

CORRECTIVE ACTIONS: Additional revegetation efforts are necessary. The operator shall perform secondary seeding in accordance with the approved Reclamation Plan. The operator shall notify the Division in writing when secondary seeding has been completed.
