PITCH RECLAMATION PROJECT COLORADO MINED LAND RECLAMATION BOARD 2024 ANNUAL RECLAMATION REPORT

RECLAMATION PERMIT NUMBER M-1977-004

April 2025

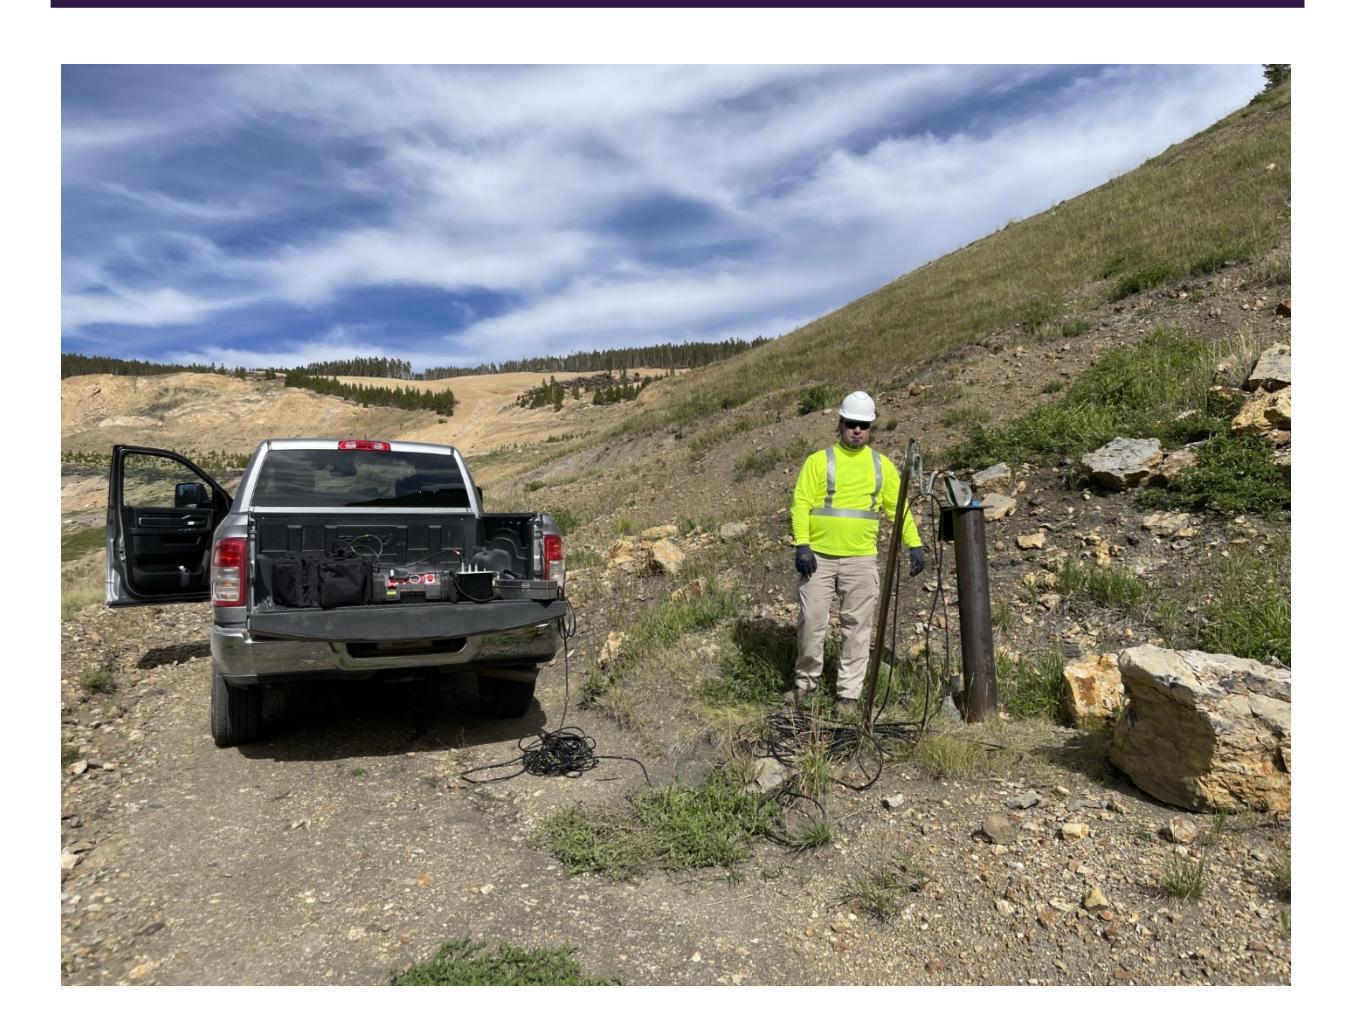
Photograph 1: Readings from inclinometer I98-1
