Holcim - WCR, Inc.

Lyons Quarry

File #: M-1977-141

112c Reclamation Permit Operations
Technical Revision

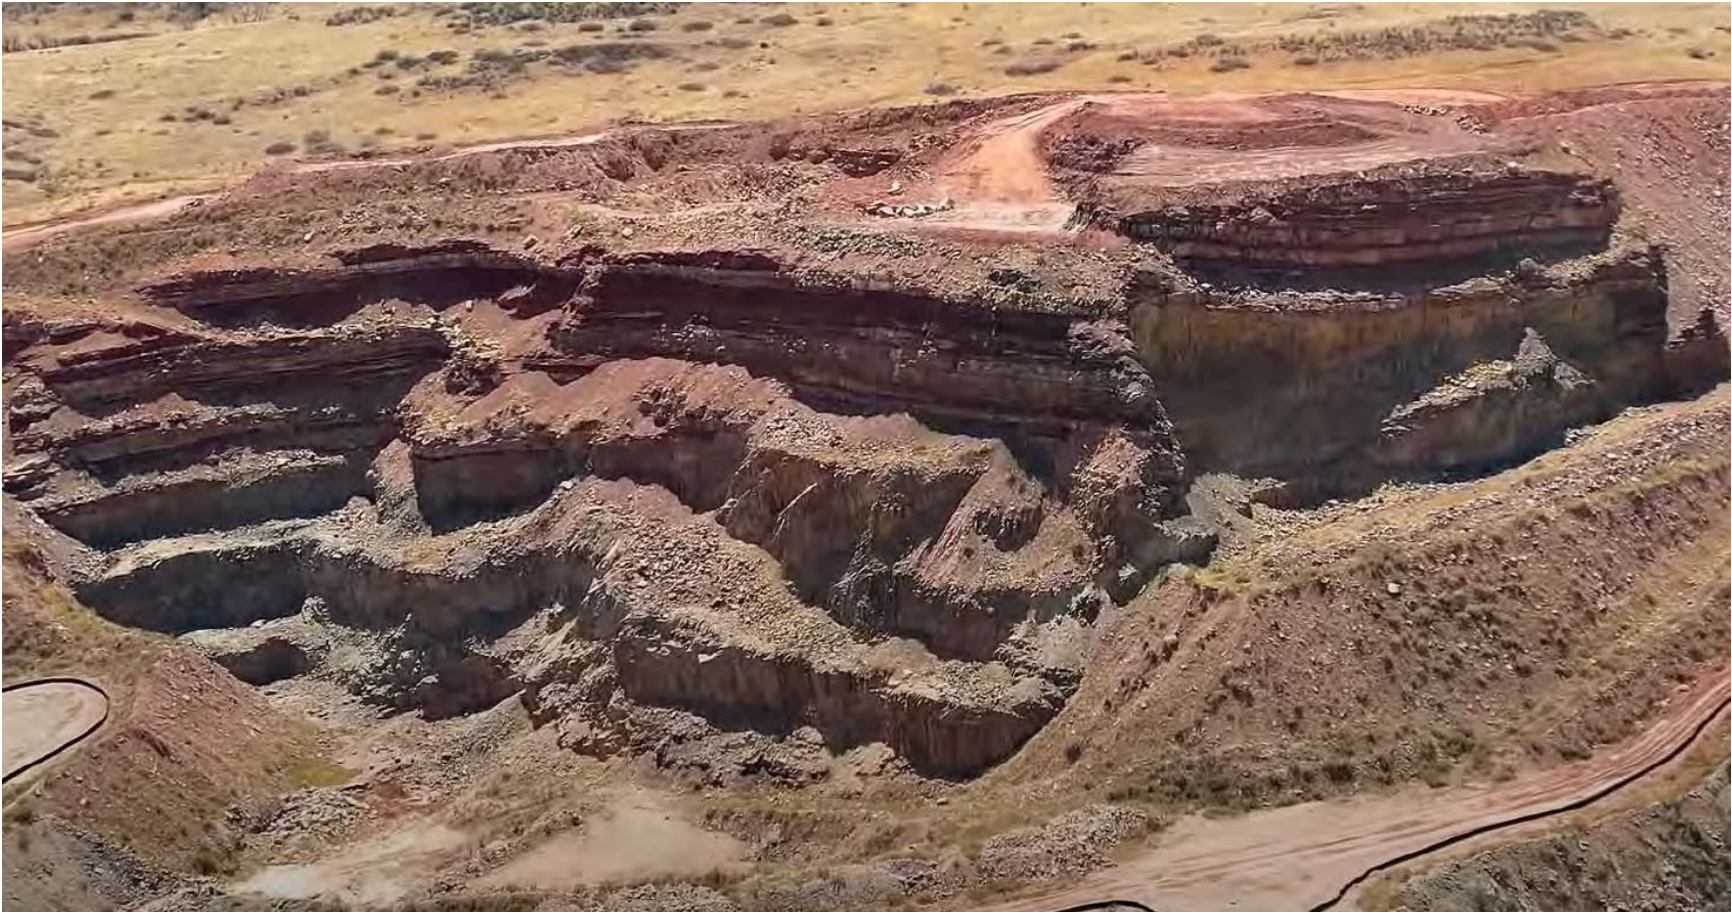
Figure 5 – Lyons Quarry Aerial April 2022

Northeast dacite face fully exposed prior to blasting of overburden

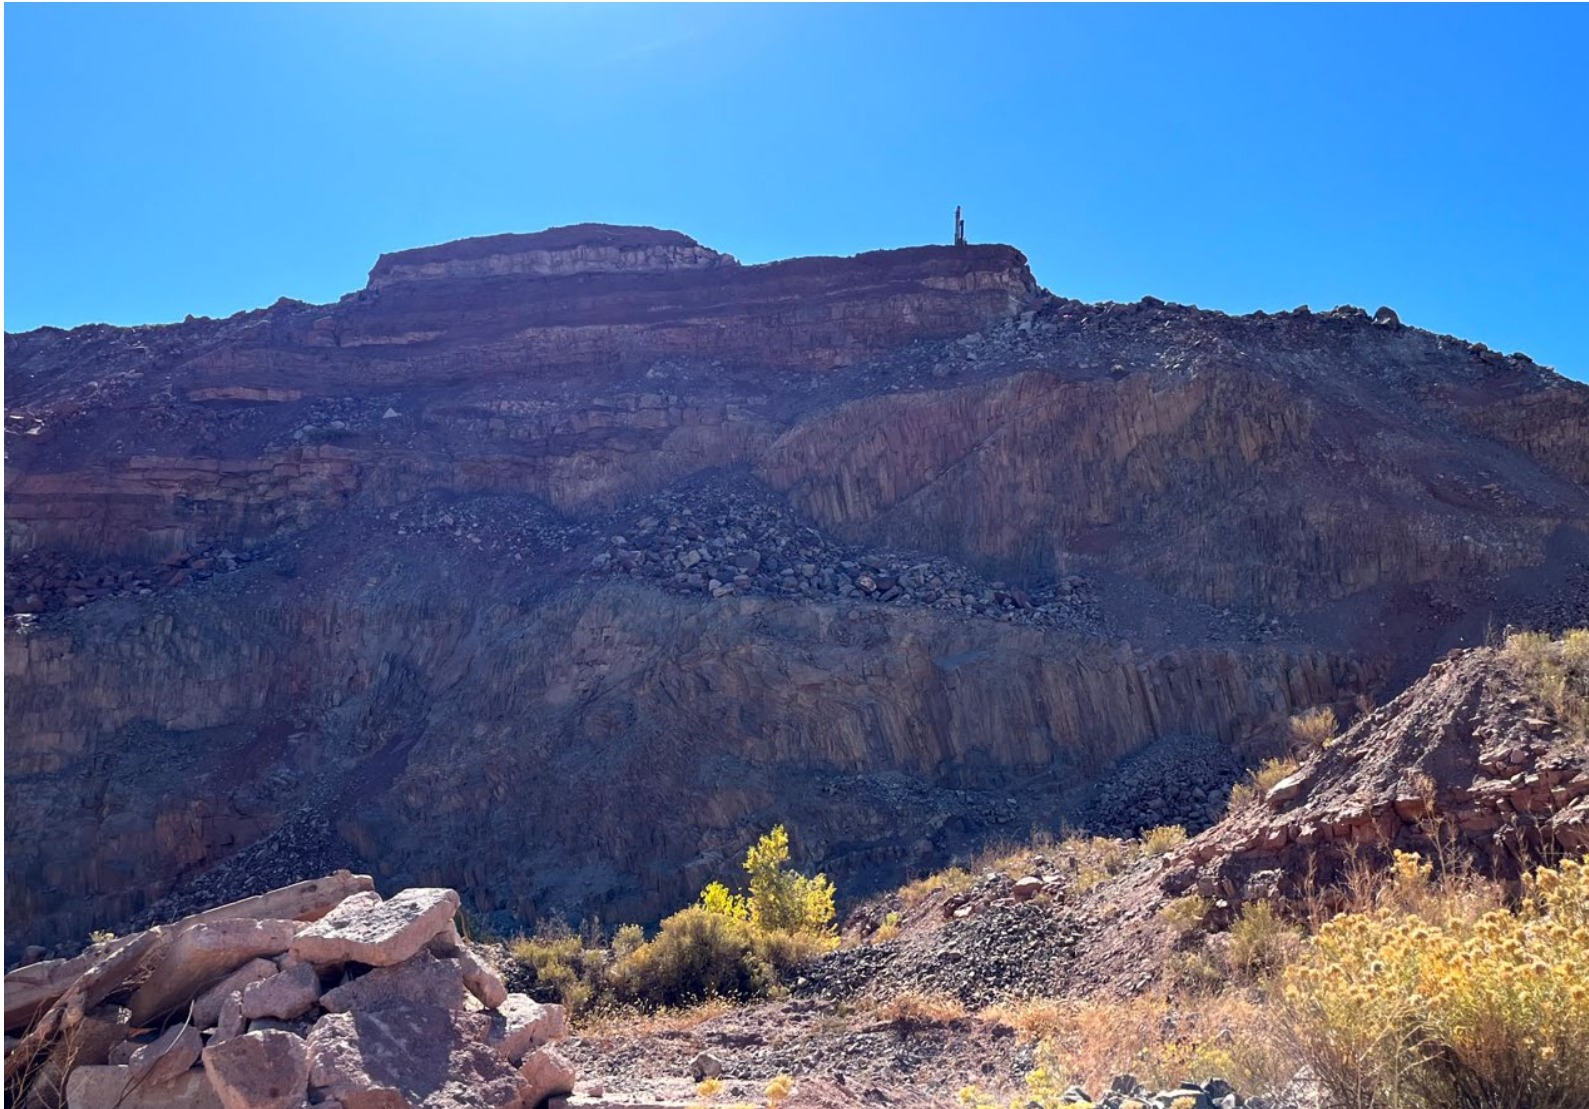
Figure 6 – Northeast Highwall October 2022

As blasting and excavation operations progressed on the sandstone overburden of the highwall very minimal blast material was accumulated on the benches, and it was anticipated that rock scaling and reinforcement following excavation would occur (see **Attachment A - Figure 5** for an aerial image from July 2022 showing site conditions five months after the start of blasting). In October 2022 most of the dacite was still visible (**Attachment A – Figure 6**) though some rock had accumulated.

Dacite formation still exposed throughout most of highwall after majority of blasting was completed.

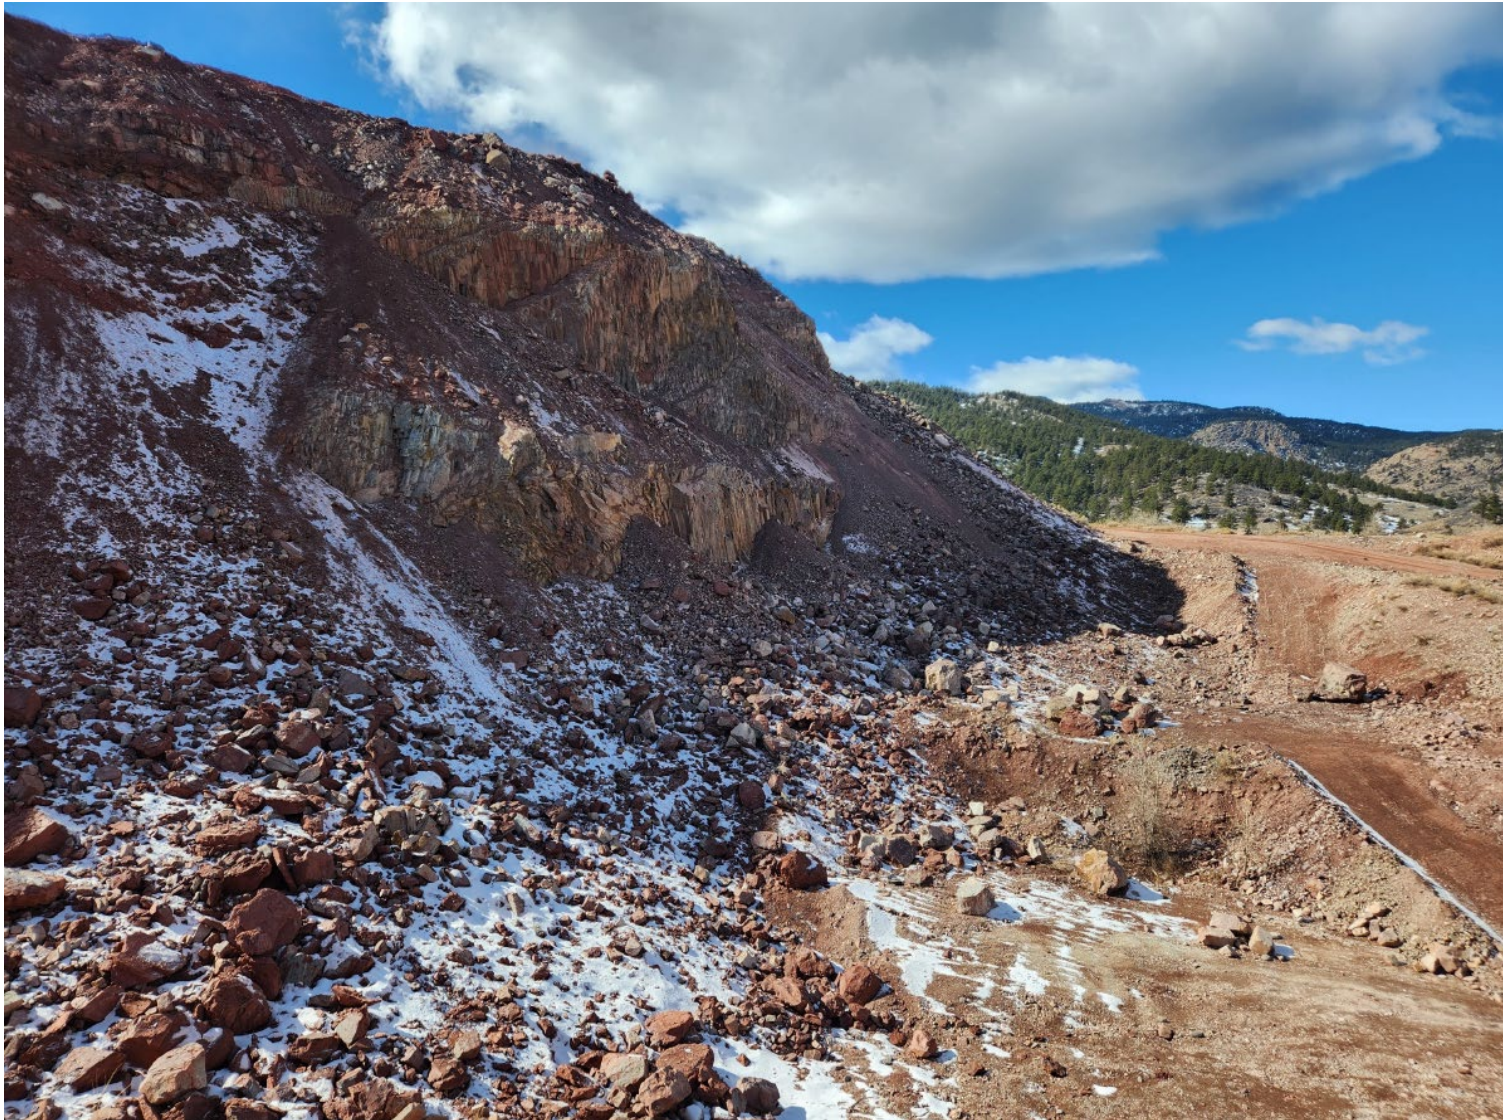
Figure 7 – Northeast Highwall December 2022

Dacite formation mostly covered by blast rock accumulation at toe and built up at angle of repose.

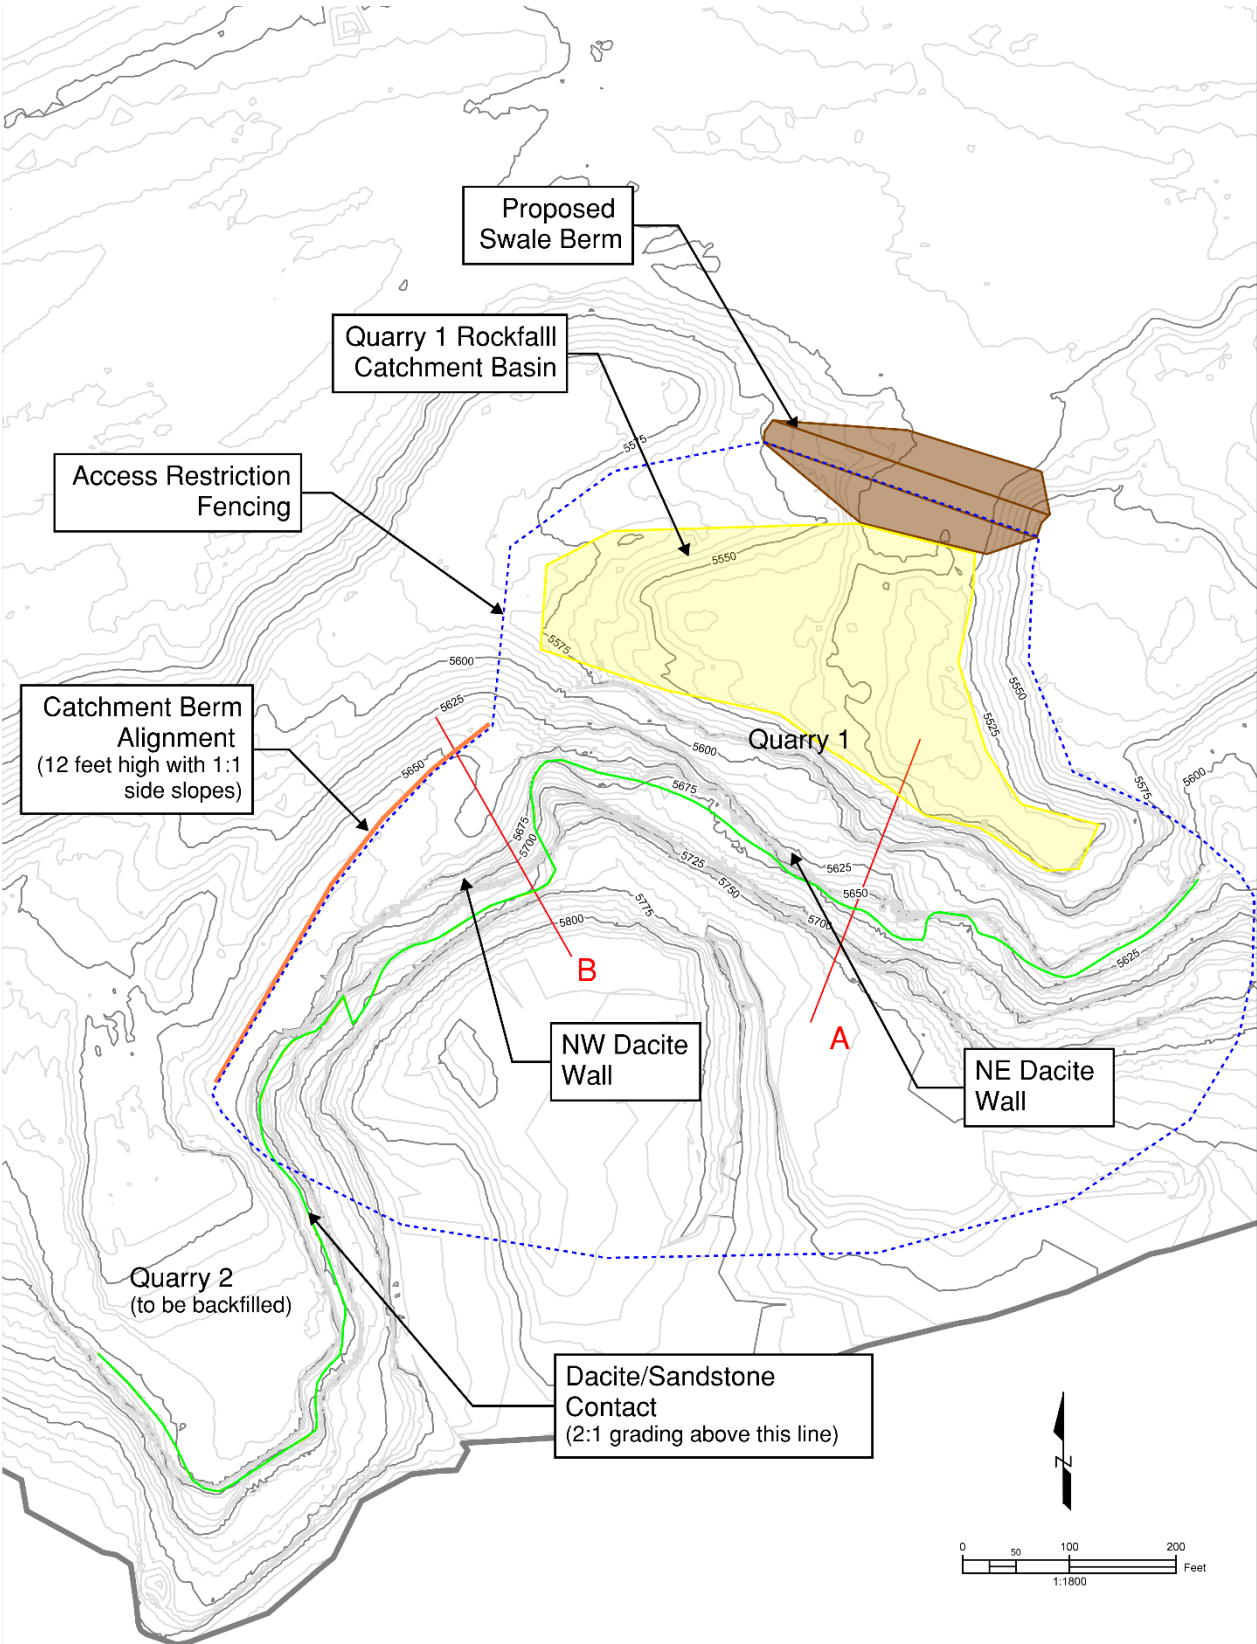
Figure 8 – Rockfall Catchment Basins and Berms, (Attachment E-2, Figure 1)

Based on the recommendations above and inherent safety issues that limit safe access the highwall face to install ground controls, it is proposed that the Ground Controls included in TR-05 be removed from the reclamation plan. The rockfall catchment berms designed under TR-05 have been installed to specifications with only minor deviations in the placement of the northwest catchment berm based on slope configurations. The geotechnical engineers reviewed the as-built files for this catchment berm and included its placement into the modeling for the analyses.
