MINERALS PROGRAM INSPECTION REPORT PHONE: (303) 866-3567

MINE NAME:	MINE/PROSPECTING ID#:	MINERAL:	COUNTY:
Skold Pit	M-1998-032	Gravel	Sedgwick
INSPECTION TYPE:	WEATHER:	INSP. DATE:	INSP. TIME:
Monitoring	Clear	March 25, 2025	12:50
OPERATOR: Sedgwick County	OPERATOR REPRESENTATIVE: Kacey Campbell, Bob Coty	TYPE OF OPERATION: 110c - Construction Limited Impact

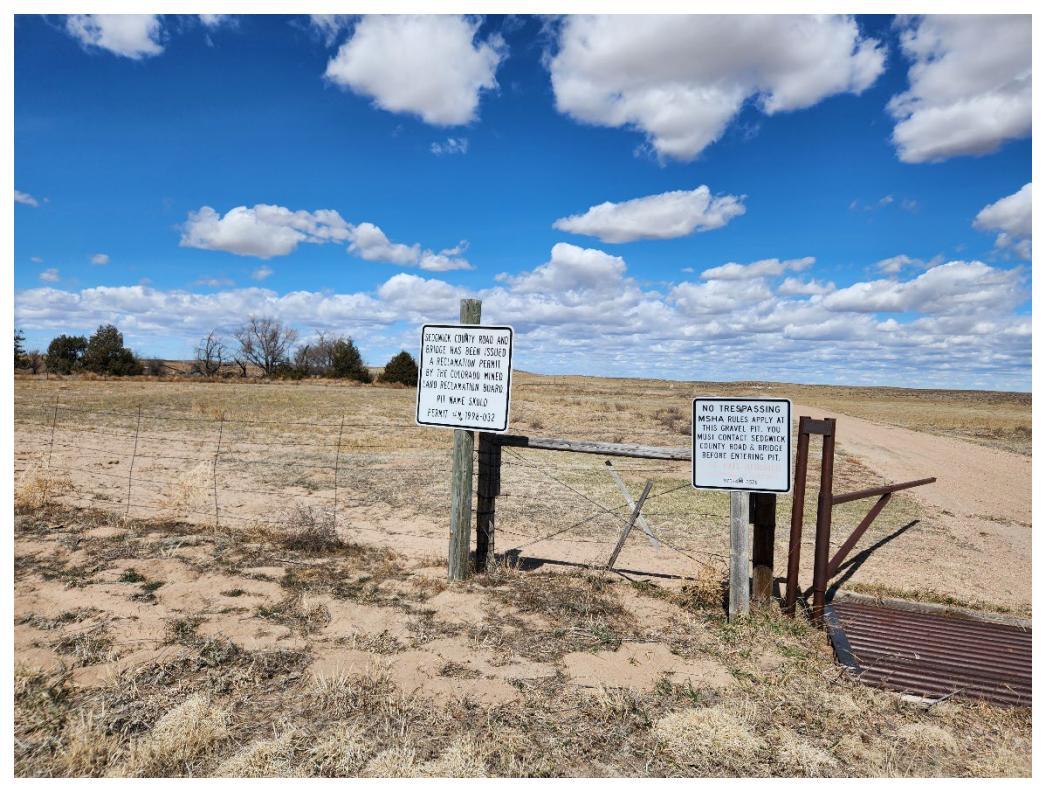
Photo 1. Mine entrance sign, looking north.

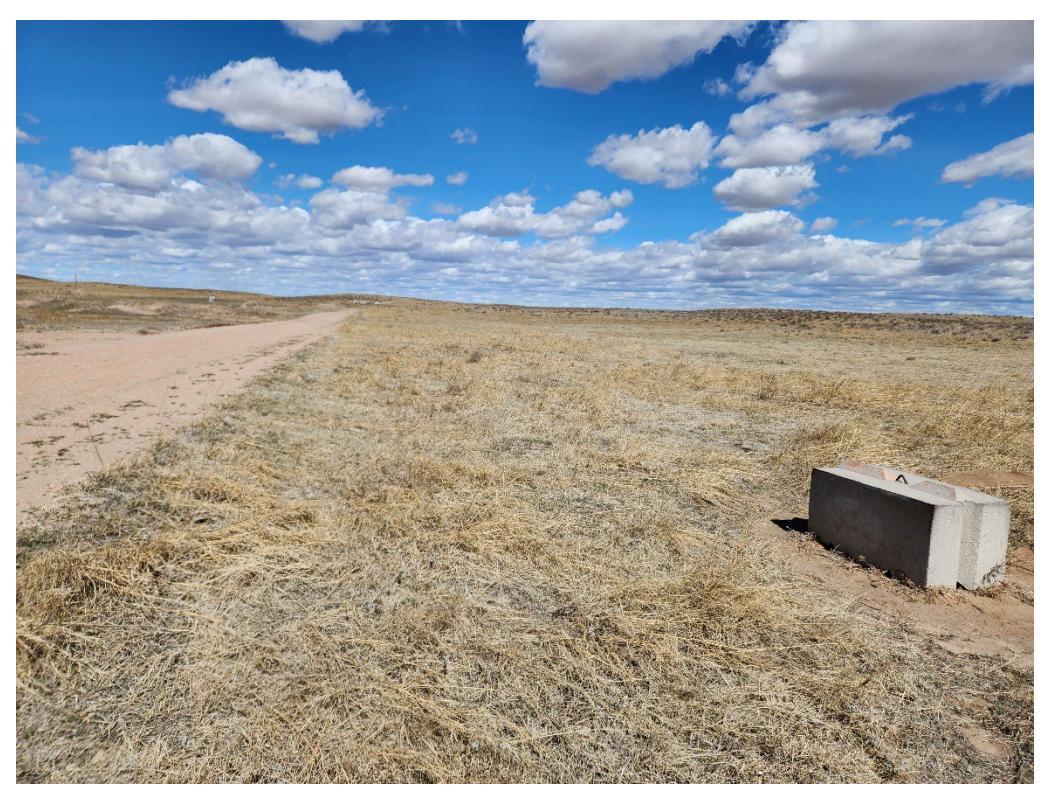
During the inspection, several structures that might serve as permit boundary markers were noted. Some cement blocks were positioned in the vicinity of where a corner boundary marker would be expected. Additionally, there were tire markers with metal posts placed nearby the cement blocks. However, it was unclear to both the Division and the operator which markers actually indicated the permit boundary. <u>This ambiguity has been cited as a problem in the inspection report. By the corrective action due date, new permit boundary markers must be installed in the correct locations, and photographic evidence of this must be submitted to the Division.</u>

Photo 2. Possible southeast permit boundary corner marked by concrete block, looking north.

PROBLEM: The affected area boundary markers are missing or incorrectly placed. This is a problem for failure to maintain boundary markers around the affected area as required by Section 3.1.12(2) of the rule. **CORRECTIVE ACTIONS:** The operator shall conduct a survey and replace the boundary markers in the correct location(s). The operator shall provide the boundary marker coordinates and photographic proof to the Division that this has been done by the corrective action date.

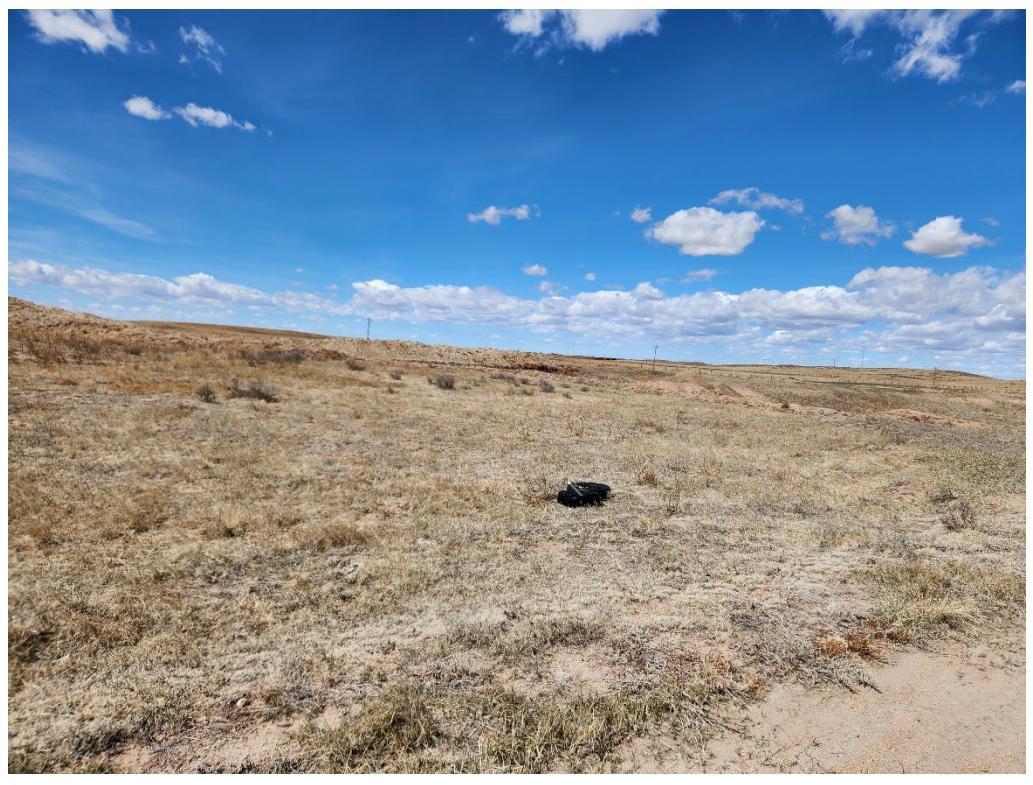
Photo 3. Possible southeast permit boundary corner marked by tires and metal posts, looking north.

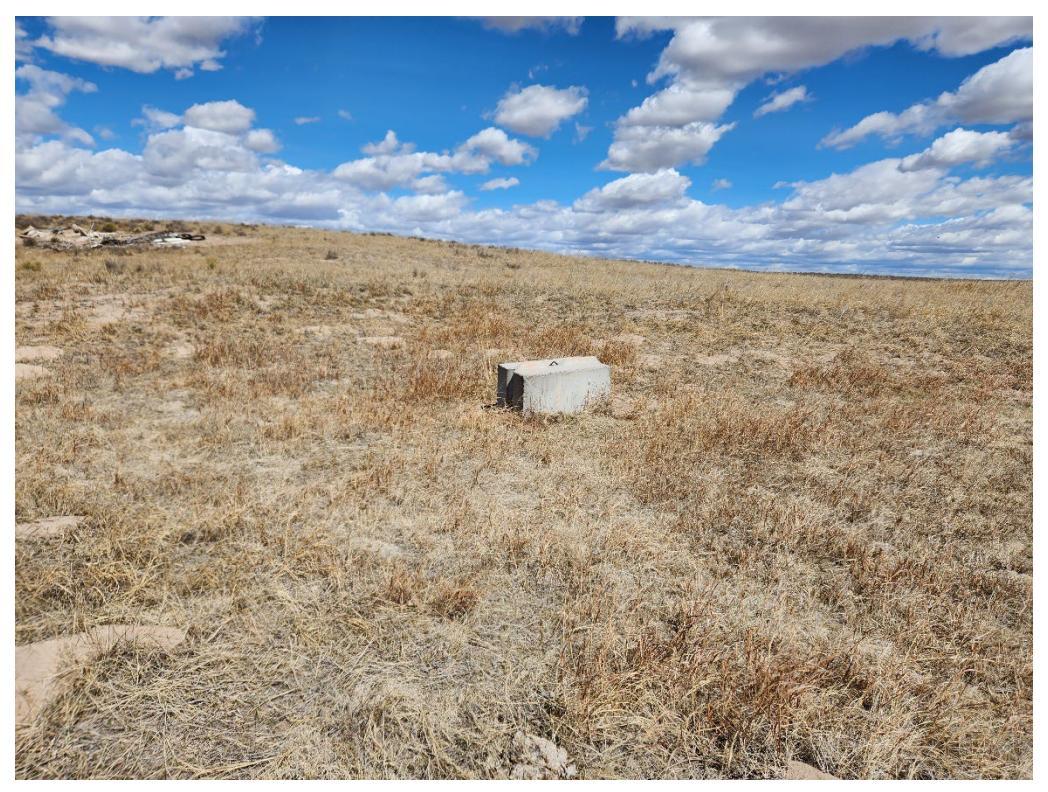
Photo 4. Concrete block possibly marking the northeast boundary corner, looking northeast.

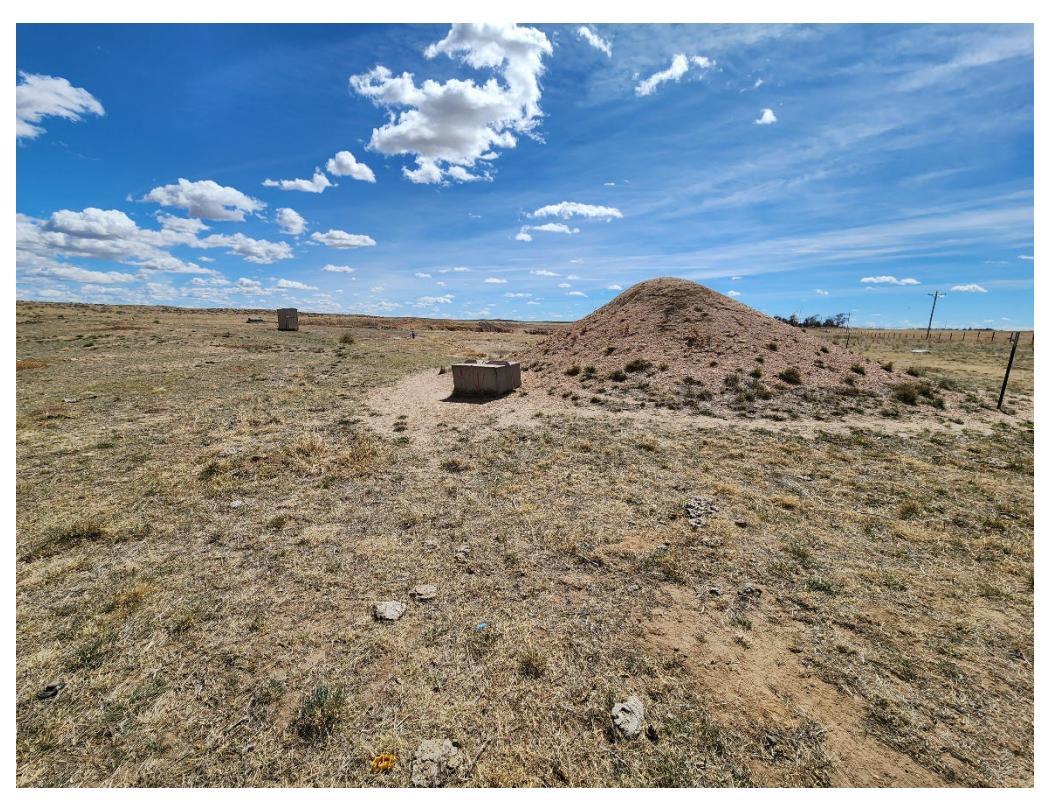
Photo 5. Concrete block in the northwest corner, possibly marking the boundary corner. The topsoil stockpile is located next to it, looking south.

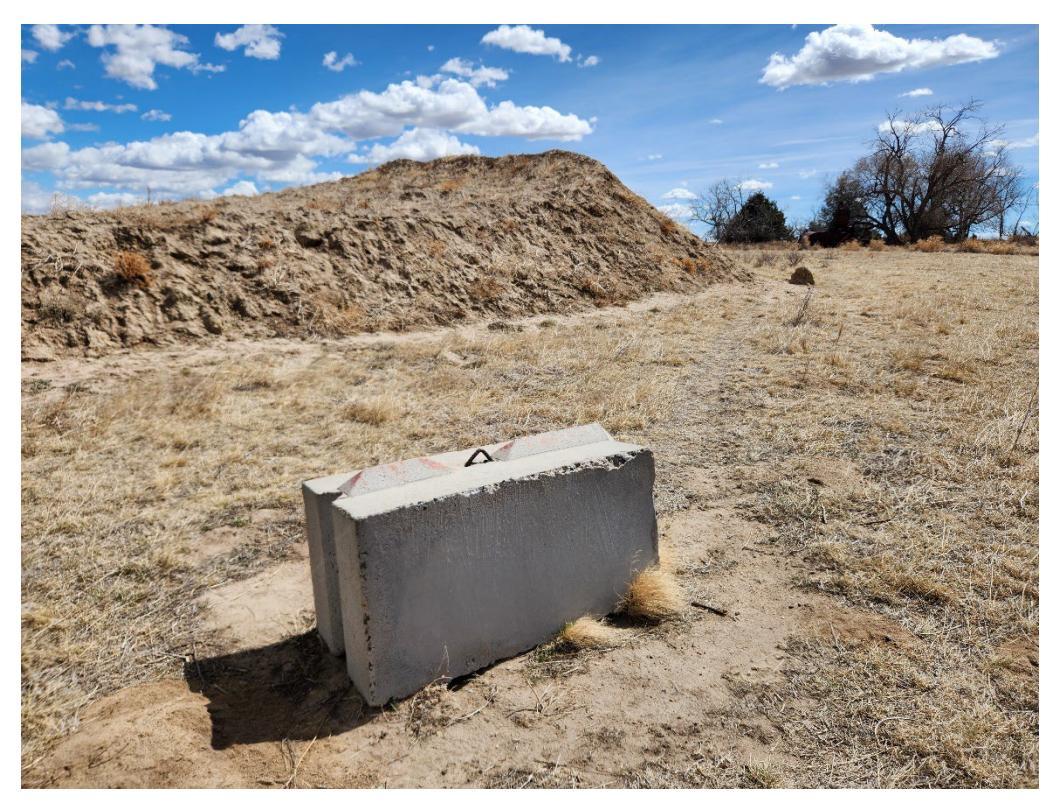
Photo 6. Concrete block in the southwest corner, possibly marking the permit boundary corner, looking south.

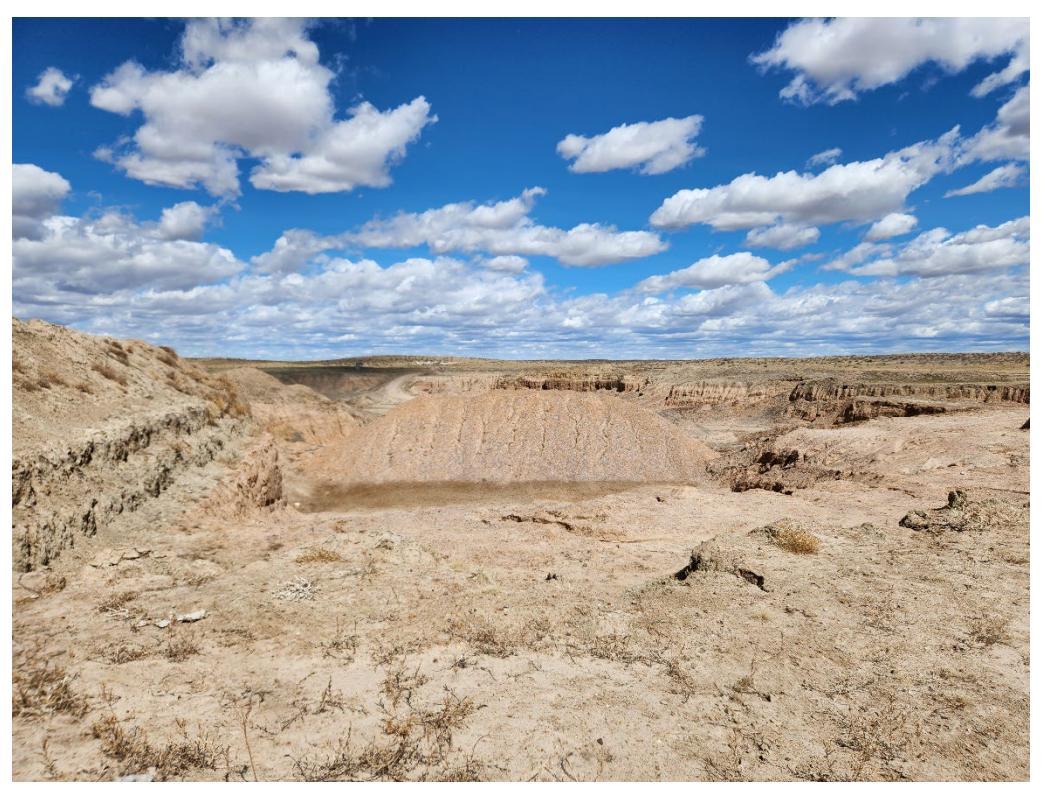
Photo 7. The mined pit with a product stockpile on the floor, looking north.

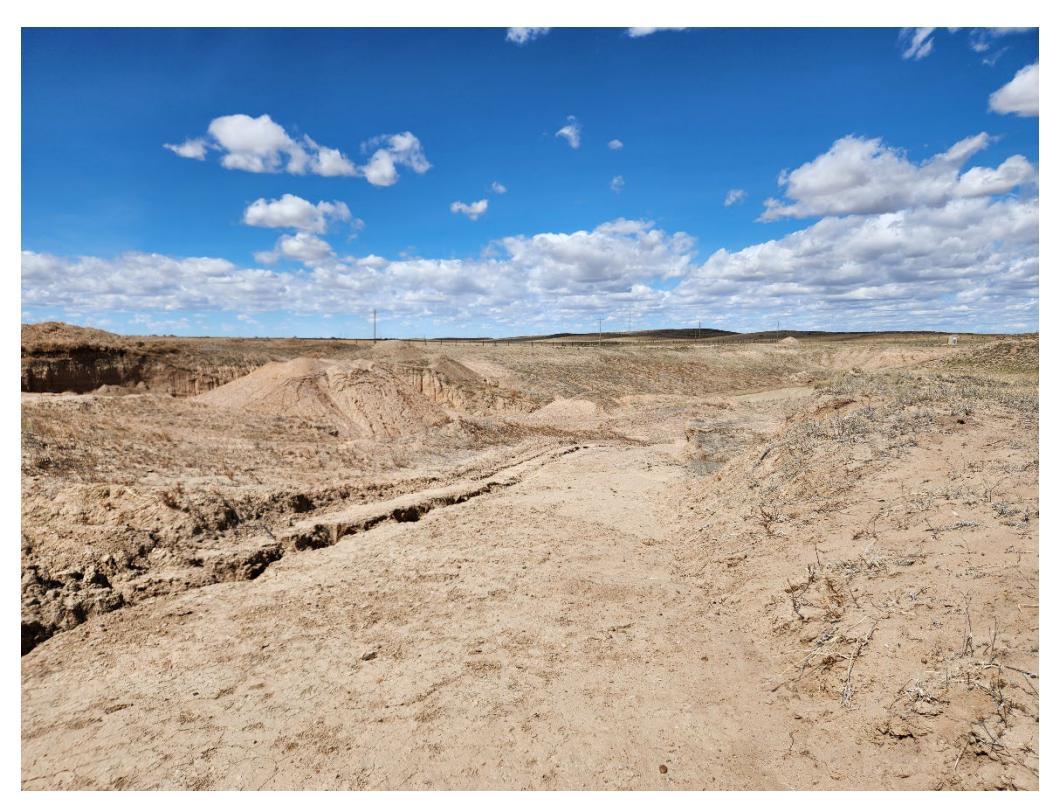
Photo 8. The mined pit, looking northwest.
