### MINERALS PROGRAM INSPECTION REPORT PHONE: (303) 866-3567

MINE NAME:	MINE/PROSPECTING ID#:	MINERAL:	COUNTY:
Kirtright Pit	M-1986-123	Sand and gravel	Larimer
<b>INSPECTION TYPE:</b> Preoperation Inspection	WEATHER: Clear	INSP. DATE: April 21, 2025	INSP. TIME: 09:00
<b>OPERATOR:</b>	<b>OPERATOR REPRESENTATIVE:</b>	<b>TYPE OF OPERATION:</b>	
Coulson Excavating Company, Inc.	Ken Coulson, Peter Wayland	112c - Construction Regular Operation	
<b>REASON FOR INSPECTION:</b>	BOND CALCULATION TYPE:	BOND AMOUNT:	
Preoperation Inspection	None	\$58,400.00	
DATE OF COMPLAINT:	POST INSP. CONTACTS:	JOINT INSP. AGE	NCY:
NA	None	None	
INSPECTOR(S): Patrick Lennberg Joel Renfro	INSPECTOR'S SIGNATURE:	SIGNATURE DAT May 5, 2025	Е:

This was a pre-operation inspection of the Kirtright Pit (M1986-123) conducted by Patrick Lennberg and Joel Renfro of the Division of Reclamation, Mining, and Safety (Division/DRMS). The inspection was completed in response to a Board Ordered Amendment Application (AM-1), received by the Division on February 27, 2024. The application was deemed complete for the purpose of filing on June 14, 2024. The site was previously inspected by the Division on June 27, 2023, in respo

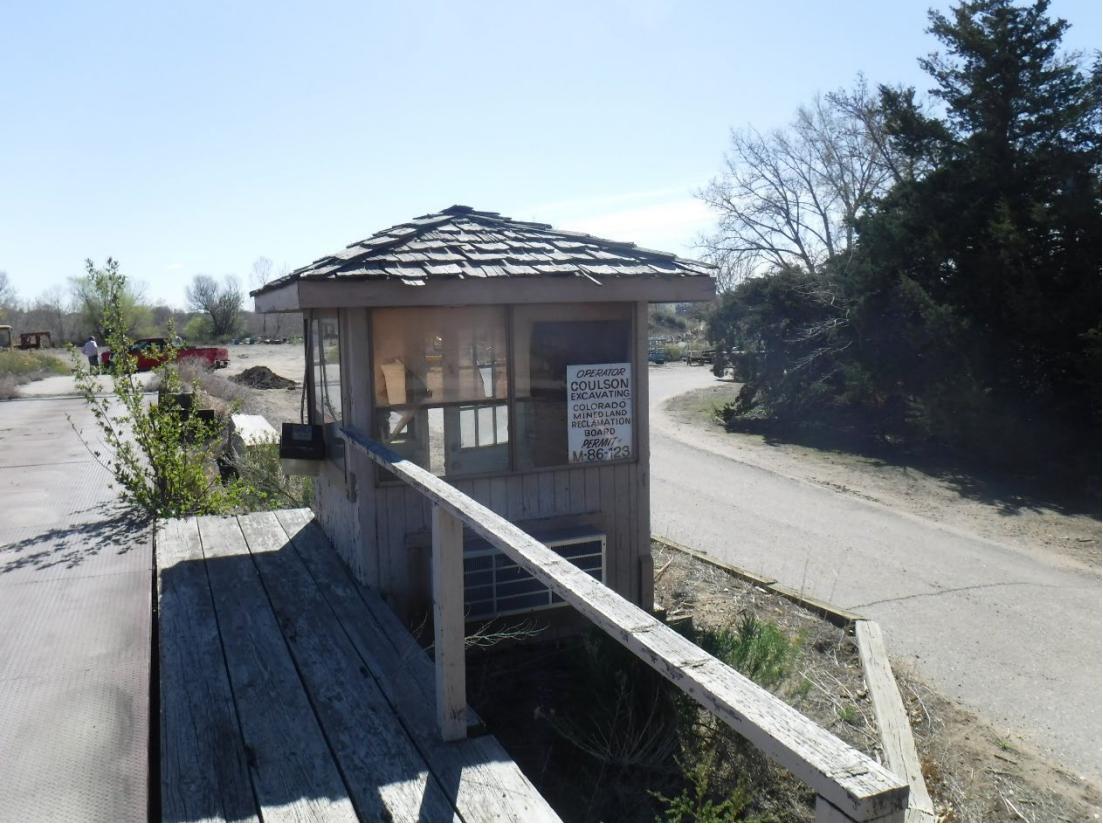
Photo 1: Mine sign located on the scale house near the mine entrance

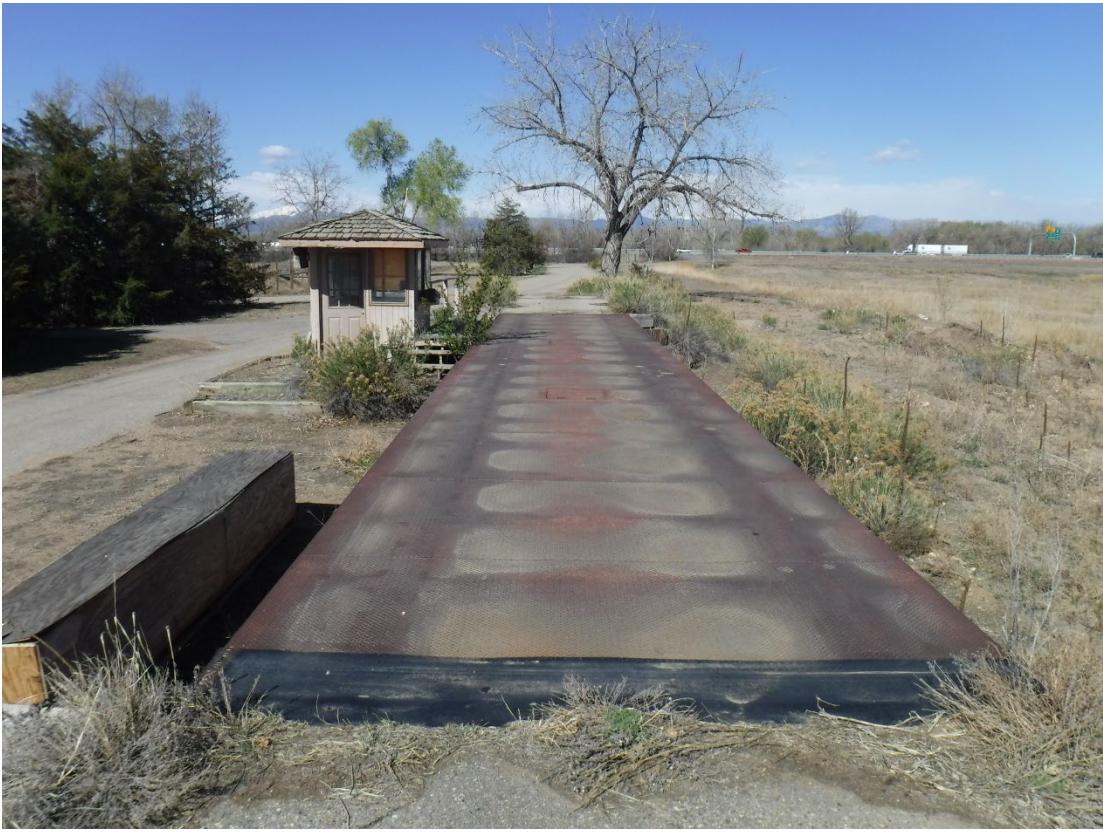
Photo 2: Scale and house will be removed as part of final reclamation activities

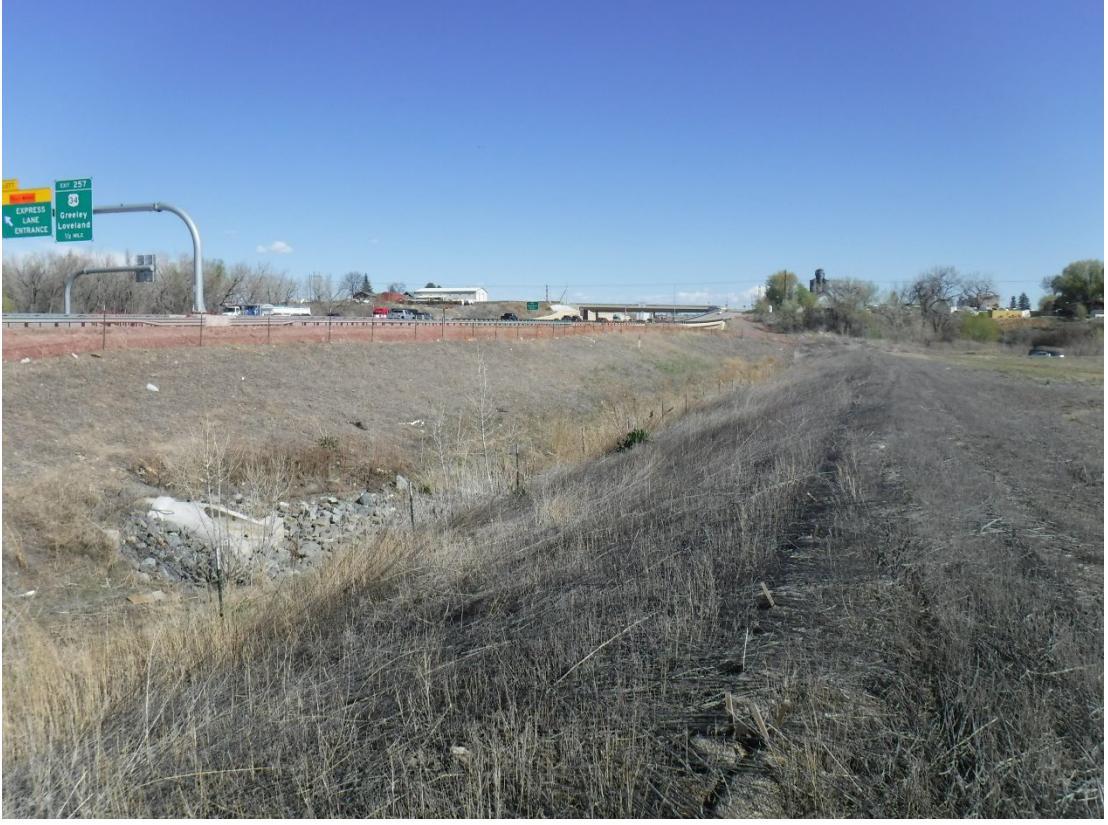
Photo 3: CDOT release area, AR-1, (center left) and topsoil stockpile (center right)

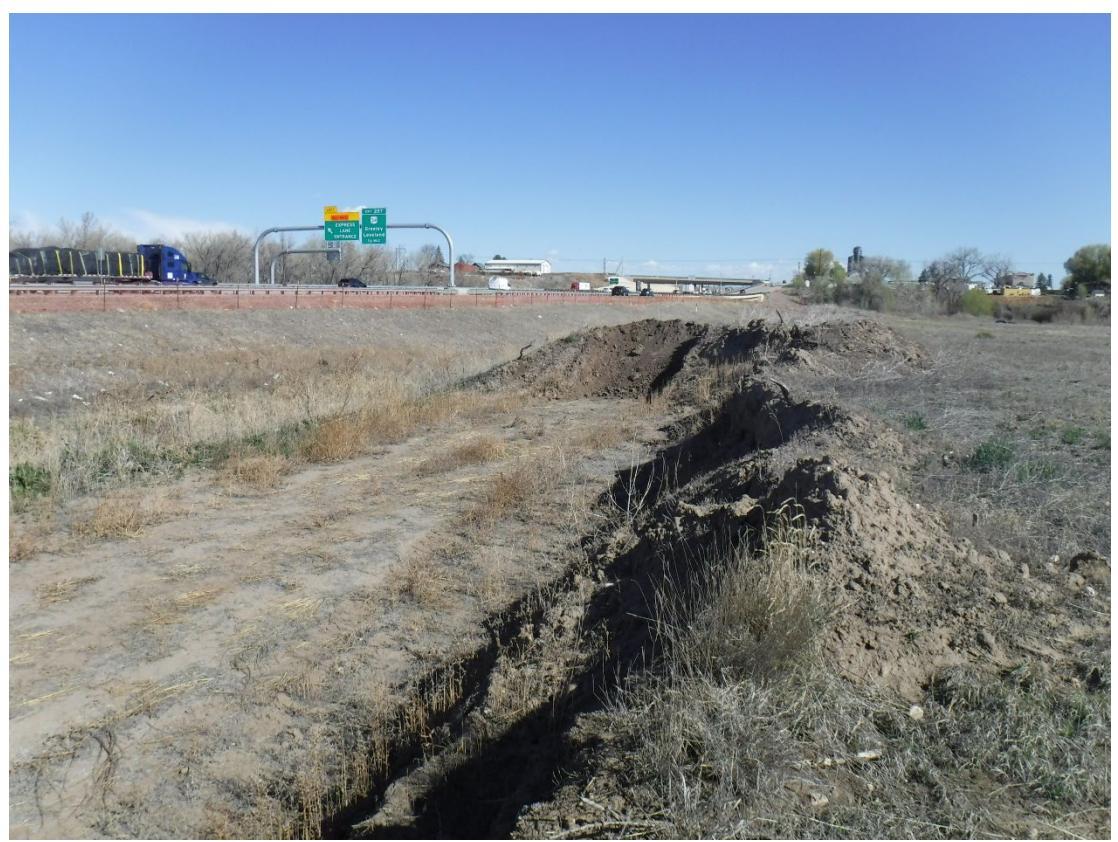
Photo 4: Southern tip of topsoil stockpile, disturbed area not part of release area

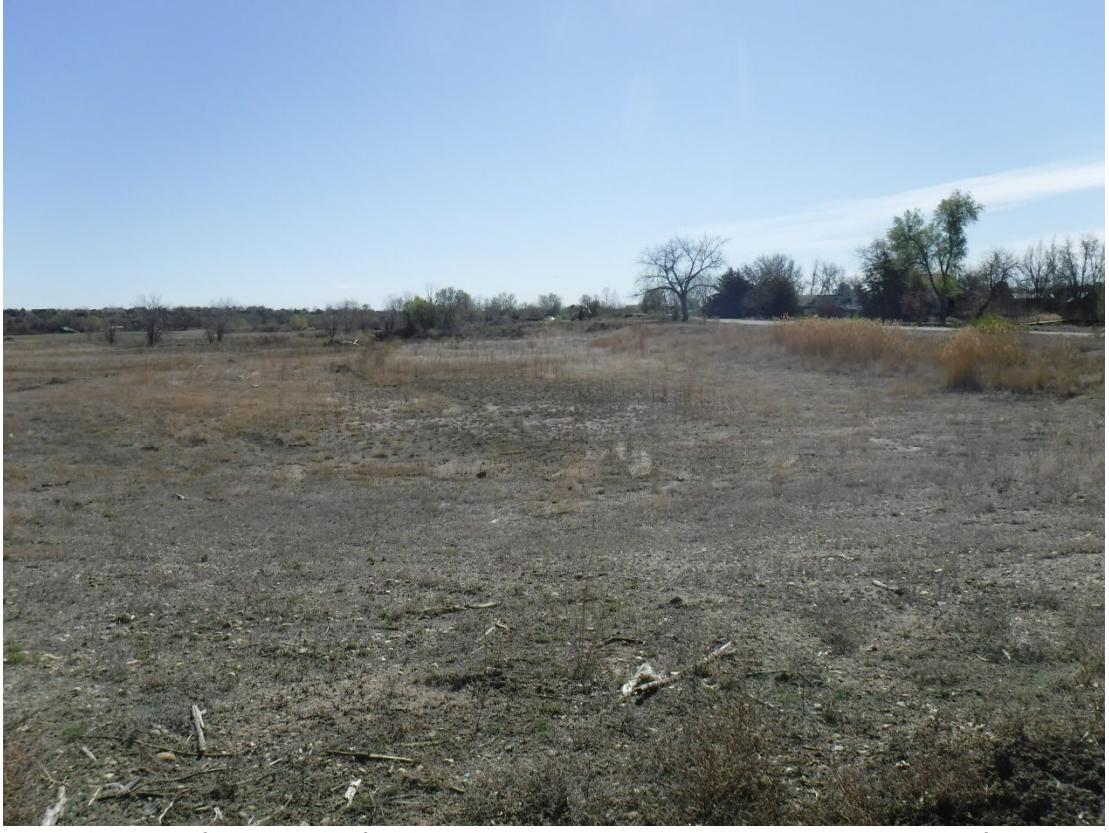
The currently approved permit was to allow for the exposure of groundwater in Ponds 1-4 pending permanent and final augmentation through Water Court. However, during the Water Court proceedings it was determined that the Operator needed to backfill Pond 1 to achieve final augmentation. During the backfilling of Pond 1 the Operator disturbed areas outside the approved permit boundary and a violation was found by the Mined Land Reclamation Board (MLRB/Board). The Board Ordered the Operator to amend the current permit boundary to incorporate the areas that were disturbed outside the permit boundary into a new permit boundary. The Operator has submitted that amendment as described above.

Photo 5: Backfilled portion of Pond 1 area, open water portion is center background of photo

AM-1 proposes to backfill the remaining portions of Pond 1 and narrow ditch up to the O'Brien property line.

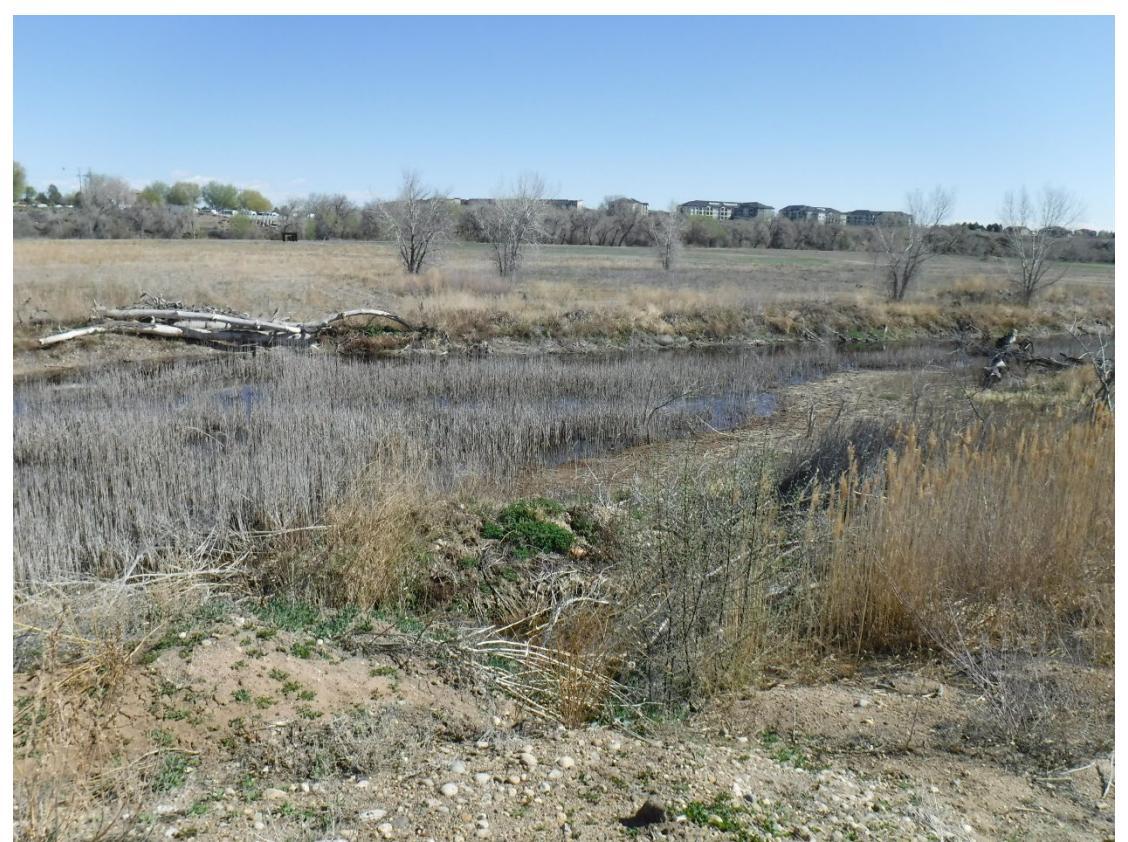
Photo 6: Open water portion of Pond 1

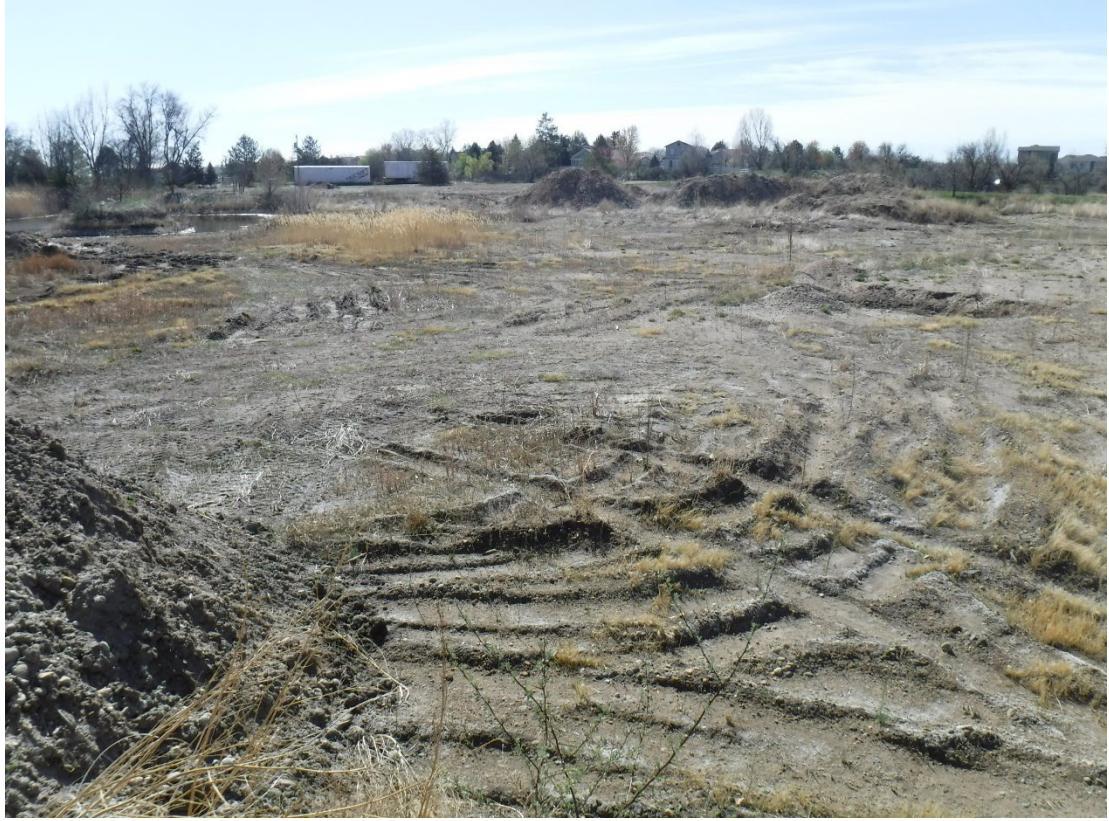
No reclamation work or revegetation has occurred in the Pre-1981 disturbance area. It appears that some portions of this area will need to be reclaimed, but the Division is awaiting details of this in the AM-1 adequacy review.

Photo 7: Looking SE across the Pre-1981 area

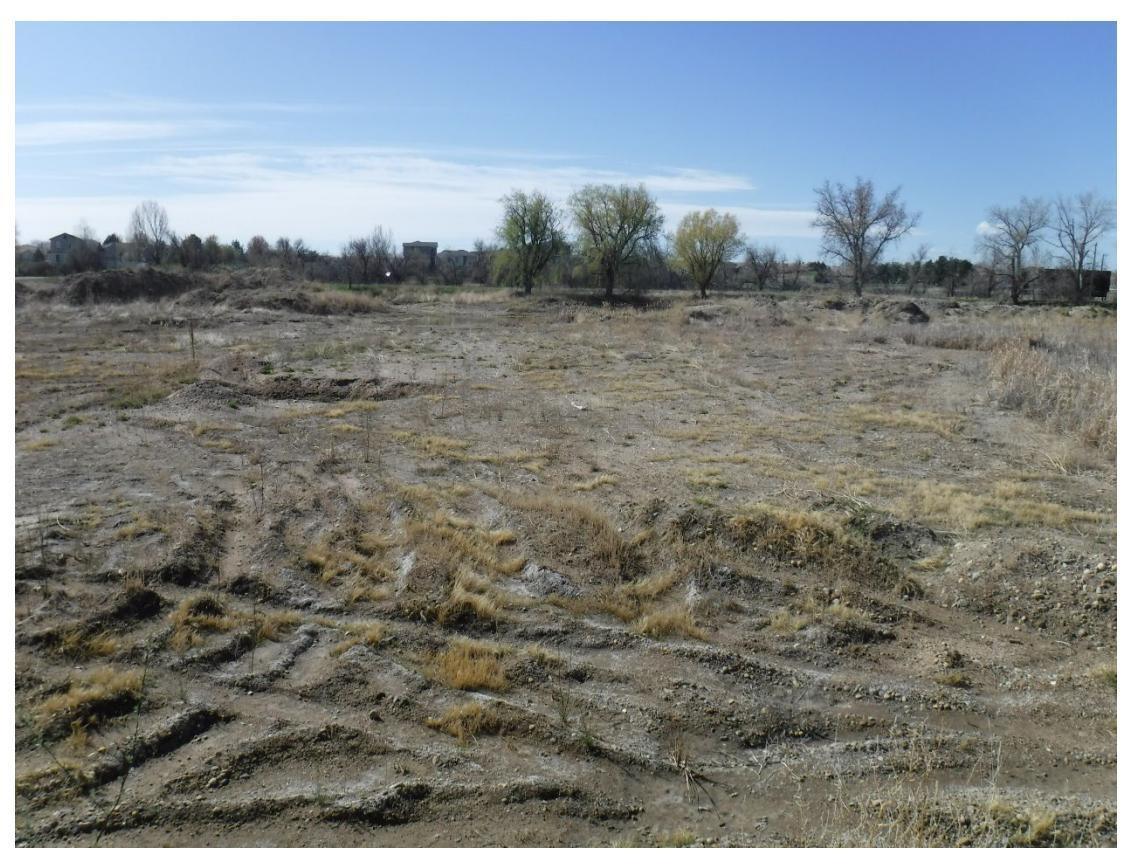
Photo 8: Looking south across the Pre-1981 area

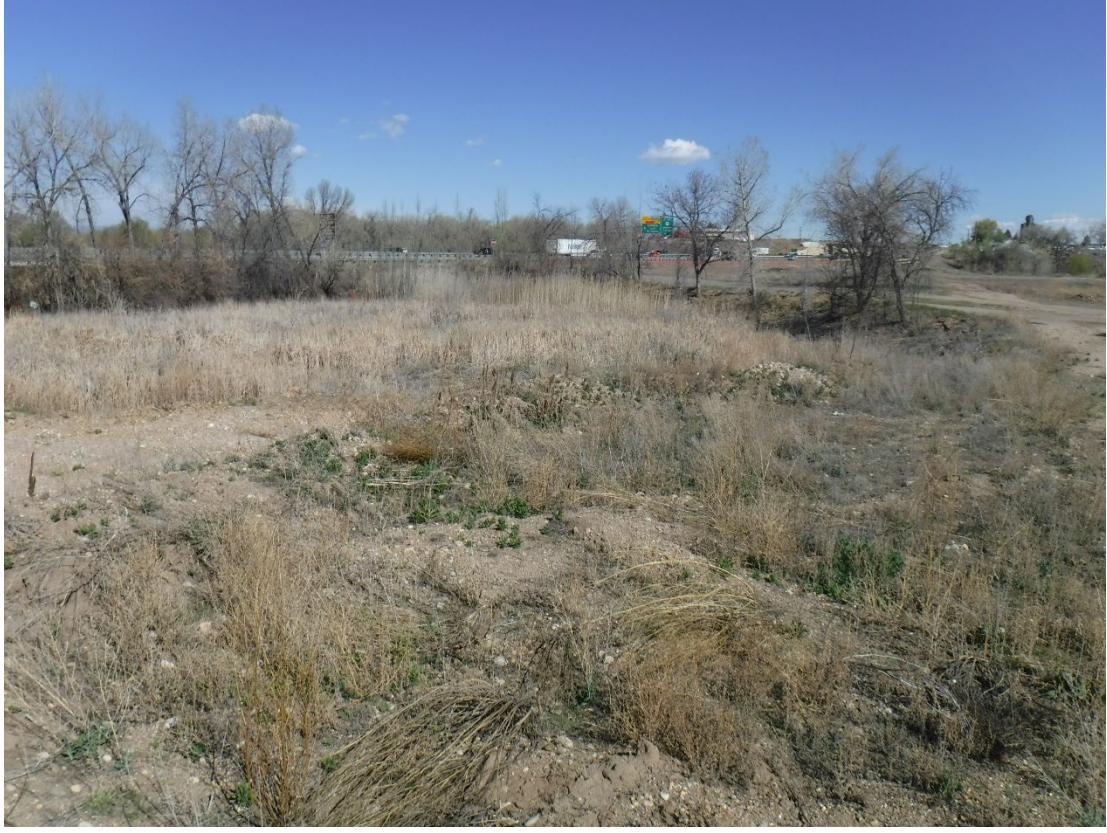
Photo 9: Looking NW across the Pre-1981 area

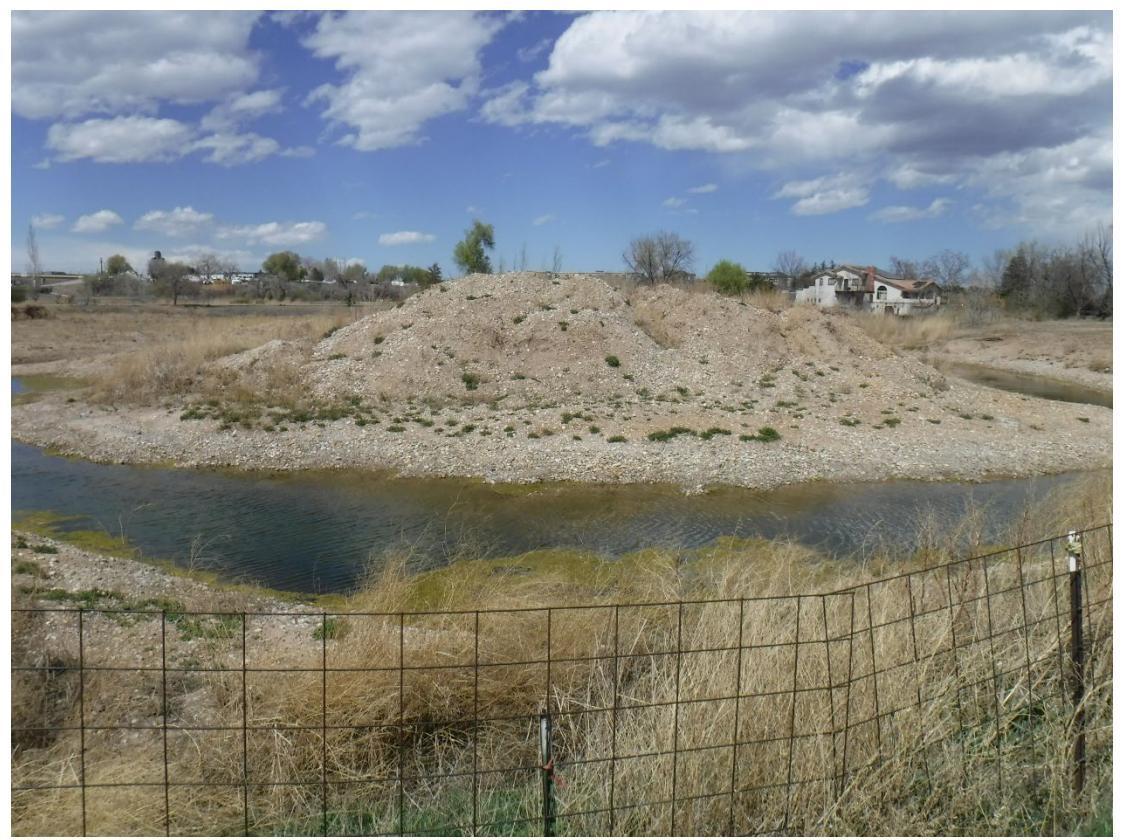
Photo 10: Looking north across the Pre-1981 area from near Lacy Lane

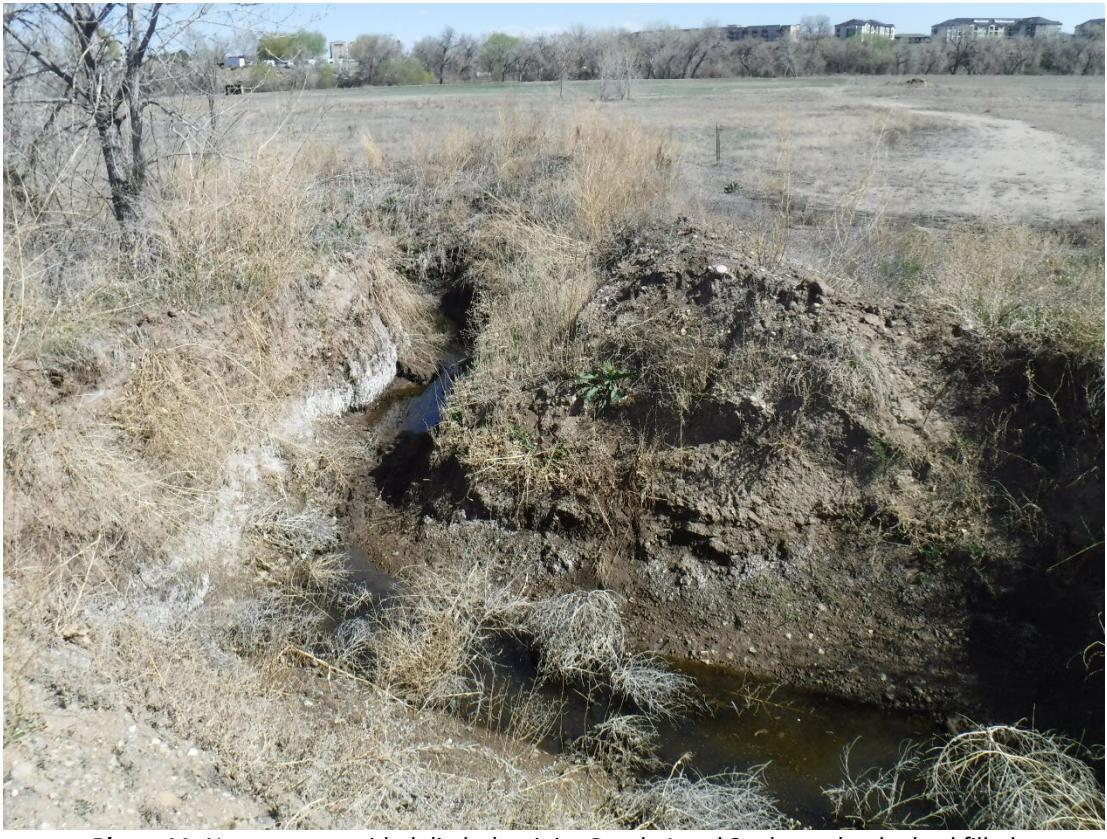
Photo 11: Narrow steep sided ditch that joins Ponds 1 and 2, planned to be backfilled

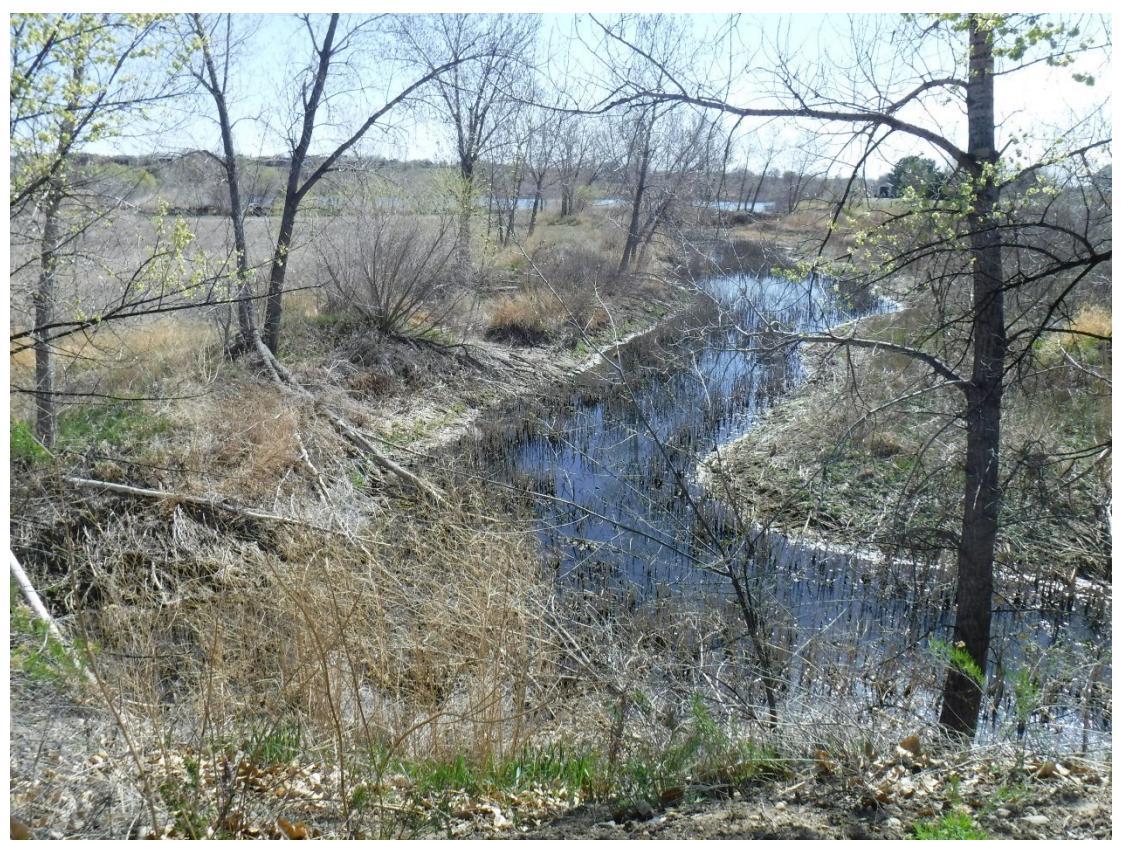
Photo 12: Northern portion of Pond 2 looking east

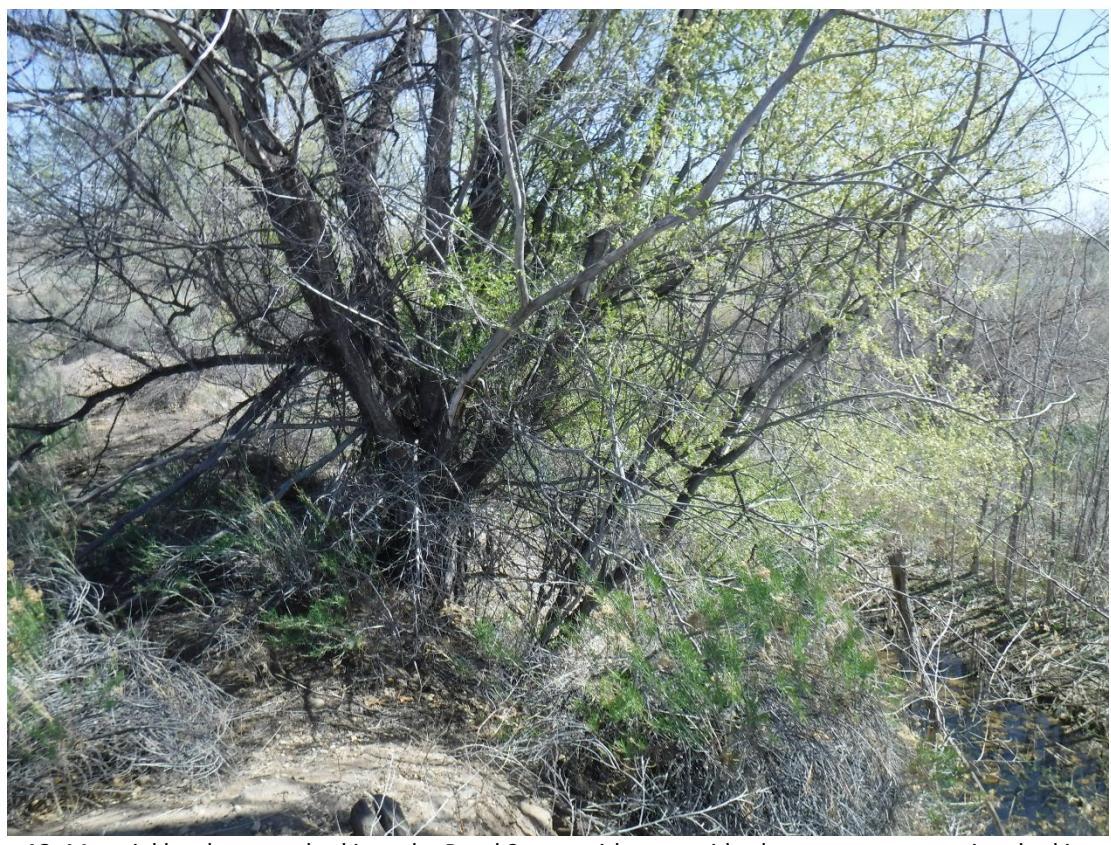
Currently, no activity is proposed to occur on the O'Brien property. However, during the inspection the Division noted several stretches along the Pond 2 area where the reclaimed pond slopes are steeper than the required 3H:1V slope. It appears that Randy during the process of leveling out a portion of his land west of Pond 2 has encroached into Pond 2 and created slopes that 1H:1V or steeper. The slopes along the southern portion of Pond 2 are not at the required slope but are well vegetated and appear stable. The slopes along the road that is between Ponds 2 and 3 are also steeper than the required slope and appear to be stable but not

Photo 13: Material has been pushed into the Pond 2 area with steep side slopes prone to erosion, looking north

well vegetated. Additionally, there is a corrugated plastic culvert that has been installed under this road that joins Ponds 2 and 3. It is unclear the purpose of this culvert and does not appear to be functioning. Reclamation of the side slopes of Pond 2 and addressing the culvert will have to be managed through the amendment that is under review.

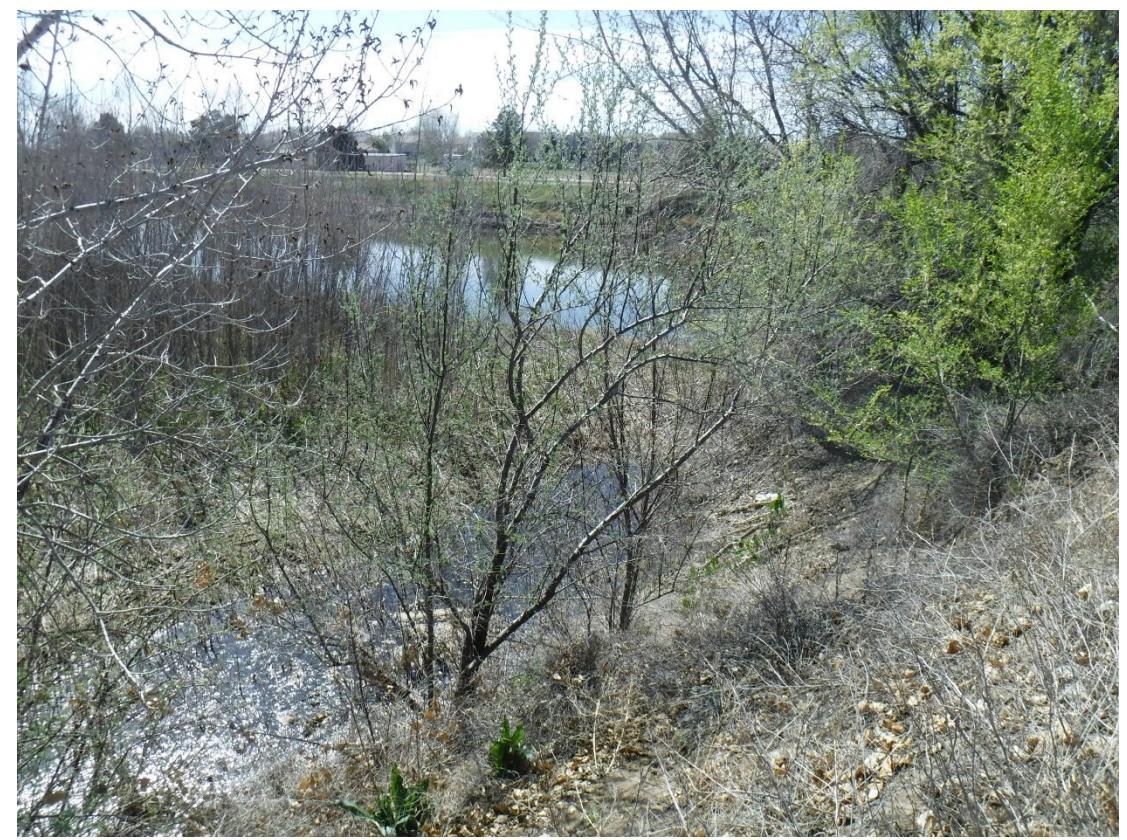
Photo 14: Material has been pushed into the Pond 2 area with steep side slopes prone to erosion, looking south

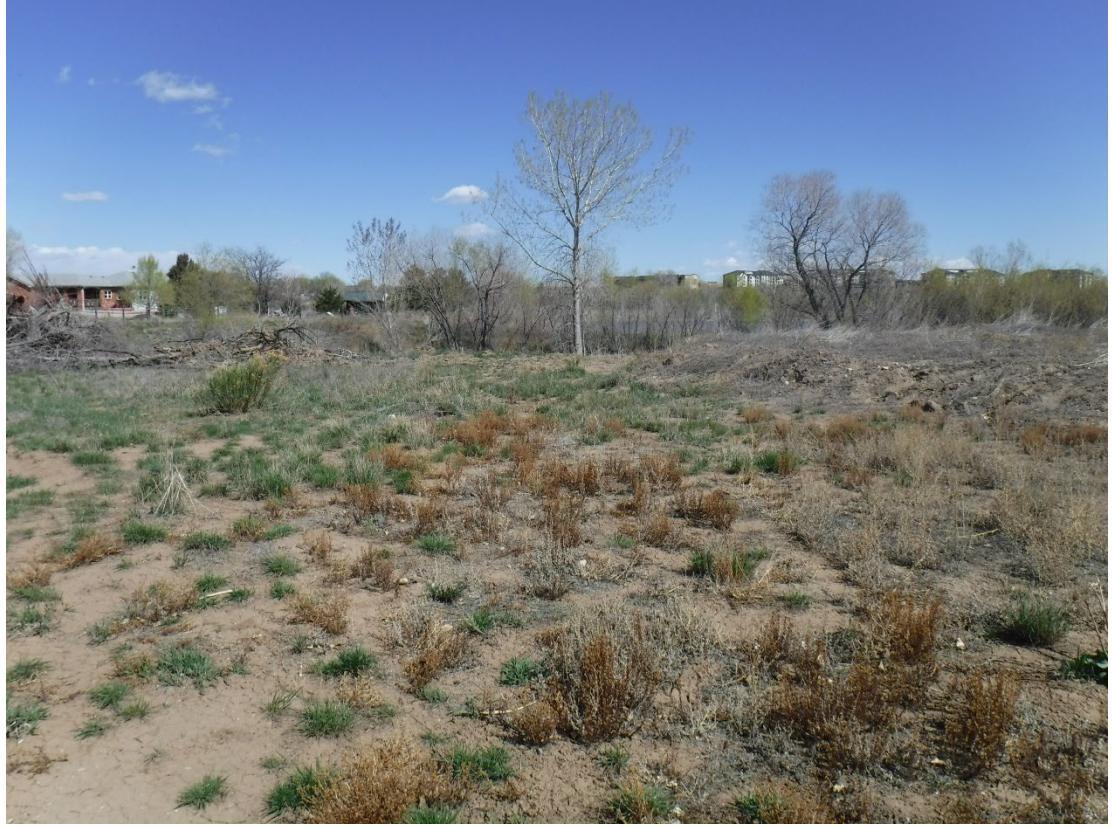
Photo 15: Looking north from the SW corner of Pond 4, grade out topsoil material center right of photo

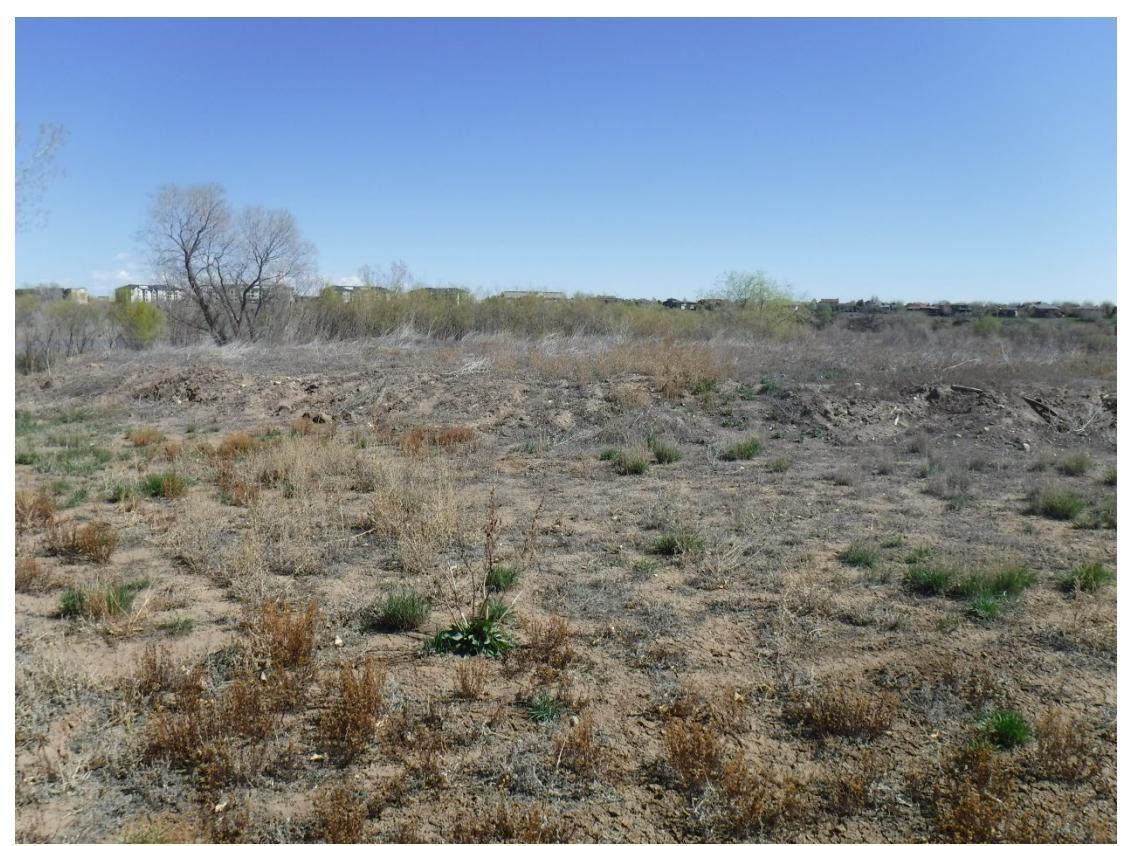
Photo 16: Grade out topsoil material

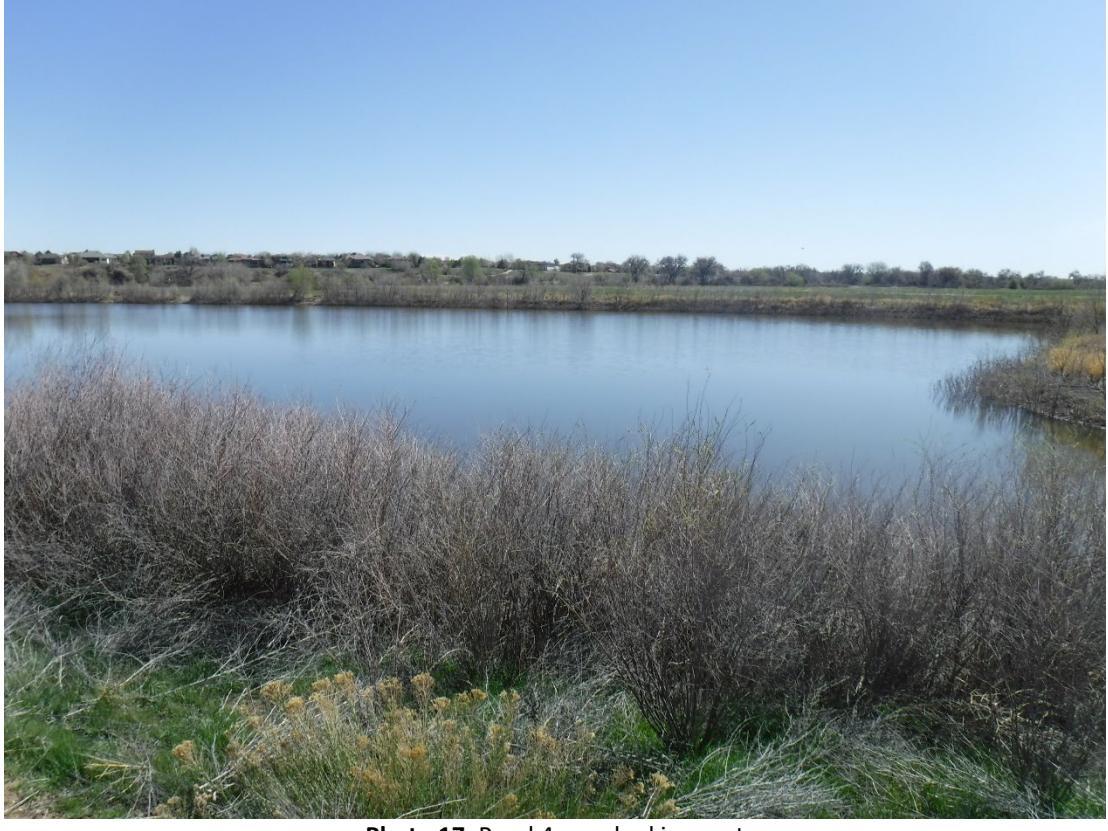
Photo 17: Pond 4 area looking east

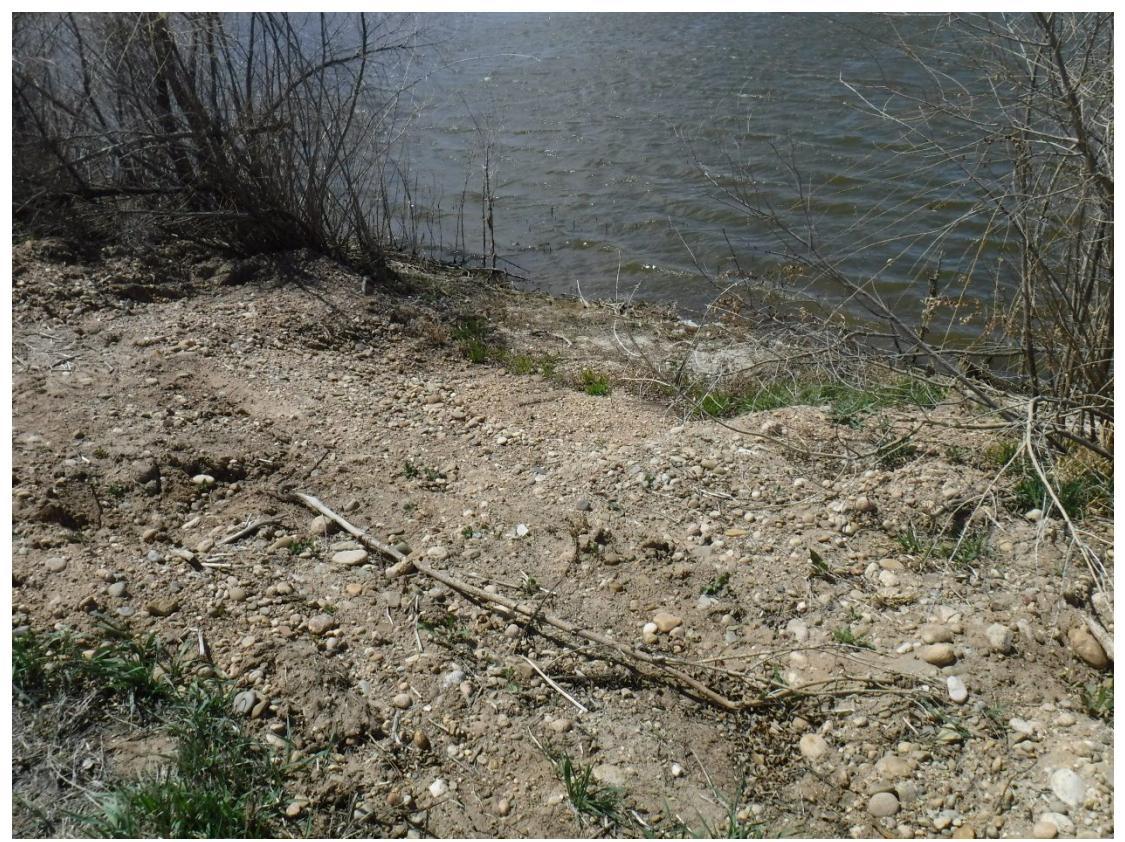
Pond 4 appears to be deeper than Pond 3 but, like Pond 3, it has some banks that appear to be steeper than the required 3H:1V. Vegetation is well established along the banks and no areas of excess erosion were noted. However, there are four areas along the banks of the eastern shoreline where someone has used a piece of equipment, likely and excavator, to remove established vegetation to the waterline and backfilled the areas with surrounding soil. These areas are very susceptible to erosion and will need to be reclaimed to establish vegetation and to prevent excess erosion.

Photo 18: Typical area where vegetation and soil has been removed to waterline on Pond 4

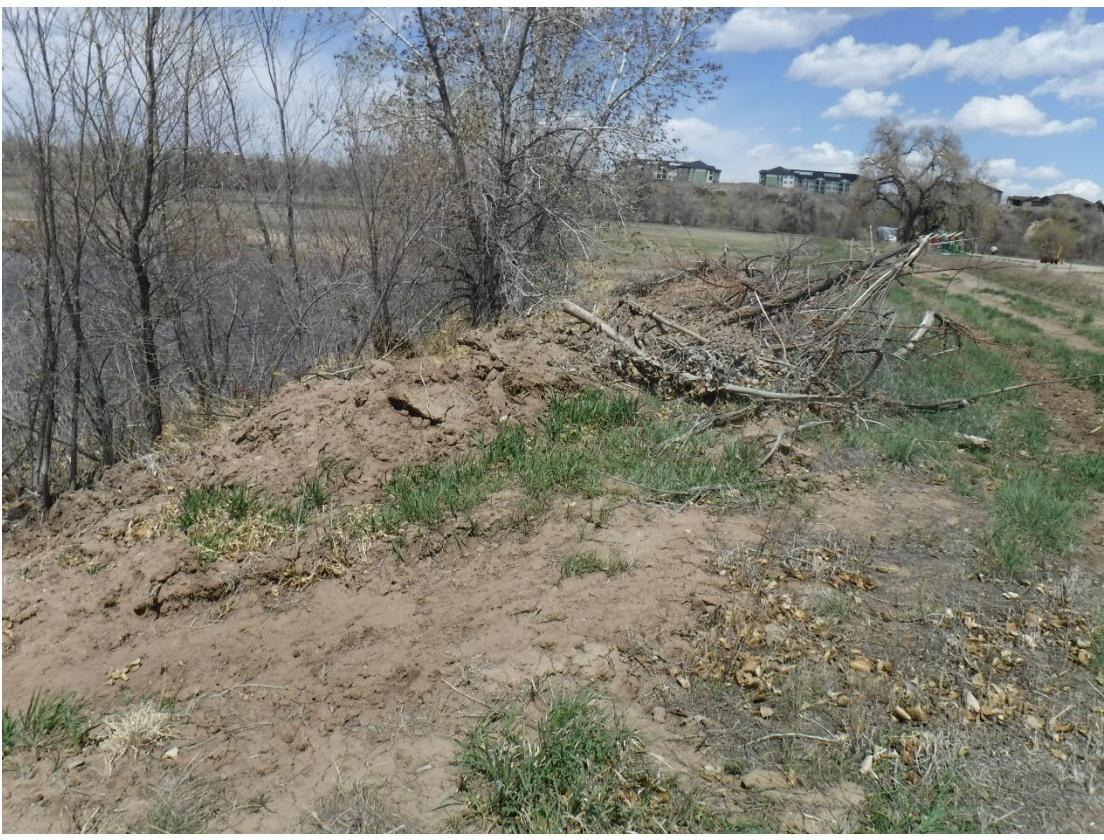
Photo 19: Typical debris pile from material removed to waterline on Pond 4

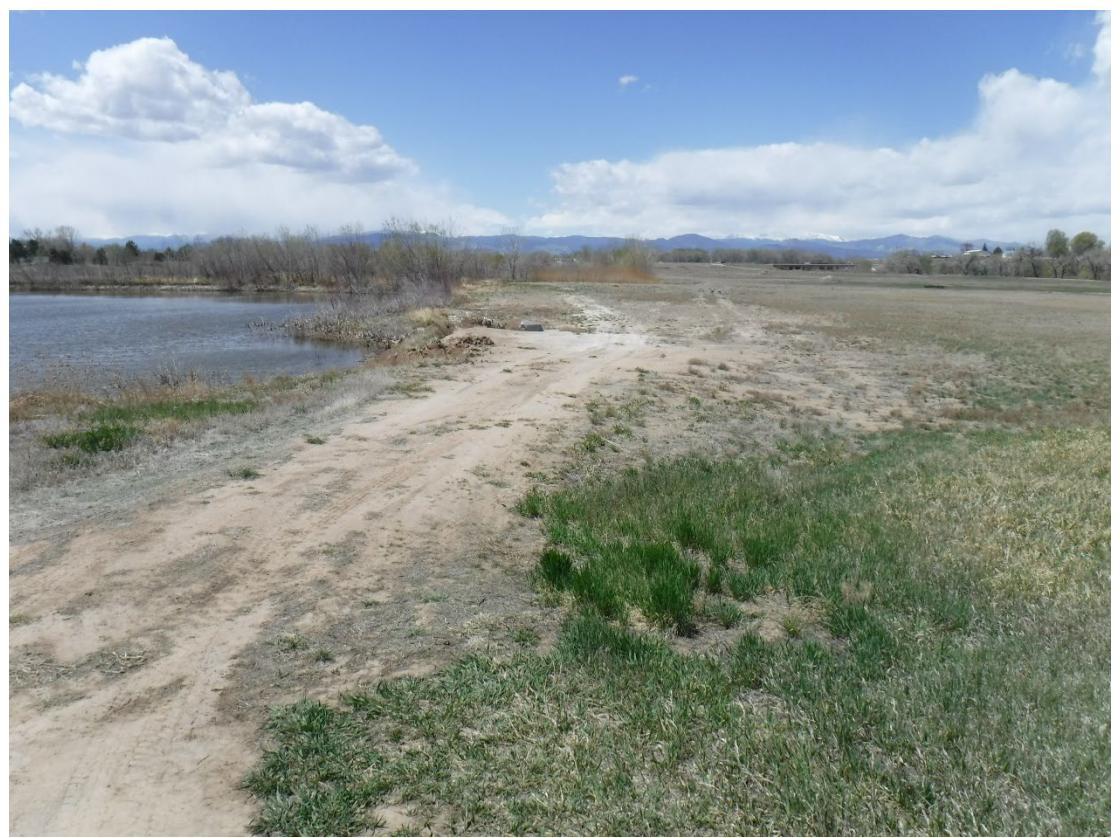
In the southwestern corner of the Pond 4 area is the location of a future home site for Randy Kirtright. At the time of writing this inspection report the Division has been informed that Larimer County has approved a building permit for this location. Additionally, the Division was made aware that Mr. Kirtright dug a hole in this location and buried a large pile of dead vegetation. This is the same location where the Division noted, in 2022, soil piles had been stockpiled. The piles have since been graded out and now there is a raised area that is approximately 3 feet in height and covers approximately 0.1 acres. The piles came from a berm that was constructed at the north end of Pond 4 in 2021. It was determined that the berm, to prevent flooding of the pond, would direct flooding onto the O'Brien property. The berm material was removed by the Operator and placed in its current location.

Photo 20: Northern end of Pond 4 where the berm was constructed in 2021 and removed in 2022

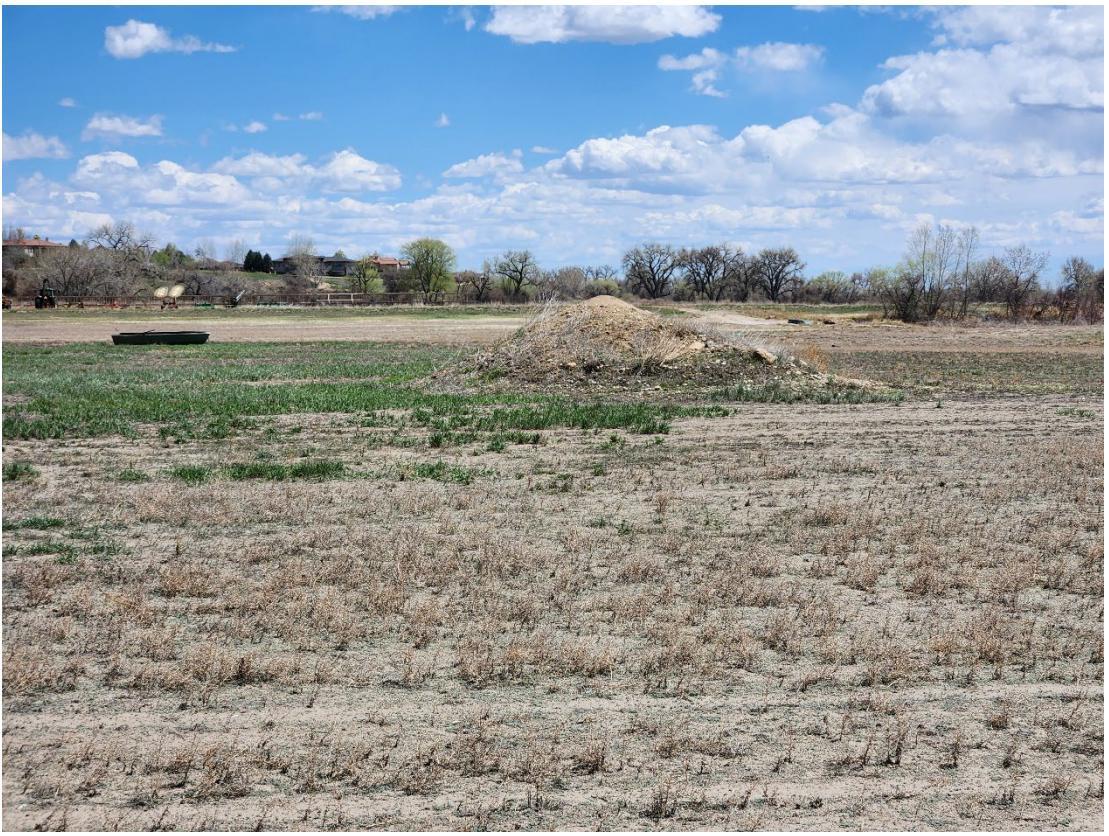
During the inspection the Division noted there are three isolated piles of gravel material in the area north of the currently approved and proposed permit boundary. Two of the piles (Pile 1 and 2) are on the easternmost property owned by Randy Kirtright and the other (Pile 3) is on the O'Brien property. Two of the piles (Pile 1 and 3) are north of the proposed/current permit boundary. The other (Pile 2) appears to be on the proposed/current permit boundary. A review of historic aerial imagery, using Google Earth and the Larimer County Assessor's website, shows that these piles were generated during mining operations at the Kirtright Pit that occurred outside the approved permit boundary. Please see Attachment 1. The Operator will have to include these piles and areas affected by mining into the revised permit boundary. After this inspection the Division issued Adequacy Review #3 addressing this concern and others.

Photo 21: Pile #2 on or very near the currently approve permit boundary

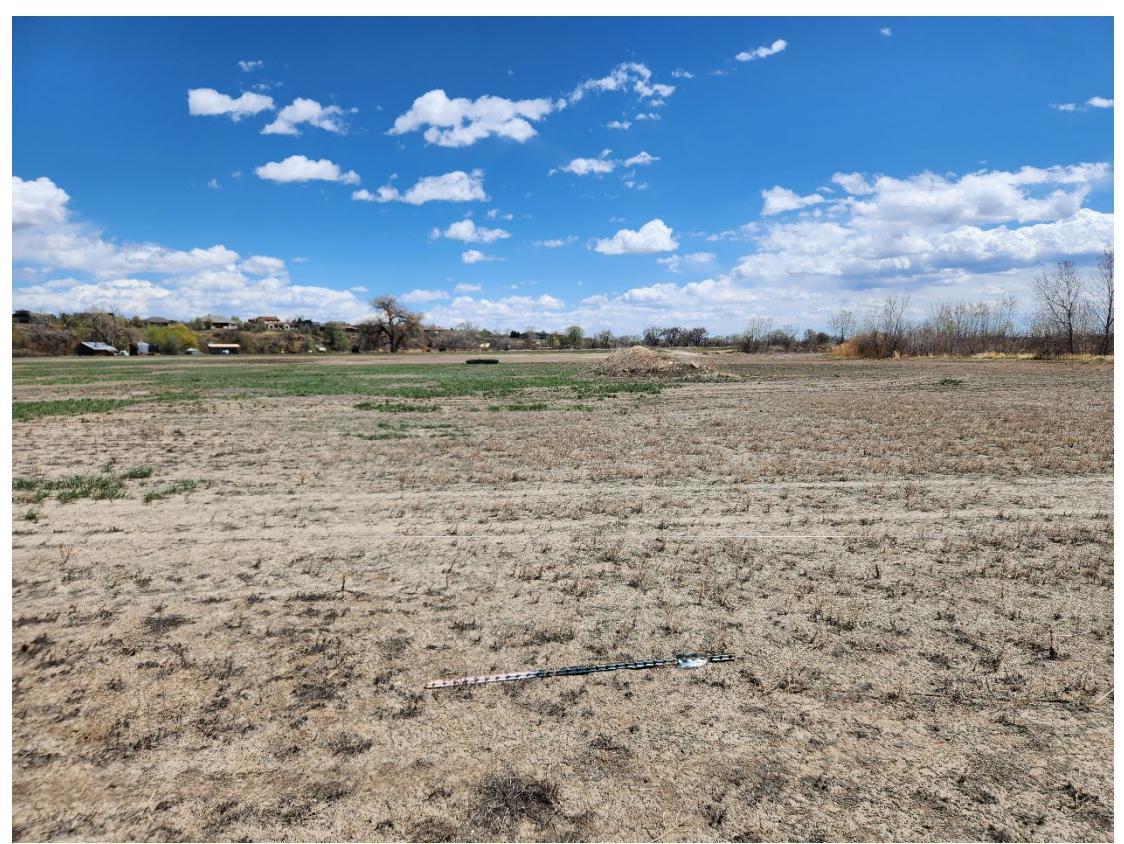
Photo 22: Pile #2 with permit boundary marker
