### MINERALS PROGRAM INSPECTION REPORT PHONE: (303) 866-3567

MINE NAME:	MINE/PROSPECTING ID#:	MINERAL:	COUNTY:
Kirtright Pit	M-1986-123	Sand and gravel	Larimer
<b>INSPECTION TYPE:</b> Preoperation Inspection	WEATHER: Clear	INSP. DATE: April 21, 2025	INSP. TIME: 09:00
<b>OPERATOR:</b>	<b>OPERATOR REPRESENTATIVE:</b>	<b>TYPE OF OPERATION:</b>	
Coulson Excavating Company, Inc.	Ken Coulson, Peter Wayland	112c - Construction Regular Operation	
<b>REASON FOR INSPECTION:</b>	BOND CALCULATION TYPE:	BOND AMOUNT:	
Preoperation Inspection	None	\$58,400.00	
DATE OF COMPLAINT:	POST INSP. CONTACTS:	JOINT INSP. AGE	NCY:
NA	None	None	
INSPECTOR(S): Patrick Lennberg Joel Renfro	INSPECTOR'S SIGNATURE:	SIGNATURE DAT May 5, 2025	Е:

This was a pre-operation inspection of the Kirtright Pit (M1986-123) conducted by Patrick Lennberg and Joel Renfro of the Division of Reclamation, Mining, and Safety (Division/DRMS). The inspection was completed in response to a Board Ordered Amendment Application (AM-1), received by the Division on February 27, 2024. The application was deemed complete for the purpose of filing on June 14, 2024. The site was previously inspected by the Division on June 27, 2023, in respo

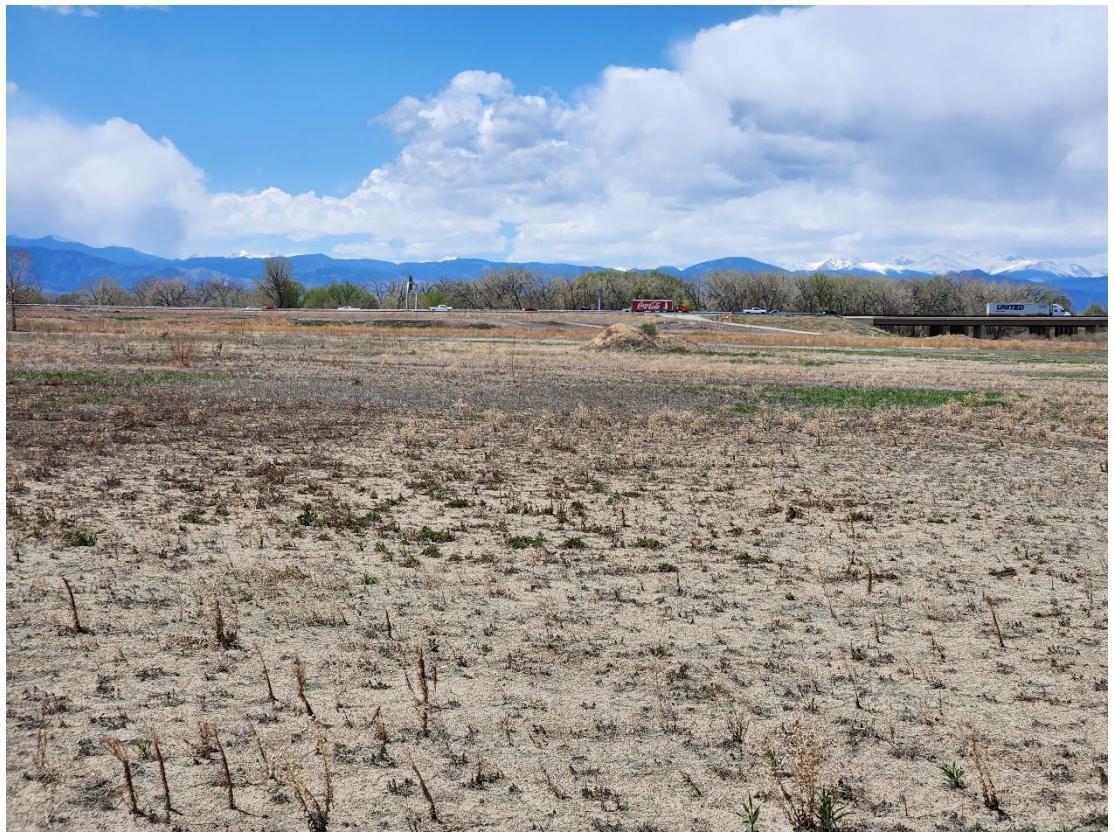
Photo 23: Pile #3 looking west

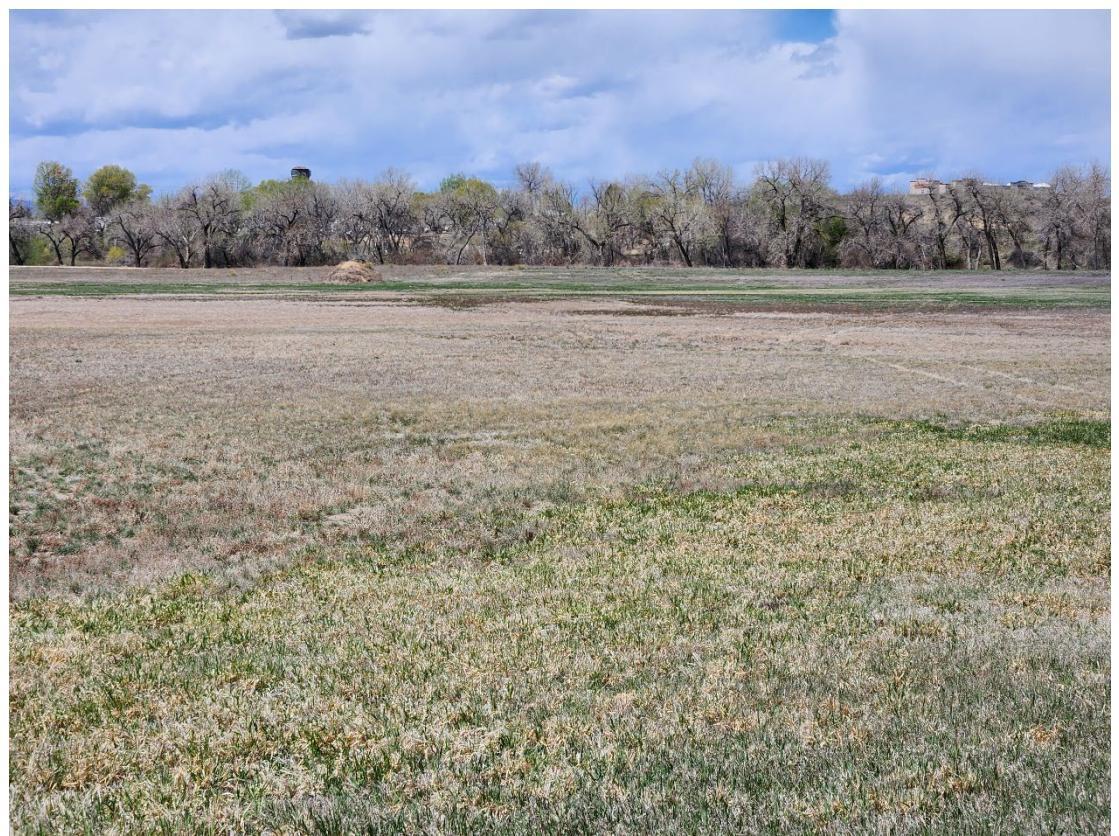
Photo 24: Pile #1 looking north

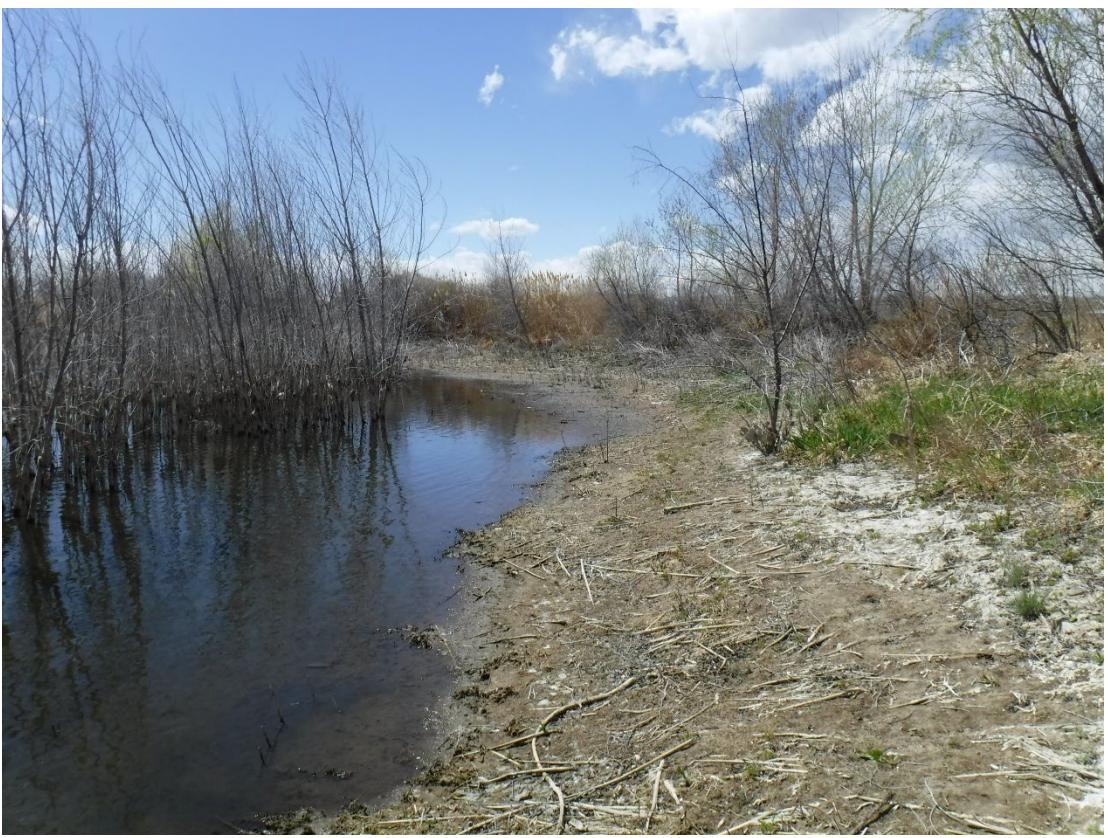
Pond 3 is a shallow pond that has established vegetation around its banks. There appear to be some banks that are steeper than the required slope, but no excessive erosion of the banks was noted.

Photo 25: Typical shoreline conditions of Pond 3 along the north end

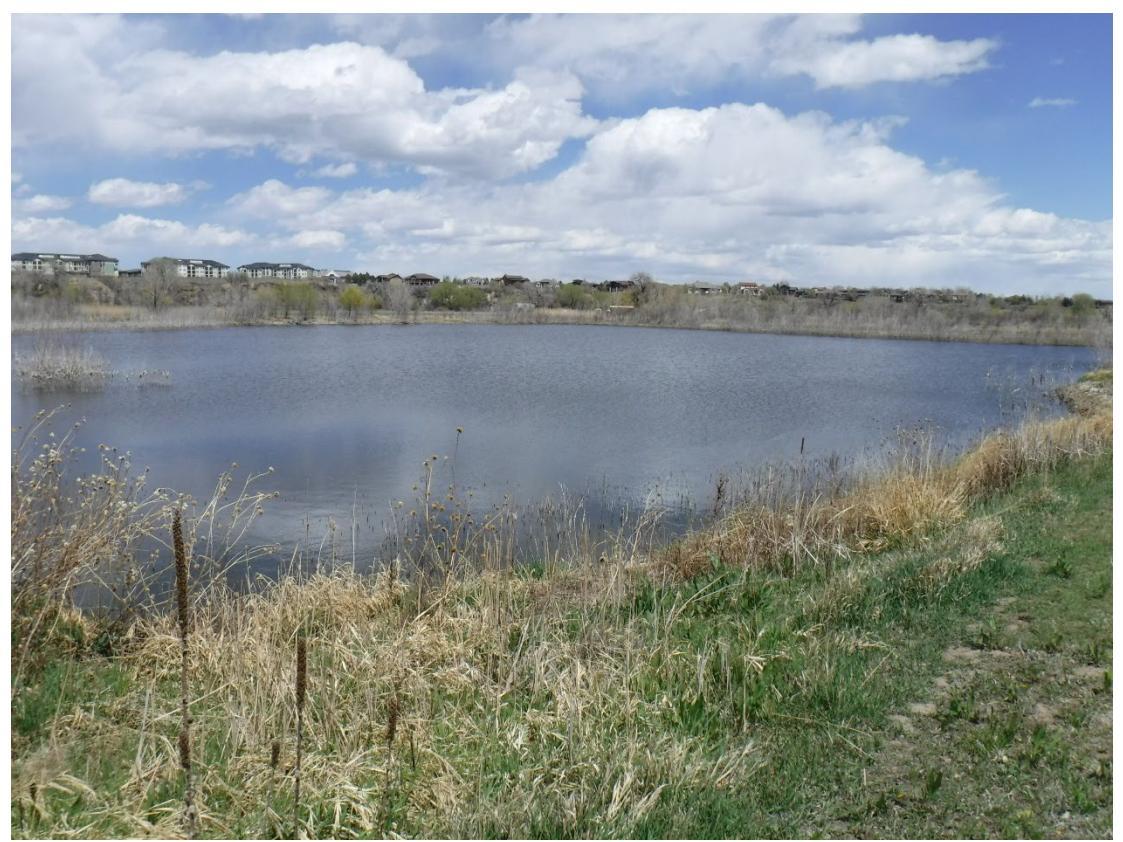
Photo 26: Looking NE across Pond 3
