# MINERALS PROGRAM INSPECTION REPORT PHONE: (303) 866-3567

| MINE NAME: | MINE/PROSPECTING ID#: | MINERAL: | COUNTY: |
|---|---|---|---|
| Walsenburg Gravel Pit | M-2000-092 | Sand and gravel | Huerfano |
| Monitoring | Clear | May 20, 2025 | 11:00 |

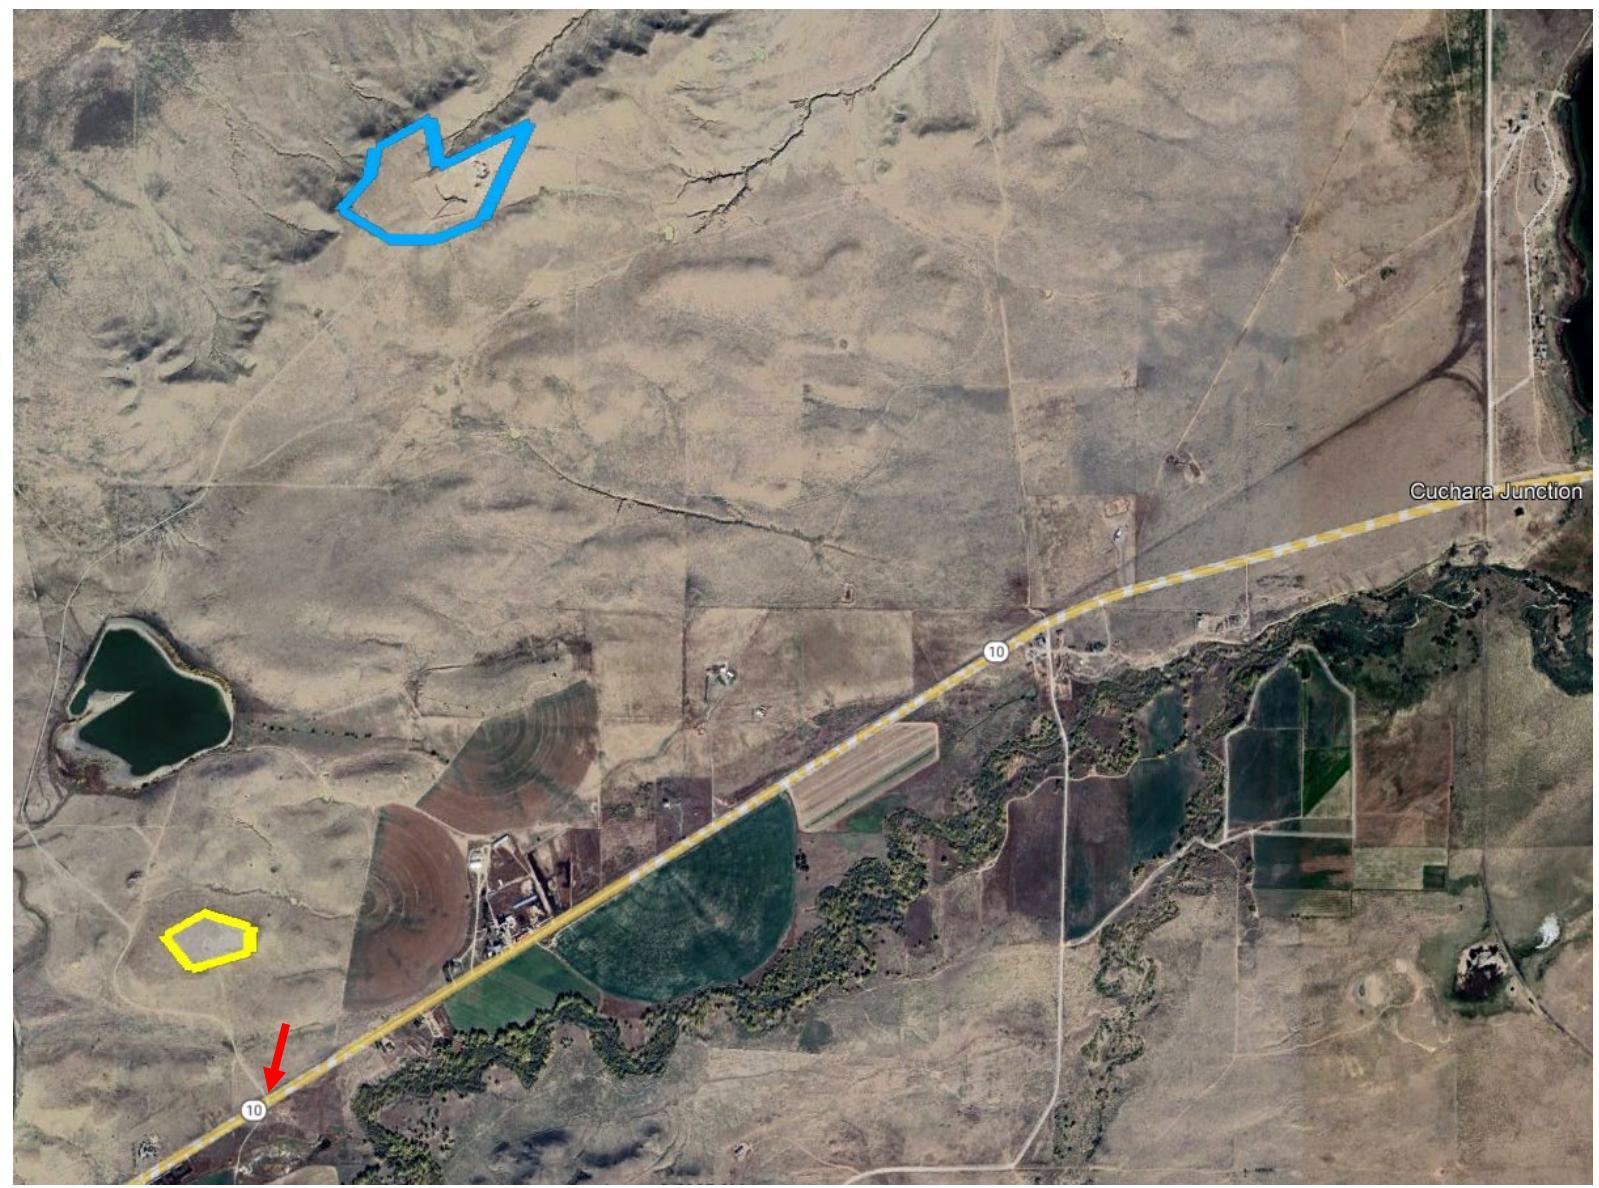
Map 1: Index map showing the relation between the Walsenburg Gravel Pit's location (yellow polygon) and the Lone Tree Pit's location (blue polygon). The red arrow points to where the locked gate is located.

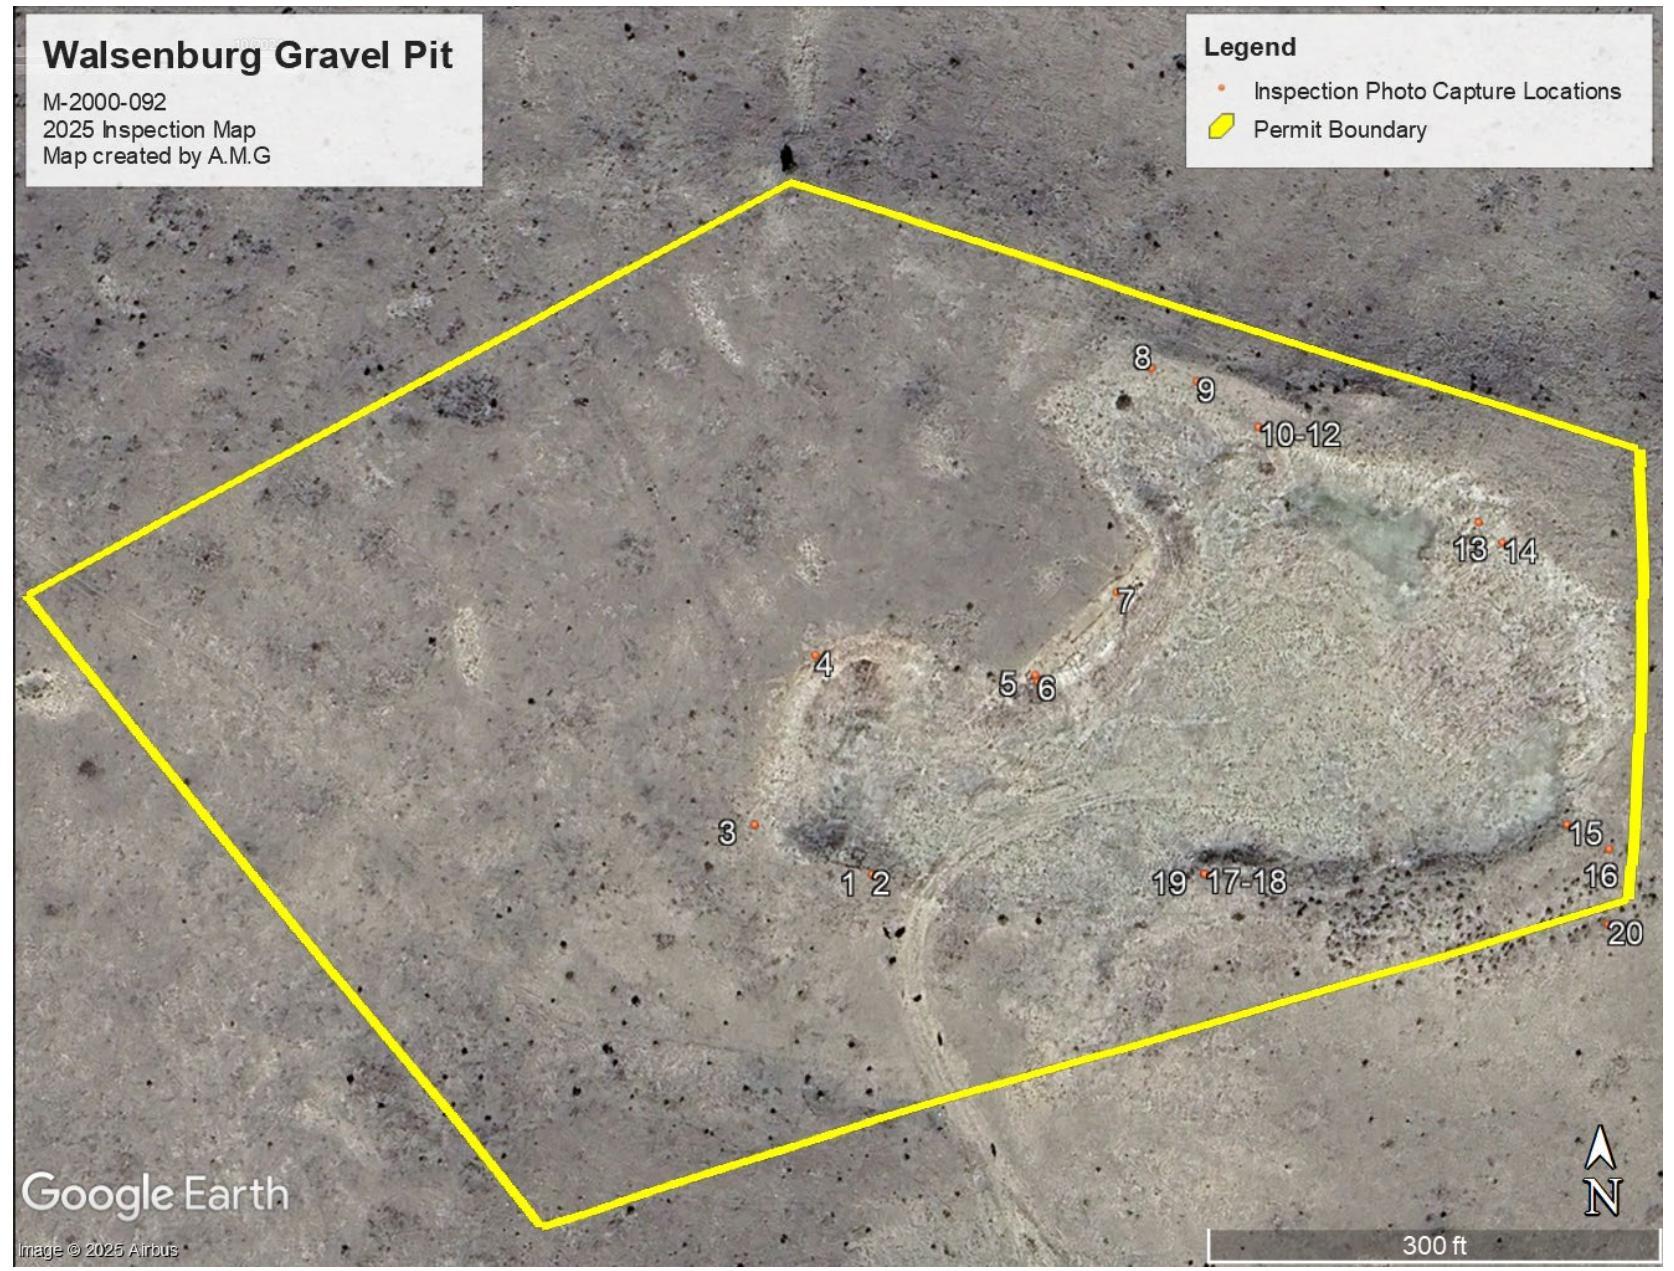
Map 2: Inspection report map for the 2025 inspection. The aerial imagery is dated 10/23/2024. The numbers correspond with the inspection report photos below.

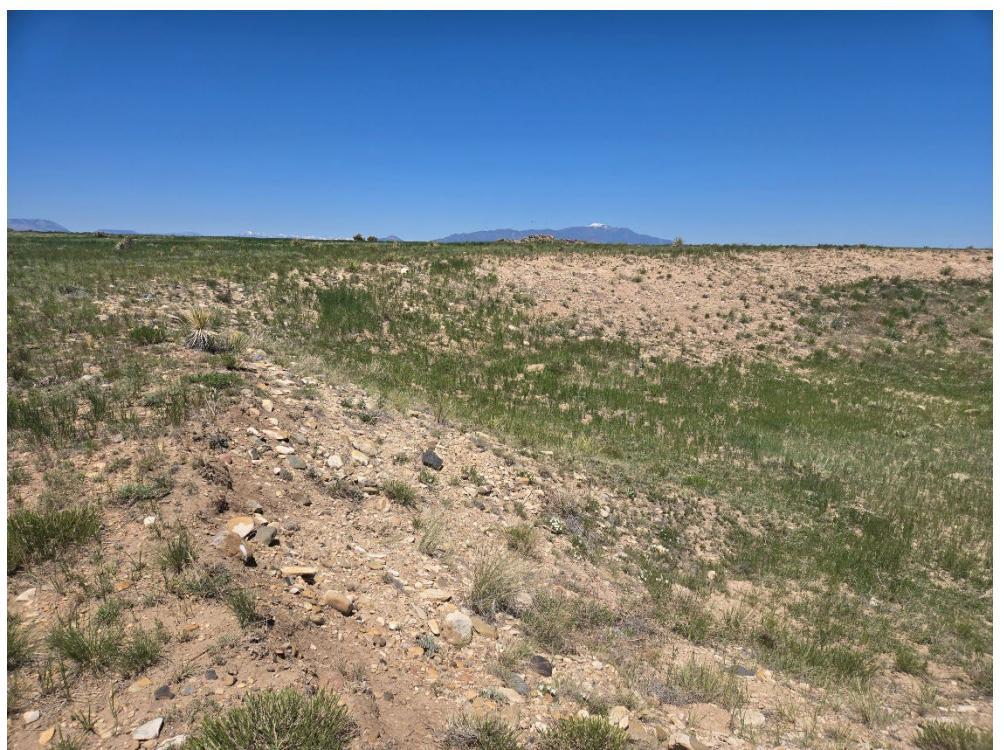
The Division's 2021 inspection mentioned a section of highwall that still needed to be backfilled and graded. It appears that this has been done since the last inspection. No highwalls remain onsite, and the slopes onsite appear to mostly be at 3H:1V slope or shallower.

Photo 1: Looking north along the western side of the disturbed area. The slope on the northside is the highwall that has been backfilled and graded since the 2021 inspection.

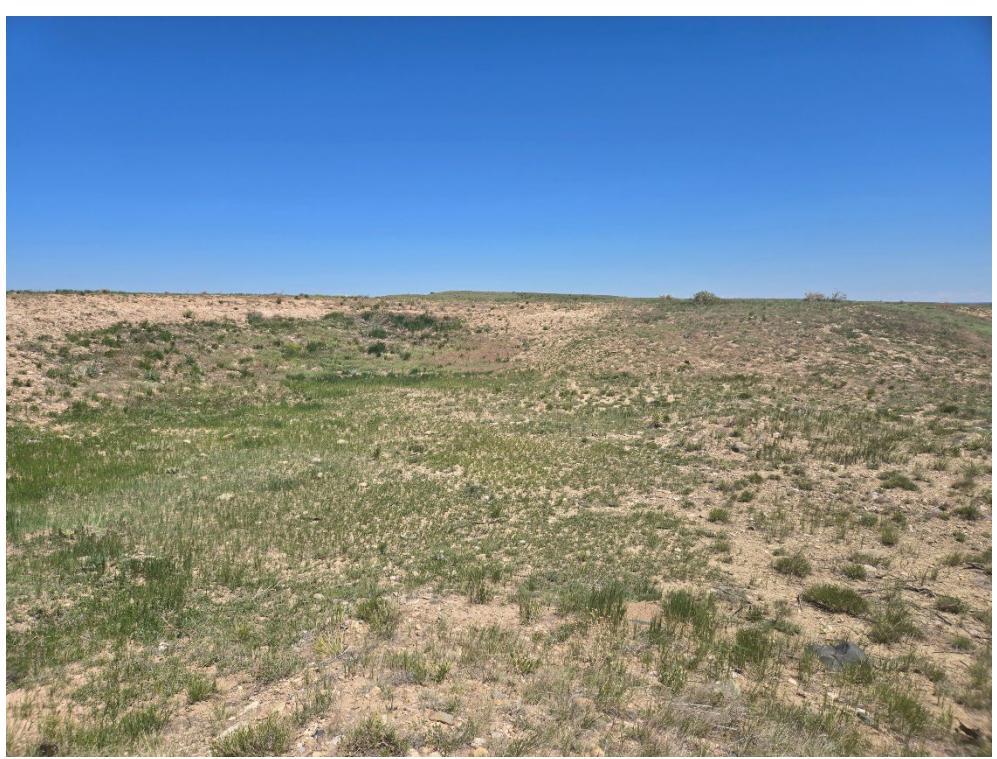
Photo 2: Looking at where the highwall has been backfilled and graded. The vegetation around it is well established but this area could use some additional cover.

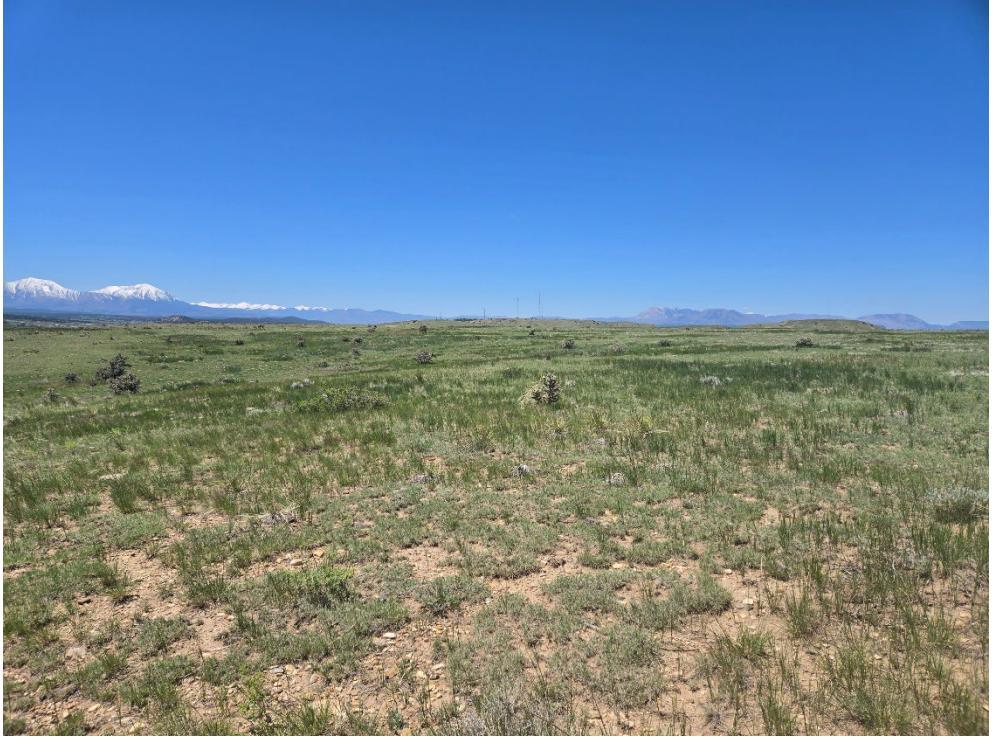
Photo 3: Looking west at the undisturbed area within the permit boundary.

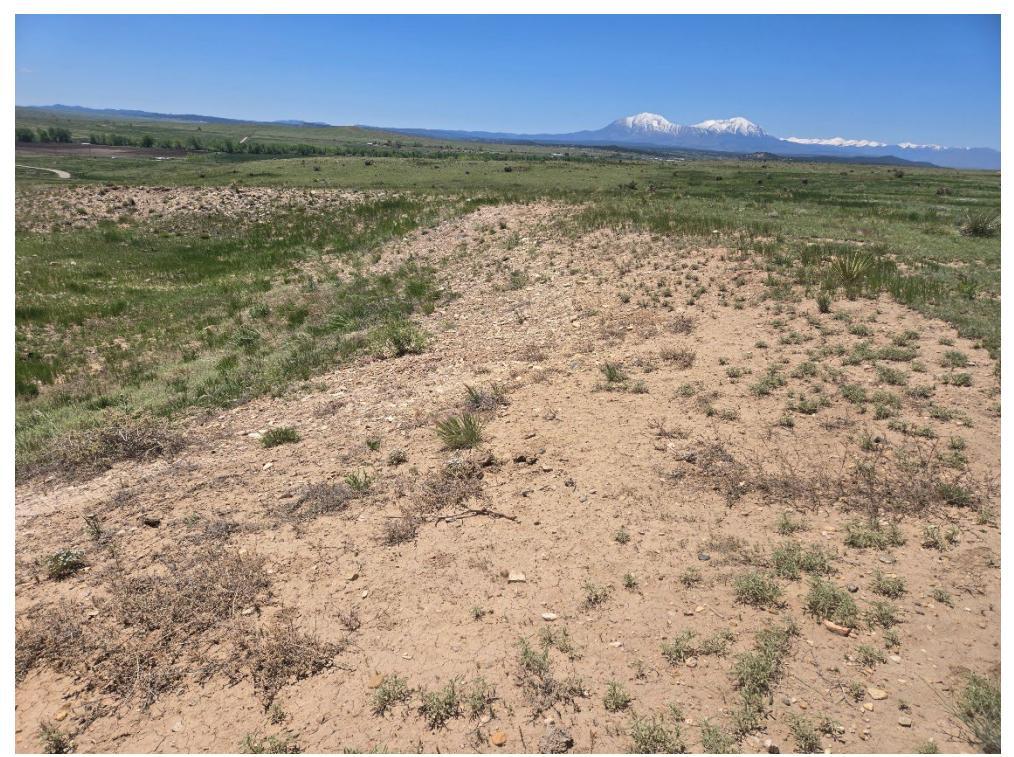
Photo 4: Looking west along the recently backfilled and graded highwall.

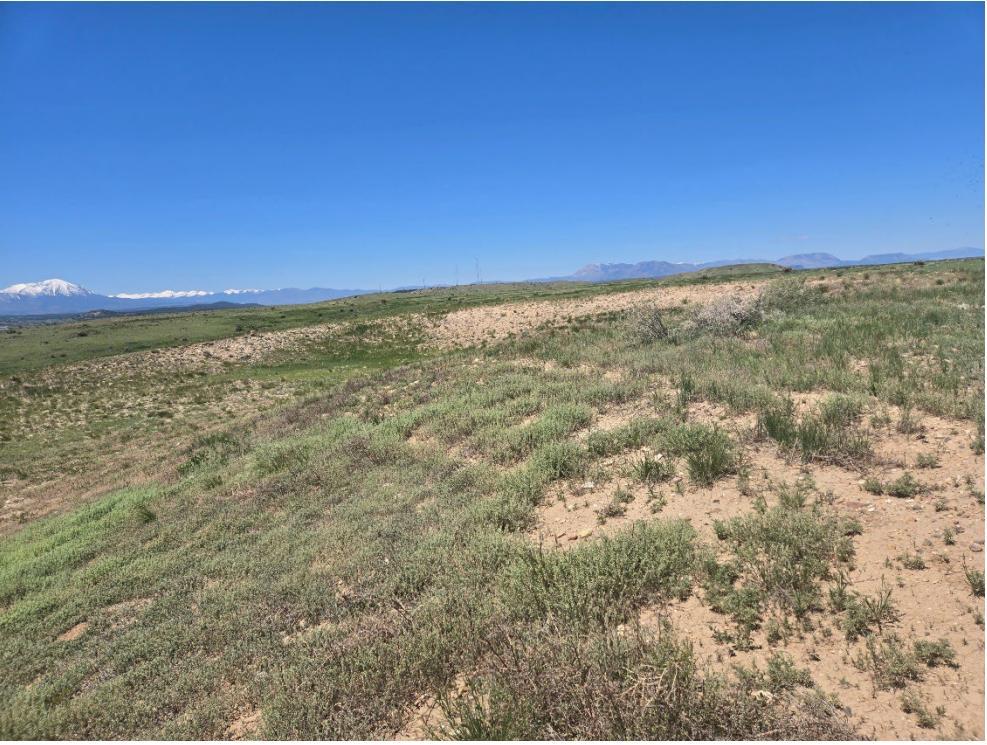
Photo 5: Looking west along the recently backfilled and graded highwall. The slope to the east that has been backfilled and graded for awhile has well established vegetation.

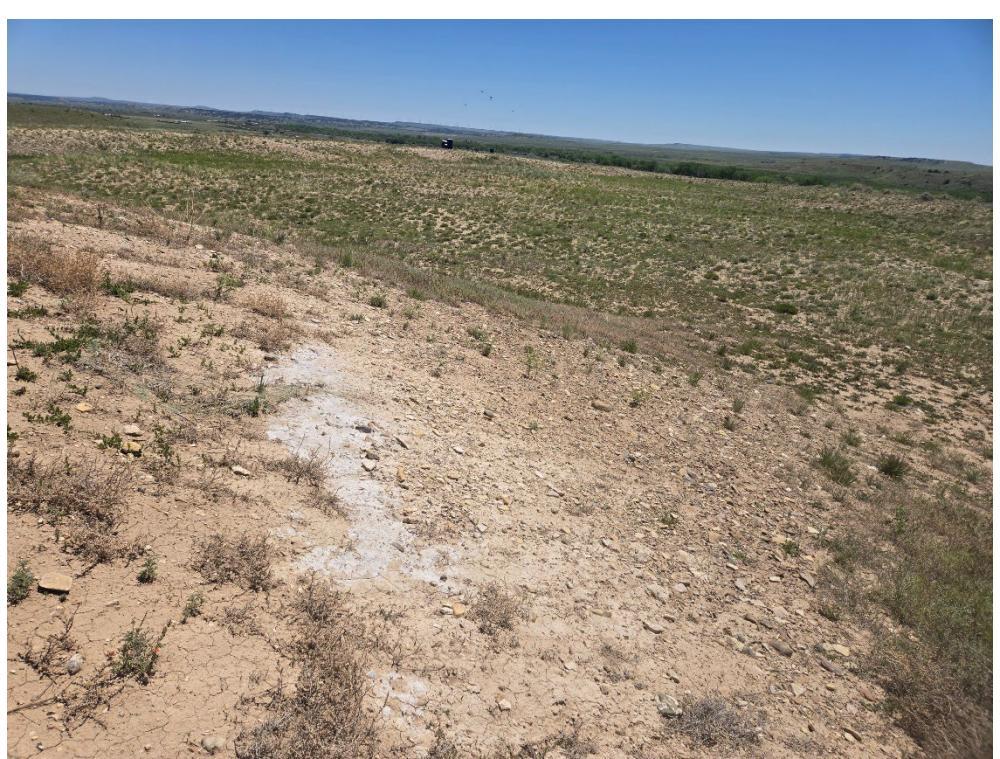
Photo 6: Looking east at an area along the north side of the disturbed area that requires additional revegetation.

The site has not been active since at least 2017. The Division's 2021 report states that the Operator representatives stated that they no longer wished to mine at the site. I had conversations with the current Operator representative (Mr. Moore) in 2023 and 2024 where he stated that they wanted to seek the permit's release. After this inspection, it appears that it will soon be eligible for release, but there are a few areas – including the recently backfilled and graded highwall – that require more vegetation growth. The Operator is advised to spread some seeds this fall in the sparse areas, being careful not to disturb the diverse vegetation established throughout the rest of the site. The Operator shall re-visit the site next spring and monitor vegetation growth before filing for the permit's release.

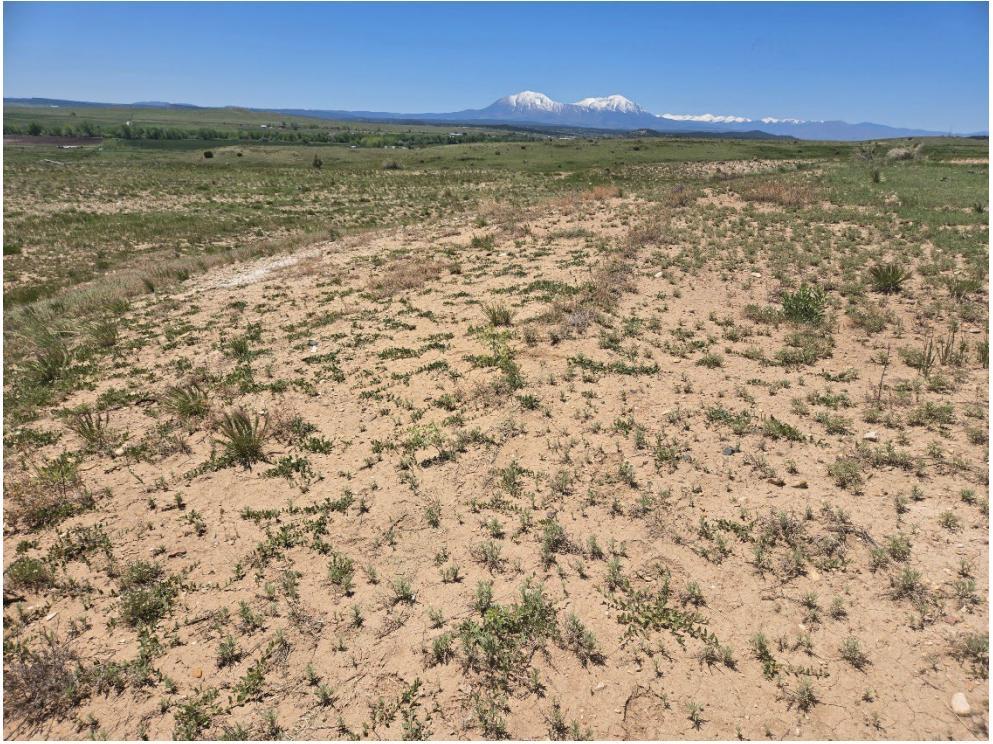
Photo 7: Looking west at an area along the north side of the disturbed area that requires additional revegetation.

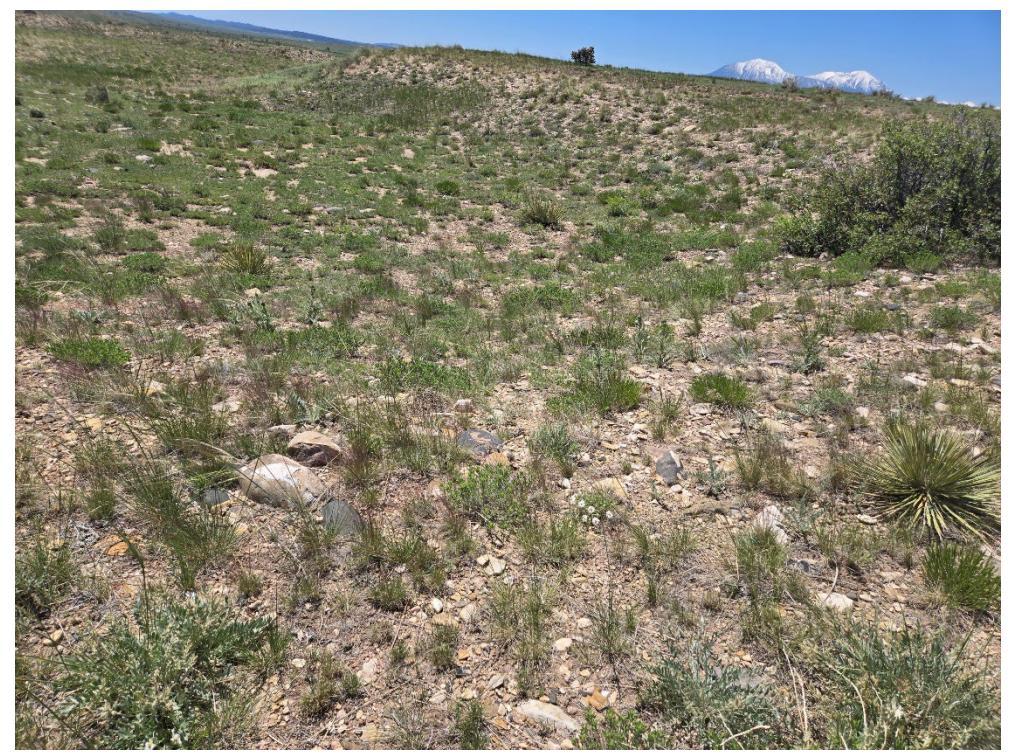
Photo 8: Looking at the diverse vegetation established along the northeast corner of the disturbed area.

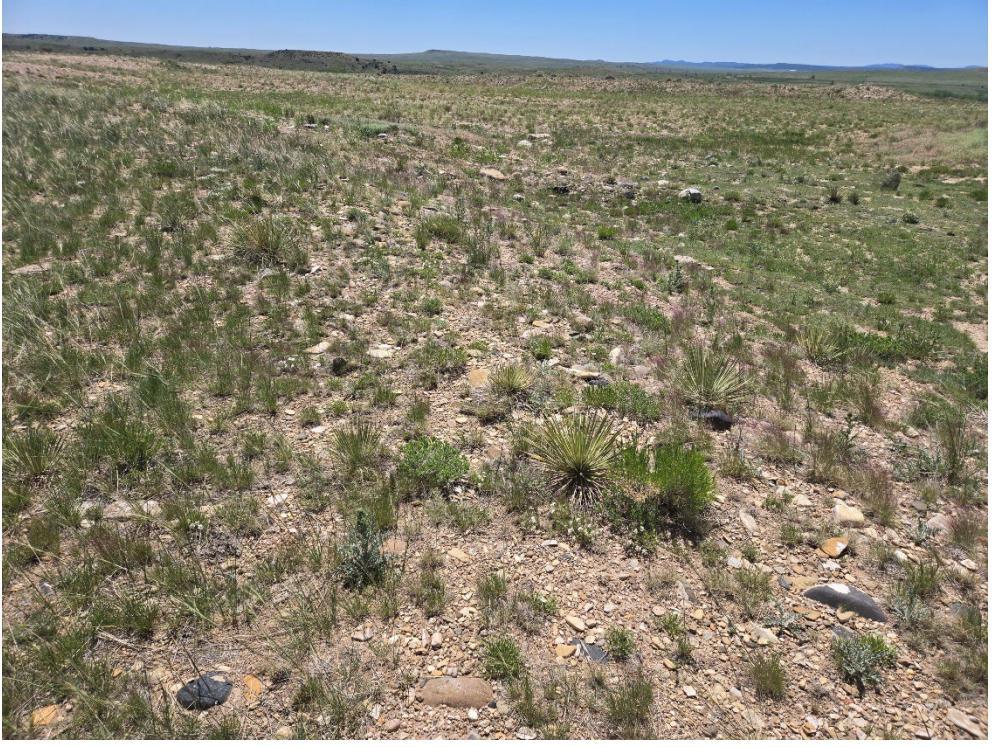
Photo 9: Looking south at the diverse vegetation established along the northeast corner of the disturbed area.

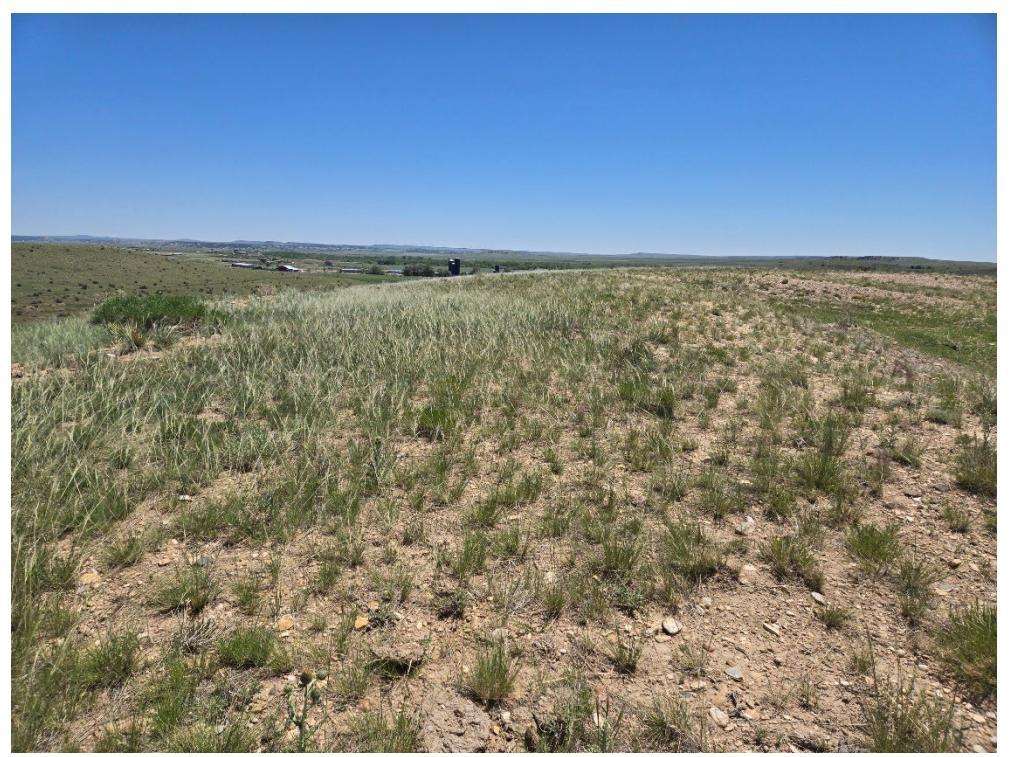
Photo 10: Looking at the diverse vegetation established along the eastern edge of the disturbed area.

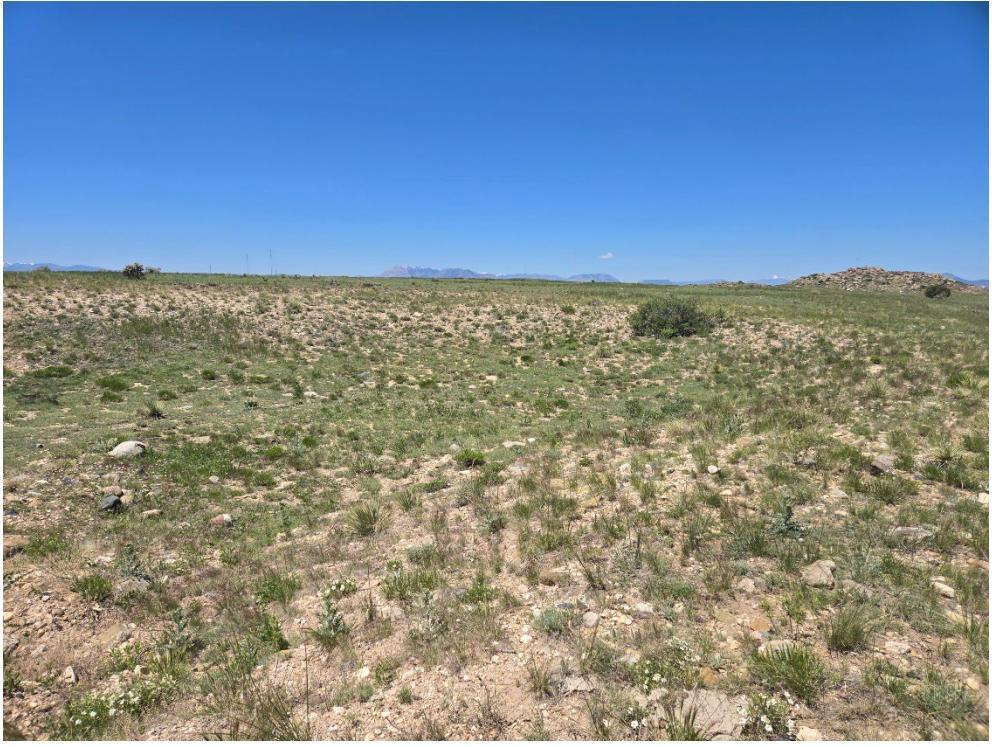
Photo 11: Looking at reclaimed slopes and the diverse vegetation established along them.

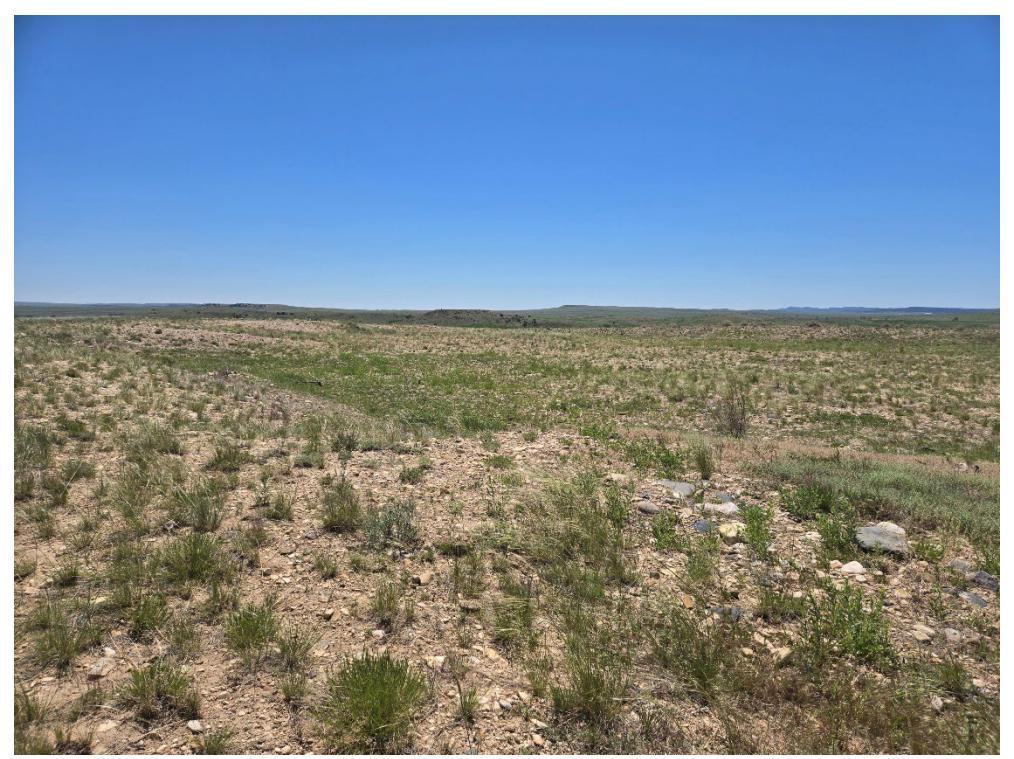
Photo 12: Looking at the gentle sloping reclaimed areas that have diverse vegetation established.

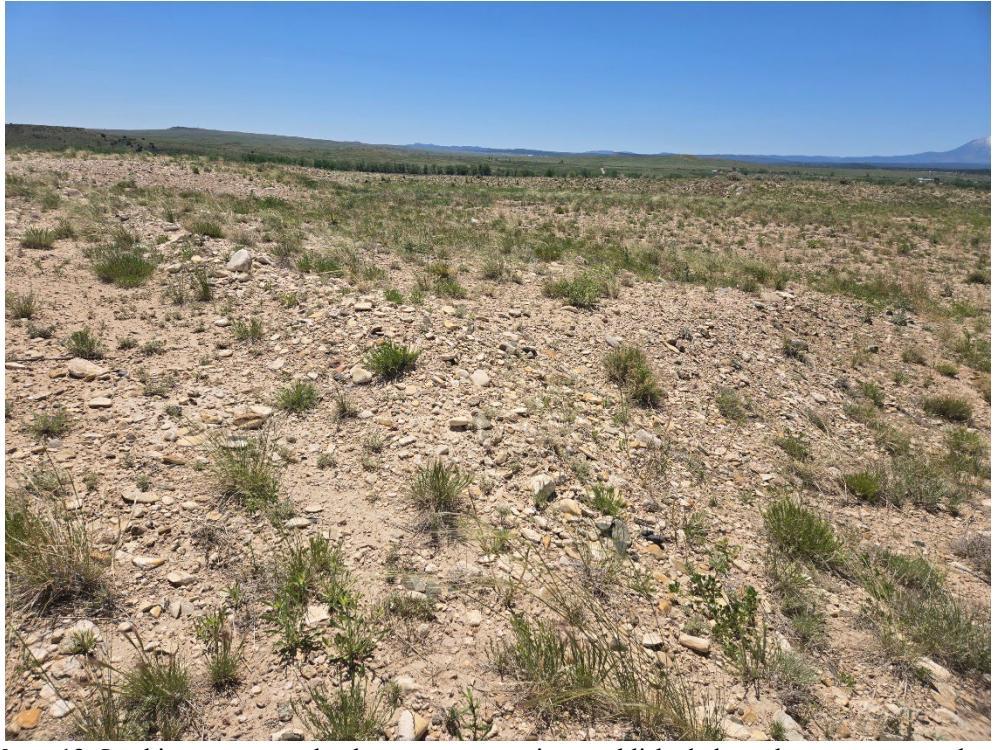
Photo 13: Looking at an area that has some vegetation established along the eastern most slope.

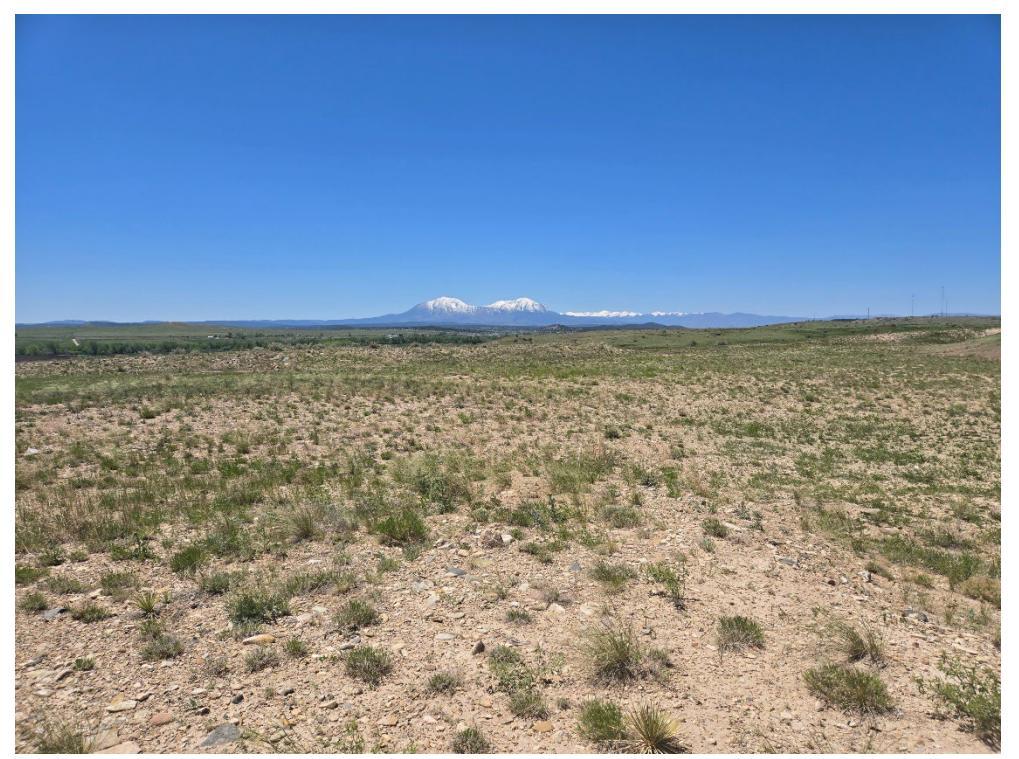
Photo 14: Looking at an area that has some vegetation established along the eastern most slope.

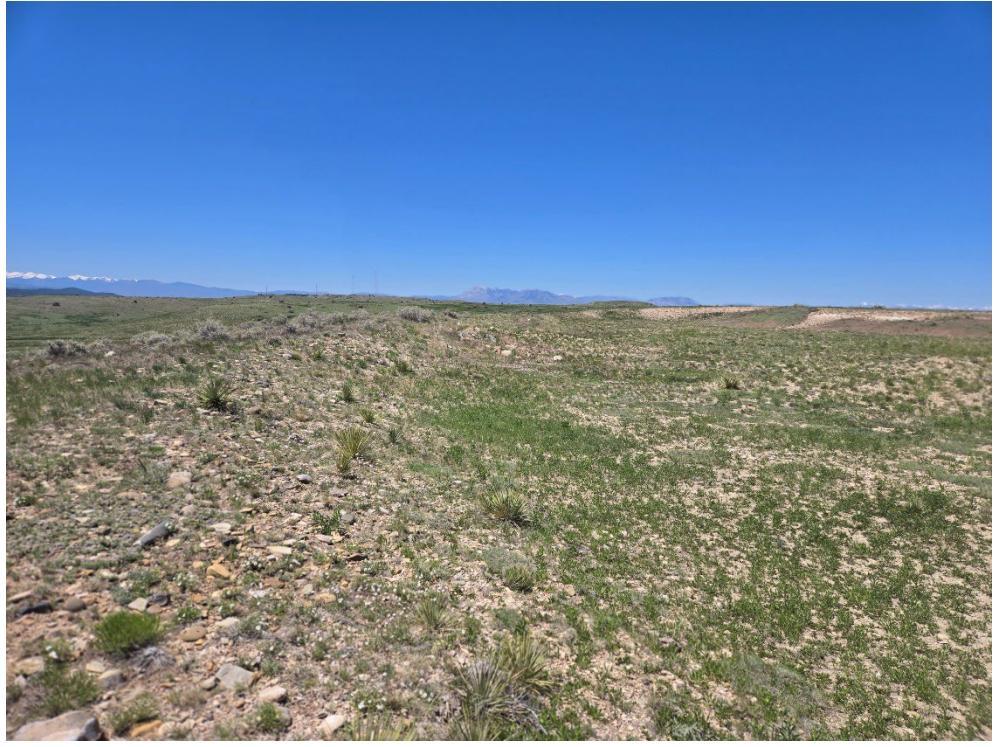
Photo 15: Looking along the southern sloped area where vegetation has become well established.

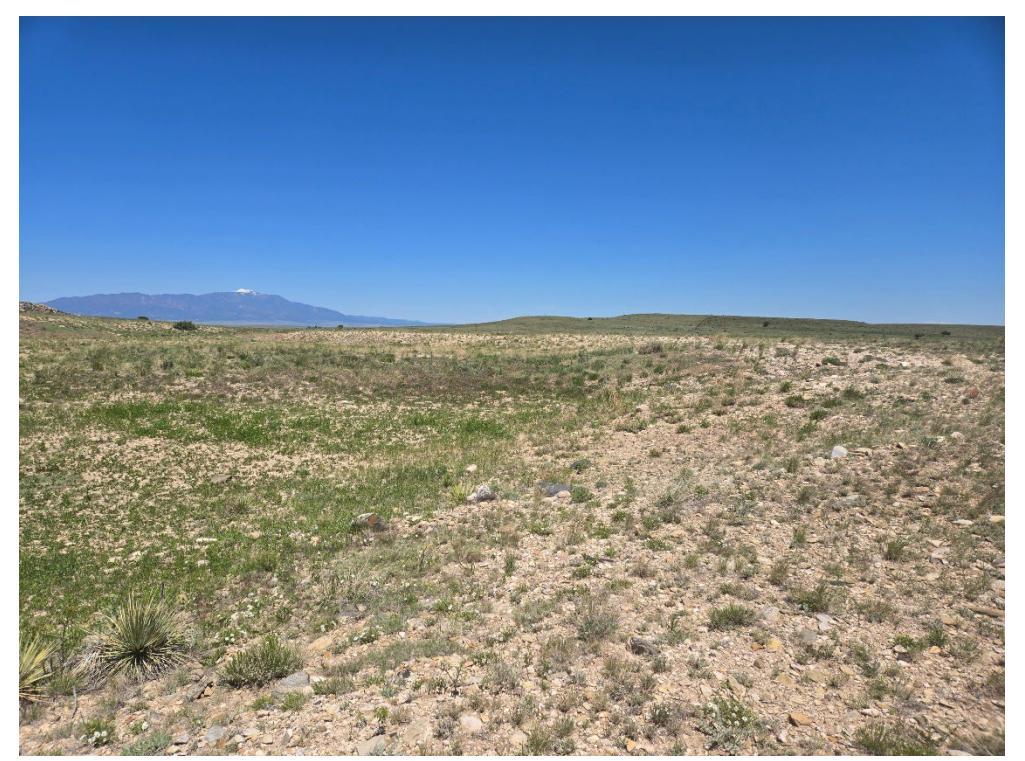
Photo 16: Looking along the easter sloped area where vegetation has become pretty established.

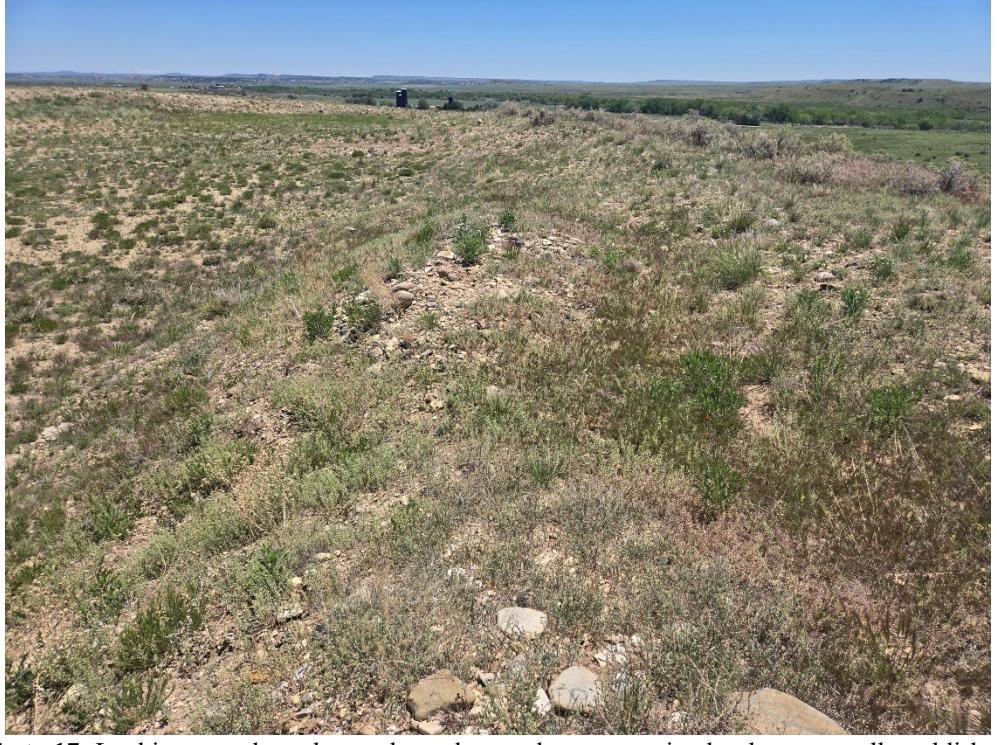
Photo 17: Looking east along the southern slopes where vegetation has become well established.

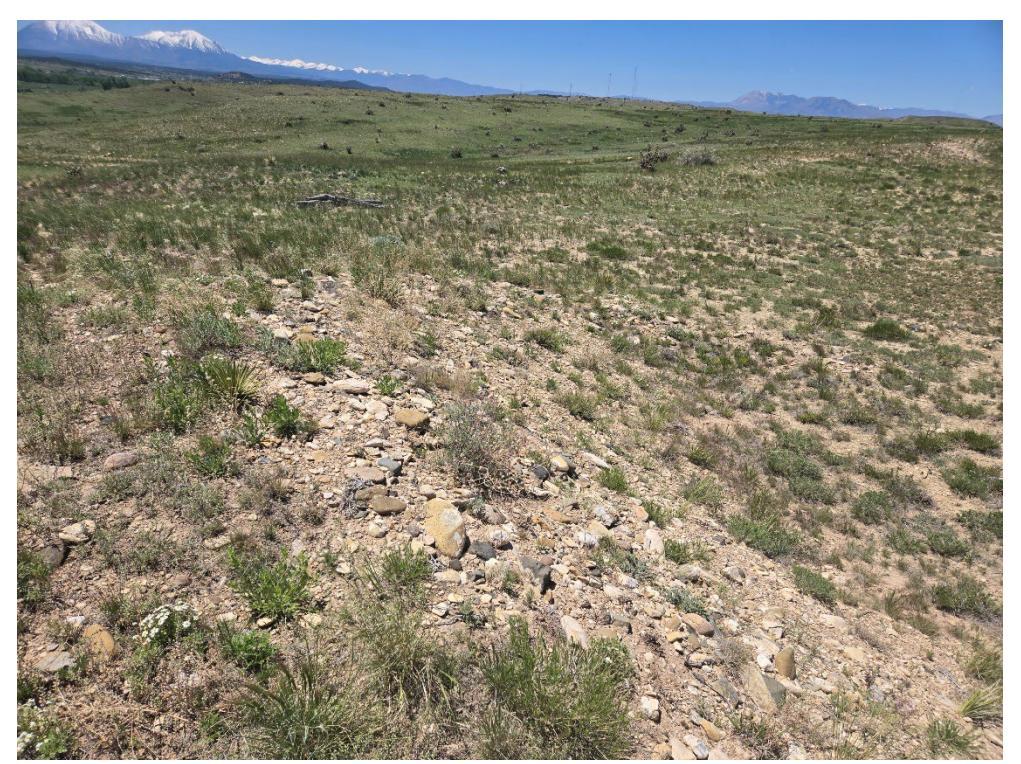
Photo 18: Looking west along the southern slopes where vegetation has become well established.

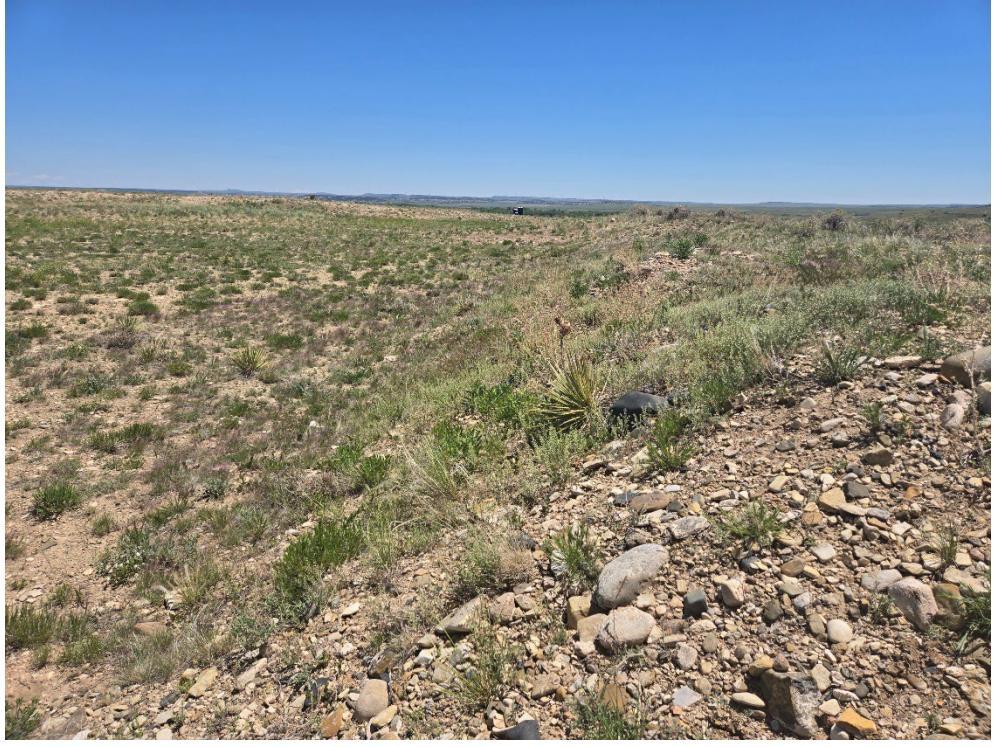
Photo 19: Looking east along the southern slopes where vegetation has become well established.

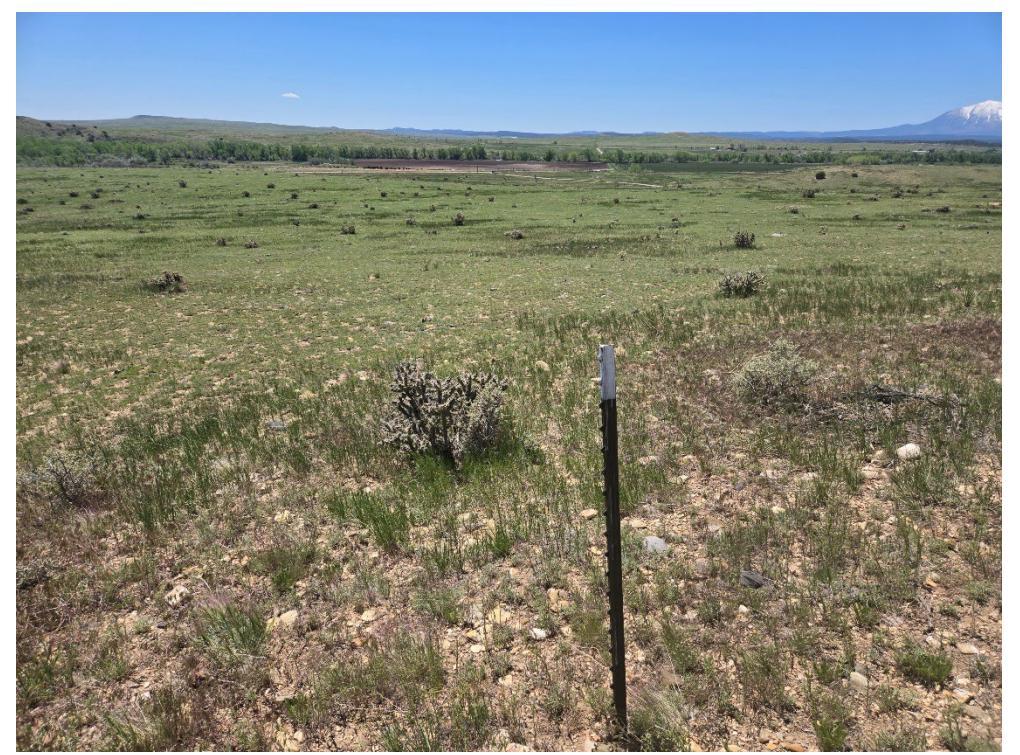
The mine sign mentioned at the 2021 inspection was not observed. **This has been cited as a problem above.** The Operator shall provide evidence that a sign in compliance with Rule 3.1.12(1) is posted at the site by the corrective actions date. T-posts marking the permit boundary were observed around the site and were posted in compliance with Rule 3.1.12(2).

Photo 20: One of the t-posts marking the permit boundary around the site.

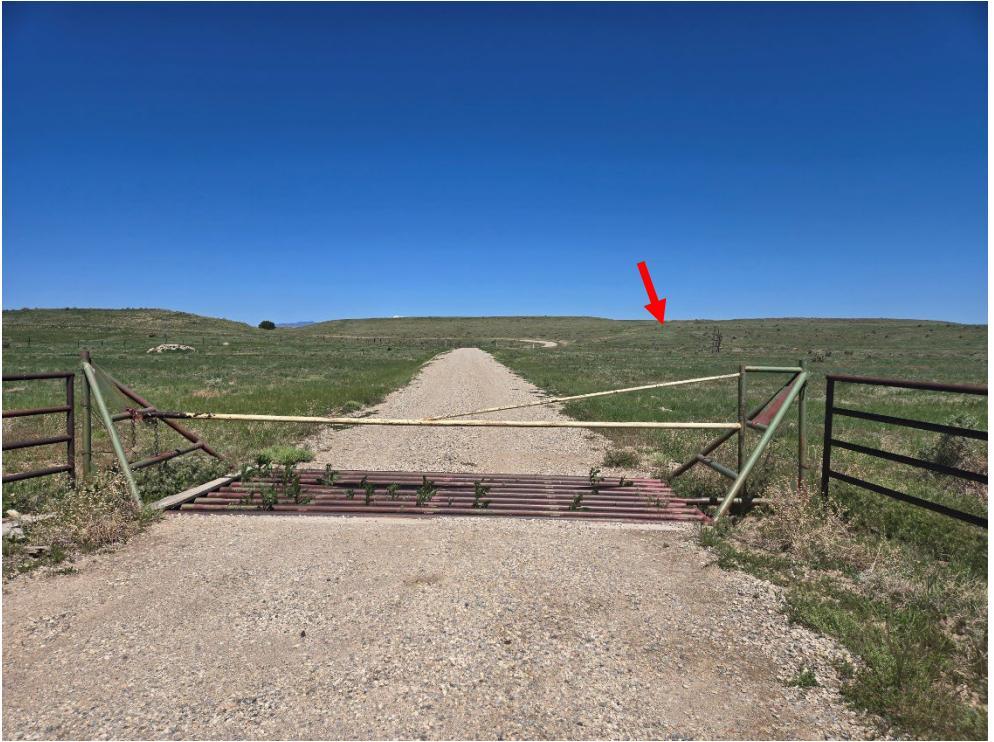
Photo 21: Locked gate at the entrance to both the Walsenburg Gravel Pit and the Lone Tree Pit. The red arrow points to where the Walsenburg Gravel Pit is located just over the ledge.

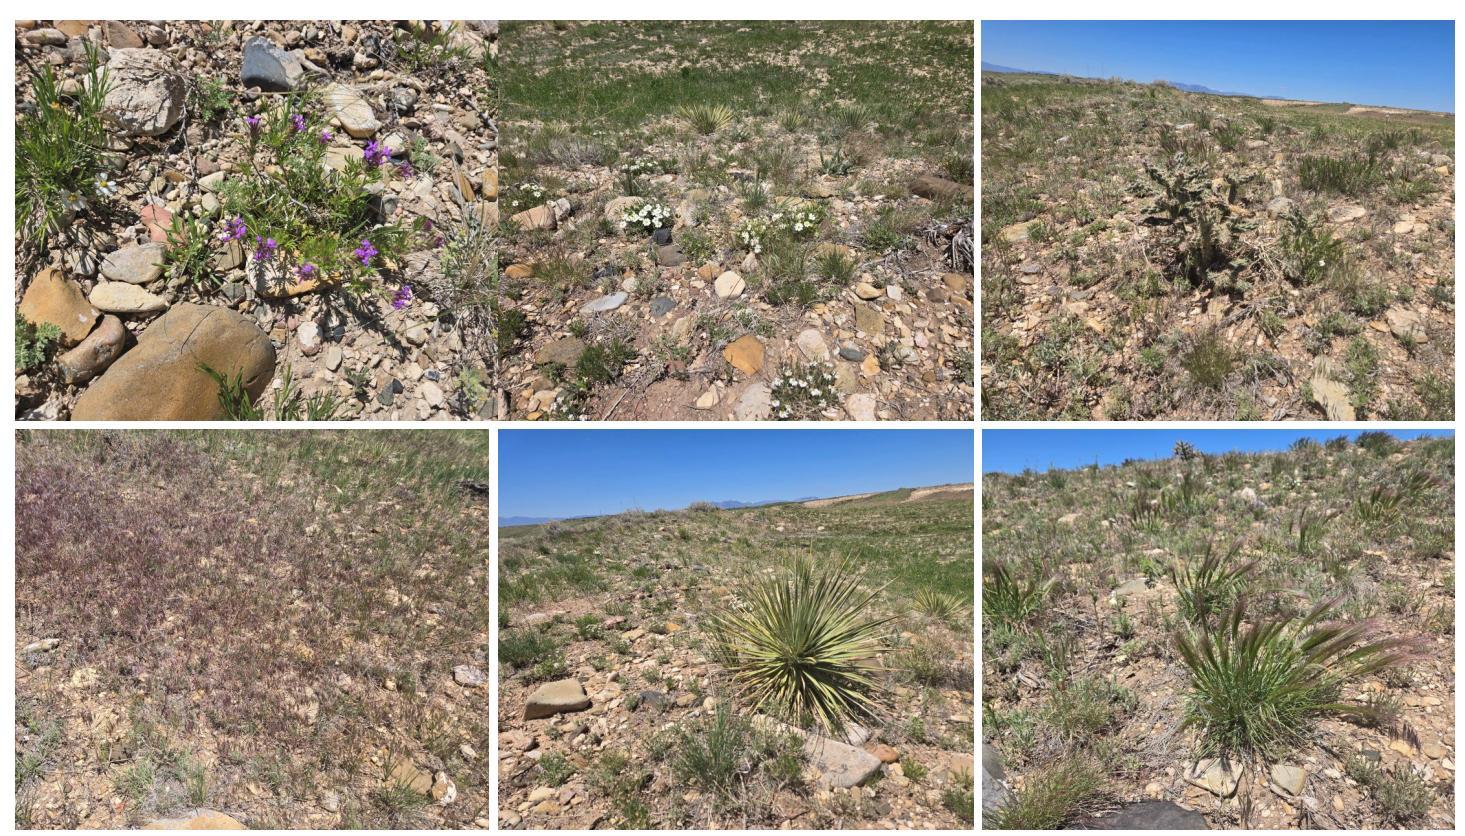
Photo 22: Examples of some of the diverse vegetation established within the site.
