MINERALS PROGRAM INSPECTION REPORT PHONE: (303) 866-3567

MINE NAME:	MINE/PROSPECTING ID#:	MINERAL:	COUNTY:
Stone Canyon Quarry	M-2012-018	Stone	Boulder
INSPECTION TYPE:	WEATHER: Raining	INSP. DATE:	INSP. TIME:
Surety Release Inspection		April 25, 2025	09:00
OPERATOR:	OPERATOR REPRESENTATIVE:	TYPE OF OPERATION:	
Stone Canyon Quarry, LLC	Bernard Buster	112c - Construction Regular Operation	
REASON FOR INSPECTION:	BOND CALCULATION TYPE:	BOND AMOUNT:	
Surety Release Requested	Complete Bond	\$2,125.00	
DATE OF COMPLAINT:	POST INSP. CONTACTS:	JOINT INSP. AGE	NCY:
NA	None	None	
INSPECTOR(S):	INSPECTOR'S SIGNATURE:	SIGNATURE DAT	Έ:
Patrick Lennberg	Patrick Lg	June 24, 2025

PERMIT #: M-2012-018 INSPECTOR'S INITIALS: JPL INSPECTION DATE: April 25, 2025

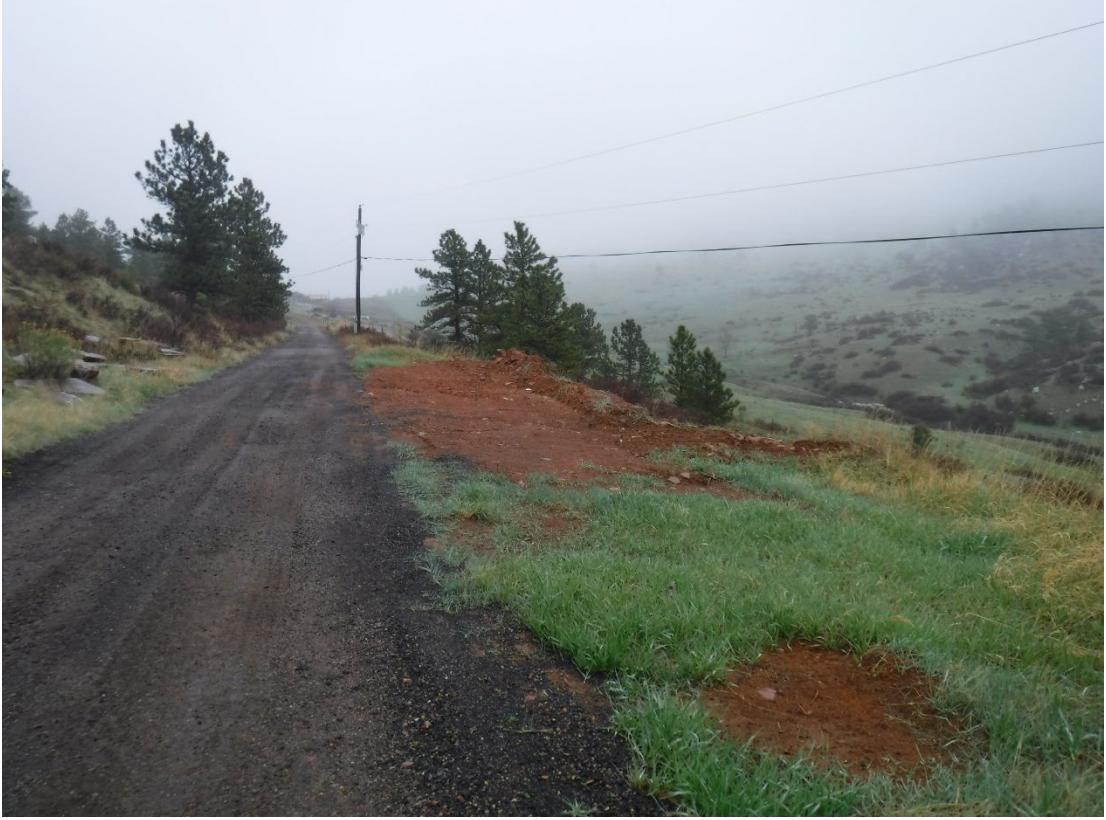
Photo 1: Location where material was being stored

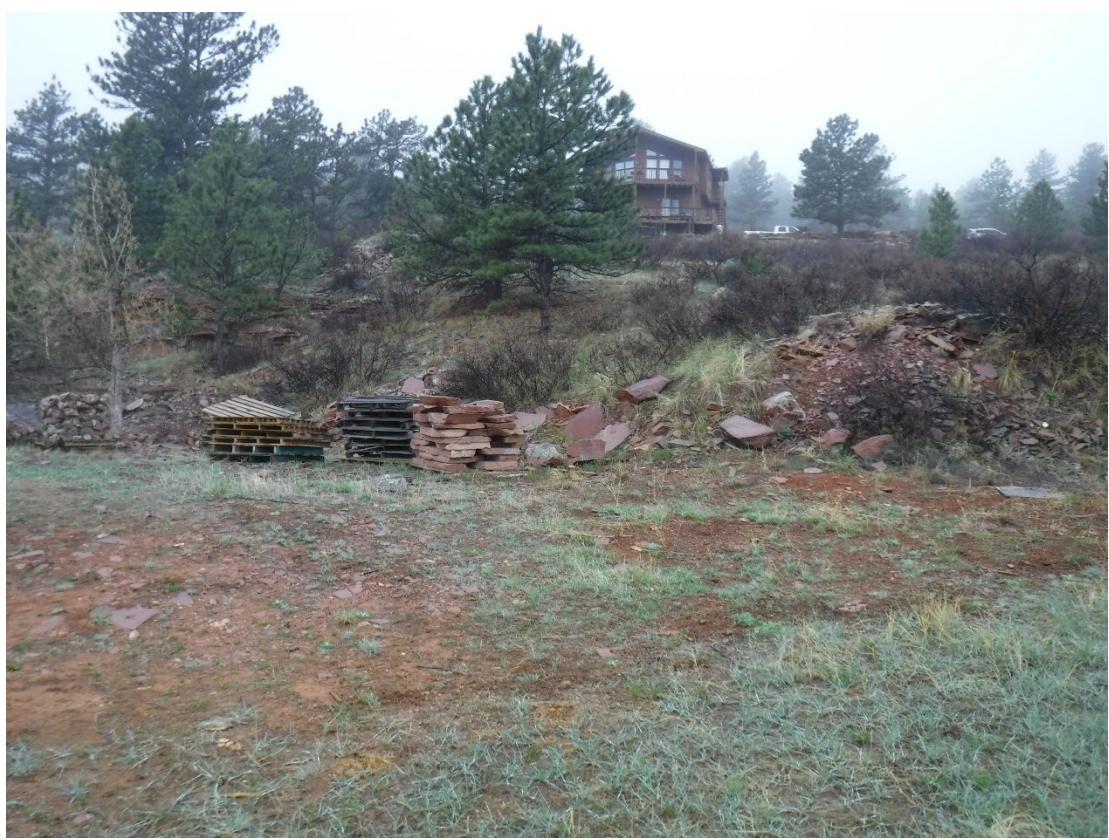
Photo 2: Storage area, palletized material cannot be moved because the pallets have fallen apart

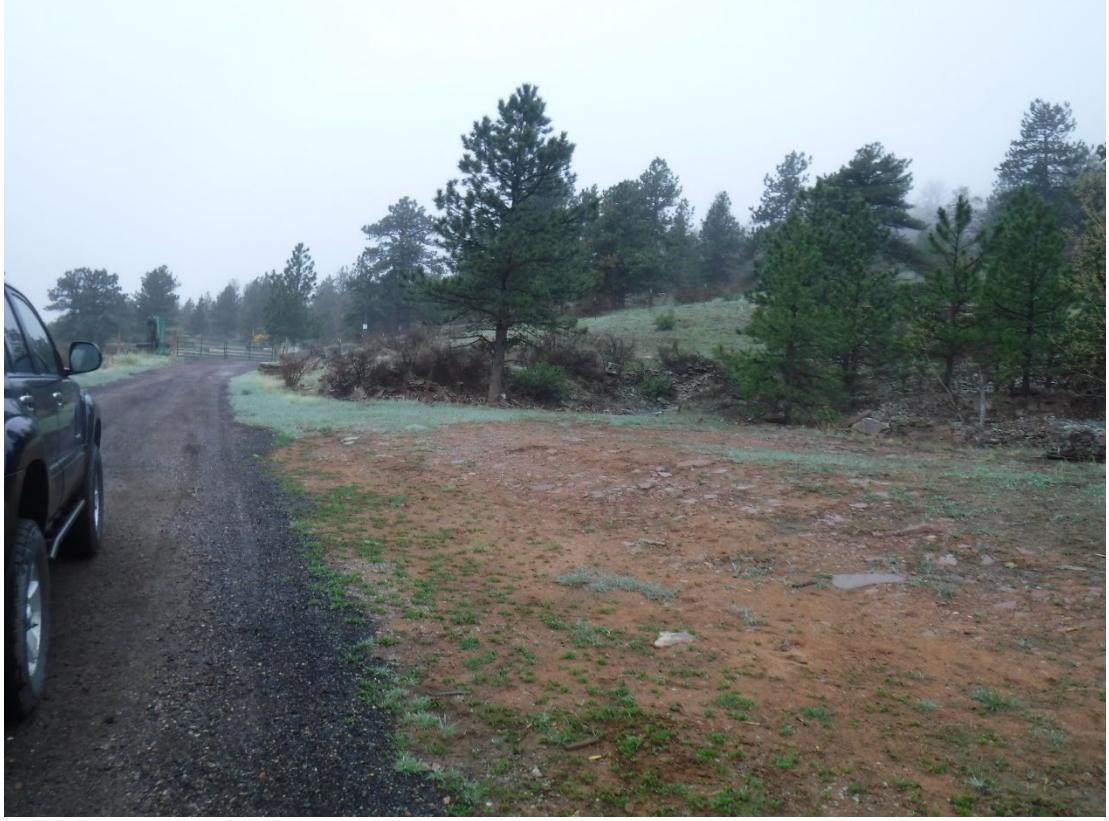
Photo 3: Storage area, looking south along access road

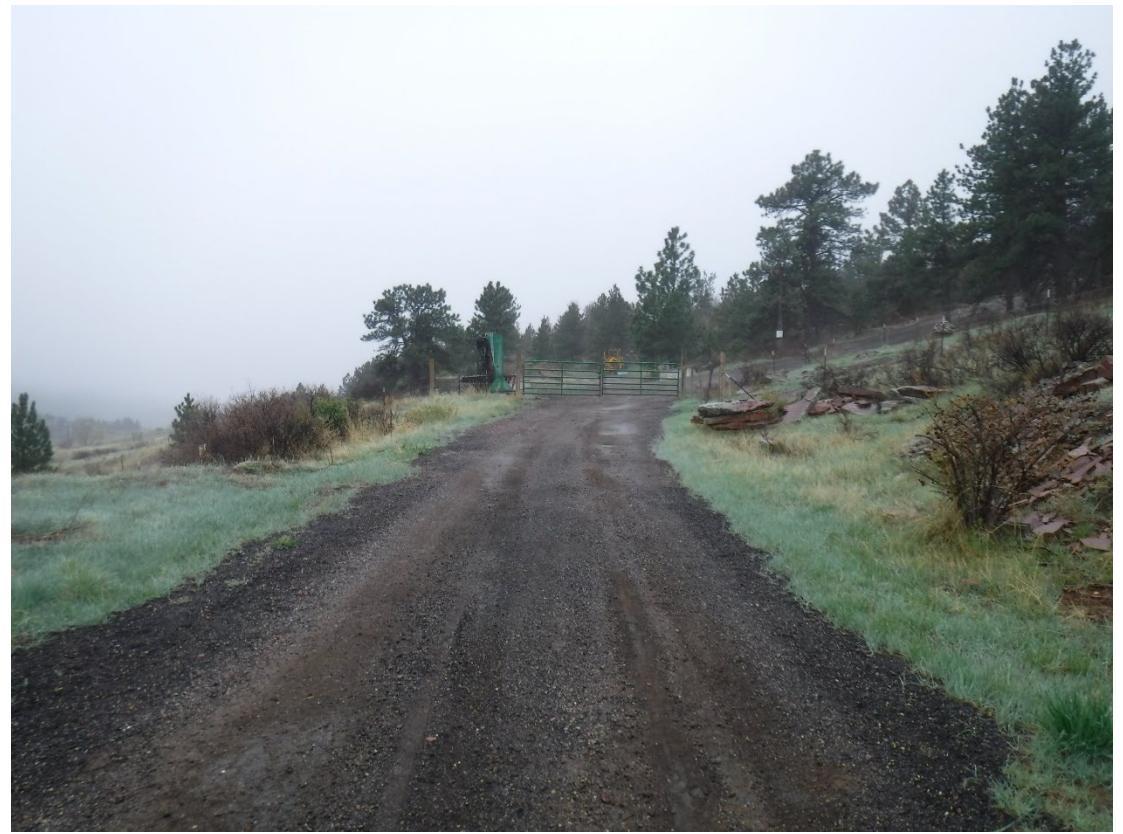
Photo 4: Access road leading to mined area, gate is used to access neighboring permit M1981-075

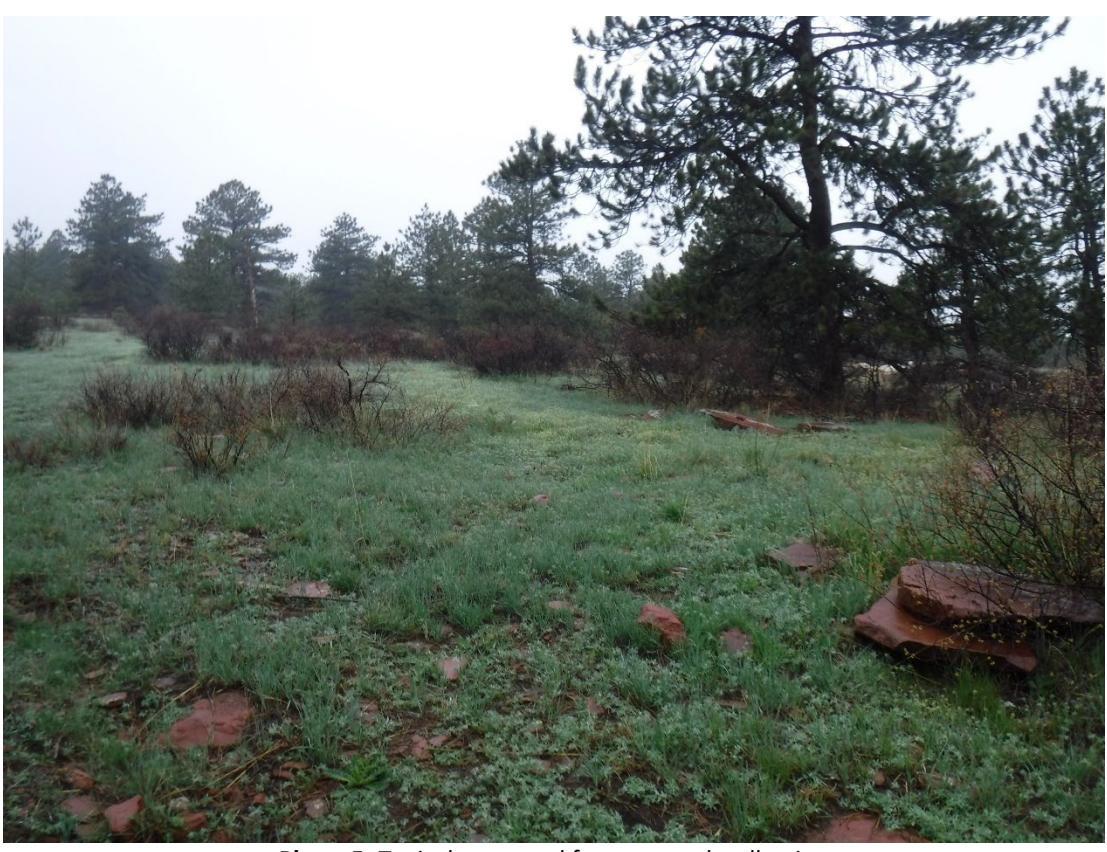
Photo 5: Typical area used for moss rock collection

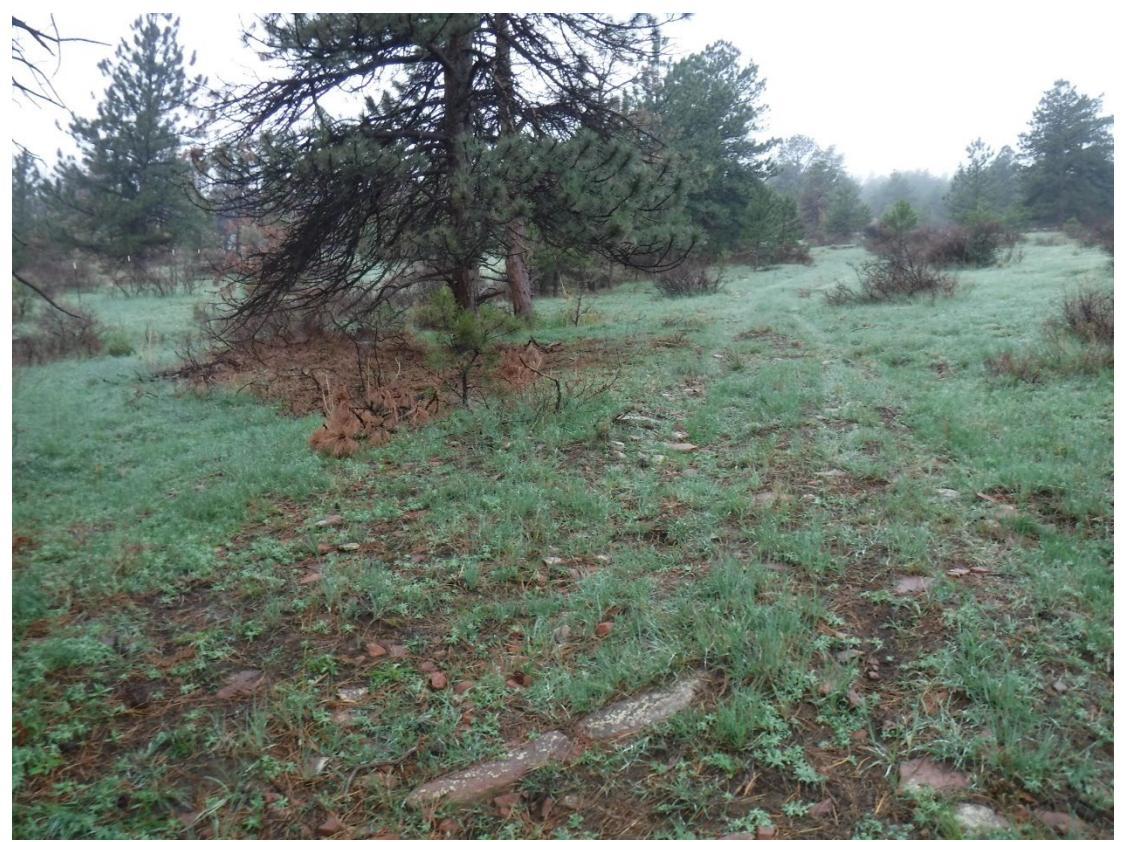
Photo 6: Looking west uphill along the access road used to transport moss rock

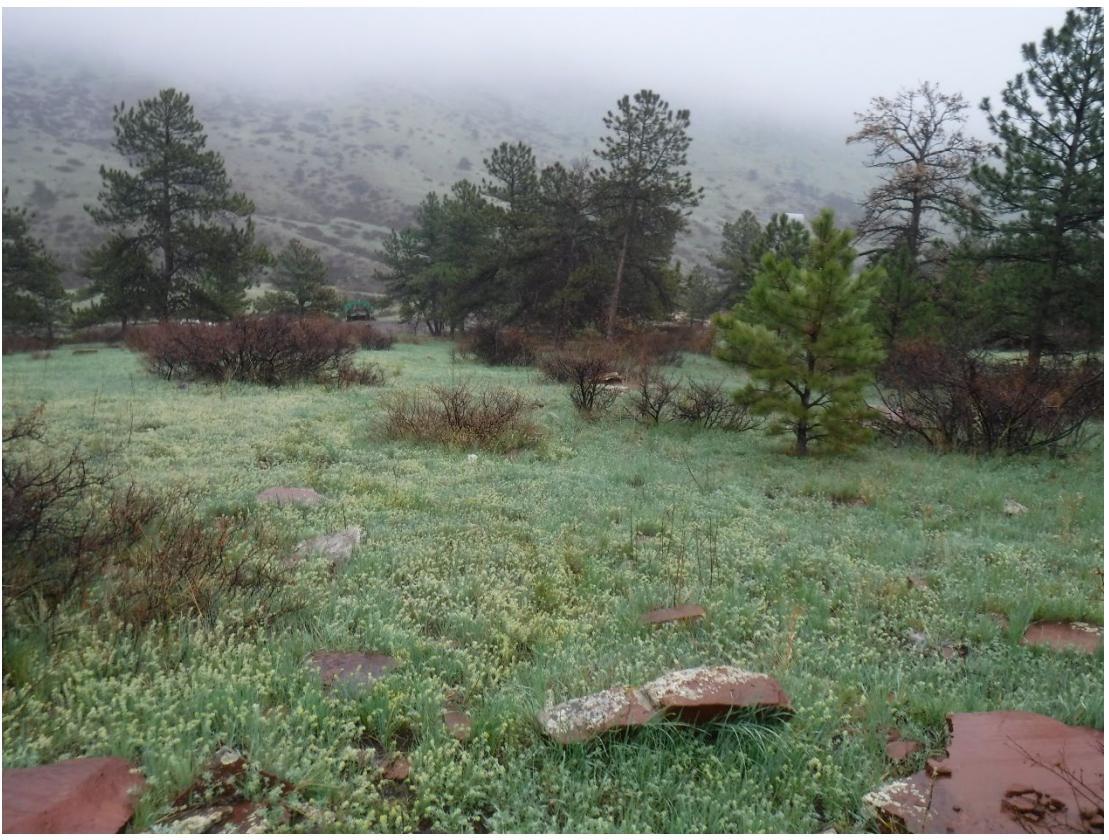
Photo 7: Looking downhill across areas used for moss rock collection

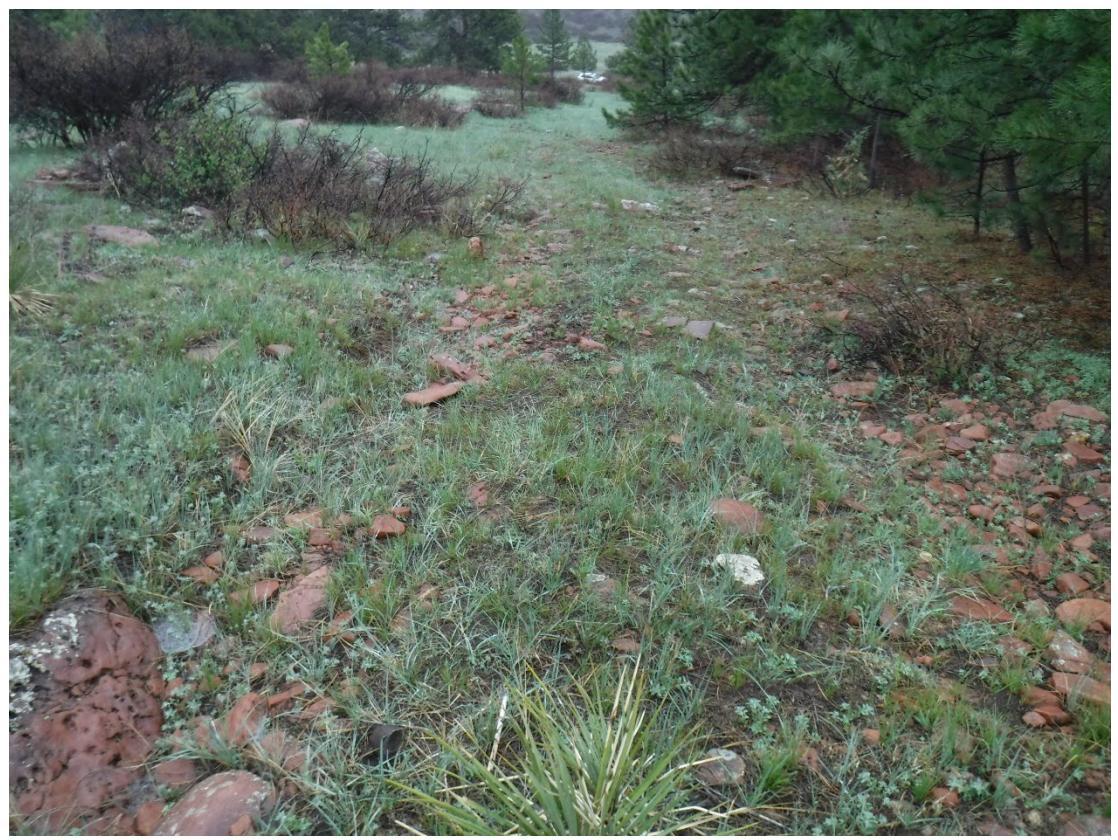
Photo 8: Looking east downhill along the access road used to transport moss rock

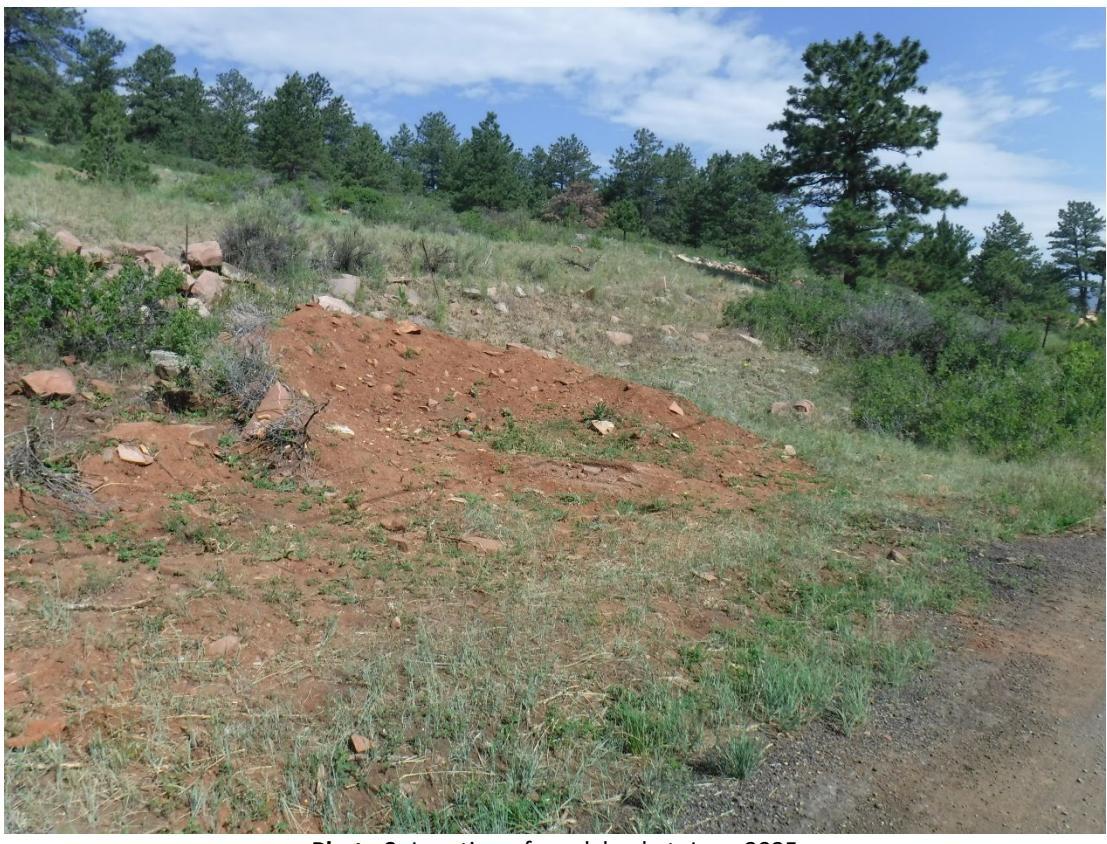
Photo 9: Location of muck bucket, June 2025

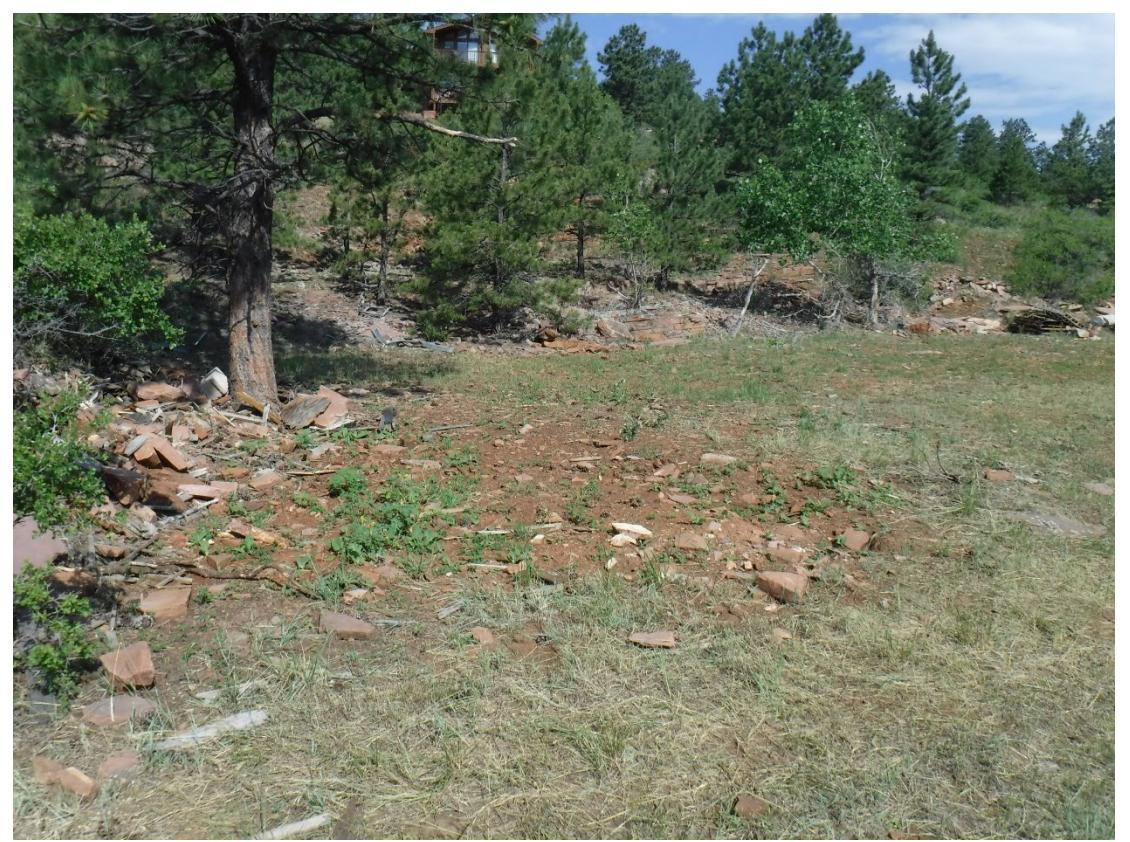
Photo 10: Storage location of marketable material that has been removed, June 2025

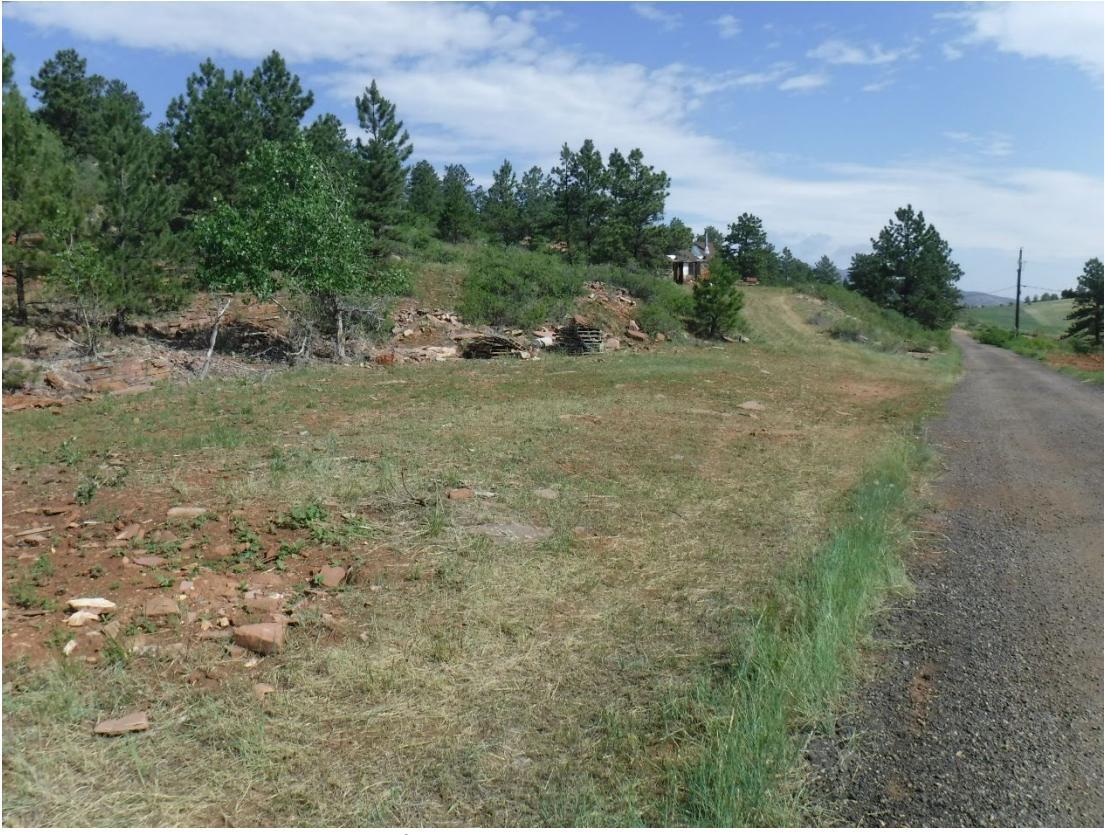
Photo 11: Storage location of marketable material that has been removed, June 2025

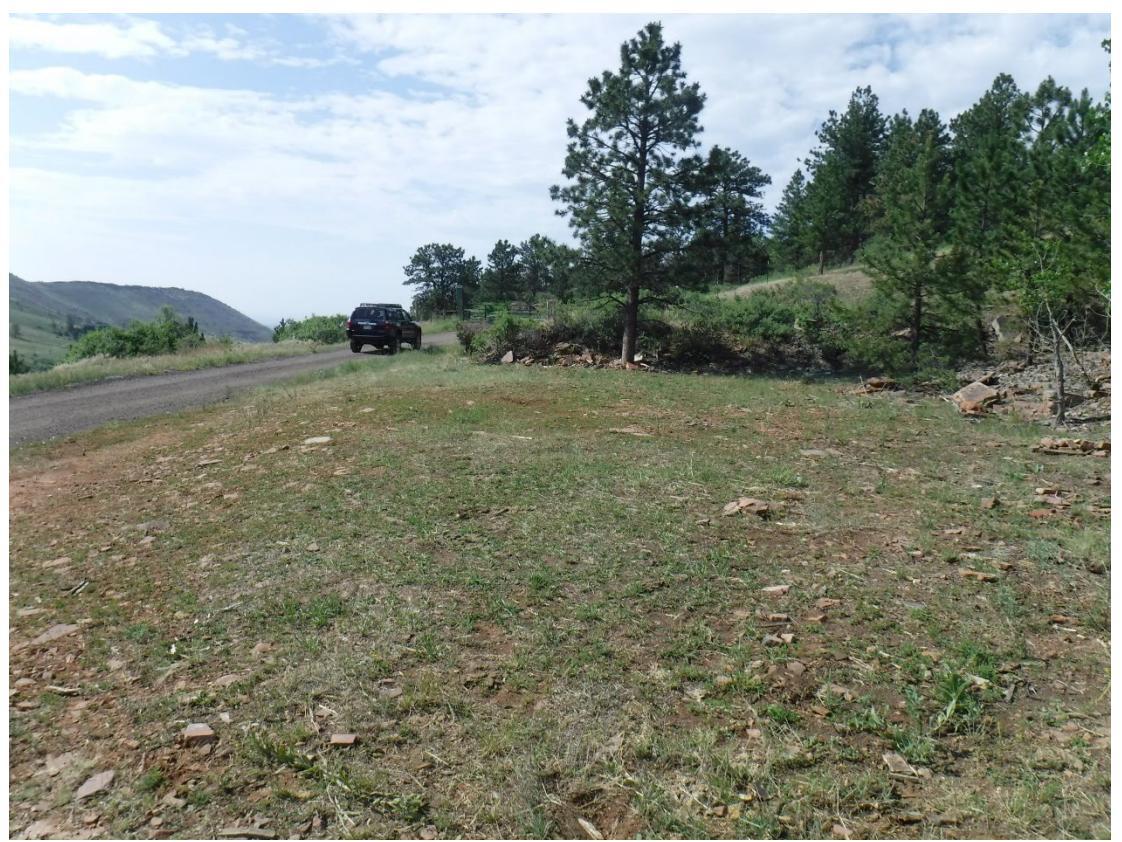
Photo 12: Storage location of marketable material that has been removed, June 2025
