RE: COLORADO YULE MARBLE - 5th PORTAL EXPANSION, M-1999-058, TR-01

NEW PORTAL TECHNICAL EVALUATION

Yule Marble Quarry Colorado – U.S.A.

OCTOBER 2011

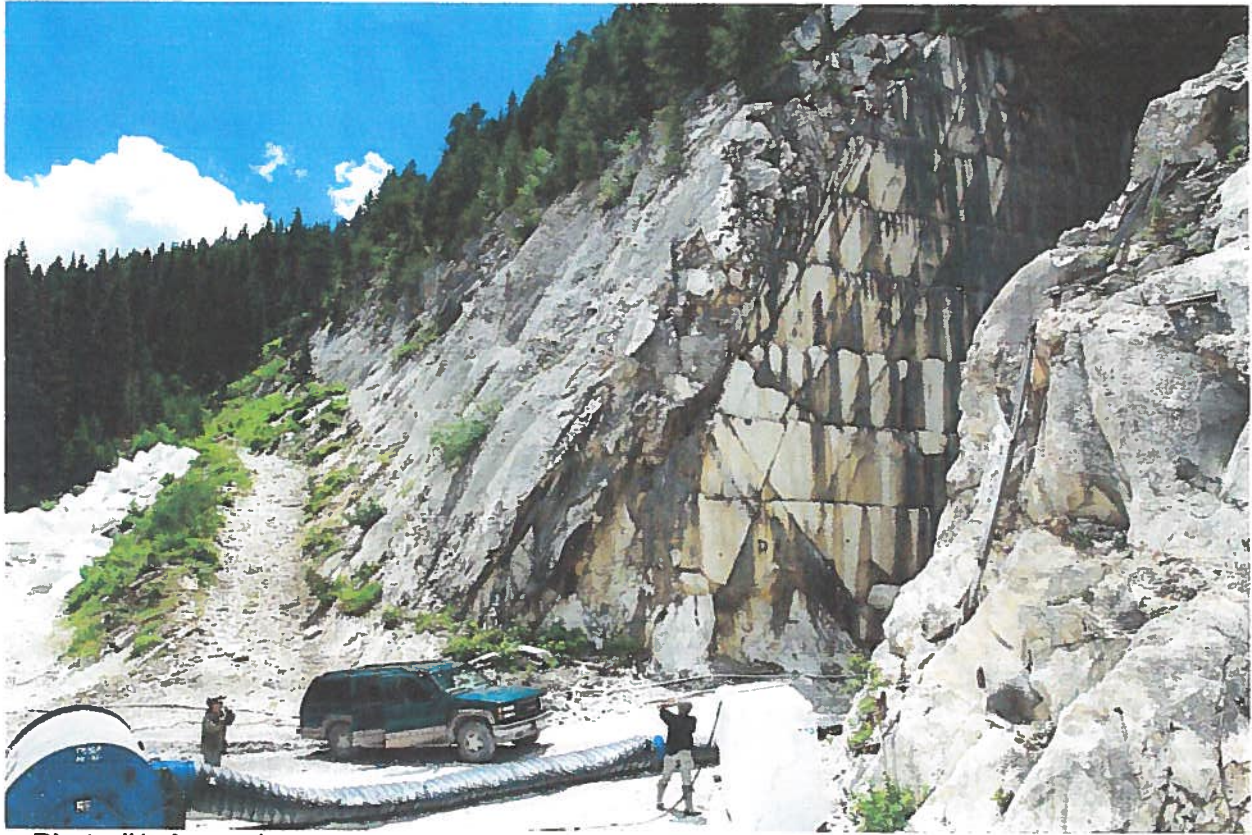
The wall exposed at the newly programmed opening (see photo below) consists of bare rock for about 60 feet above the projected working surface and consists of a naked fracture surface cleared from the weather.

Rock is quite competent and formed by marble. All the surface where the new opening will be excavated is clear from other important fractures, which does it mean that the work could be expected safe.

Looking photo #1 it is possible to observe that this kind of superficial natural fractures are parallel to each other for more or less 25-30 ft and disappear inside the rock mass. Geologically speaking this fractures can be interpreted as fractures of relaxation sub parallel to mountainside elongated in NW-SE direction and dipping like mountainside 60°-65° in E direction.

Due to their direction and being sub parallel to opening direction, they form a sort of arch on the opening roof ensuring this way a good stability of it. This observation and marble good competence ensure together stability of new portal.

Anyway is quite simple take a comparison with other existing portal, particularly #3, which are very wider then new one, see i.e. photo #1, and to date can be considered safe although excavated for decades.

Photo #1. Approximate position new portal

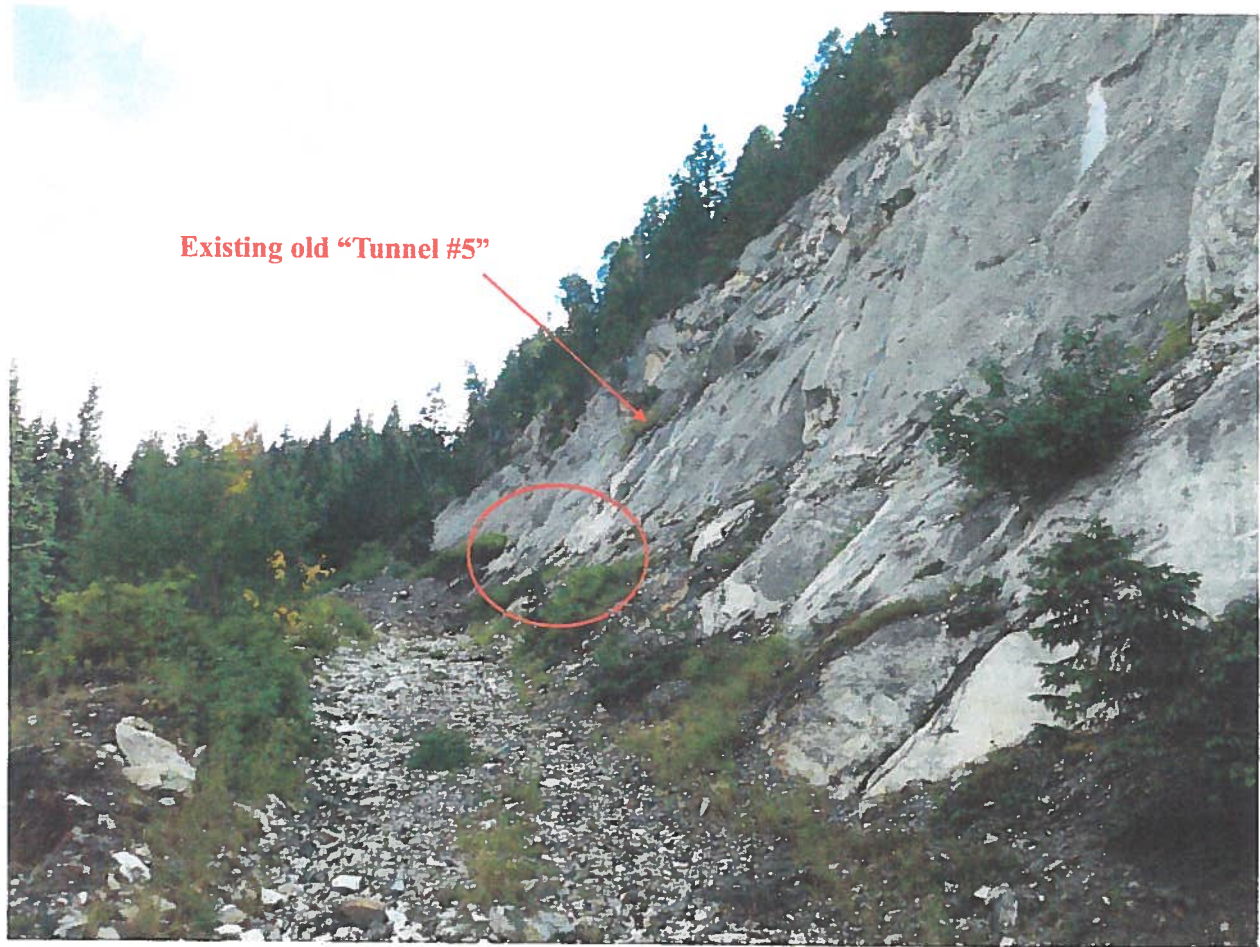
Photo #2. New opening position

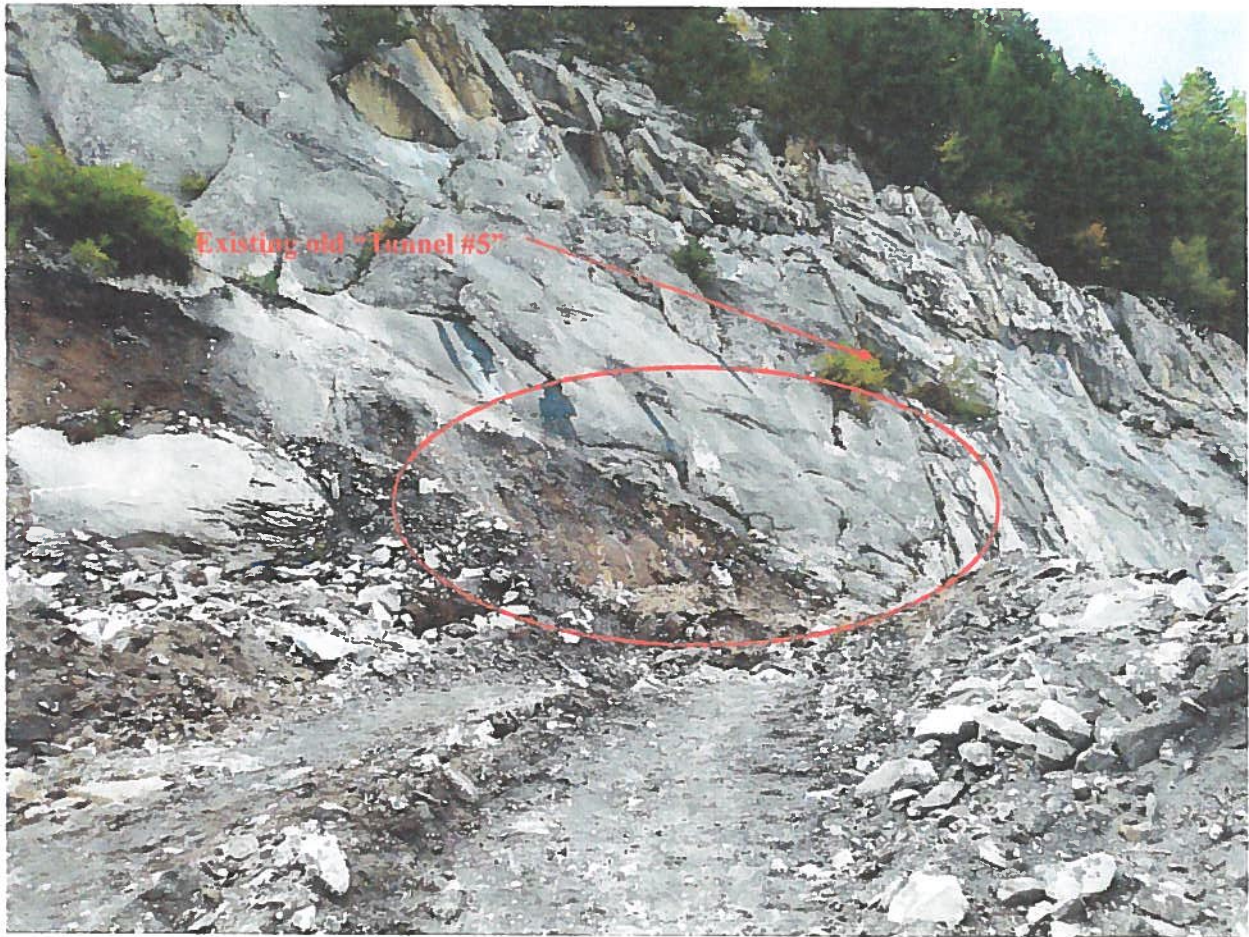
Photo #3. New portal position.

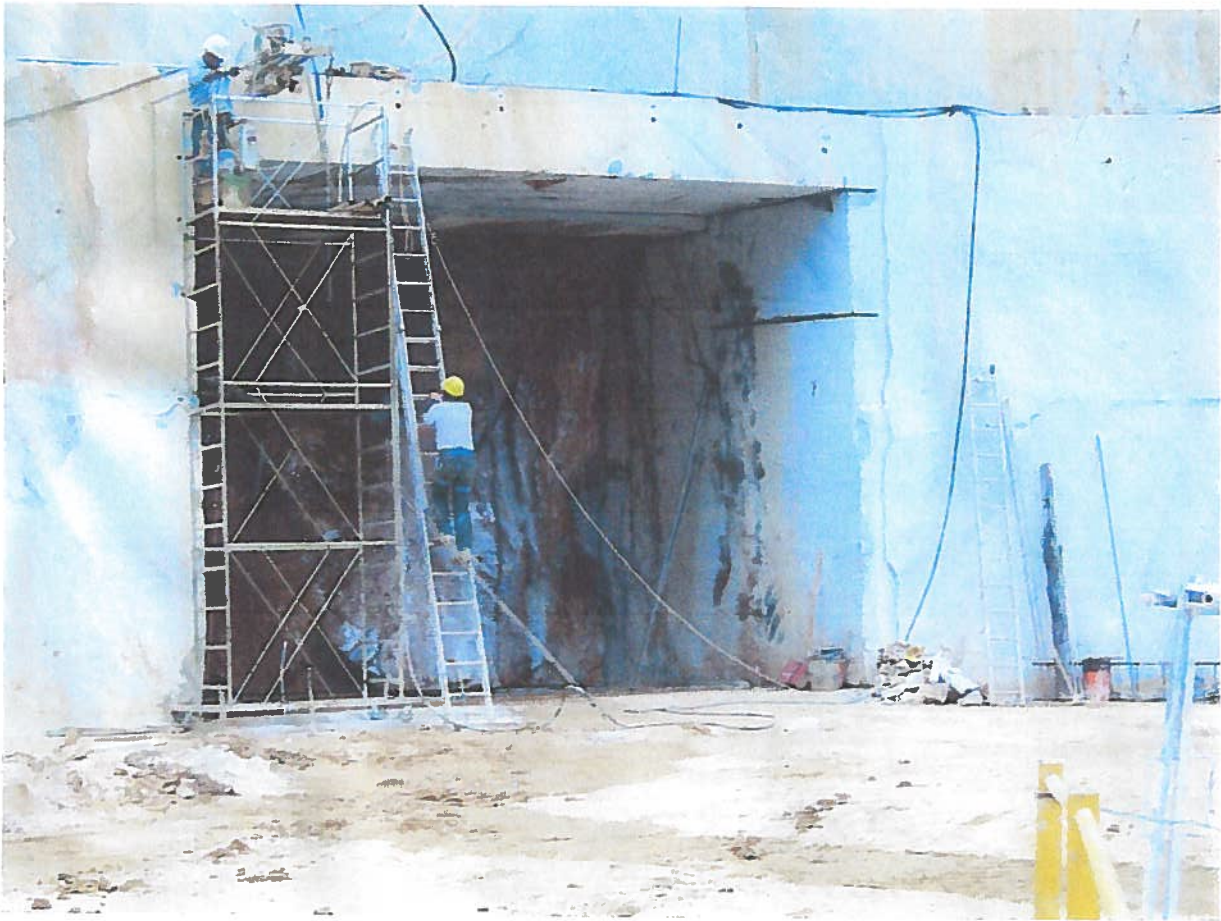
Photo #6. Typical consolidation application in a new portal in a marble quarry (Carrara, Italy)

Particular attention anyway should be given to the first few meters of excavation progress as near free external surface could form blocks in roof beginning that need bolting or other consolidation operation if other fracture set intersect free surface. This is a normal procedure in all cases in which new openings are excavated and usually are verified after first cut is made and resulting blocks are removed (see photo # 6).
