April 30, 2012

Re: Comments on the Carnation Mine (M/1977/416) Bond Recalculation Estimate.

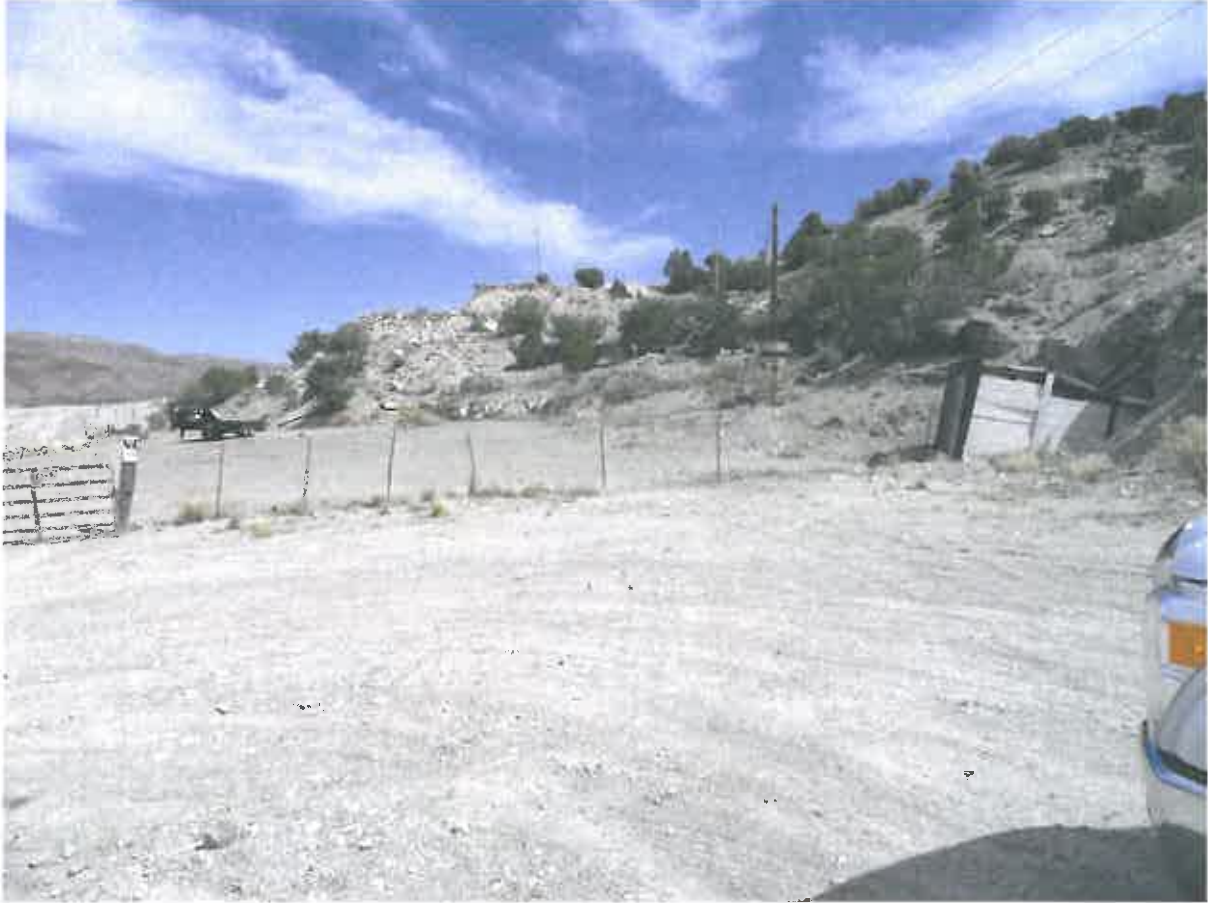
Photo 1.

- The Shop/Office building has been removed. See Photos 1 and 2.
- Photo 3 has been included to show the status at the old Carnation tire shop, reclaimed previously.

The Carnation yard with building removed. Trailer in photo is contractor conducting maintenance on storm water structures in the area.

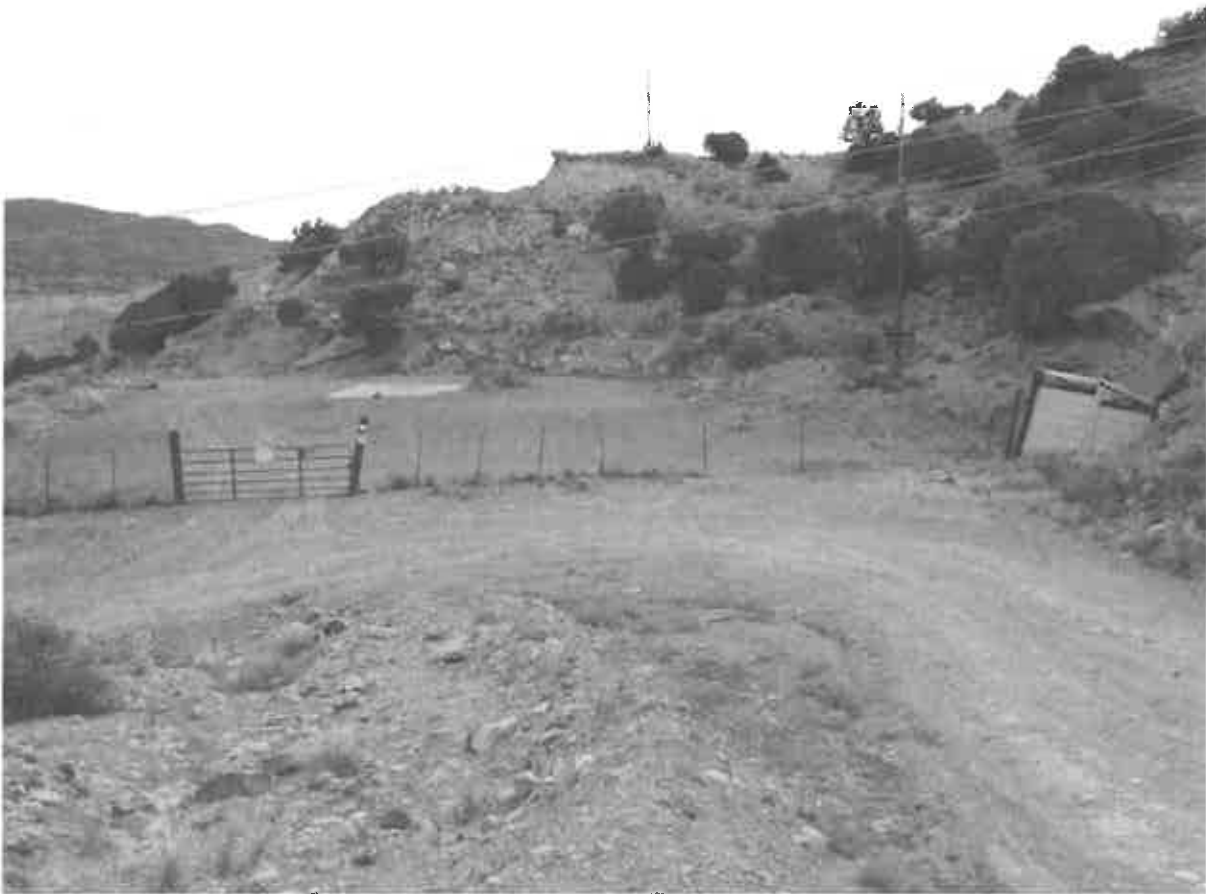
Photo 2.

Carnation Portal – Building removed – slab and portal entry remain.

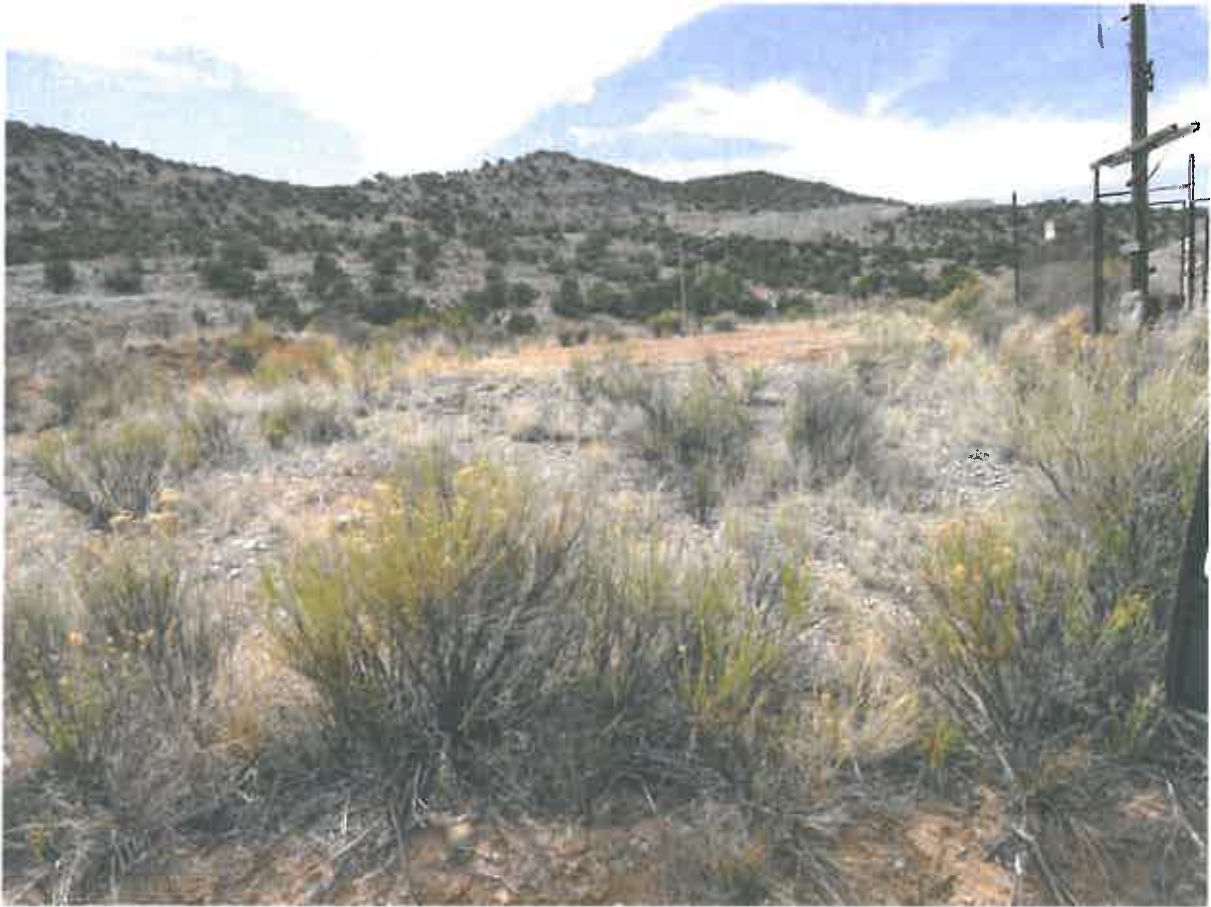
Photo 3.

The old Carnation tire shop and slab site. All structures removed and vegetation established.
