# COLORADO DIVISION OF RECLAMATION, MINING AND SAFETY MINERALS PROGRAM INSPECTION REPORT PHONE: (303) 866-3567

MINE NAME:	MINE/PROSPECTING ID#:	COMMODITY:	COUNTY:
McNulty Cinder Pit	M-1980-003	Sand and gravel	Eagle
INSPECTION TYPE:	INSPECTOR(S):	INSP. DATE:	INSP. TIME:
Monitoring	Dustin Czapla	June 5, 2012	1600
OPERATOR:	<b>OPERATOR REPRESENTATIVE:</b>	TYPE OF OPERA	TION:
Quarter Circle 8 LLLP	Justin Helmer	110c	
<b>REASON FOR INSPECTION:</b>	BOND CALCULATION TYPE:	BOND AMOUNT:	
Monitoring	Complete	\$ 23,000.00	
DATE OF COMPLAINT:	POST INSP. CONTACTS:	JOINT INSPECTI	ON AGENCY:
NA	None	None	
WEATHER:	INSPECTOR'S SIGNATURE:	SIGNATURE DAT	ГЕ:
Clear		June 12, 2012

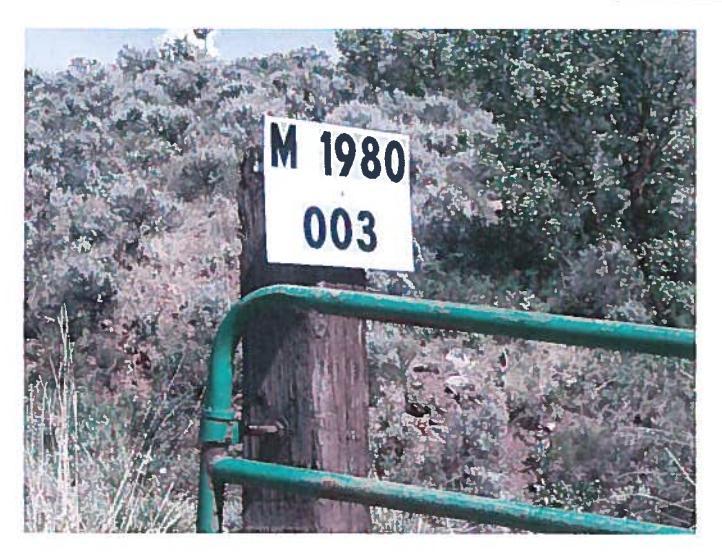
Adequate mine identification signage was noted at the entrance to the site.

Figure 1: Mine I.D. sign located at site entrance.

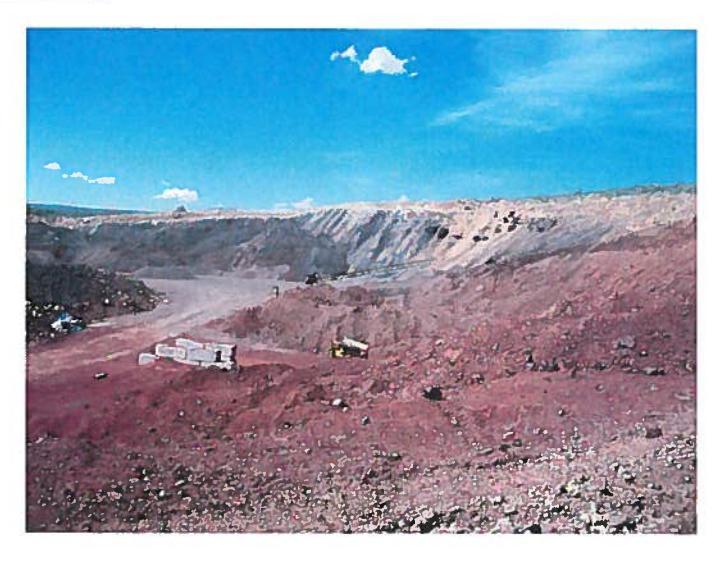
Figure 2: View towards highwall from near office area.

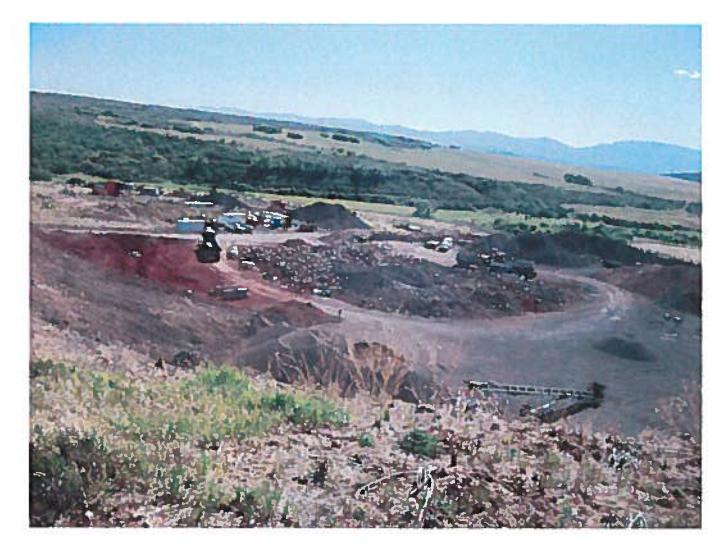
Figure 3: View facing west from top of highwall.

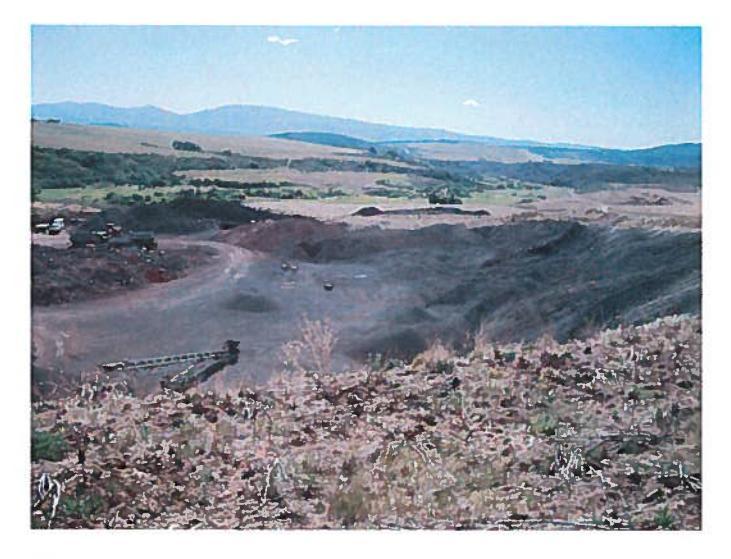
Figure 4: View facing southwest from top of highwall.
