STATE OF COLORADO

DIVISION OF RECLAMATION, MINING AND SAFETY Department of Natural Resources

February 22, 2013

RE: Map Errors for Annual Report received February 20, 2013, Costilla Pit, Permit No. M-1987-040

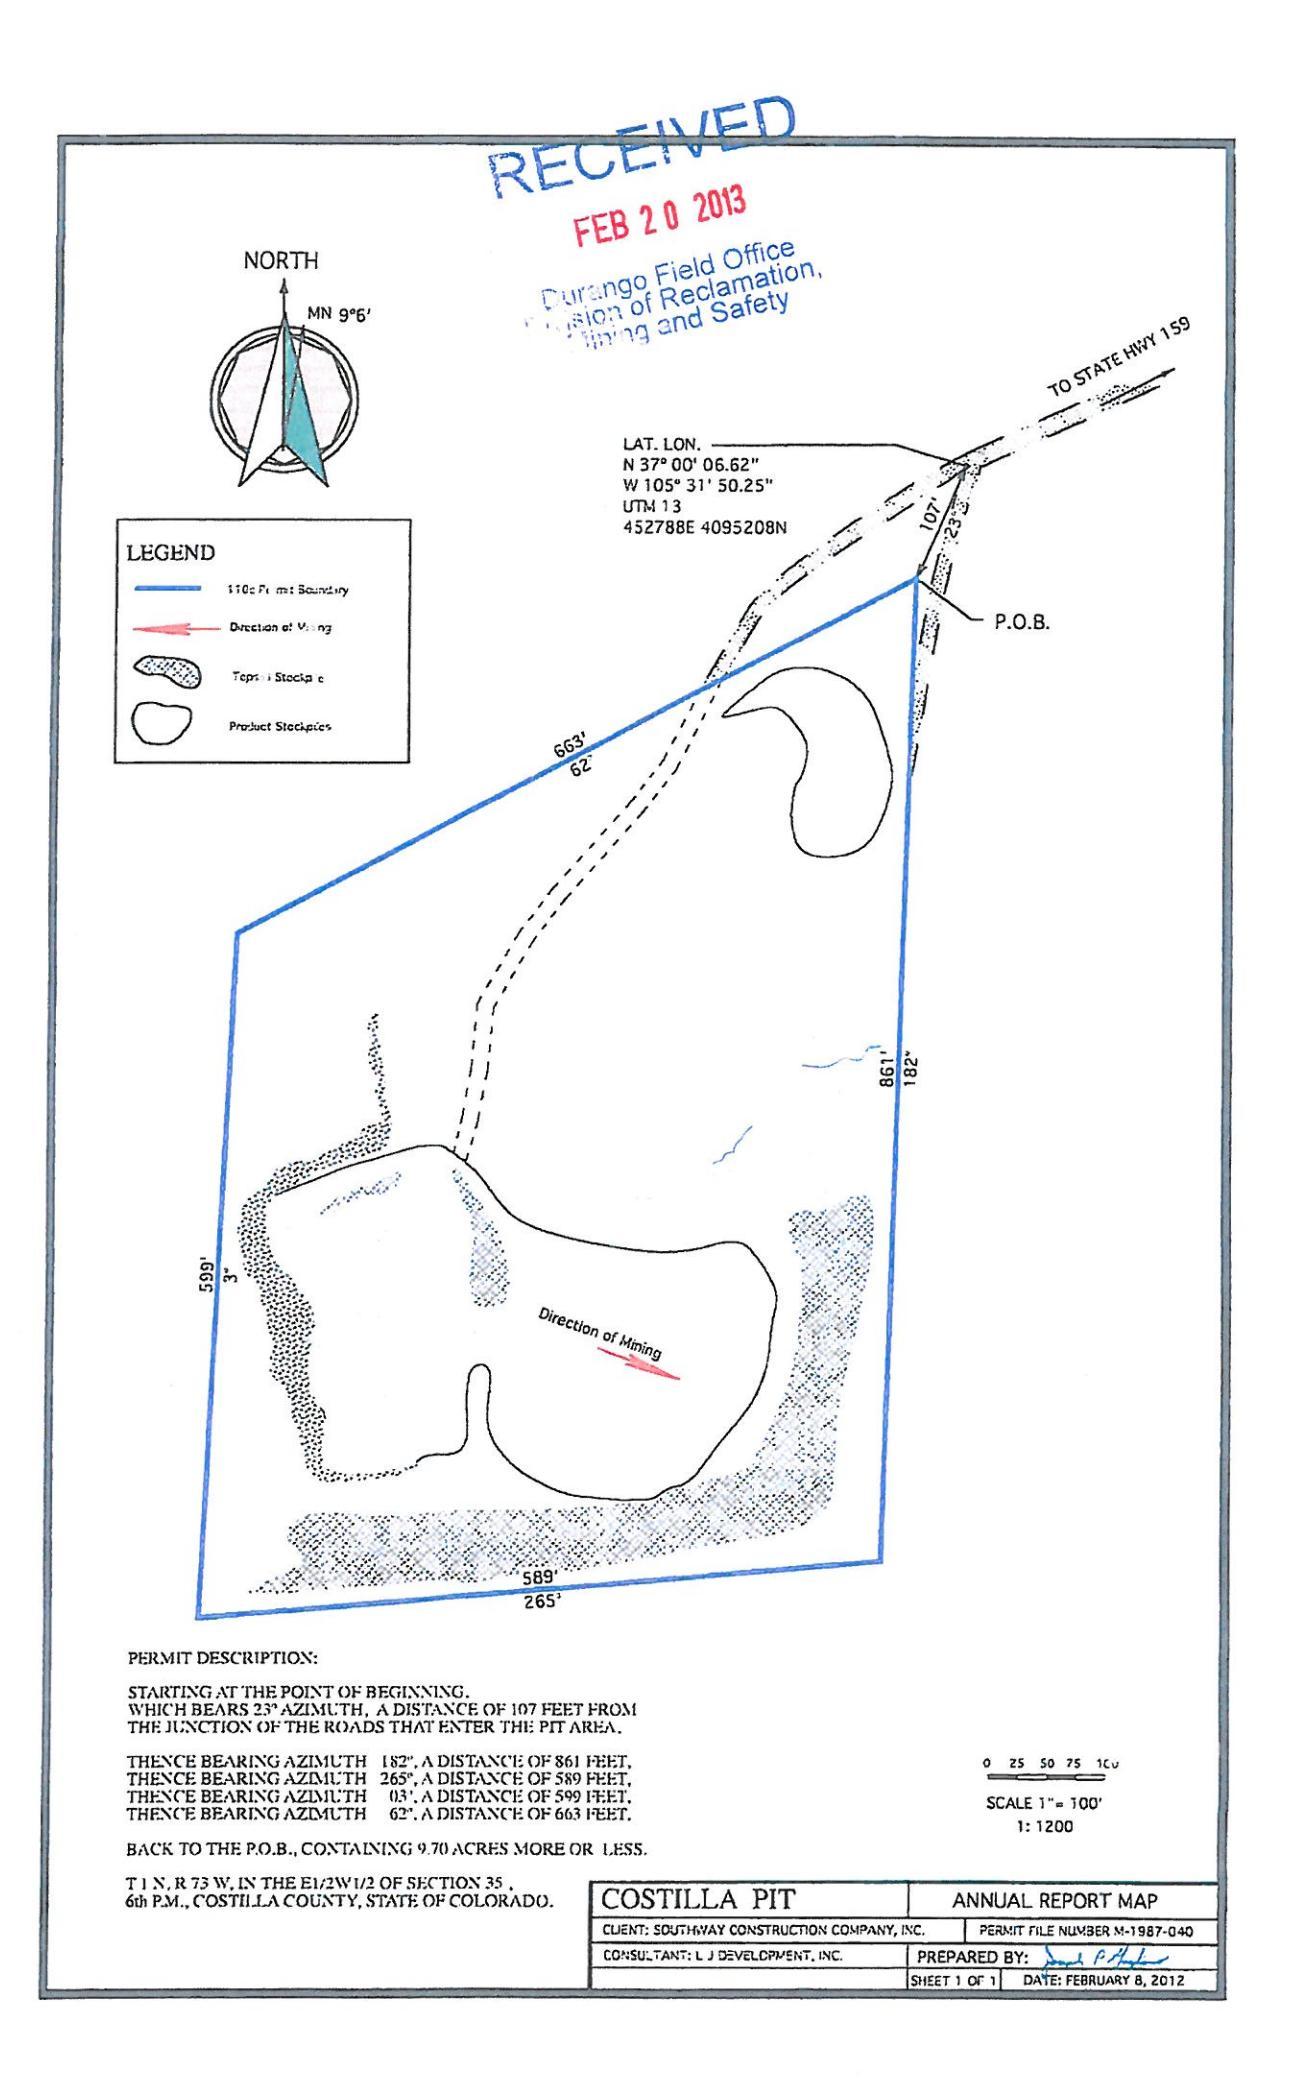
10 COSTILIA EXMOST E 7. 12 -----Accis 11: DIREC Silin noive Proxity same as Souleast and wers Seat w= 5.2 inchos = 5.2 × 105 = 513 L = 7.75 vielen = 7.75×105 = 813 1.1.5 COSTILIA Pit Soutriway Const. Co. Dispasso of: J. Ungobug P.E. 2/23/87 Existina Condition Proposed Mining Plan

- The Map delineates the permit boundary at a configuration different from the maps of the approved permit. As shown on the enclosed Exhibit E, dated February 23, 1987, the permit boundary is rectangular shaped. However, according to the recently submitted Map, the permit boundary is delineated as a four-sided polygon, not rectangular, with length and width dimensions greater than those indicated on Exhibit E. Permit records indicate there have been no Technical Revisions or Amendments to the permit whereby the configuration of the permit boundary may have been modified from what was originally approved. Therefore, the permit boundary delineated on Exhibit E, dated February 23, 1987, is the approved permit boundary and the Map, dated February 8, 2012, is in error.

- The Map delineates the permit boundary and/or the access road at a location different from the maps of the approved permit. As shown on Exhibit E, the access road intersects the east permit boundary at the lower third of that boundary, with the permit area extending approximately 535 feet to the north and 260 to the south from the access road. However, according to the recently submitted Map, the access road enters the permit area at the northeast corner, with all portions of the permit area extending south of the access road. According to the Map, the permit area has shifted

Please ensure the Division has received a corrected map for the annual report, originally due on May 21, 2012, which illustrates the appropriate location and configuration of the permit boundary, and satisfies all applicable requirements of Section 34-32.5-116(3)(a) C.R.S., and Construction Materials Rule 6.2.1(2), by <u>April 5, 2013</u>. Please note, April 5, 2013, is also the deadline by which Southway Construction Company must address a deficiency in the bond, provide photographic evidence of newly installed permit boundary markers, and provide a surveyed map of affected lands, as indicated in the Division's inspection report generated from the January 23, 2013 site inspection, signed February 4, 2013. Failure to comply will result in the Division pursuing enforcement action and civil penalties against Southway Construction Company.

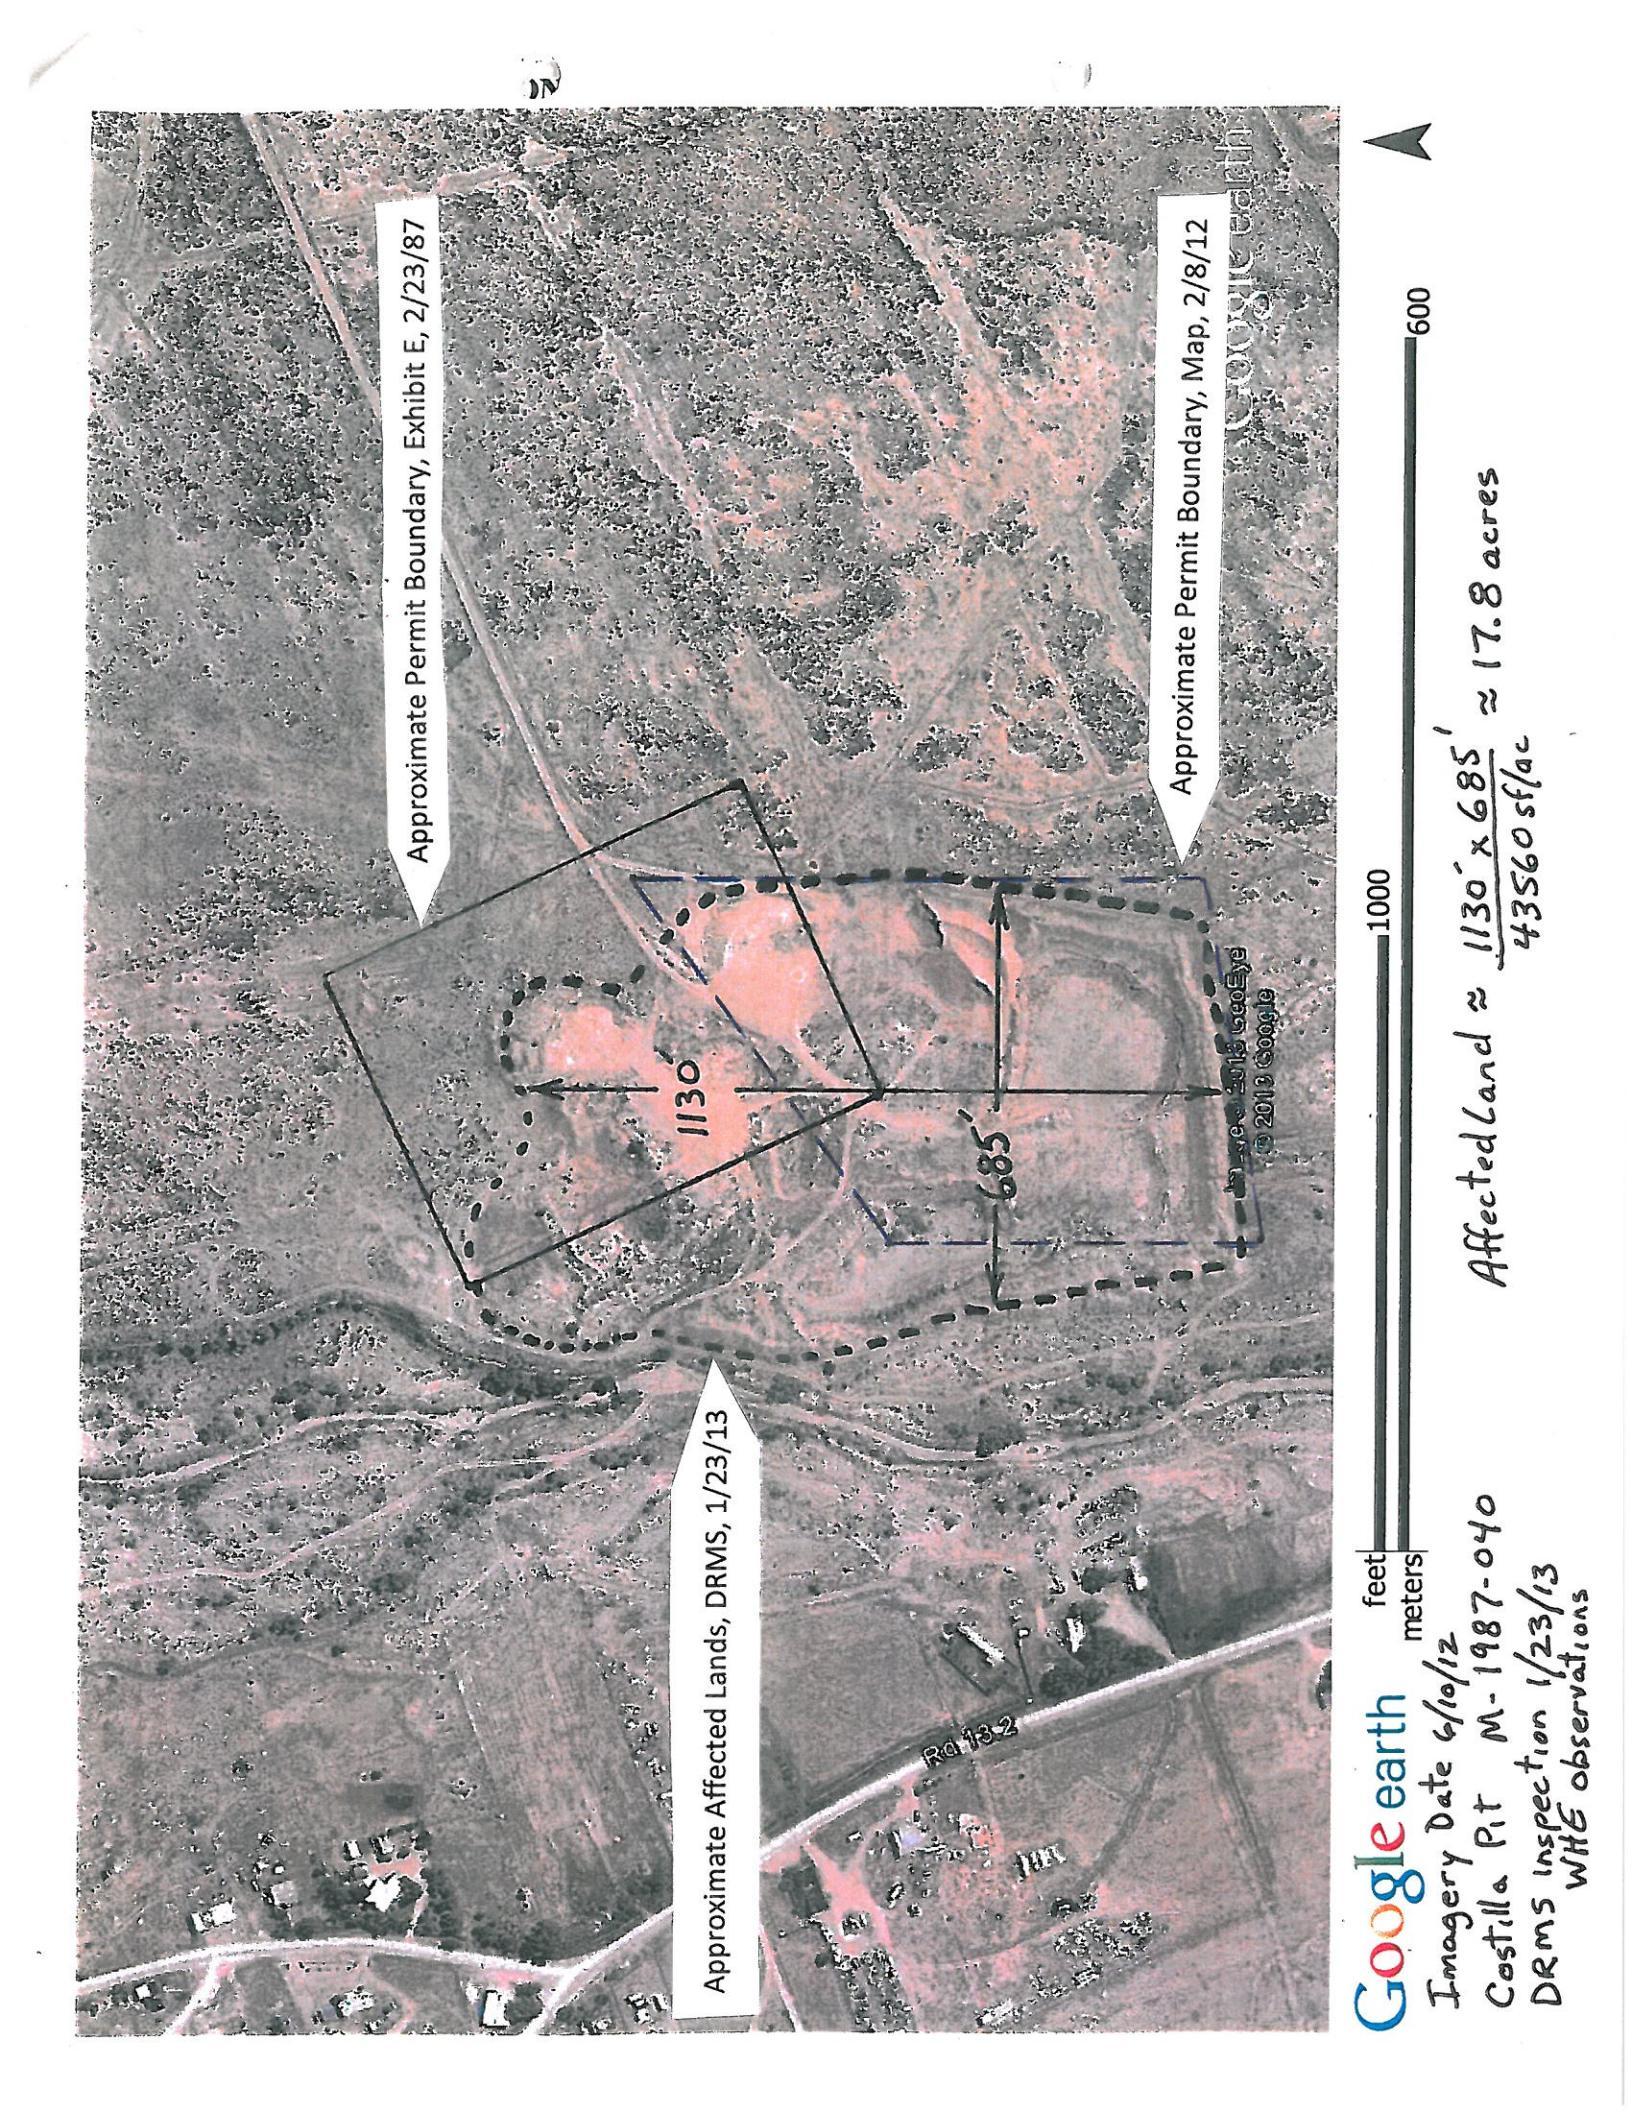
On February 20, 2013, the Division received the annual report and map for the above referenced site. The annual report and map were due on the anniversary date of the permit, May 21, 2012. The map, dated February 8, 2012 and received by the Division on February 20, 2013 (the "Map"), is in error and must be corrected prior to the Division accepting the map. Therefore, the Division requires timely response from the Operator, correcting the errors of the Map as discussed below. These errors are further illustrated on an enclosed screen shot from Google Earth.

The Map fails to identify all affected lands, as described within the permit documents and in the Division's most recent inspection report, generated from the January 23, 2013 inspection, signed February 4, 2013. Pursuant to Section 34-32.5-116(3)(a) C.R.S., please ensure the corrected map identifies all affected lands associated with the mining activities conducted under this permit, as well as the affected lands for the previous Special 111 permit which existed prior to the permit conversion.
