## COLORADO DIVISION OF RECLAMATION, MINING AND SAFETY COAL PROGRAM INSPECTION REPORT

Permit Number: C-1980-007 Mine Name: West Elk Mine Operator: Mountain Coal Company, LLC Operator Address: Ms Kathleen G Welt P.O. Box 591 Somerset, CO 81434 County: Delta, Gunnison Operation Type: Underground Permit Status: Active Ownership: Federal

Inspection Start Date: May 22, 2013 Inspection Start Time: 08:30 Inspection End Date: May 22, 2013 Inspection End Time: 12:30			<b>Inspection Type:</b> Coal Partial Inspection <b>Inspection Reason:</b> Normal I&E Program <b>Weather:</b> Clear	
Joint Inspection Agency:		Joint Inspection Contacts:		
None				
Post Inspection Agency:		Post Inspection Contacts:		
None				
Inspector(s):	Inspector	r's Sig	nature: S	Signature Date:
Leigh D. Simmons Daniel I. Hernandez	1A	fi	5.	/24/2013

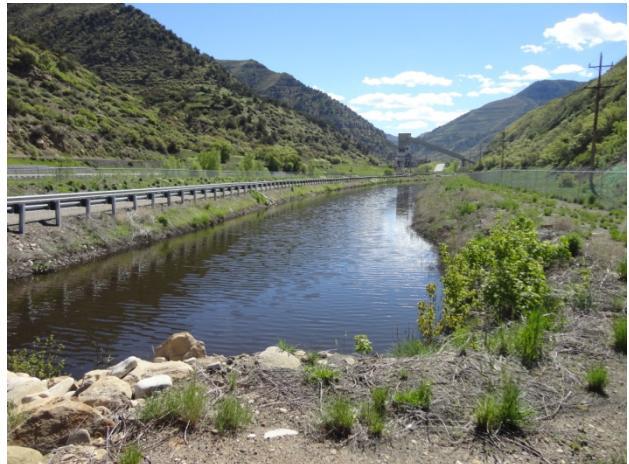
Photo 1: West Elk mine looking east, from Pond MB-5E

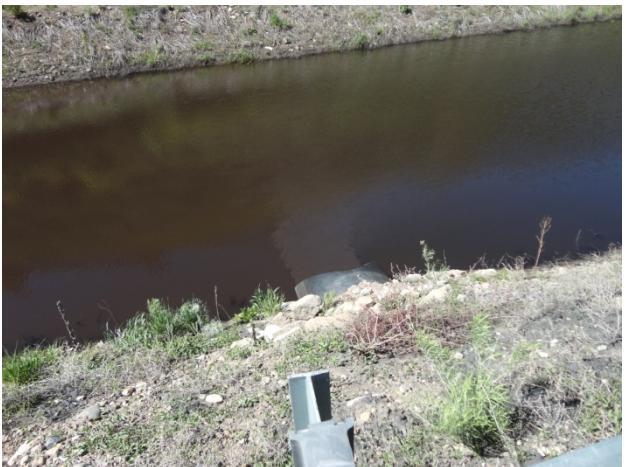
Sediment pond MB-5E at the west end of the site is designed as two cell pond to aid with cleaning. At the time of the inspection, the southerly cell was receiving runoff. Neither cell was discharging. The embankments and spillways were in good order.

Photo 2: Discharge into southerly cell of Pond MB-5E

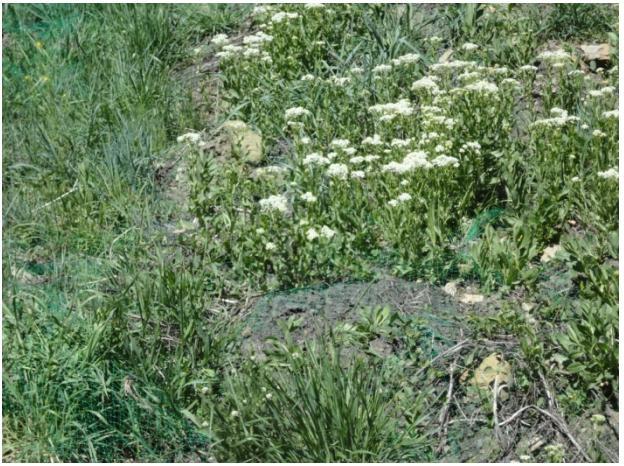
The subsoil pile adjacent to pond MB-5E was well vegetated, but had a significant amount of Whitetop/Hoary Cress (*Cardaria draba*). This list B noxious weed should be controlled. According to Ms Welt, contract sprayers will be on the site soon - the site is sprayed for weed control twice a year.

Photo 3: Whitetop on subsoil pile near to Pond MB-5E

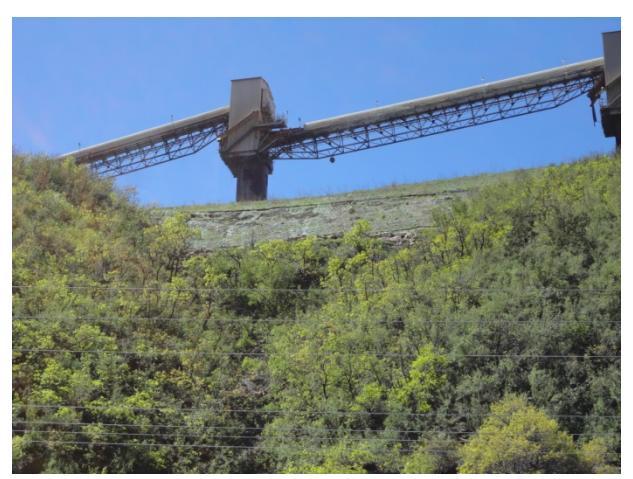
The slide on the slope to the south of pond MB-5E (ST-02?) was inspected from below. The repairs appeared to have been successful and no instability was observed.

Photo 4: Repaired slide ST-02

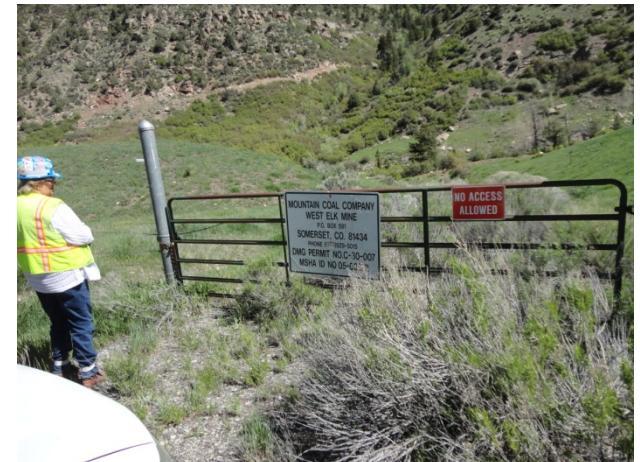
Photo 5: Entrance to soil storage area north of the highway

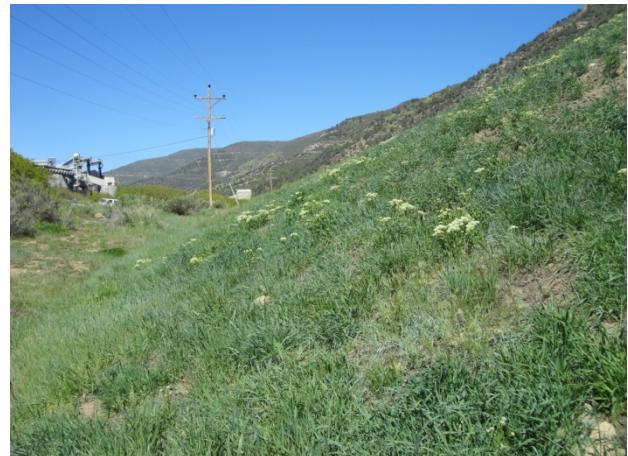
The topsoil piles on the north side of highway 133 were inspected and found to be clearly marked and well vegetated. Whitetop/Hoary Cress (*Cardaria draba*) and Cheat Grass/Downy Brome (*Bromus tectorum*) were observed on the pile. These are list B and list C noxious weeds, respectively. Rule 4.06.3(2)(a) specifies that protection of stored topsoil shall be accomplished by "An effective cover of non-noxious, quick-growing annual and perennial plants..."

Photo 6: Some cheatgrass and whitetop on topsoil pile

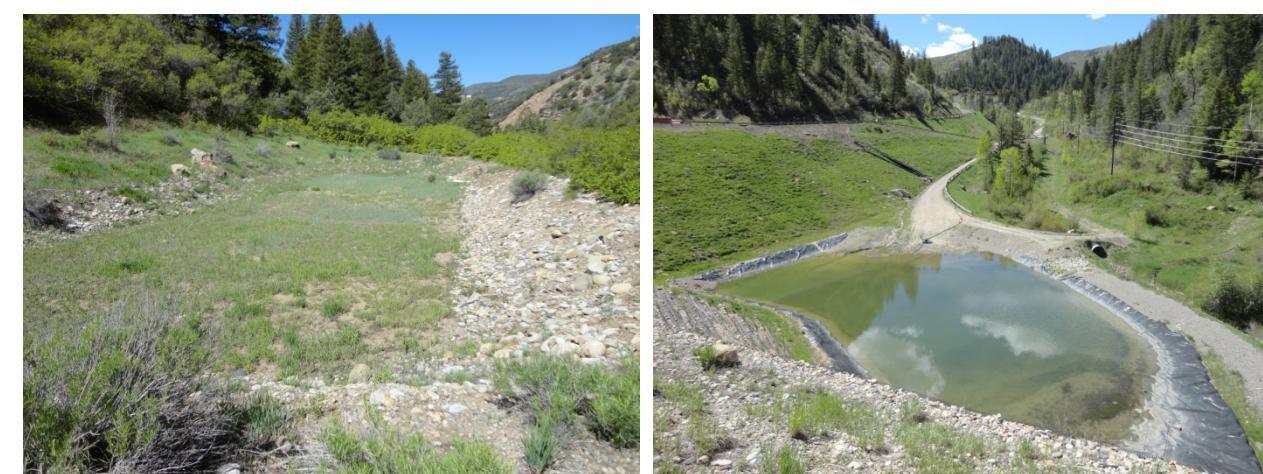
The small sediment pond (NSSA) treating the topsoil piles north of the highway was dry. All ditches, berms and spillways associated with the pond were in good order.

The shallow pond (SG-1) up the Sylvester Gulch haul road was holding water but not discharging. The pond is lined with hdpe to avoid direct hydrologic communication with adjacent alluvial water in the gulch, per the permit. This can lead to problems with algal growth in the shallow warm water.

Photo 7: Sediment pond NSSA

Photo 8: Sediment pond SG-1

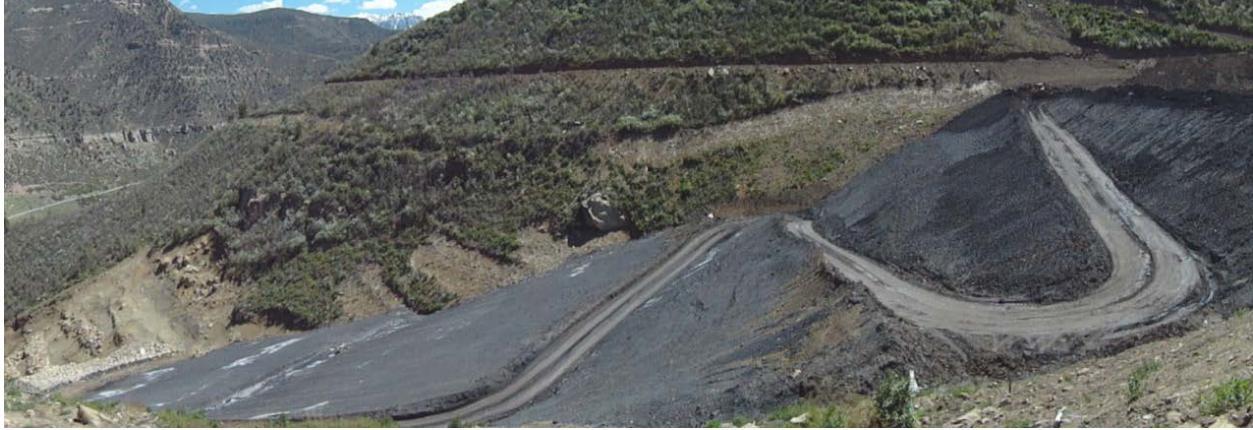
The RPE pond is another two cell pond. The first cell was holding significant water, but was below the discharge level. The second cell just had a little water in the bottom. Both cells are hdpe lined, for the same reason, and with the same problems as described above. The ditch adjacent to the pond was being cleaned at the time of

Photo 9: RPE

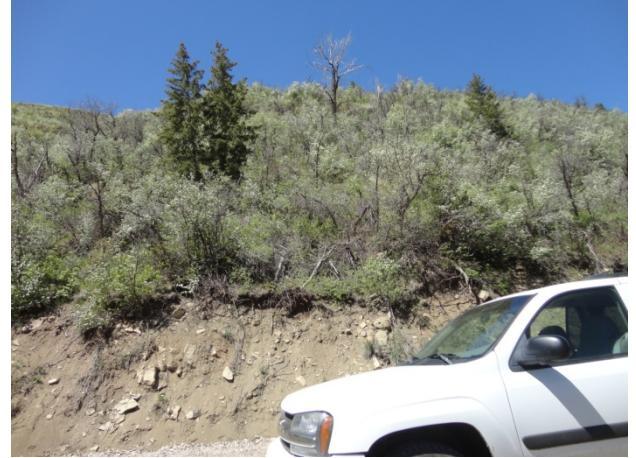
The slopes crossed by the RPE East haul road were profligate with Chokecherry (*Prunus virginiana*) which was flowering to a greater extent than in previous years.

Photo 10: Chokecherry in bloom above RPE haul road

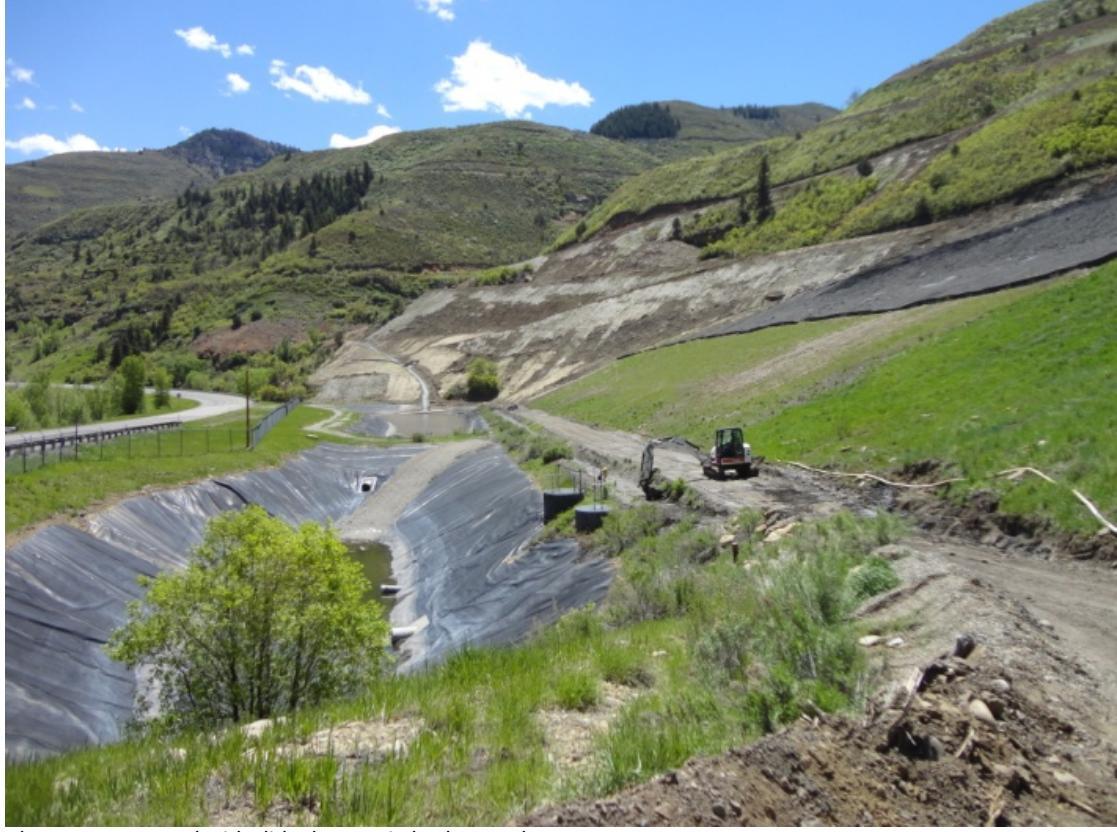
The extensive slide at the eastern end of the site, around the RPE East access/haul road was observed from the RPE sediment pond. Repair work was ongoing.

Photo 11: RPE pond with slide damage in background

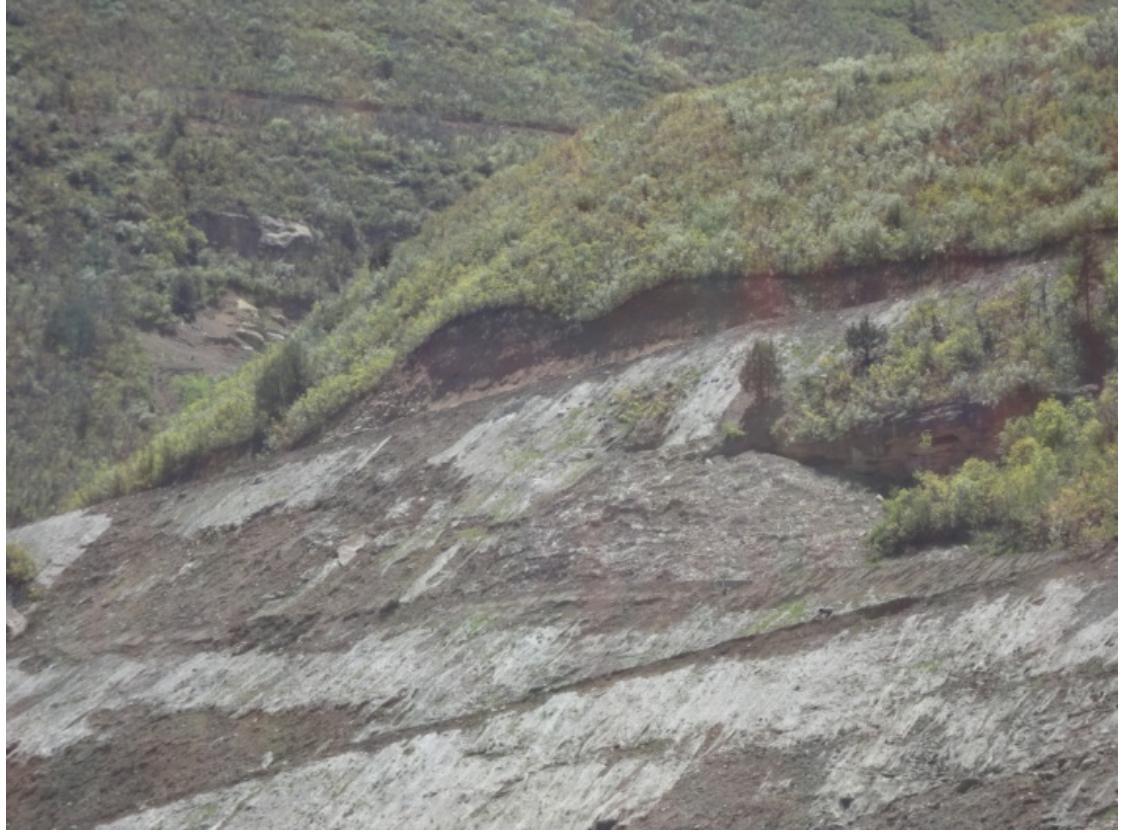
Photo 12: Close up of RPE haul road slide damage
