**From:** Lucero, Jeremy J [Jeremy.Lucero@dot.state.co.us]  
**Sent:** Thursday, March 22, 2012 3:48 PM  
**To:** Czapla, Dustin  
**Cc:** Spor, Corinne  
**Subject:** RE: BLM Burnt Shale Pit, Unresolved Problems Noted in a Past Inspection Report  
**Attachments:** Response Letter.pdf

**COLORADO DIVISION OF RECLAMATION, MINING AND SAFETY**  
**MINERALS PROGRAM INSPECTION REPORT**  
**PHONE: (303) 866-3567**

<b>MINE NAME:</b> BLM Burnt Shale Pit	<b>MINE/PROSPECTING ID#:</b> M-1985-170	<b>MINERAL:</b> Sandstone	<b>COUNTY:</b> Garfield
<b>INSPECTION TYPE:</b> Monitoring	<b>INSPECTOR(S):</b> Dustin M. Czapla	<b>INSP. DATE:</b> February 1, 2012	<b>INSP. TIME:</b> 12:00
<b>OPERATOR:</b> Colorado Division of Highways	<b>OPERATOR REPRESENTATIVE:</b>	<b>TYPE OF OPERATION:</b> 110c - Construction Limited Impact

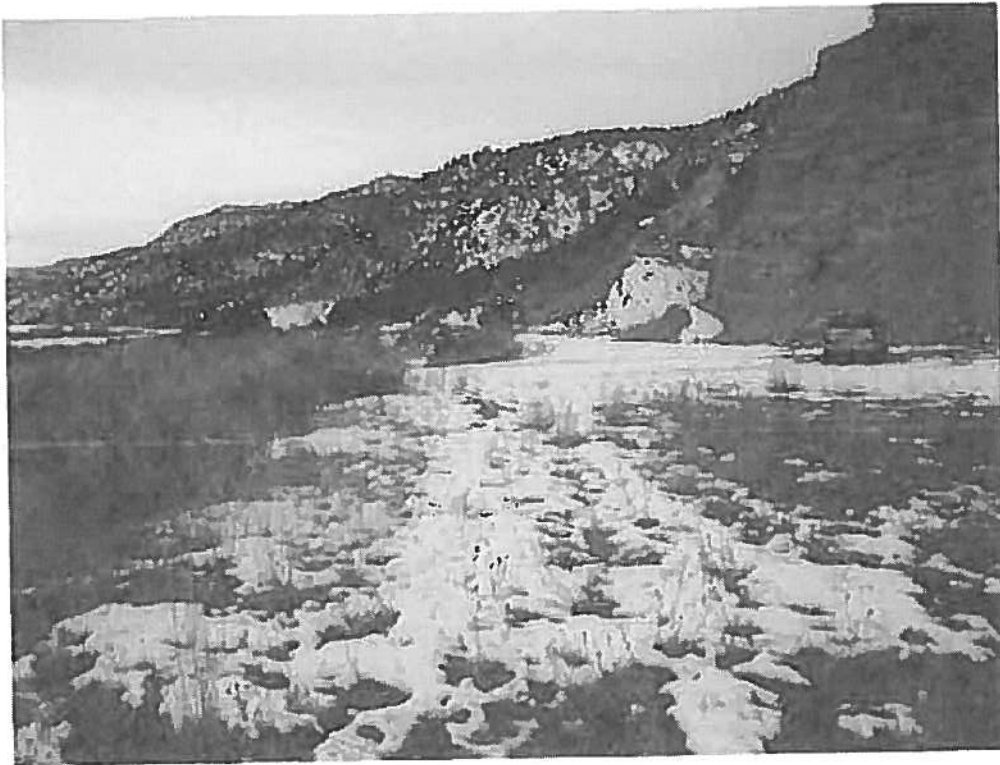
**Figure 1: View facing southwest from northeast corner of site.**

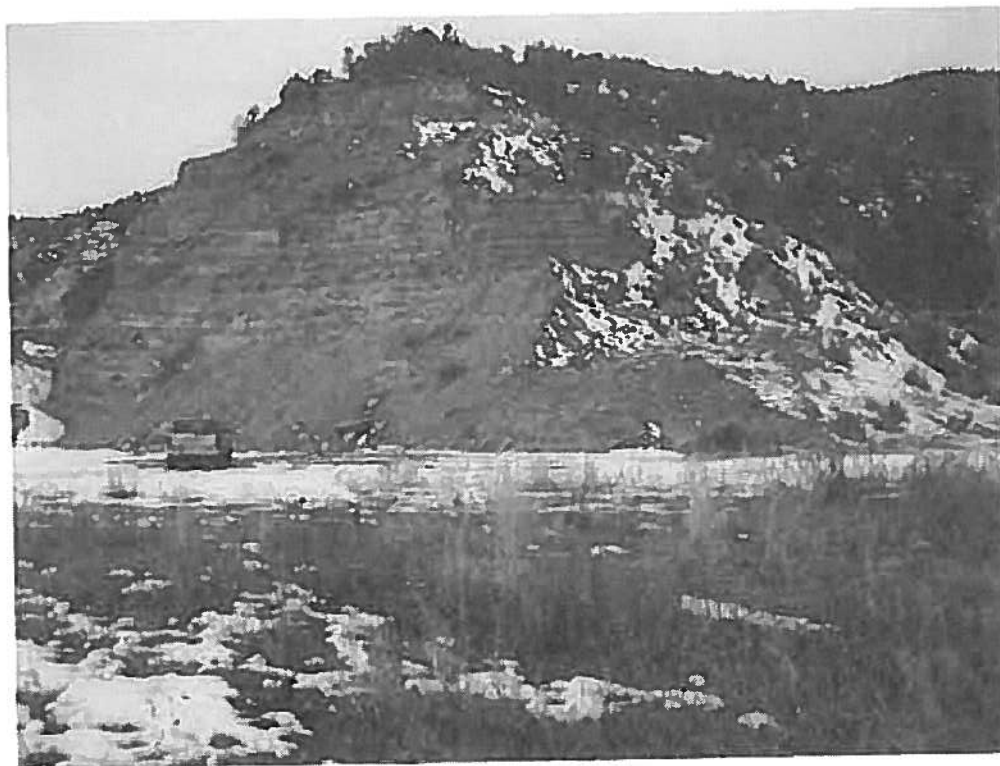
**Figure 2: View facing west from northeast corner of site.**

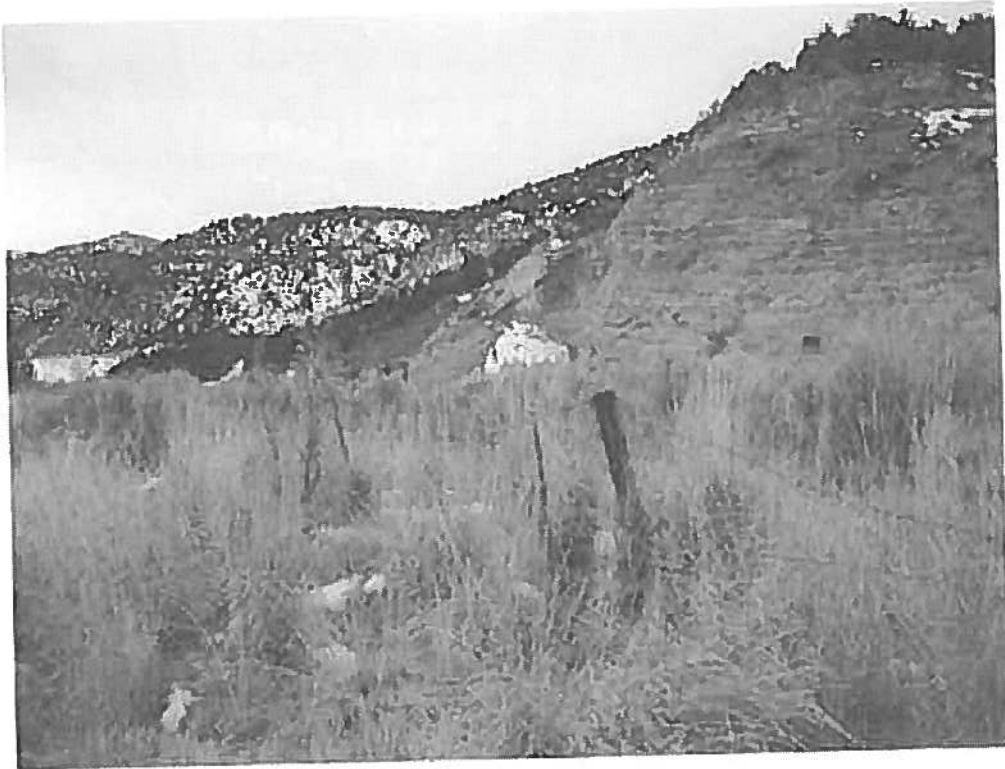
**Figure 3: View facing southwest from northeast corner of site.**

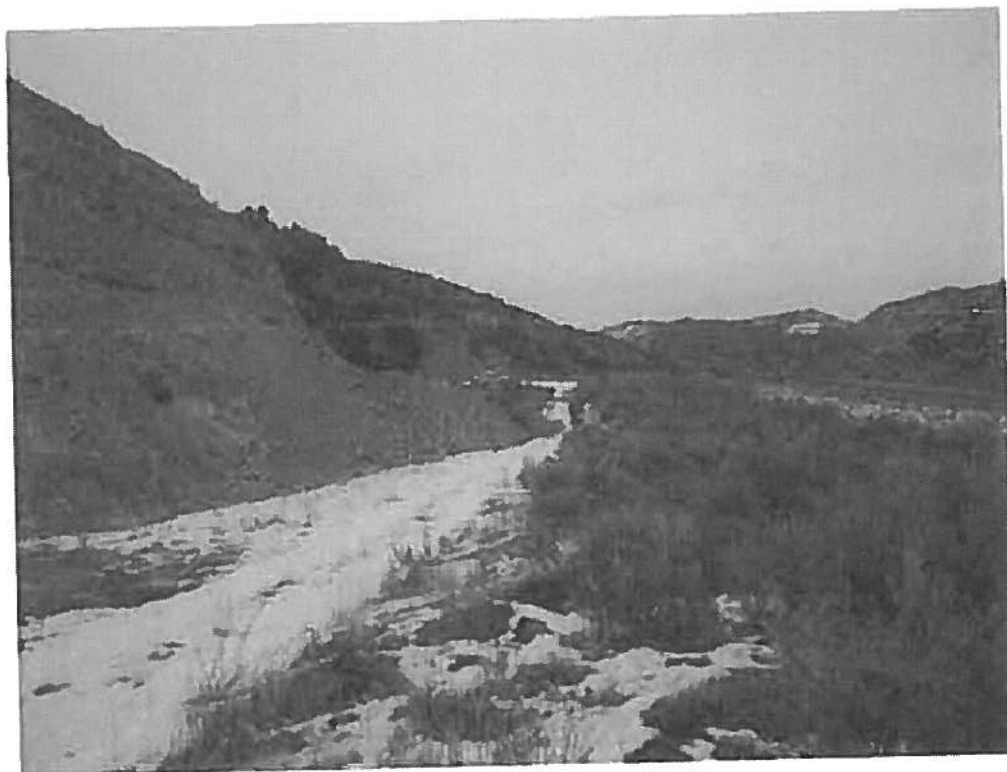
**Figure 4: View facing northeast from southeast corner of site.**
