Geomorphic Change Detection in Grand Canyon: Comparison of 2000 LIDAR and 1923 Survey Data

*C.S. Magirl, R.H. Webb, and P.G. Griffiths
US Geological Survey, Tucson, Arizona*

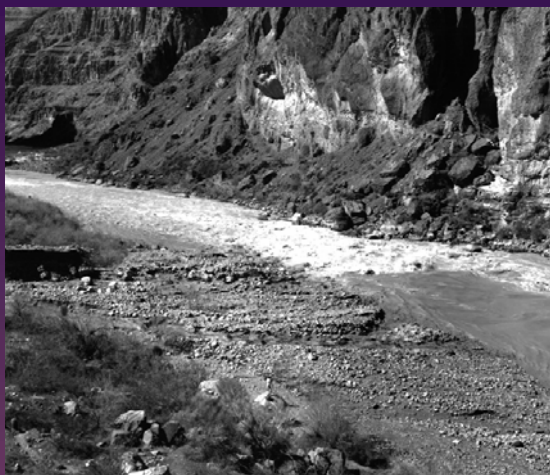
Fresh debris-flow deposit at Lava Falls, 1995 (R.H. Webb, Stake 2964b).

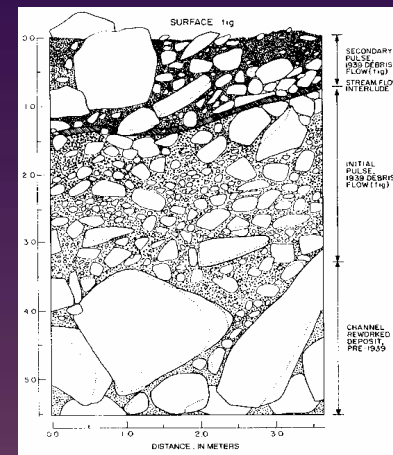
Typical debris flow stratigraphy from Prospect Canyon (Lava Falls Rapid).

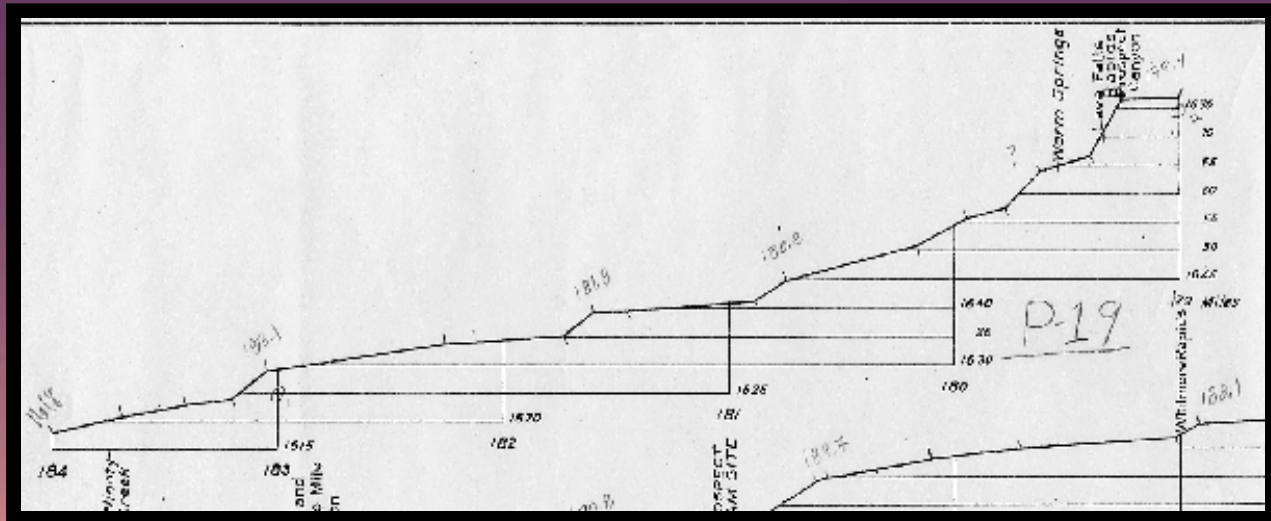
U.S. Geological Survey. 1924. Plan and profile of Colorado River from Lees Ferry, Ariz., to Black Canyon, Ariz.-Nev. and Virgin River, Nev.: U.S. Geological Survey, 21 sheets (A-U).

- Led by Colonel Claude Birdseye
- Used stadia rod and theodolite survey technology
- Took four boats and one canvas canoe
- August 1, 1923 (Lee's Ferry, AZ) to October 19, 1923 (Needles, CA)
- Detailed survey along river corridor
- Published first comprehensive water-surface profile of Grand Canyon

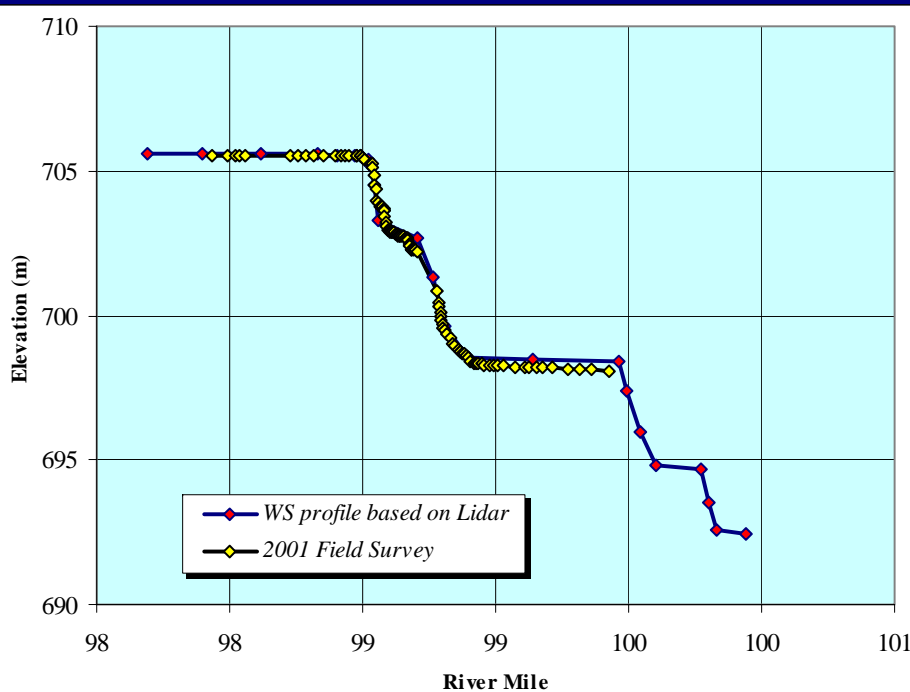
Crystal Rapid

Verification of Lidar Profile with in-situ Survey

Survey data collected May 2002

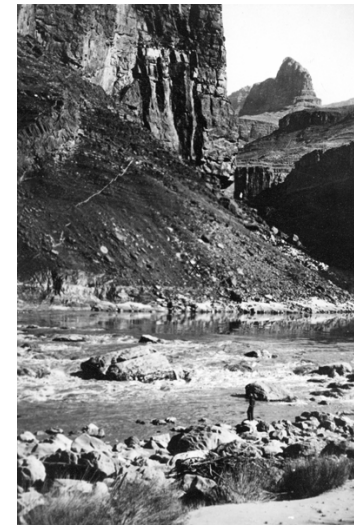
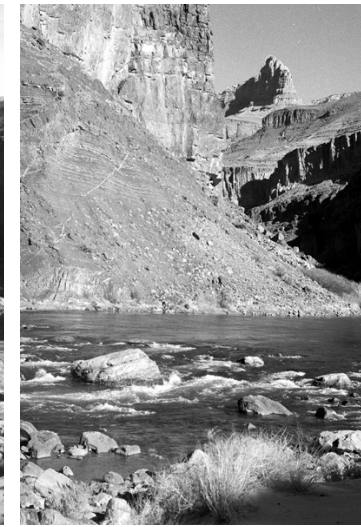
Using rapids that were not constricted by debris flows between 1923-2000 to tie together data sets

Hance Rapid unchanged form 1911 to 1990. Left: Kolb photograph 5834, courtesy of Special Collections, the Cline Library, Northern Arizona University. Right: Tom Brownold, Stake 1451

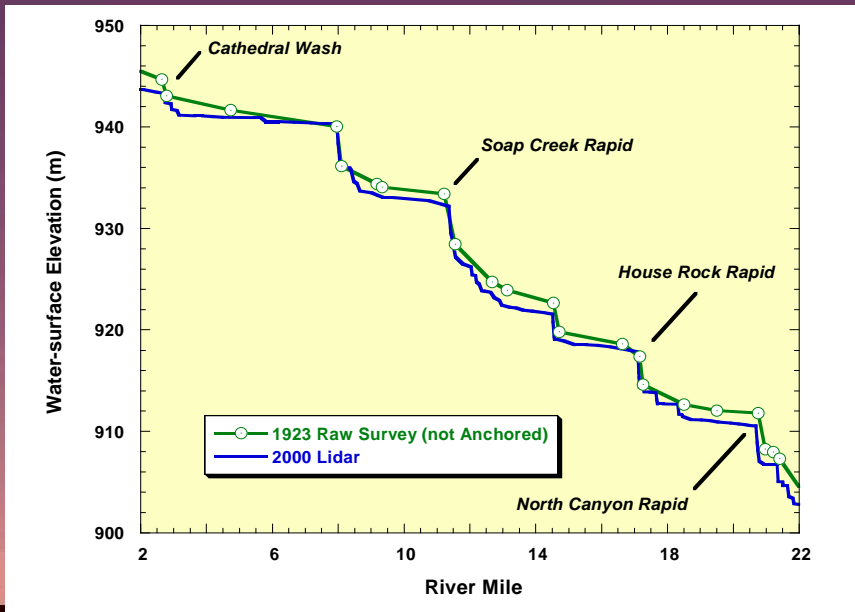
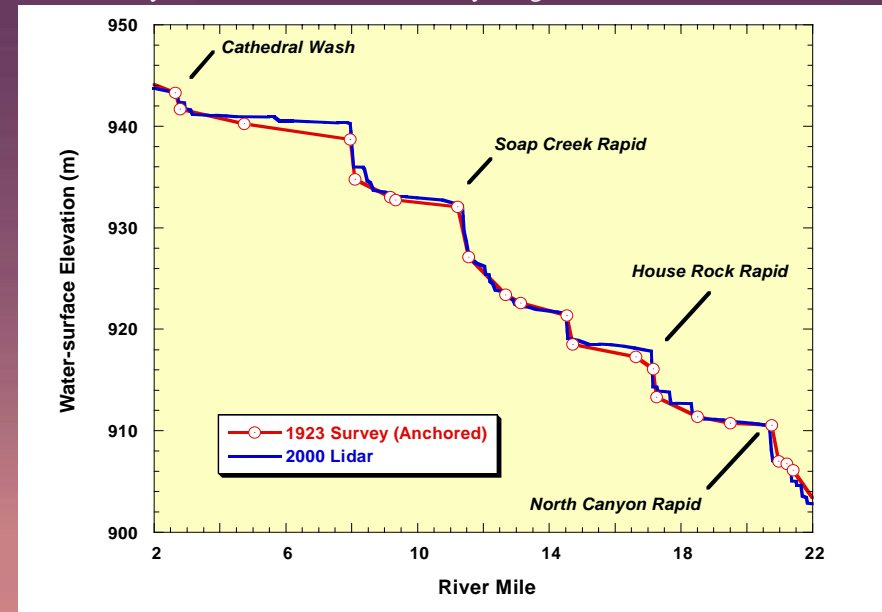
Marble Canyon; Before Anchoring

After Anchoring

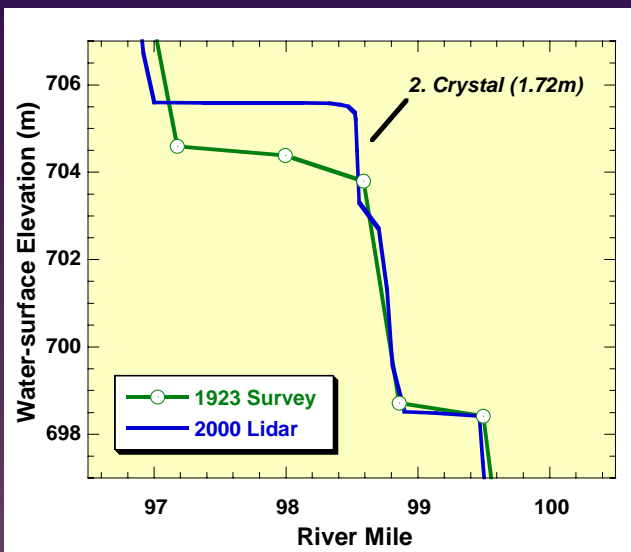
Crystal Rapid

- 1966 Debris Flow
- Reworking in 1983

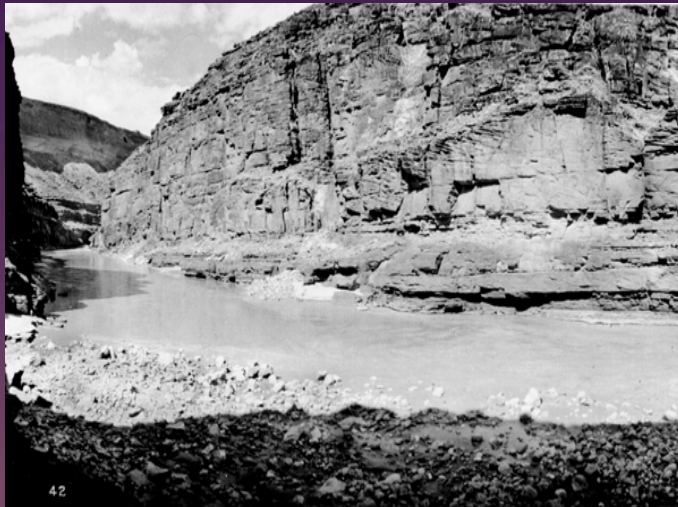
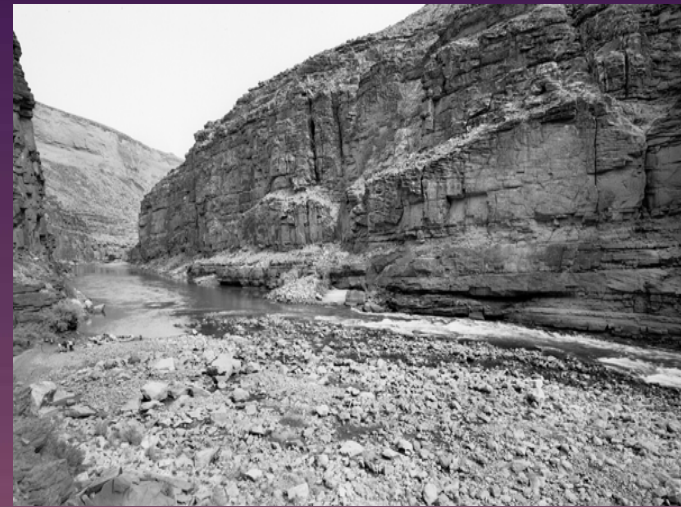
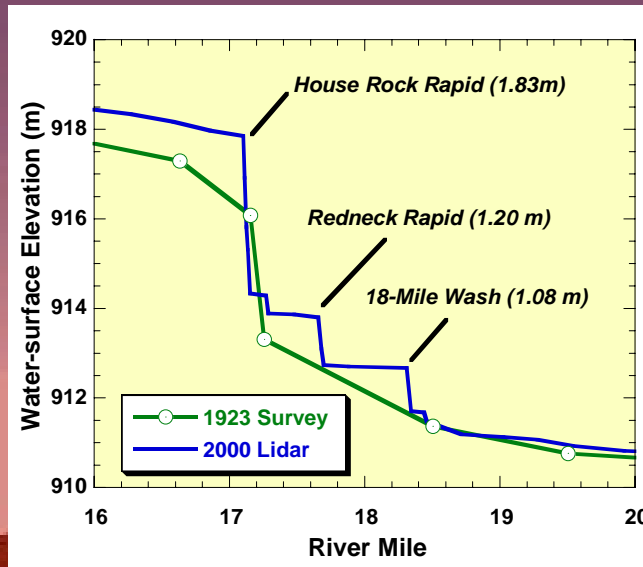
House Rock Rapid, mile 17.1

Largest Rise at Head of a Rapid

Net Rise: 1.83 m

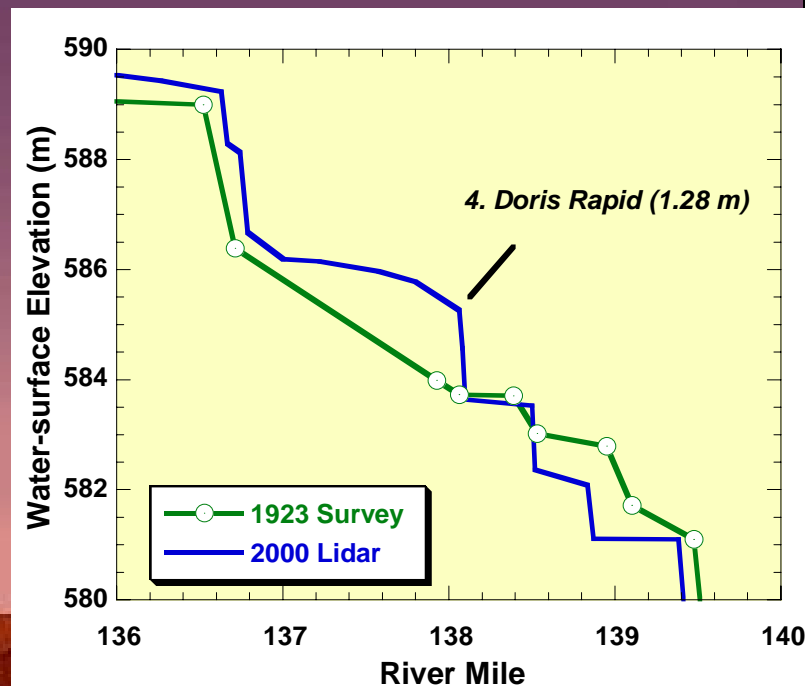
The riddle of Doris Rapid (mile 138.3):

- 1890: Stanton reports a 2.4-3.0 m drop
- 1923: Birdseye measures a 0.3 m drop
- 1940: Doris Nevills swims an enlarged rapid
- 2000: LIDAR measures a 1.62 m drop

1. Debris flow occurs between 1884-1890
2. The 6,230 m³/s flood in 1921 reworks the first deposit
3. A second debris flow occurs between 1923-1940

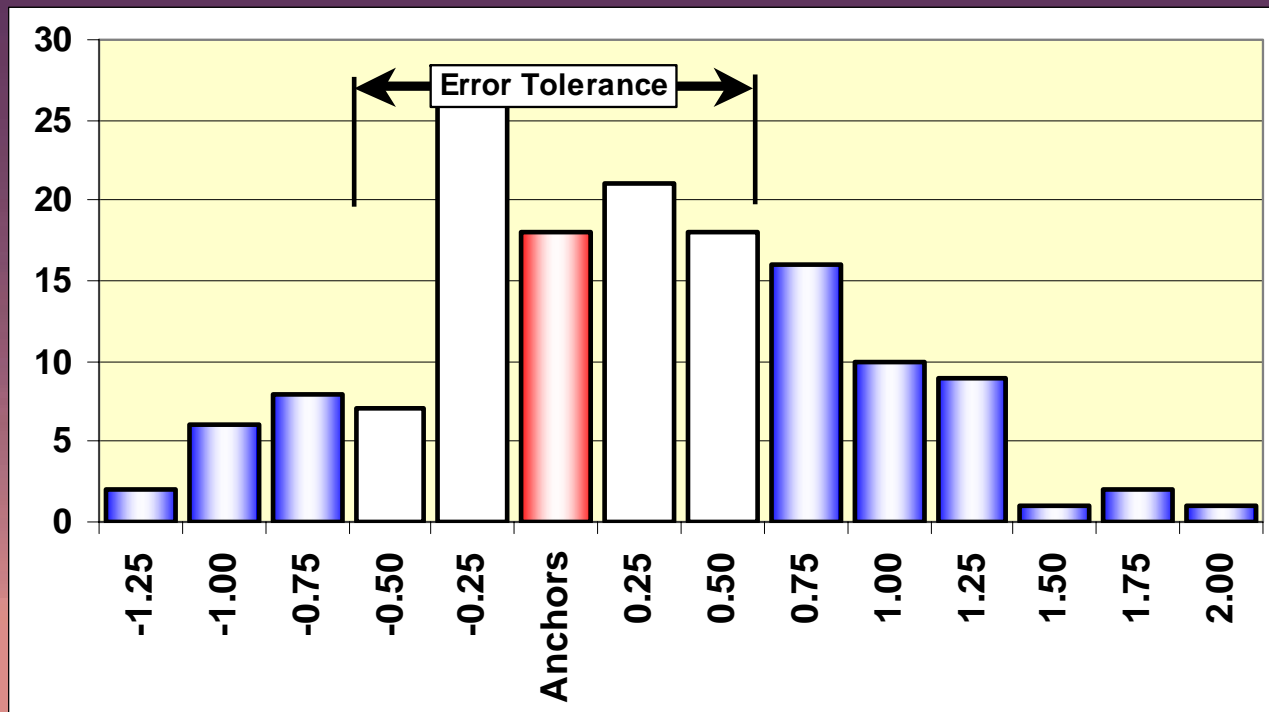
- 145 drops (18 anchors, 127 tributaries measured)
- Error tolerance in measurement roughly ± 0.5 meters
- 39 tributary mouths are aggraded
- 16 tributary mouths show degradation
- 72 saw net change less than 0.5 m
- Mean aggradation at 145 tributaries: +0.18

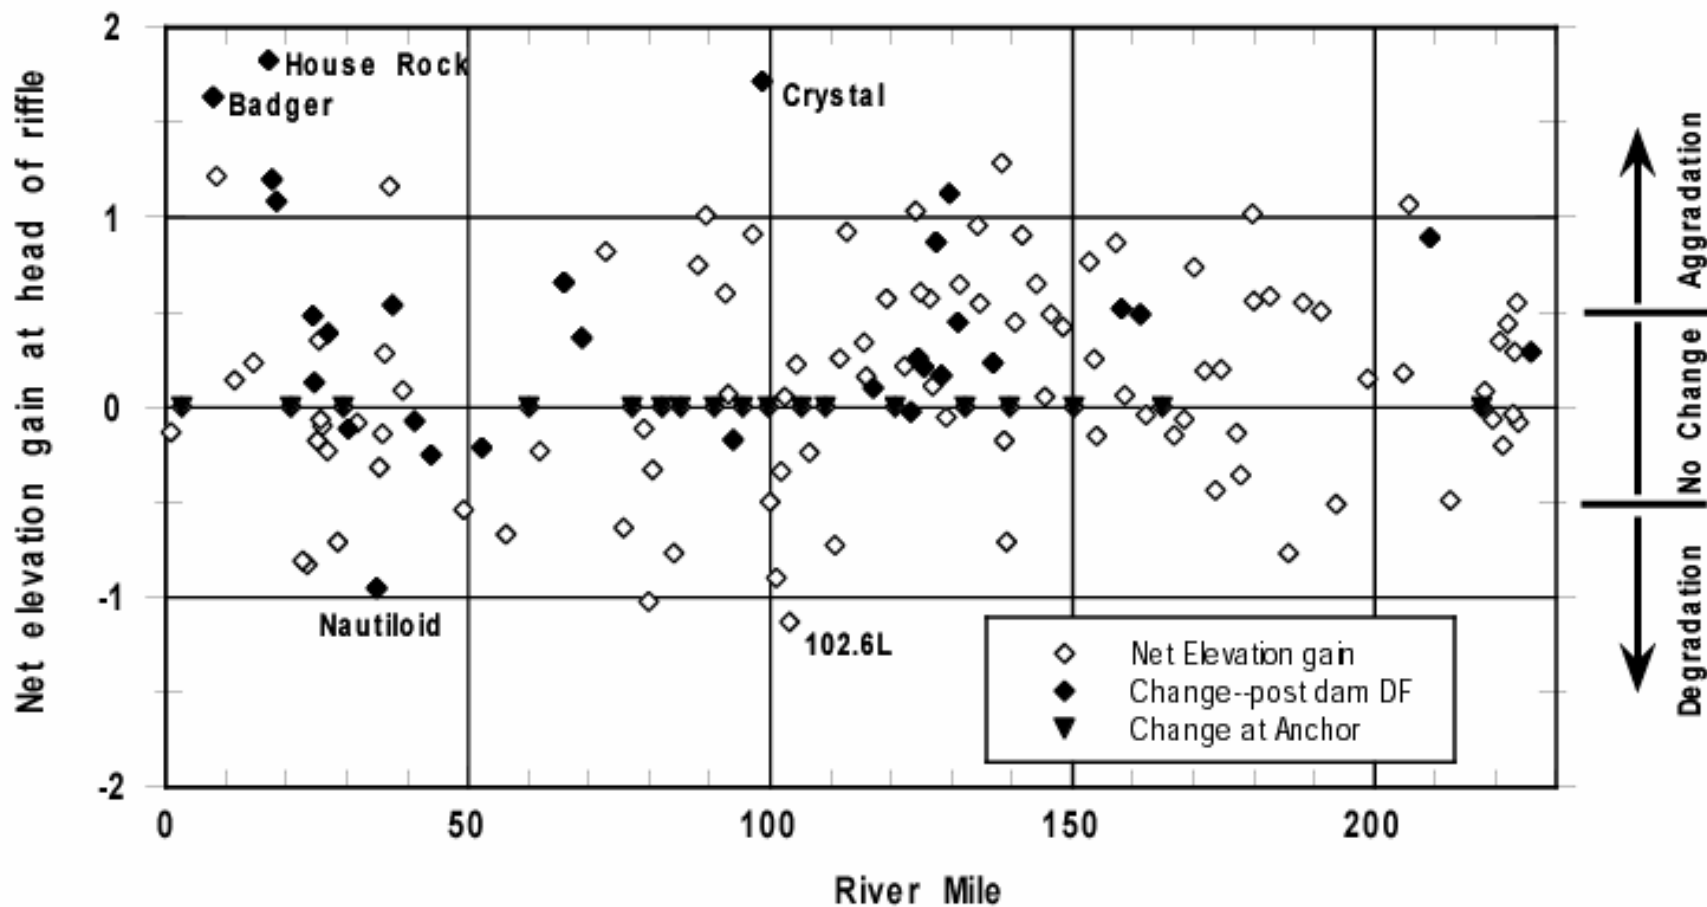
Net Change at riffle by river mile

- More aggradation than degradation
- No clear spatial signal

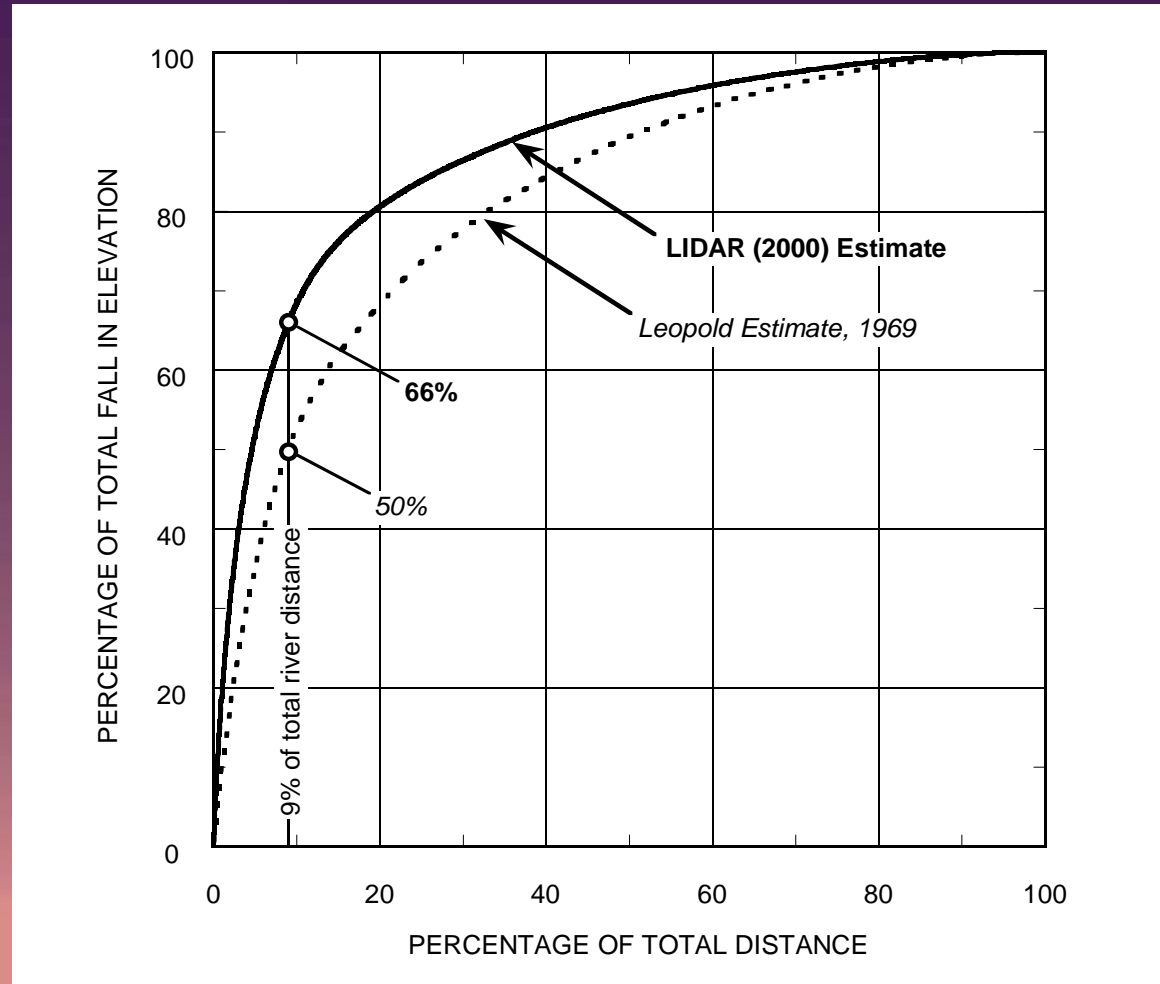
Luna Leopold (1969) stated ...50% of total decrease in elevation takes place in only 9% of the total river distance... [based on Birdseye profile]

New estimate,
based on 2000
LIDAR
profile: 66%
of drop in 9%
of distance
