GULLY EROSION OF CULTURAL SITES

Joel Pederson,
Paul Petersen, Wally McFarlane
and **GCMRC survey group**

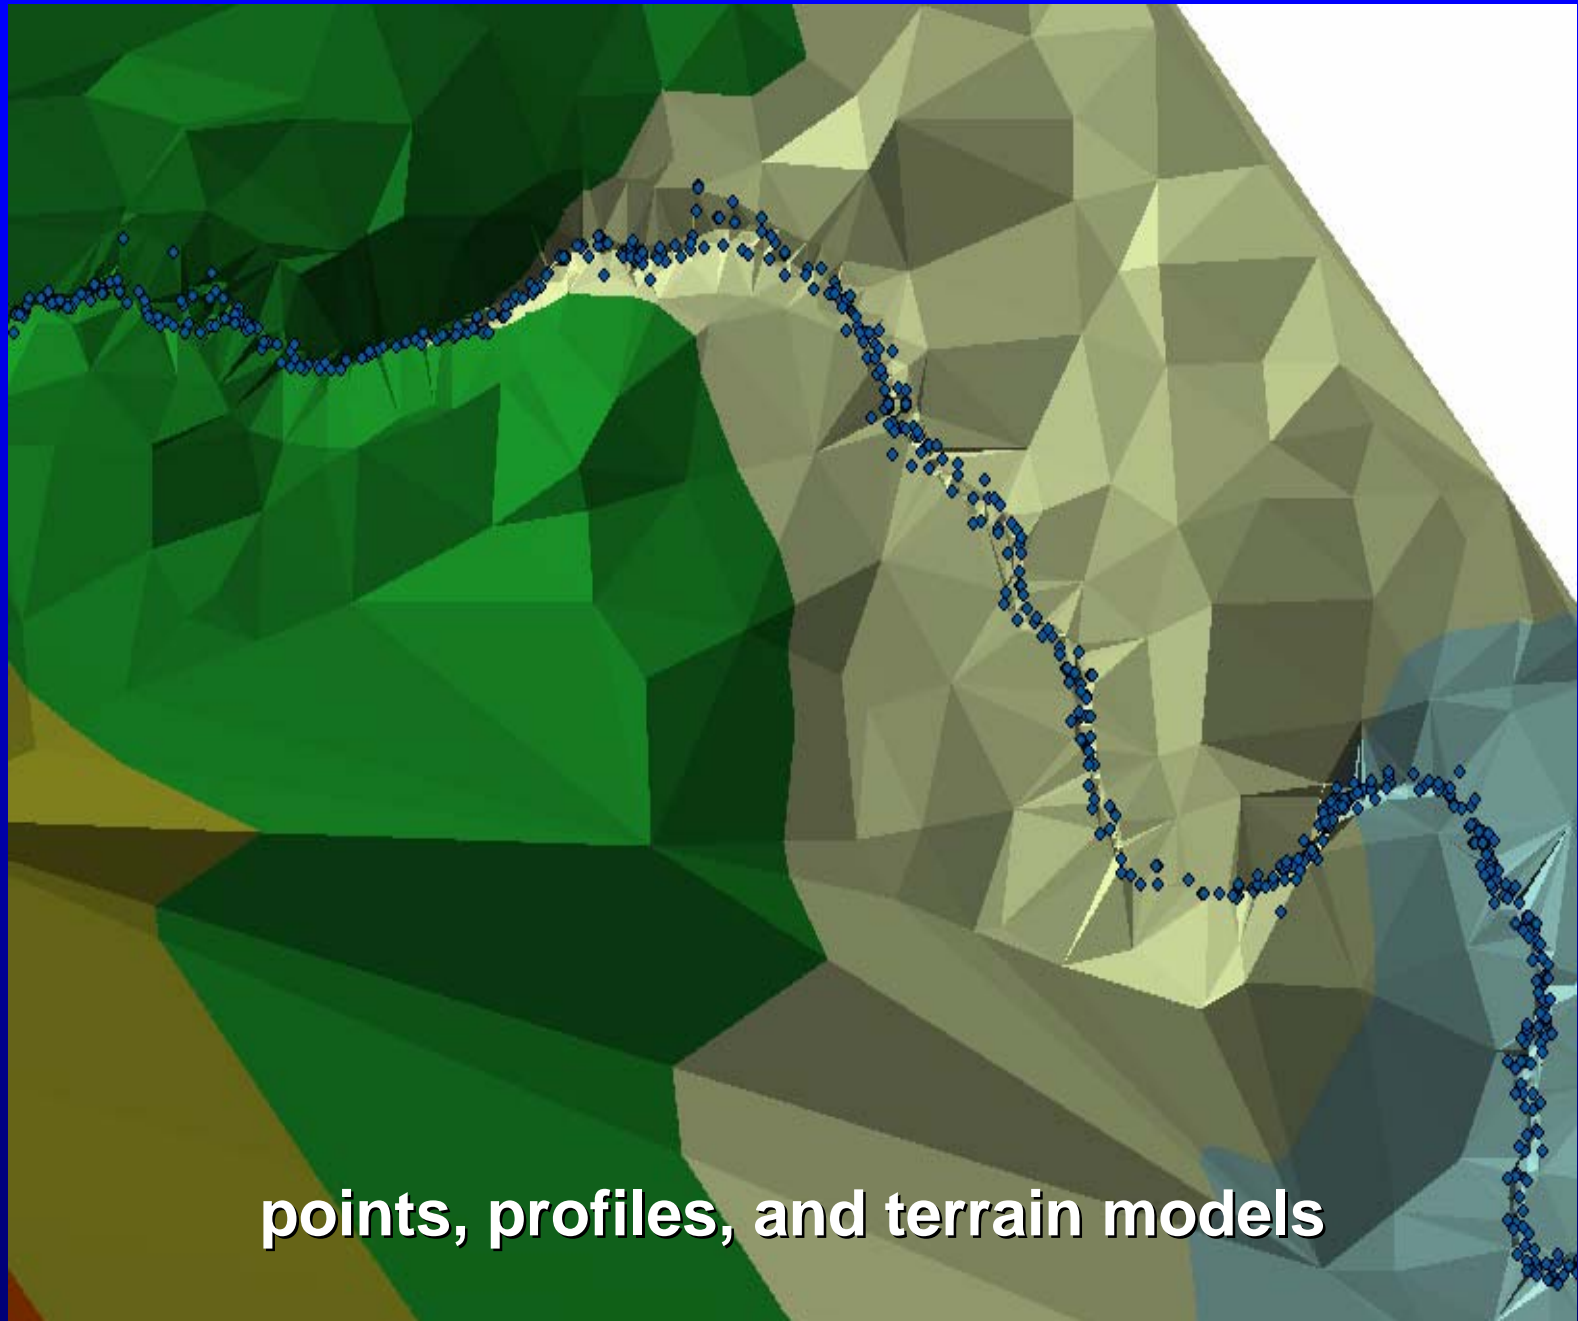
Methods

points, profiles, and terrain models

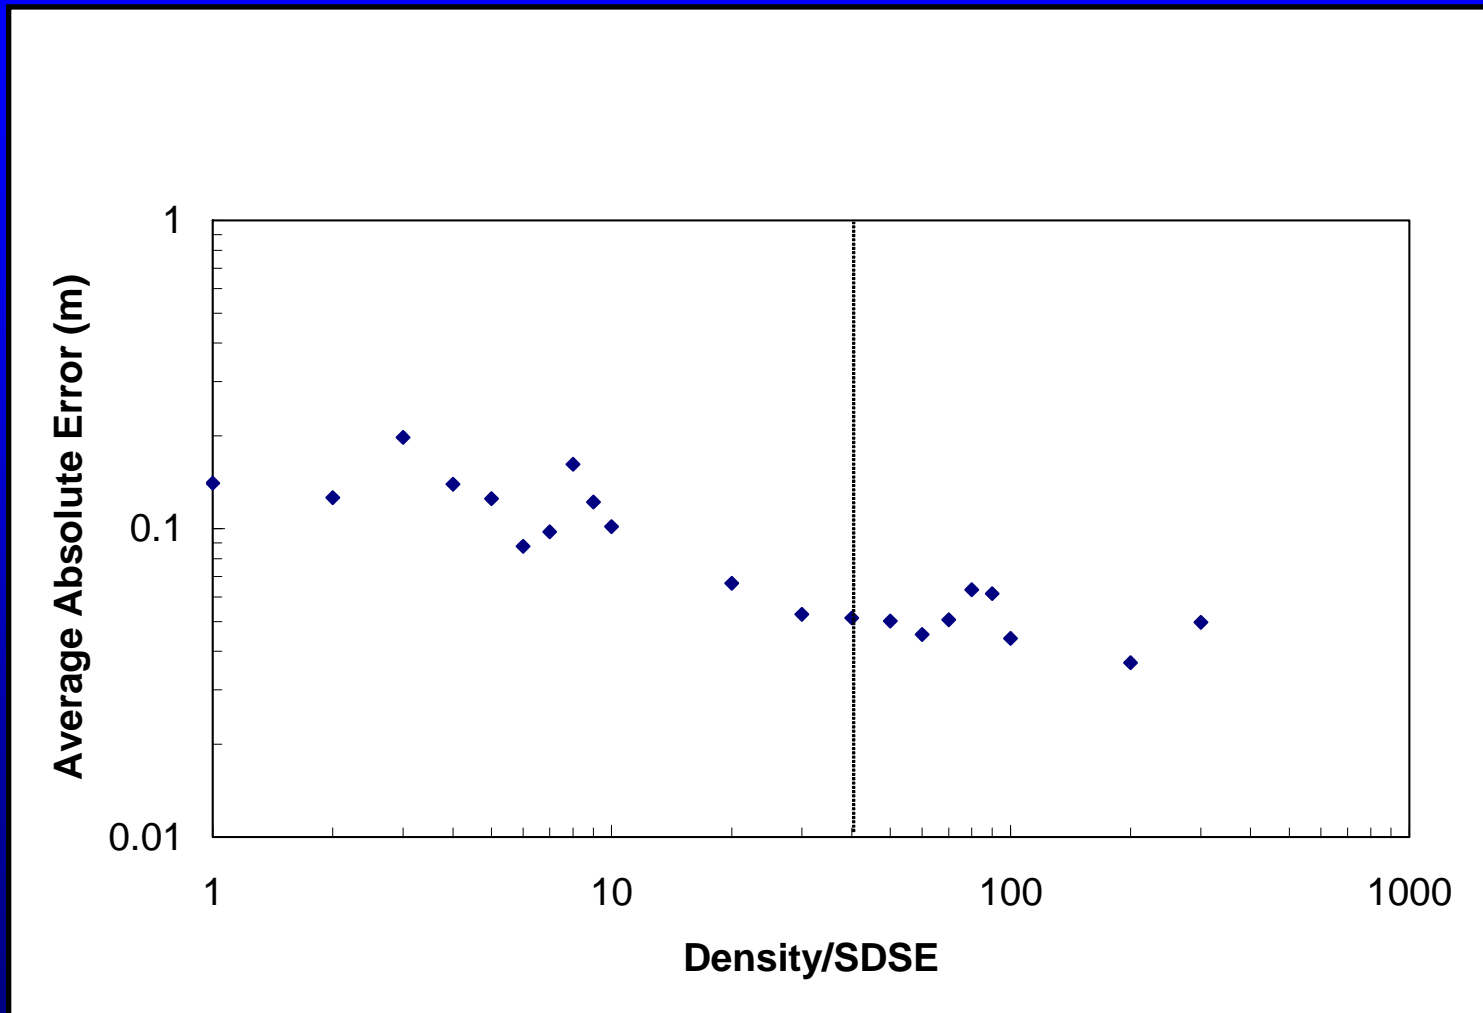
Results—GIS Error Analysis

THE POINT : optimal error = 5-7 cm

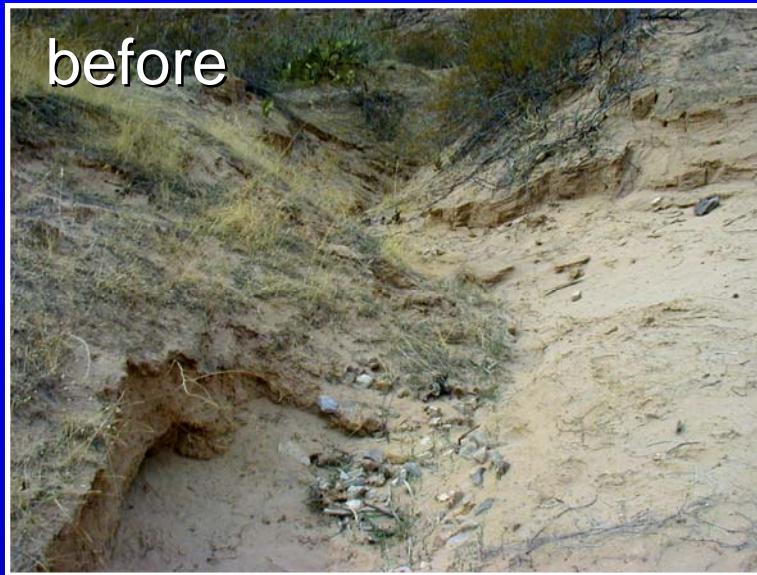
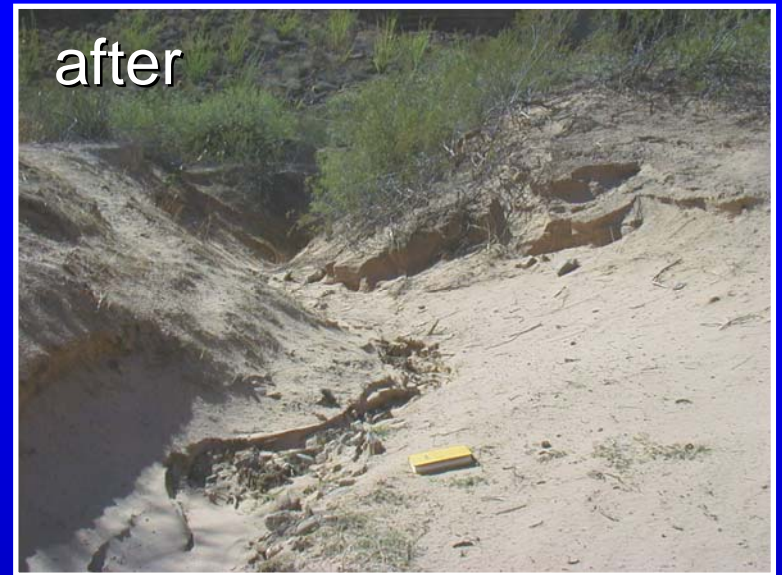
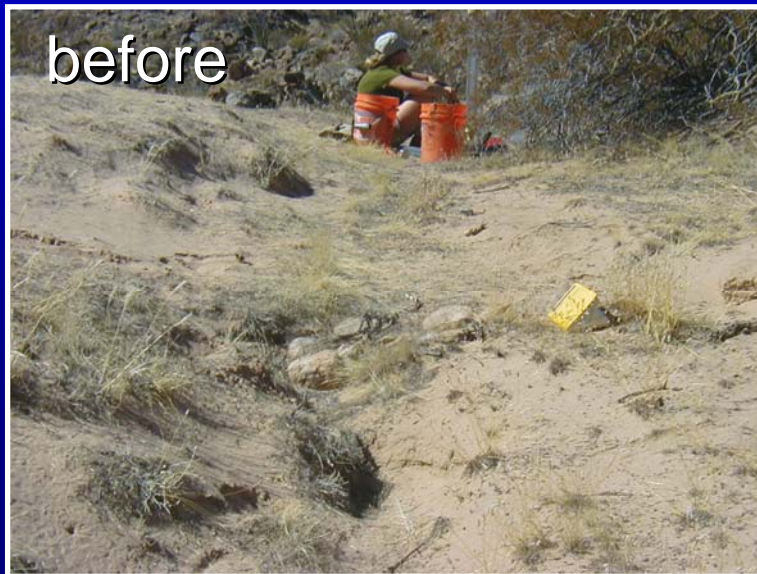
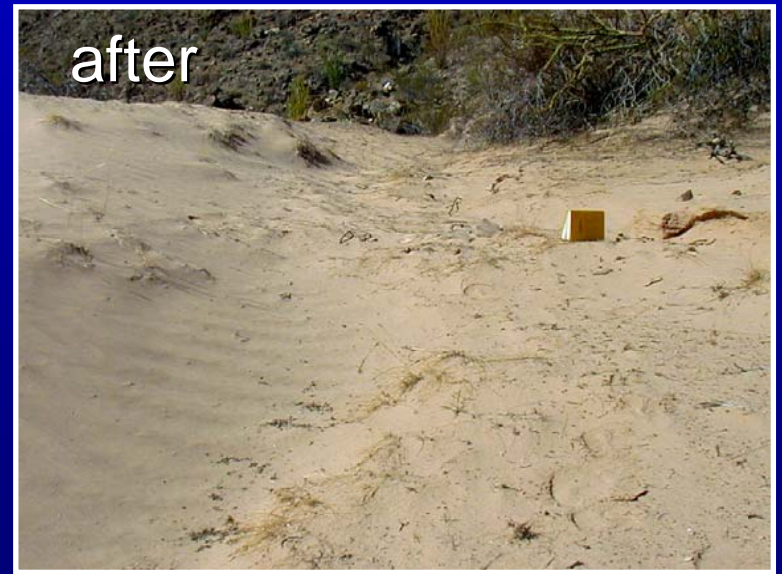
Results—Change Detection

~10 cm of observed change over study period

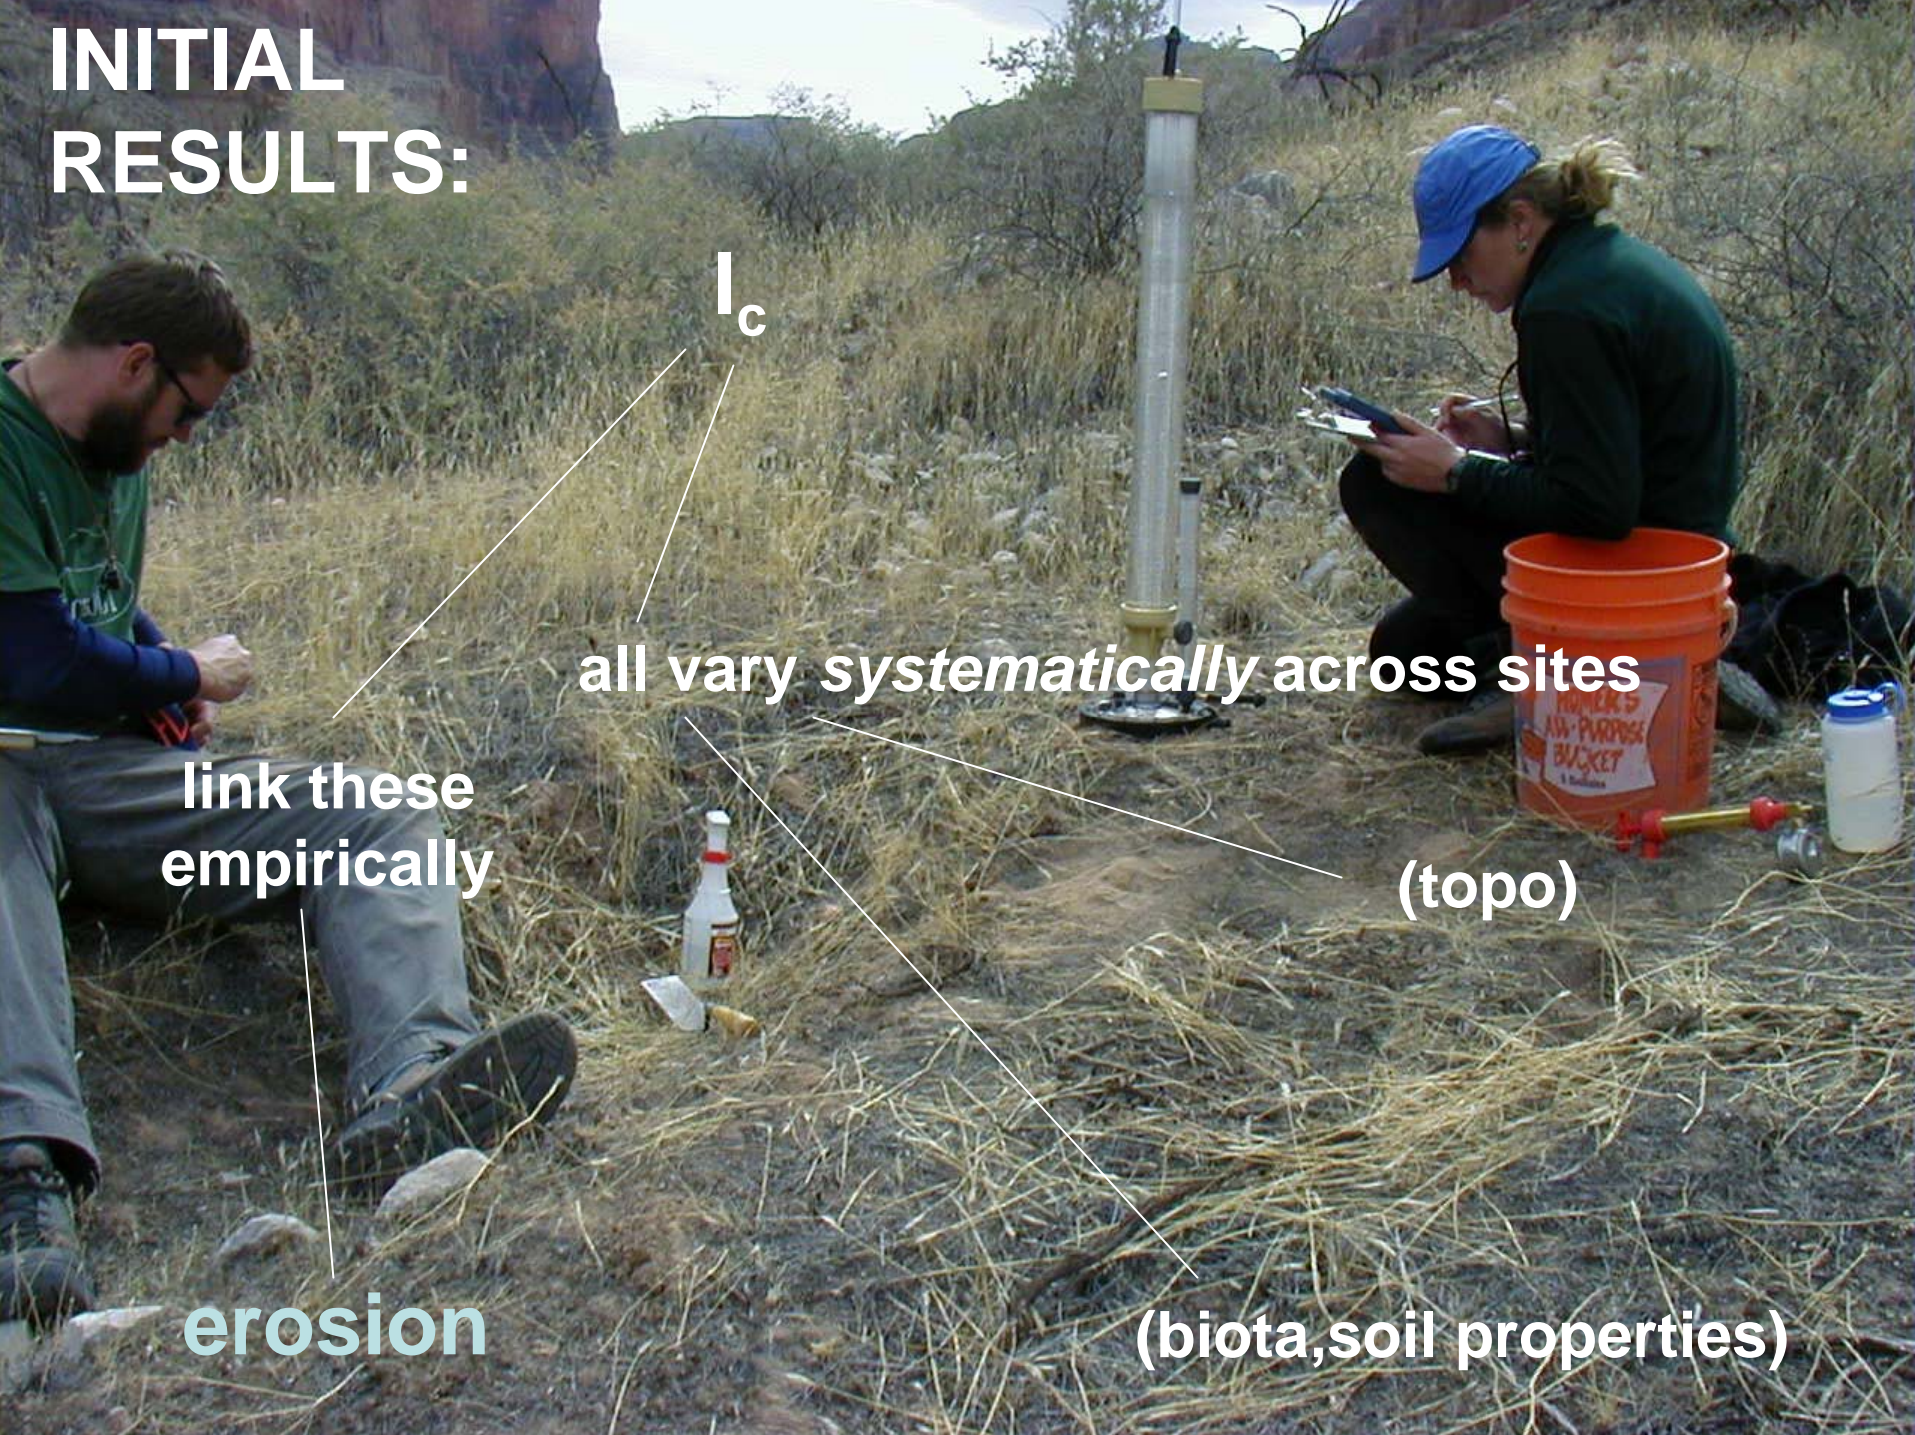
erosion, knickpoint formation, and checkdam failure correlate with high gradient

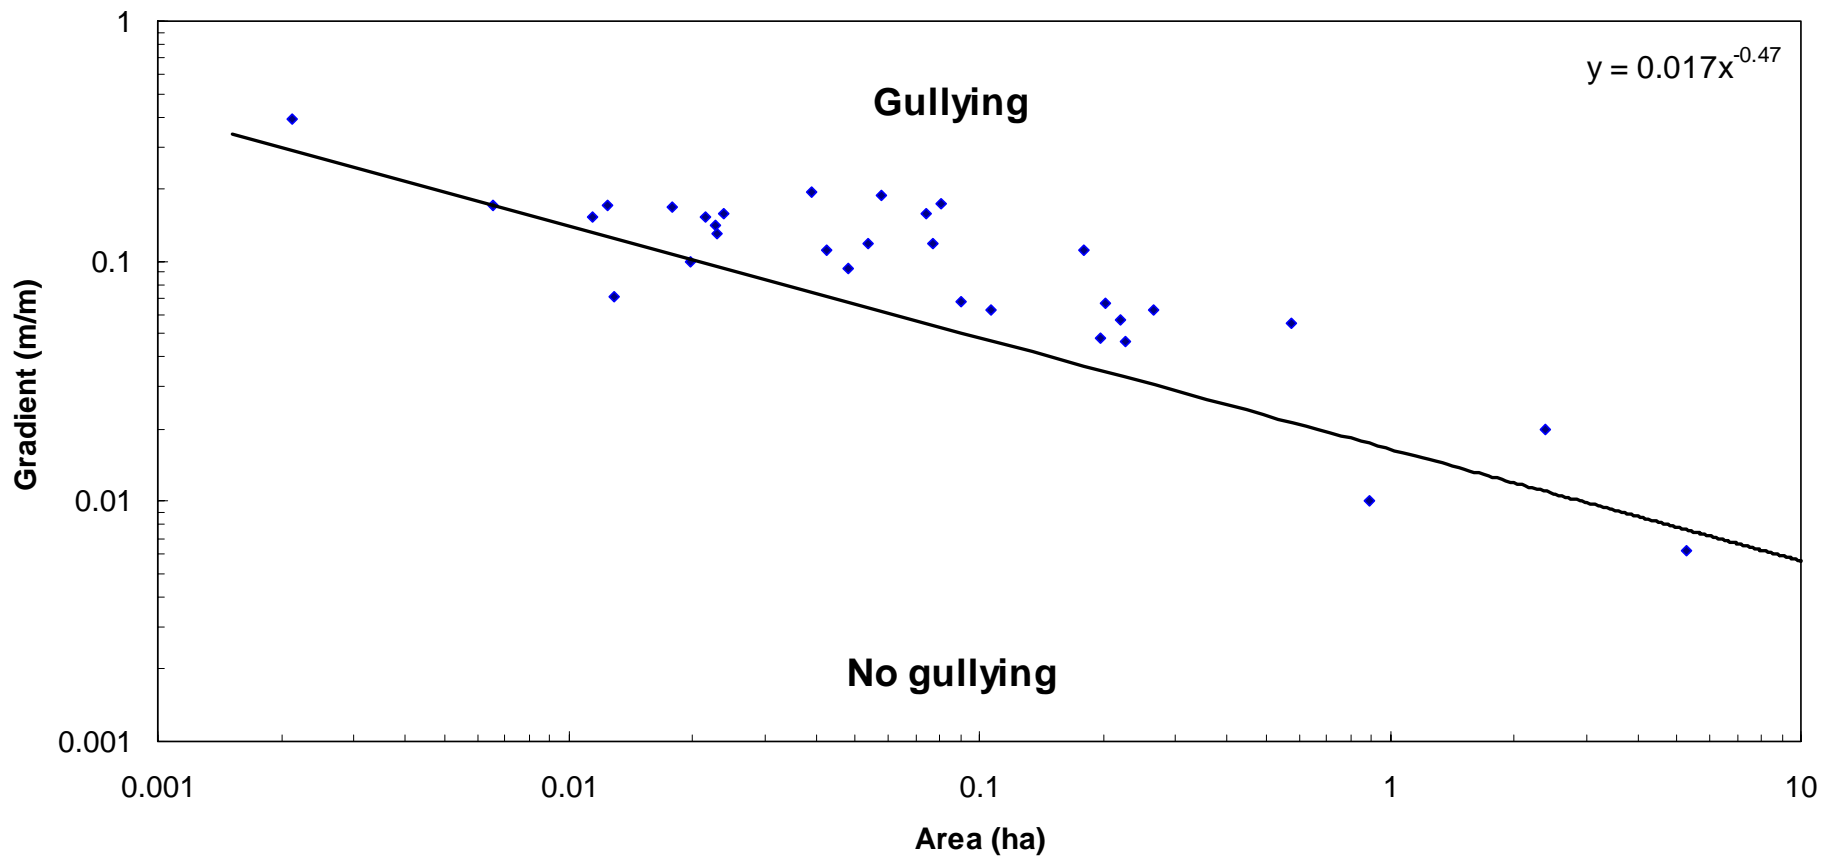
predictive modeling

# Gullies Observed	# Gullies Represented	Percentage
68	66	97
