# Upper Pine River Watershed

## State of the Watershed Report 2008

*Edited By Win Wright, Certified Professional Hydrologist*

# **Upper Pine River Watershed State of the Watershed Report 2008**

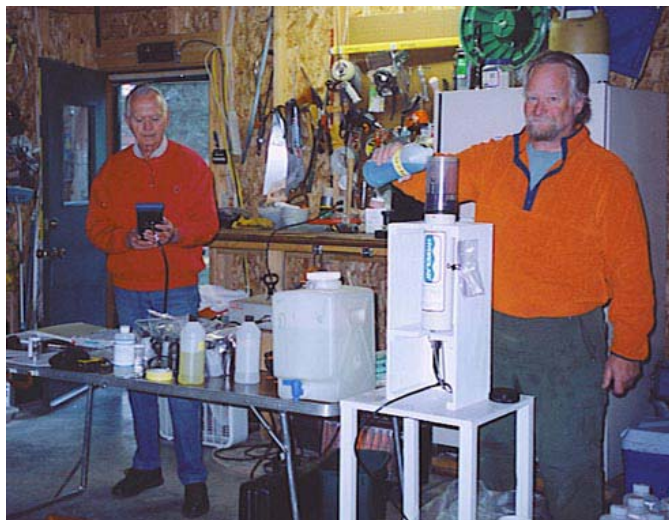
Meet early to calibrate the water-quality sonde, which is checked for the accuracy of pH, specific conductance, temperature, and dissolved oxygen readings.

With grant funds, a lake-water sampler (Kemmerer sampler) and water-quality data sonde (Hydrolab™) were purchased. Training was provided by the USGS in the proper methods for calibration of the sonde and collection of water samples for laboratory analyses.

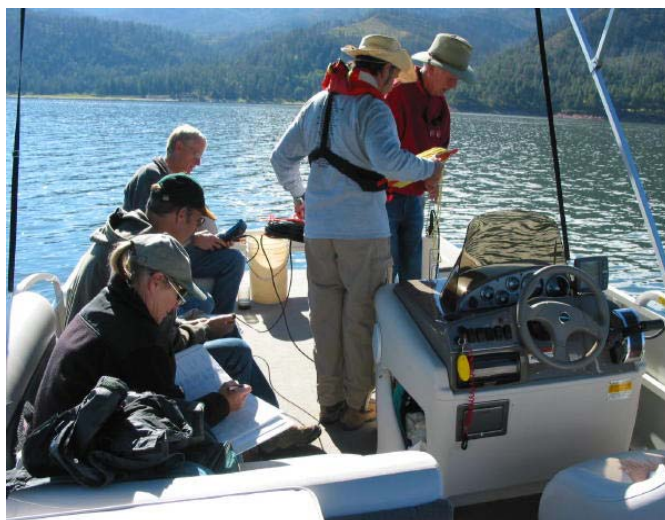
The sonde is lowered into the lake 5 or 10 feet at a time, and water properties are sent to the data unit, where readings are recorded by a notetaker. On this day, we had the luxury of a pontoon boat. Most sampling days are spent in a small outboard motor boat.

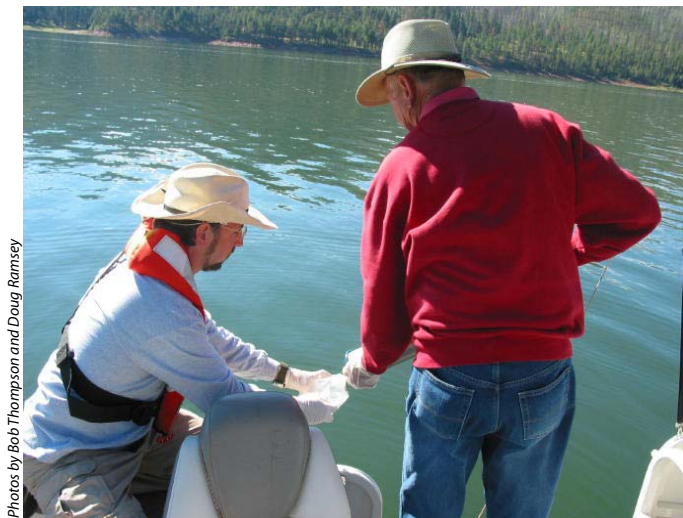
Water samples are collected at the bottom and top of the lake using a point-sampler on a rope with a weighted "messenger" to trigger open the sampler. Samples are poured into one-liter cube bottles. A sample number with a suffix of "L" indicates the lower sample, and a "U" indicates the upper sample.

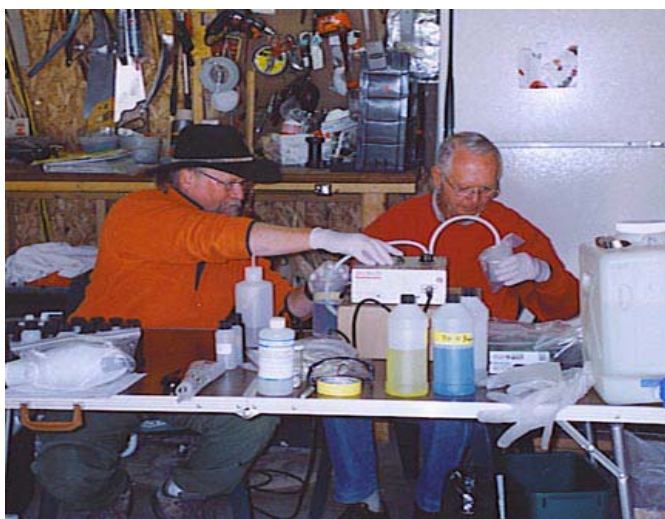
Water samples collected from the lake are filtered and preserved afterwards. Laboratory request forms are filled out, and samples are delivered to the laboratory by express shipping.

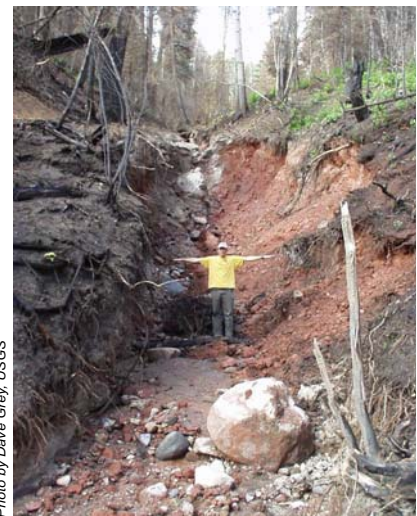
Scour in Root Creek from rain on burned forest, July 22-23, 2002.

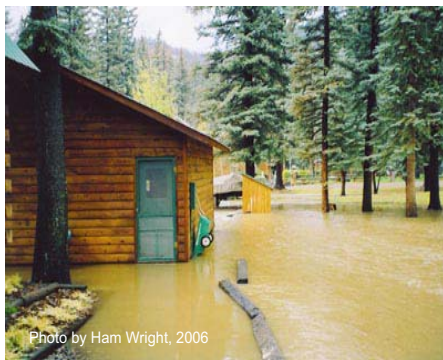
High-flow event in Vallecito Creek, October 6-7, 2006

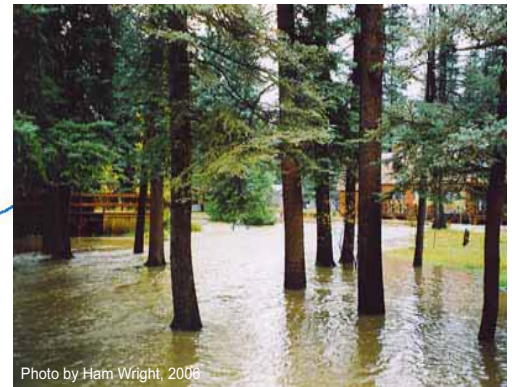
High-flow event in Vallecito Creek, October 6-7, 2006

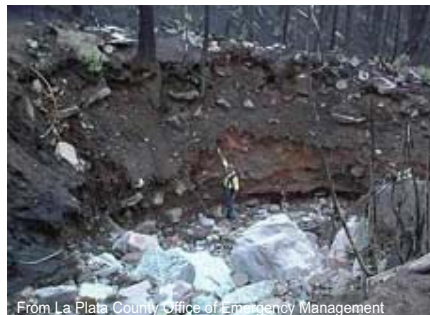
Flood and scouring event, September 2002

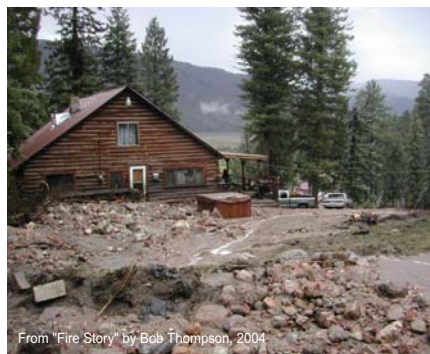
Debris flow damages house, September 2003

A number of side creeks have flooded during past history. Flooding in the mountain drainages creates alluvial fans that form due to deposition of gravels, rocks, and flood debris. After the wildfire, several debris flow events caused flooding and damage to houses located near the side creeks (**Figure 9**).
