## Watershed Plan for the East Fork of the Dolores River in Dolores County

Prepared for:  
The Town of Rico  
August 17, 2006

Prepared by:  
Grayling Environmental  
18050 Rd G  
Cortez, Colorado 81321  
(970) 565-0278

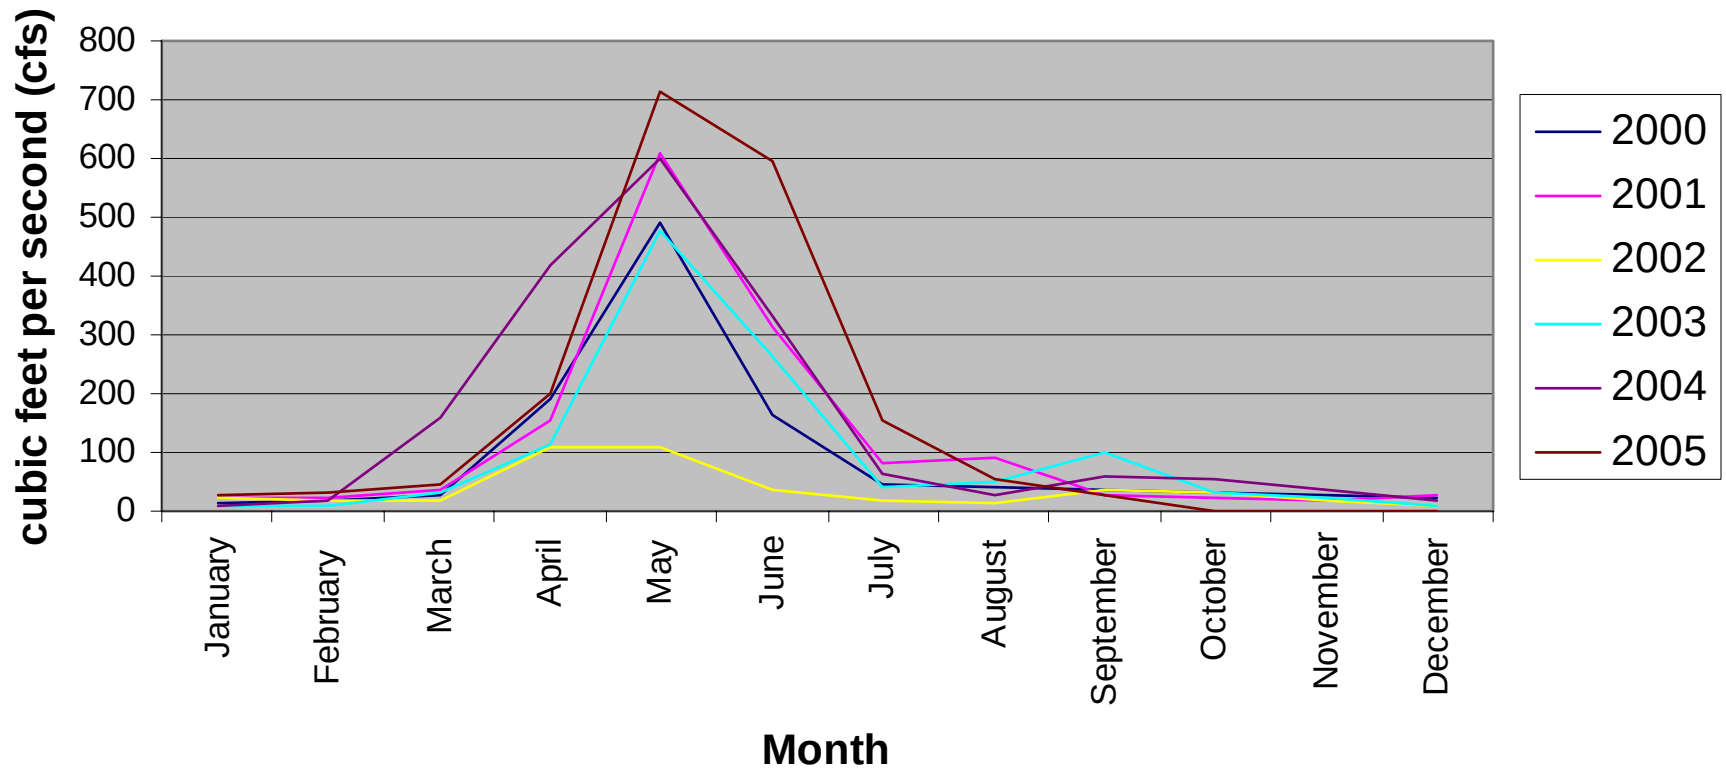
**Figure 2.12. 2000-2005, Monthly Stream Flow Hydrograph of the Dolores River at the Montelores Bridge USGS Gauging Station (USGS Gauging Station 09195000).**

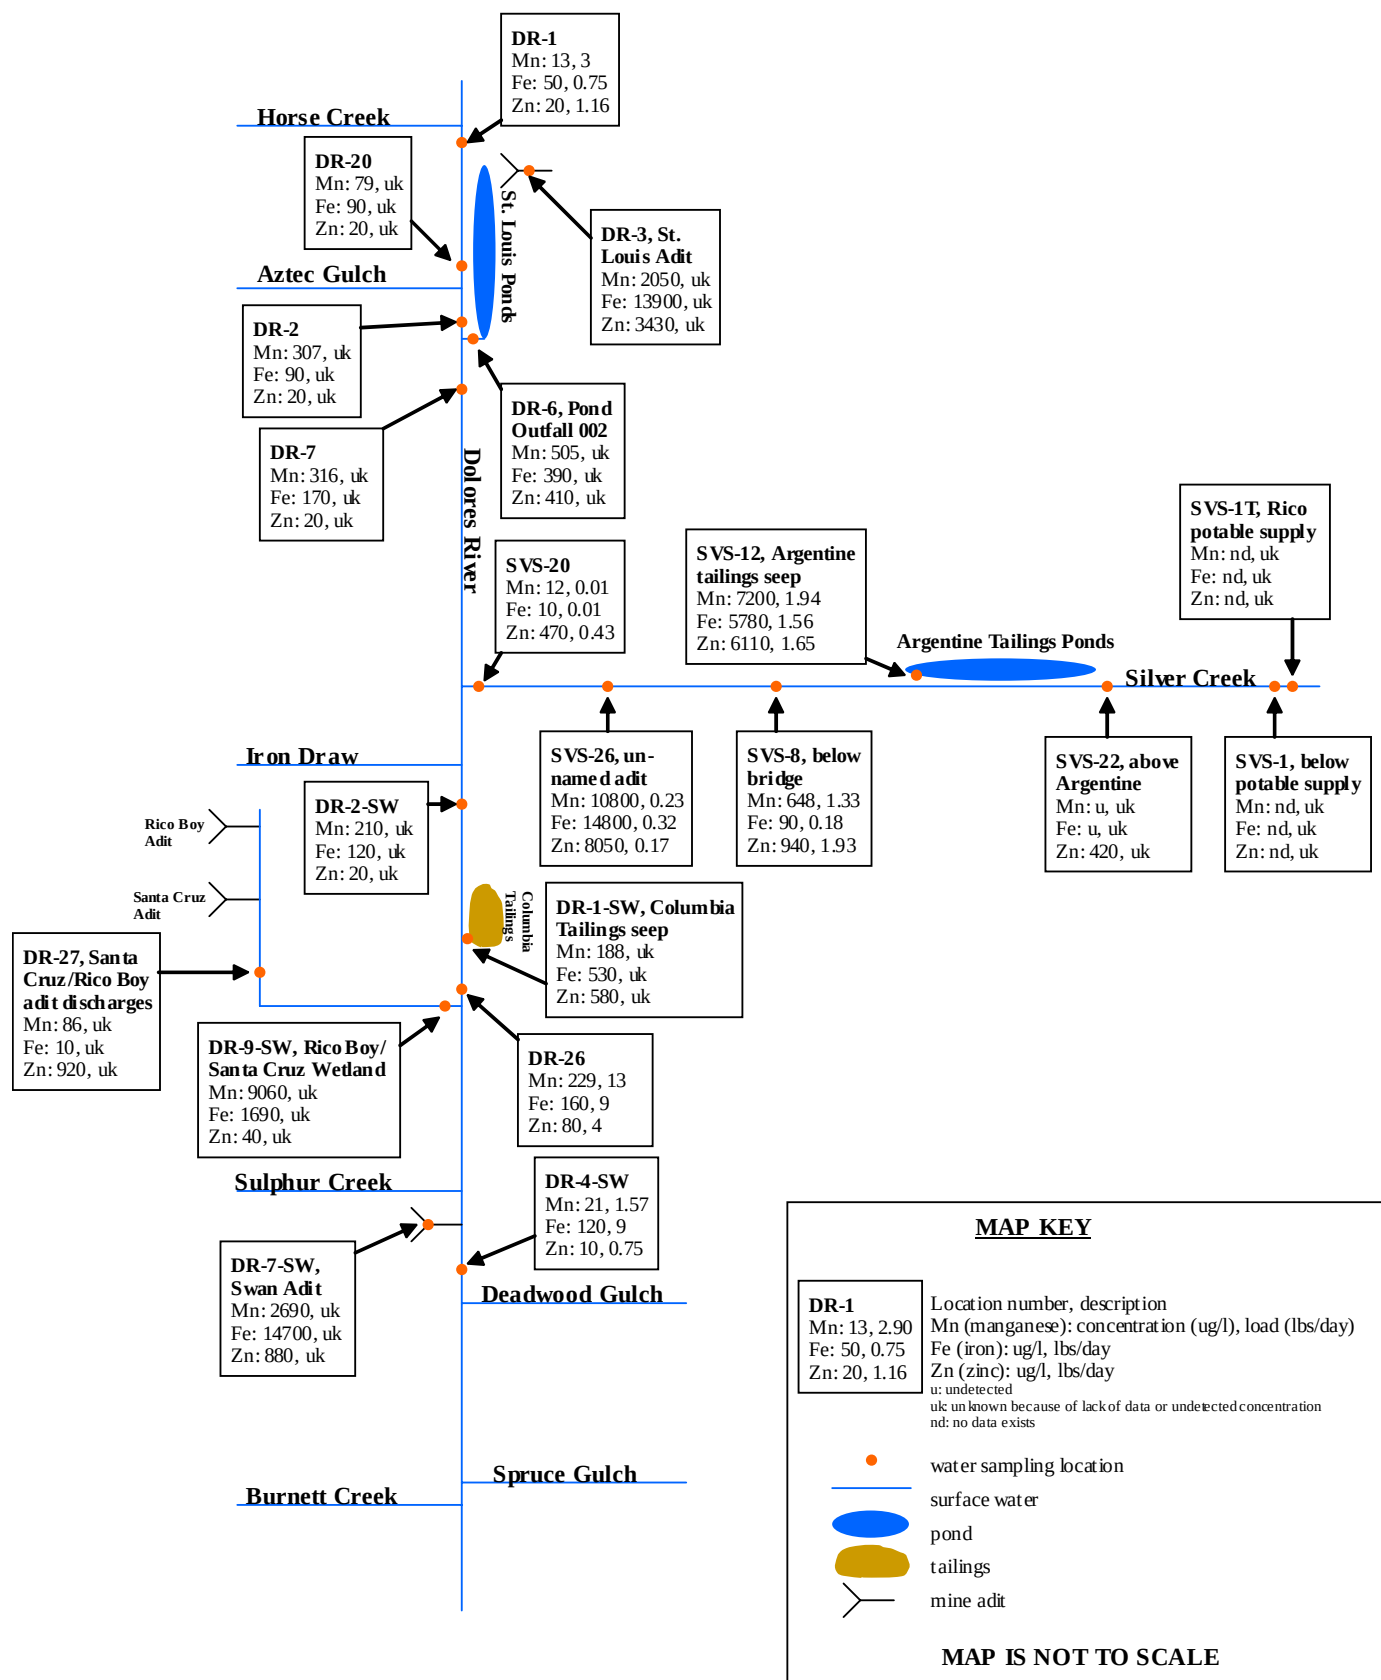
**Figure 4.7. July 18-19, 2002. Conceptual Diagram of the Metals Concentrations (ug/L) and Loading (lbs/day) within the Project Area.**

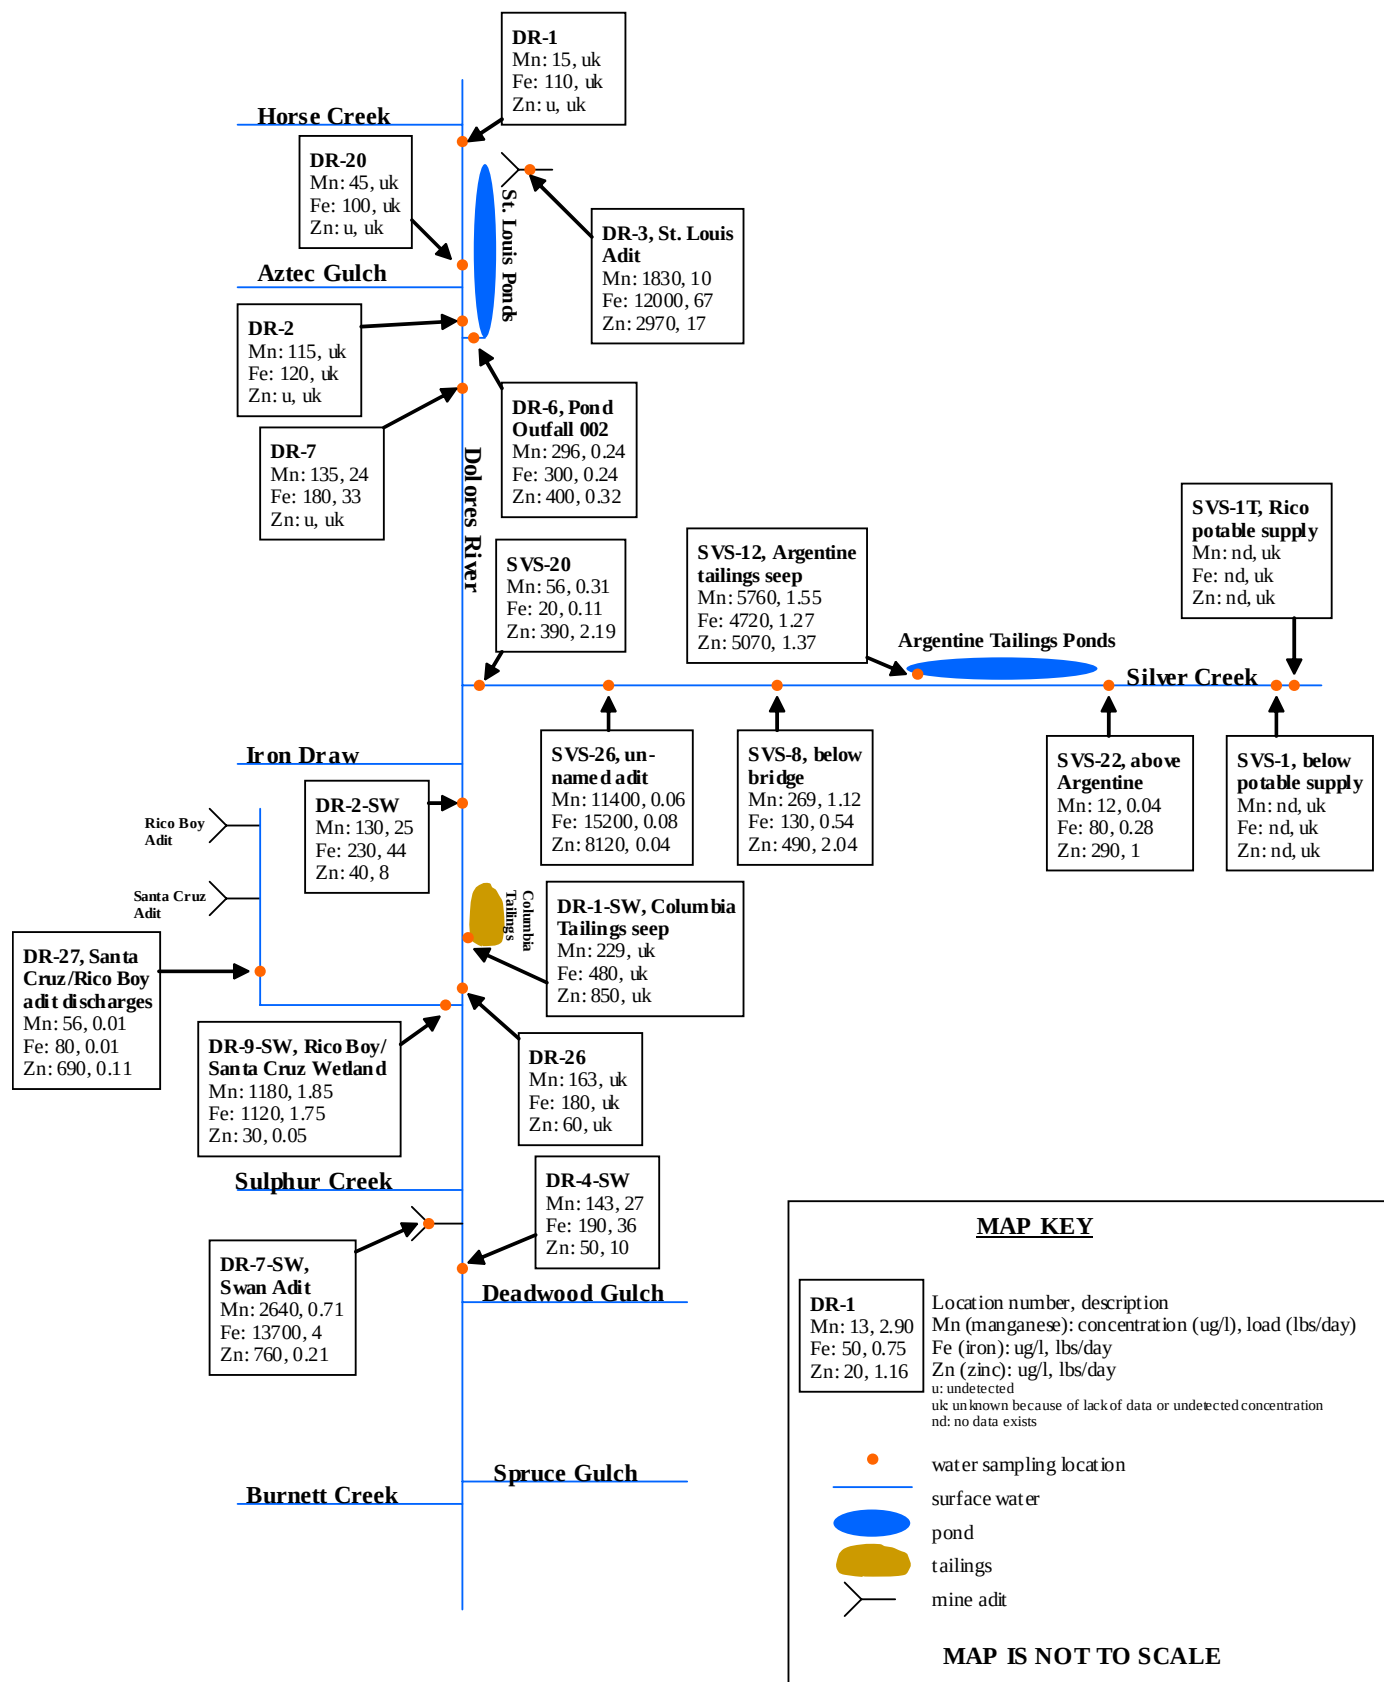
**Figure 4.8. October 6-9, 2002. Conceptual Diagram of the Metals Concentrations (ug/L) and Loading (lbs/day) within the Project Area.**

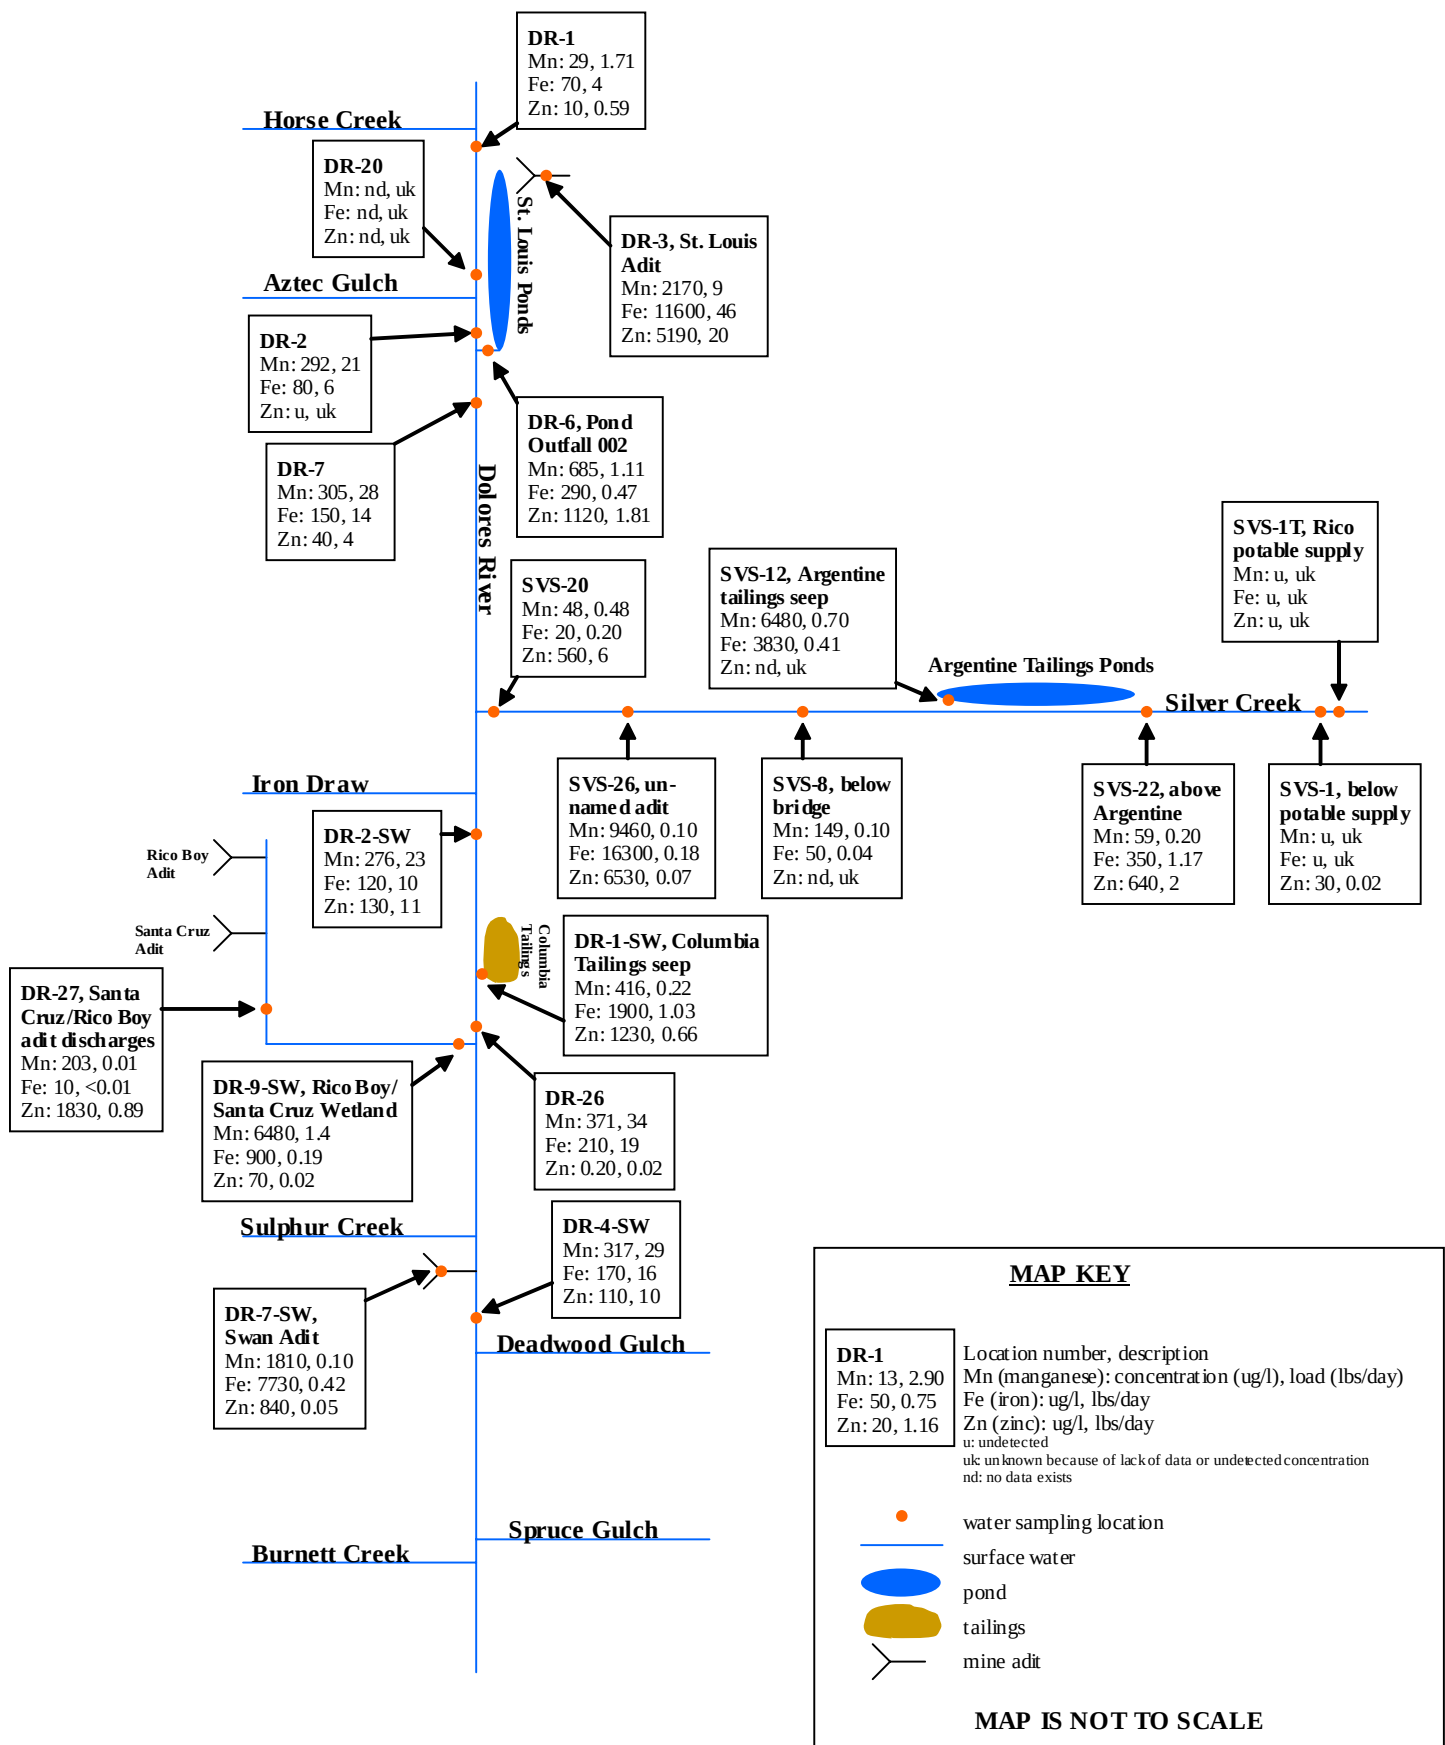
**Figure 4.9. October through December, 2003. Conceptual Diagram of the Metals Concentrations (ug/L) and Loading (lbs/day) within the Project Area.**

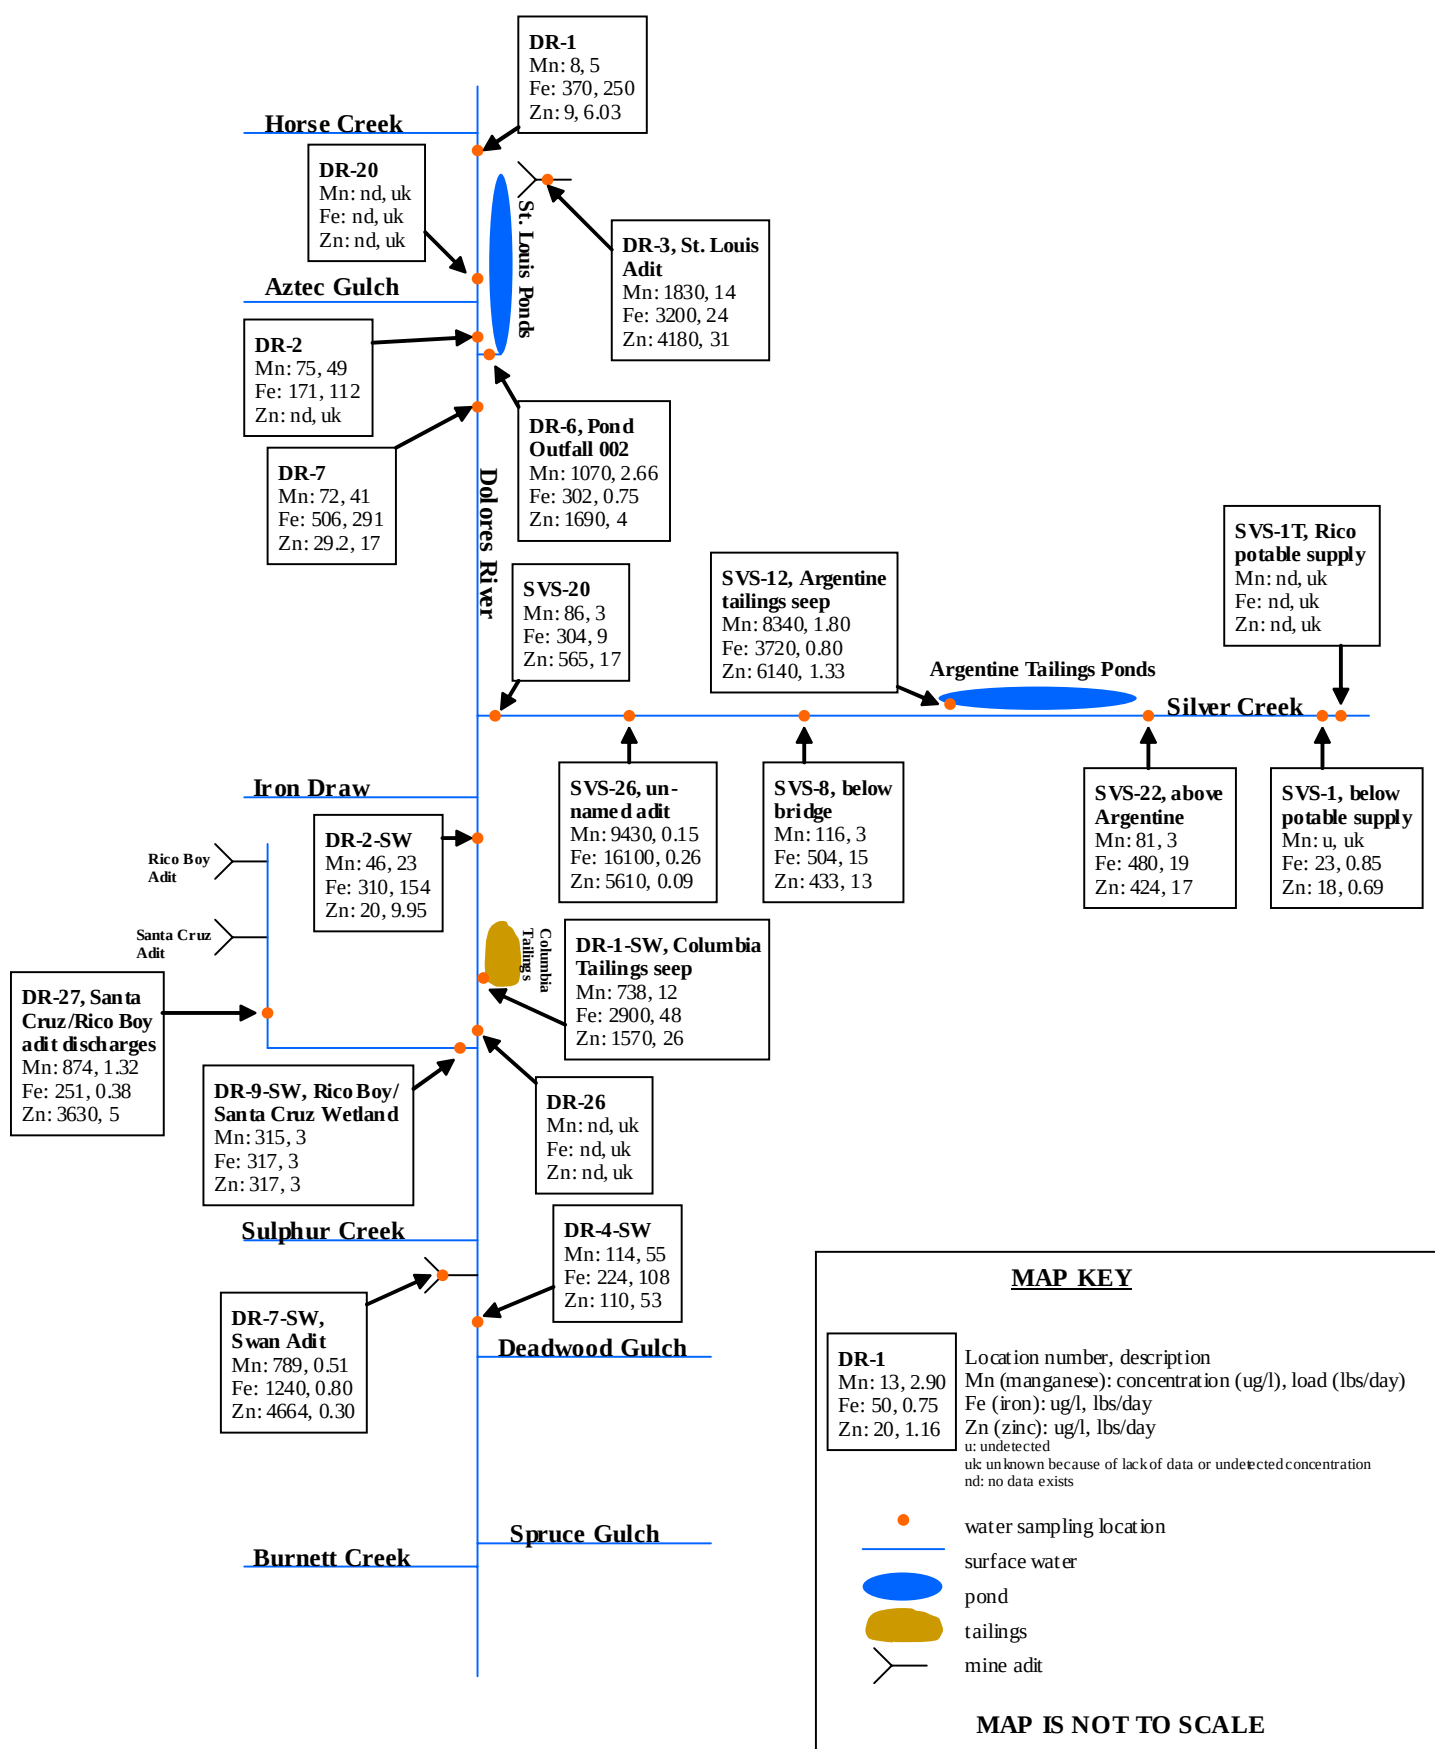
**Figure 4.10. April 26-28, 2004. Conceptual Diagram of the Metals Concentrations (ug/L) and Loading (lbs/day) within the Project Area.**

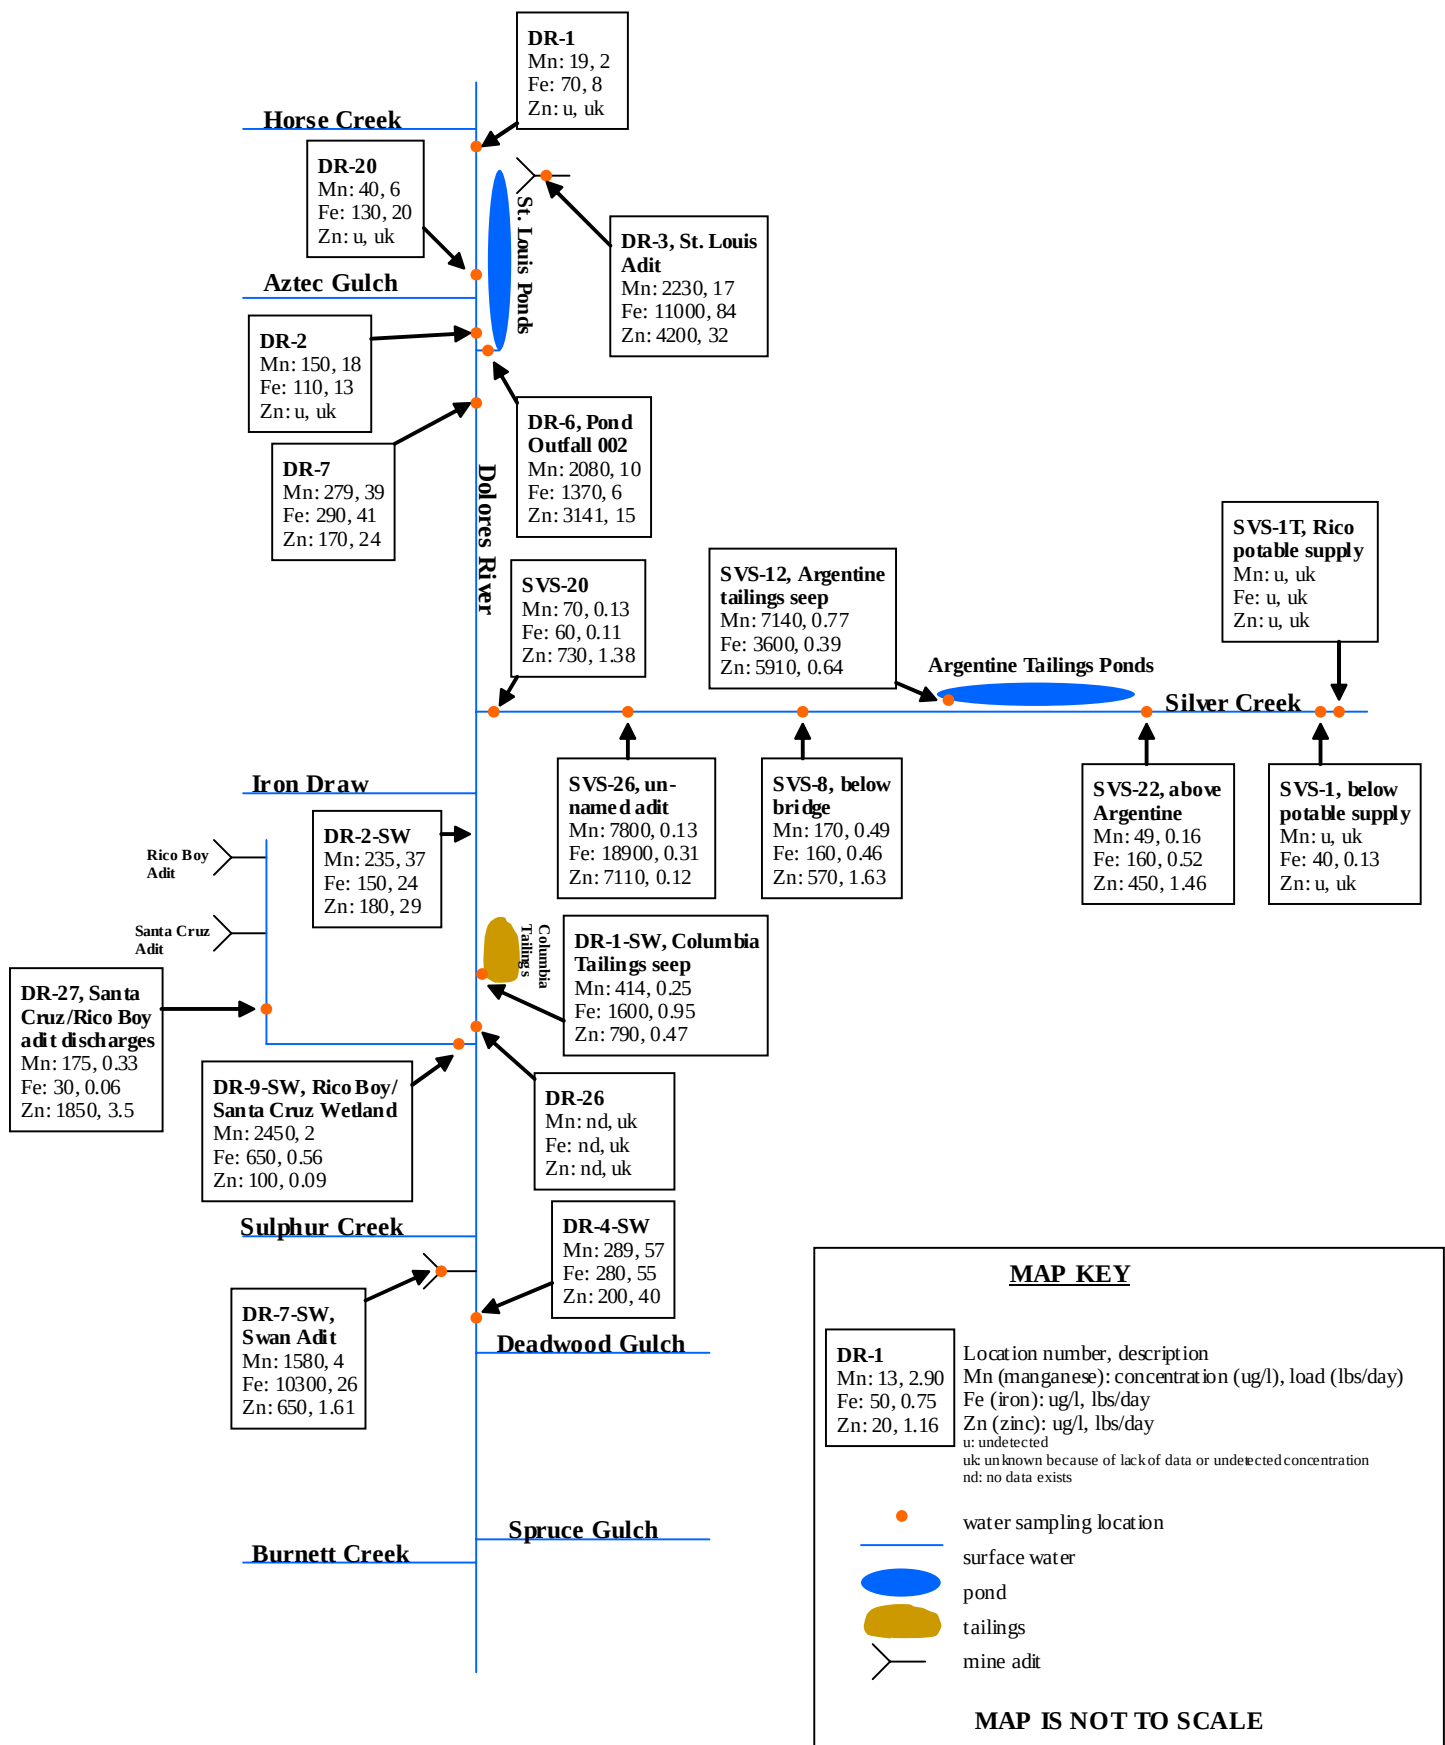
**Figure 4.11. December 6-8, 2004 . Conceptual Diagram of the Metals Concentrations (ug/L) and Loading (lbs/day) within the Project Area.**

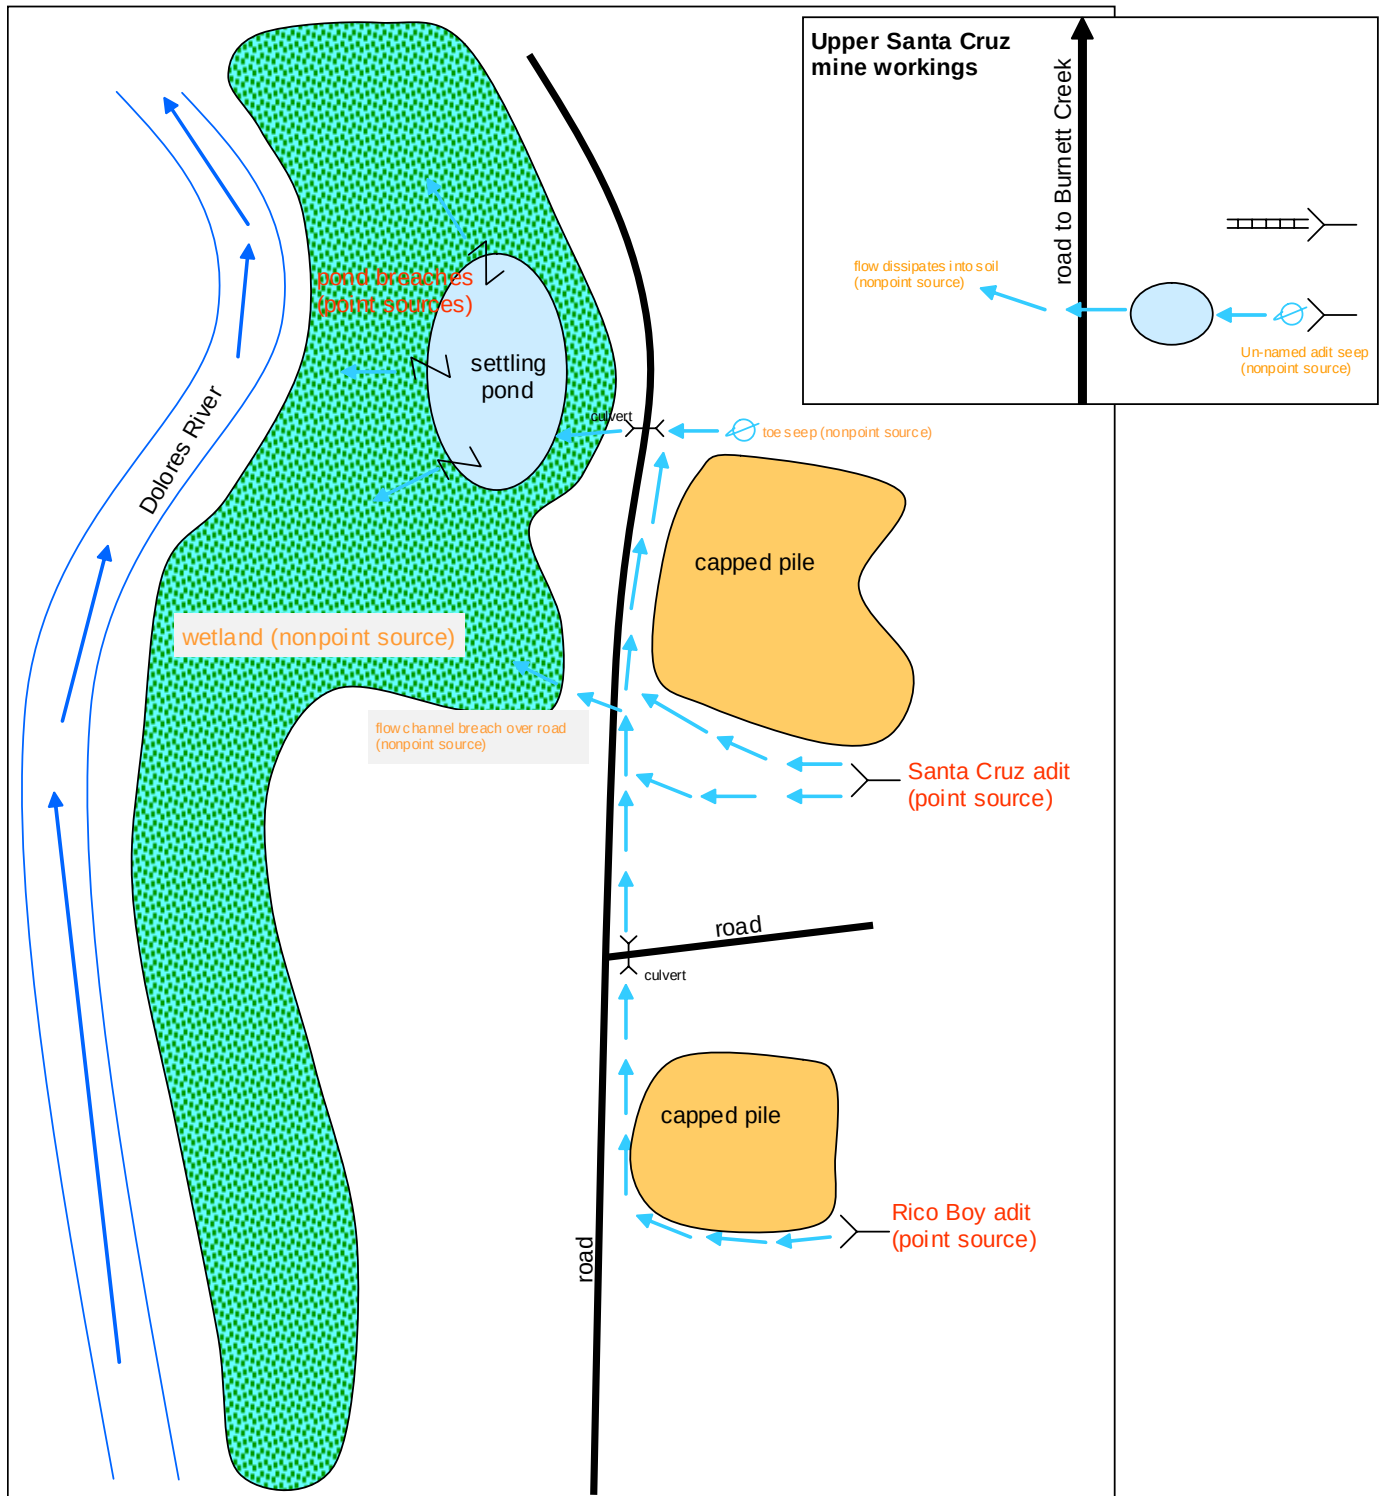
Figure 6.1. Conceptual Model Depicting the Point and Nonpoint Source Discharge Areas Associated with the Rico Boy and Santa Cruz Mines.

2. **For the Santa Cruz/Rico Boy Adits:** Review of the historic conditions of this point source indicates the potential need for control of the water and possible treatment. The settling pond associated with these point releases historically had a singular outfall into a wetlands area that is linked directly to the Dolores River. However, erosion and the collapse of the settling pond berm have lead to additional point discharges that exist currently. It appears that this pond requires maintenance and perhaps additional footprint area to assist with the passive treatment of the water. It appears that the existing passive treatment procedures for these combined flows are not sufficient to address the water quality concerns. Significant amounts of metals are possibly being released to the Dolores River as a result of these flows. It is recommended that these flows be further studied to identify a more aggressive, suitable remedy.

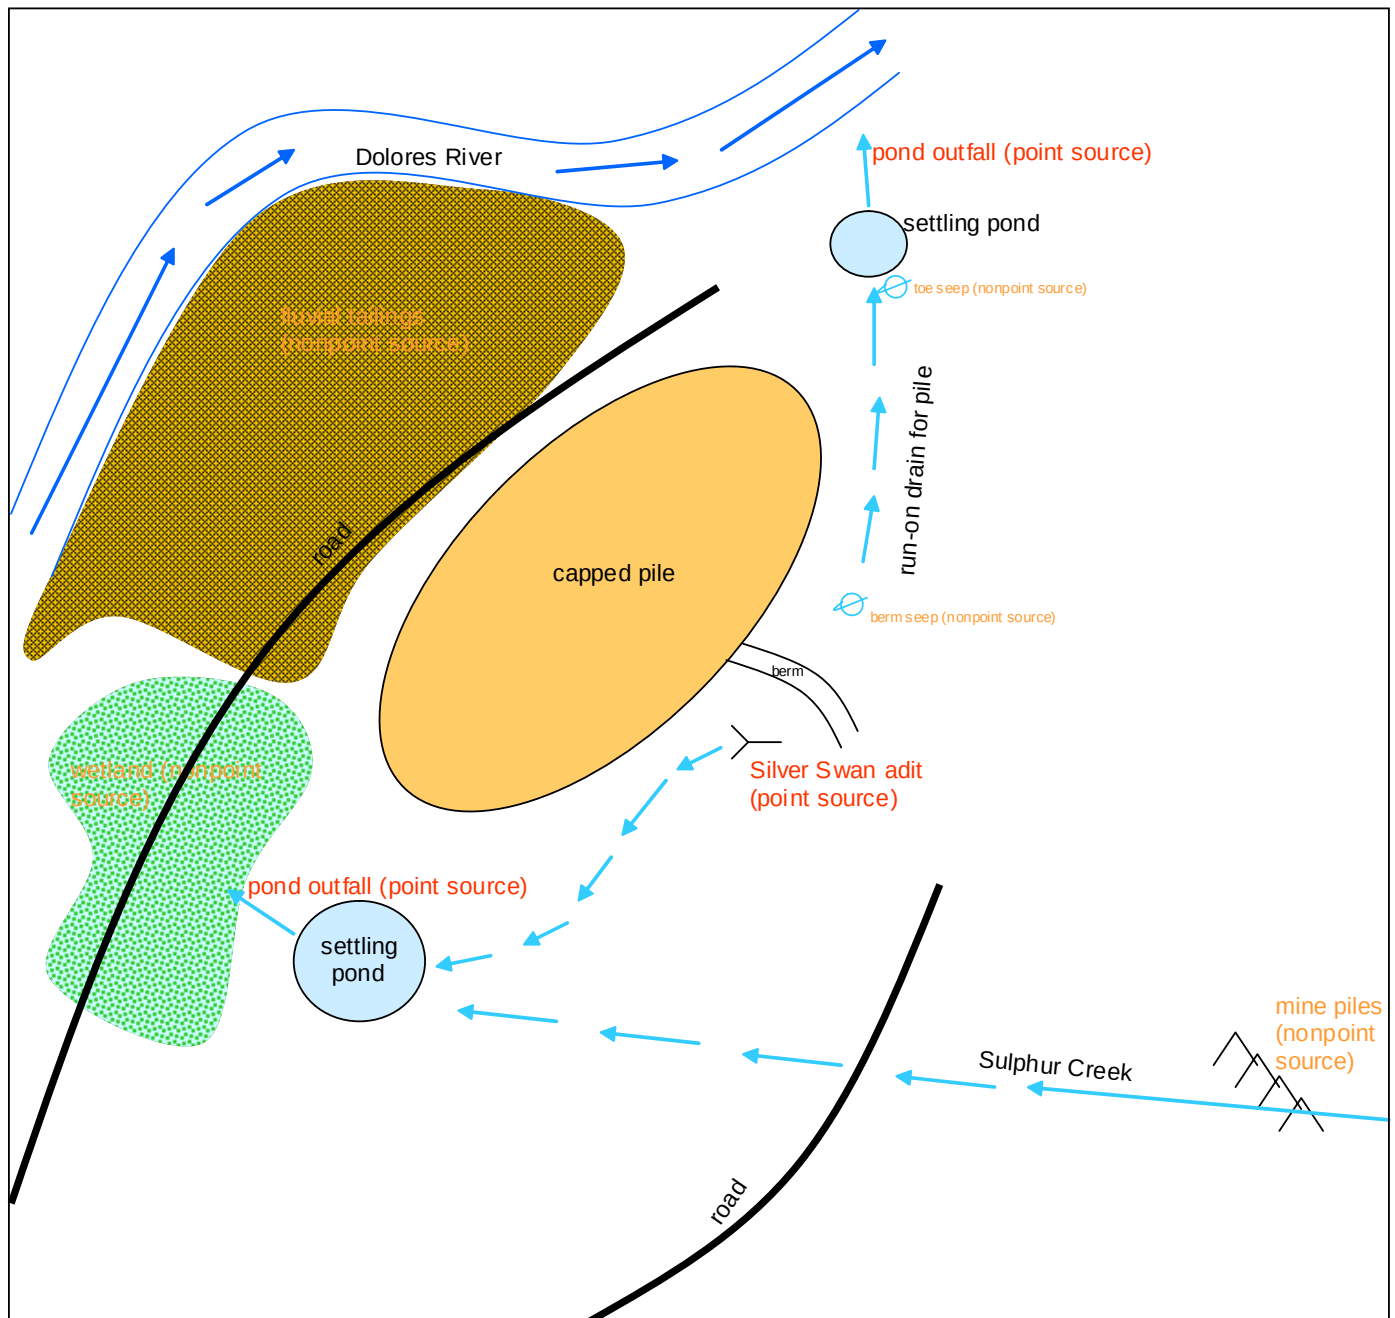
Figure 6.2. Conceptual Model Depicting the Point and Nonpoint Source Discharge Areas Associated with the Silver Swan.

3. **For the Silver Swan Adit:** Review of the current conditions of this point source indicates the need for continued study and possible control or treatment of the water. There are two ‘flowing’ features associated with the Silver Swan Site, the flows from the adit provide a significant metals load to the receiving wetlands. There is also, flow associated with the captured nonpoint waste rock seep and stormwater collection system. These flows are routed to a settling pond and released at a distinct point to the Dolores River. The water quality associated

with this point release does not appear to have been studied. The amount of metals contribution associated with the Silver Swan site needs further evaluation. cursory information gained from the water quality analysis does indicate that there is a concern and the need for additional remedy efforts. It is recommended that the Town further study this site, become involved with decision process in regards to its fate and endorse further action once additional information becomes available.

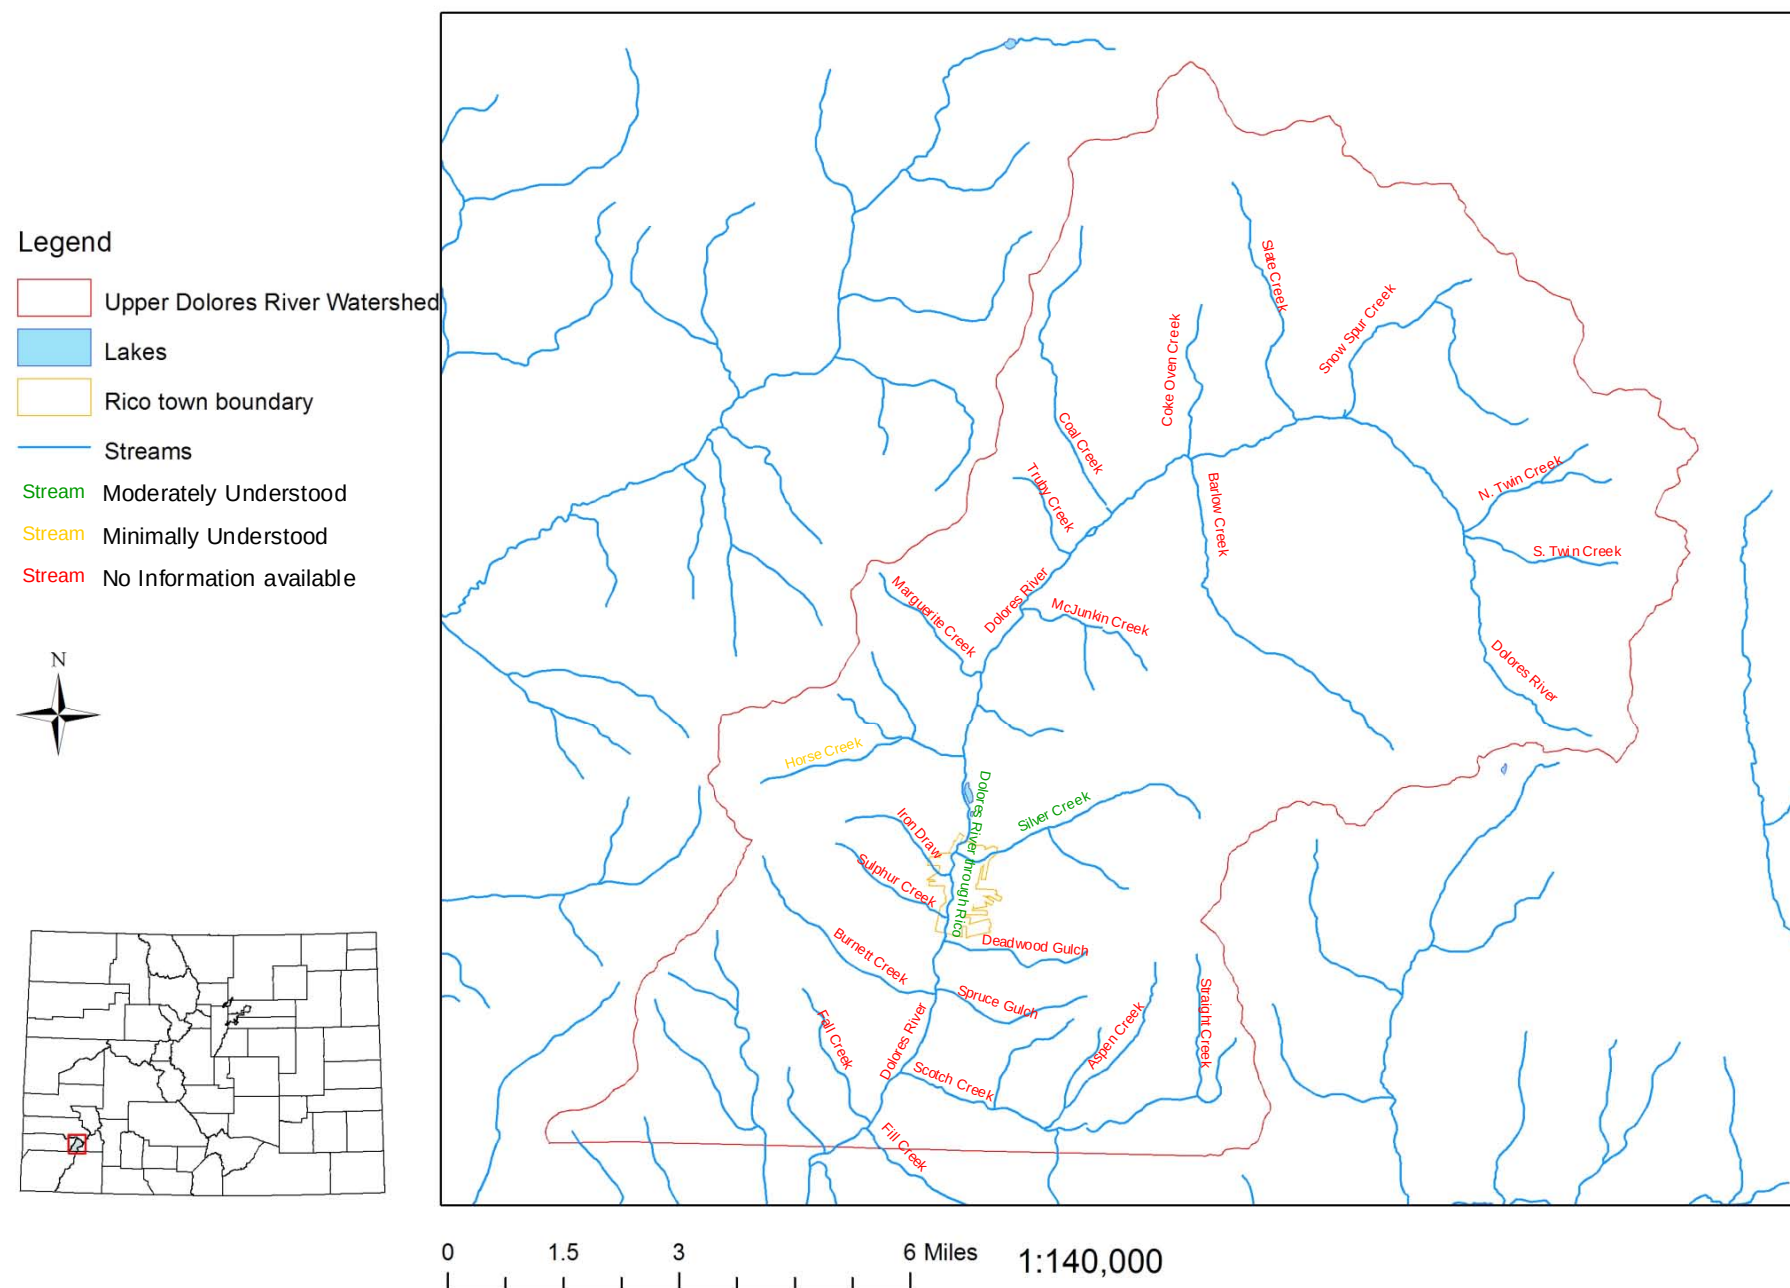
Figure 7.6. Conceptual Model Depicting Segments with Data Gaps.

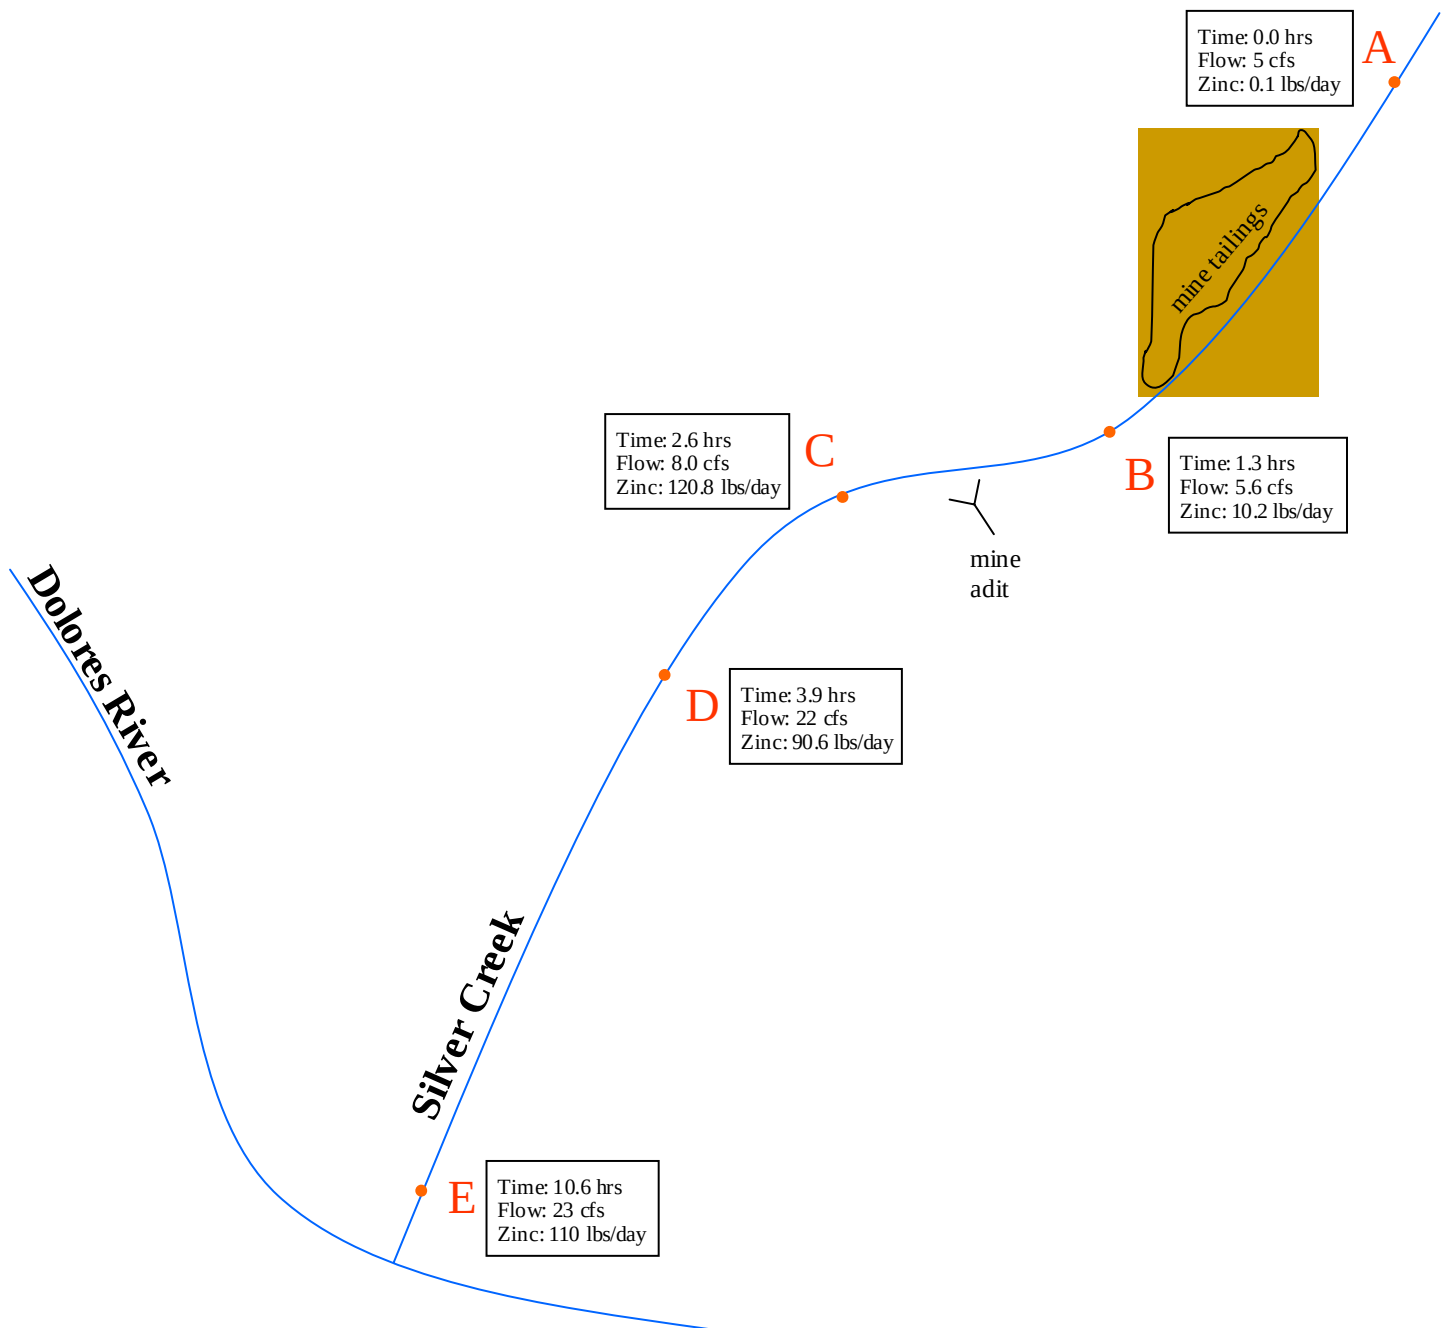
Figure 7.7. Hypothetical Example of a Synoptic Sampling Effort.

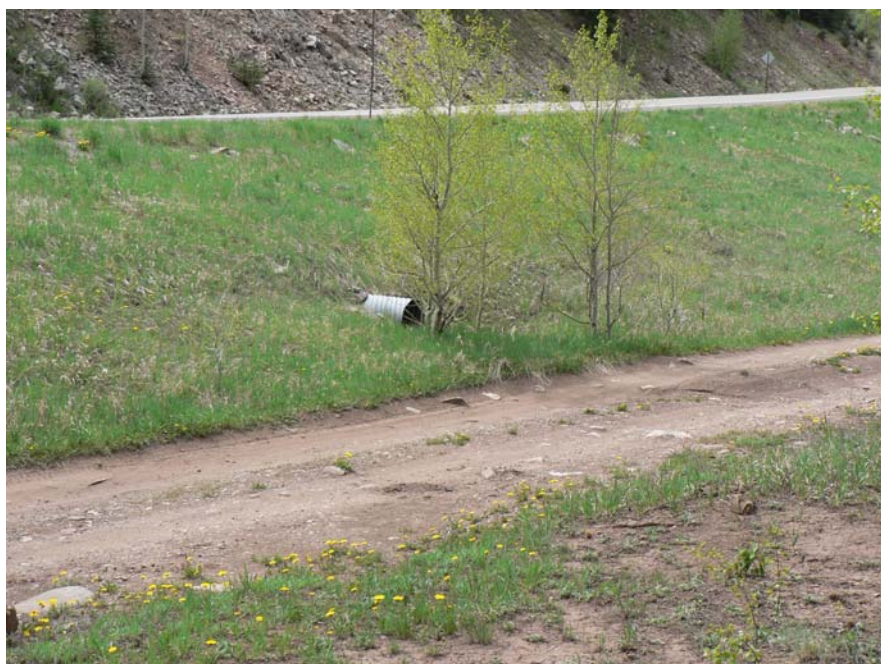
Photo 7.1. Example of Stormwater Impacts created by Recreator Activity. (storm drain located on top of a dirt road accessing an unrestricted campground adjacent to the Dolores River).
