## Watershed Plan for the East Fork of the Dolores River in Dolores County

Prepared for:  
The Town of Rico  
August 17, 2006

Prepared by:  
Grayling Environmental  
18050 Rd G  
Cortez, Colorado 81321  
(970) 565-0278

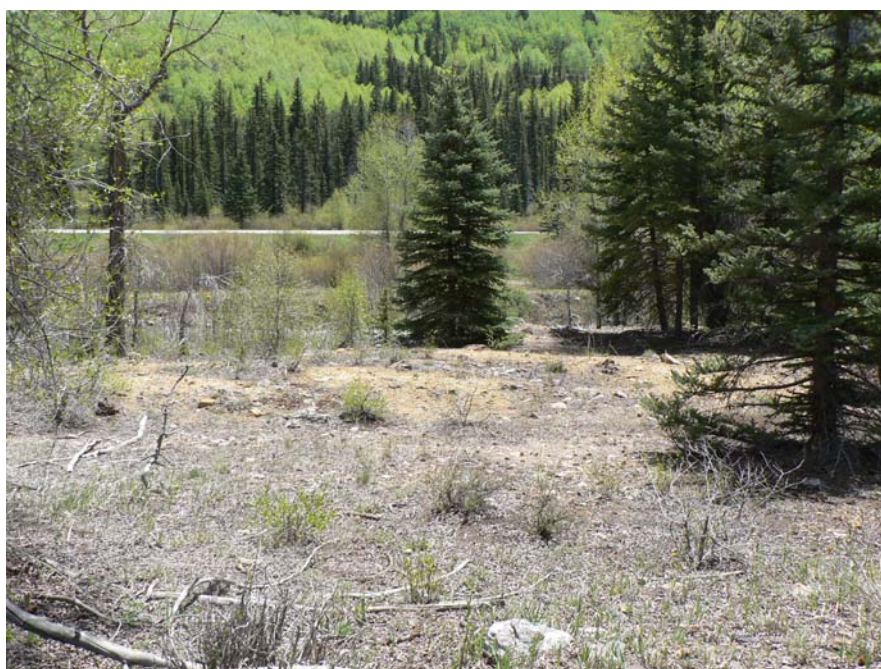
Photo 7.2. A Potential Nonpoint Source Requiring Further Evaluation : Fluvial Tailings Located Adjacent to the Santa Cruz and Rico Boy Mine Sites.

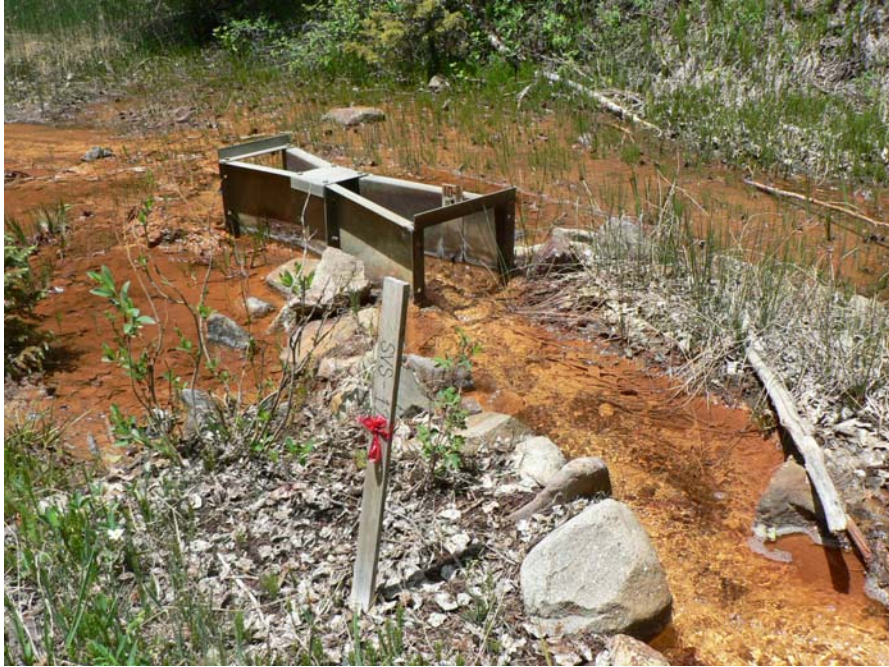
Photo 7.3. Ironoxide Deposits Associated with the Argentine Tailings Seep. This Photo Captures the SVS 12 Sampling Location.

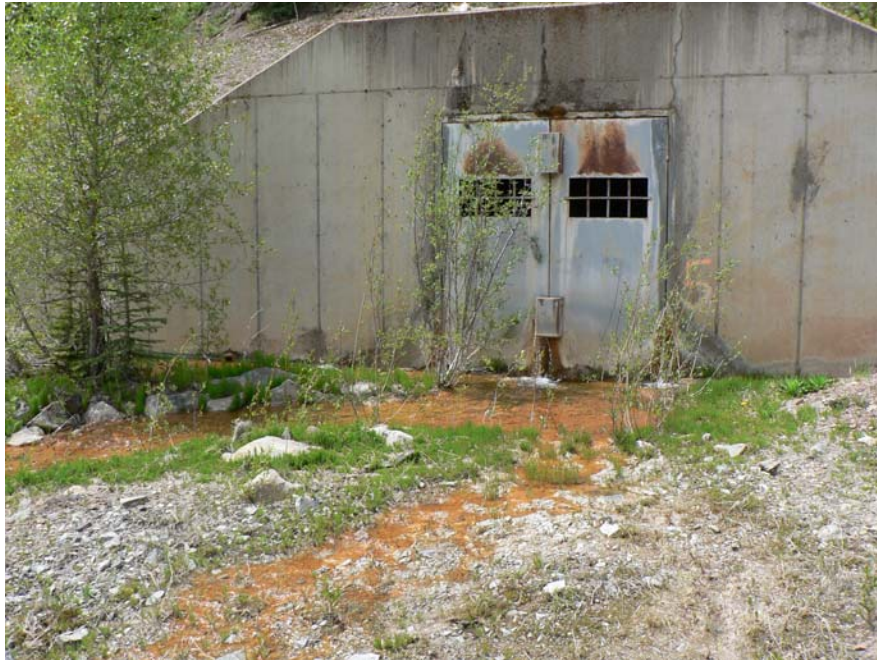
Photo 7.4. The Santa Cruz Mine Adit. This Photo shows the Controlled Flow Channel (left) and the Uncontrolled Flow that is Circumventing the Remedy.

2. **For the Santa Cruz/Rico Boy Adits:** Review of the historic conditions of this point source indicates the potential need for control of the water and possible treatment. The settling pond associated with these point releases historically had a singular outfall into a wetlands area that is linked directly to the Dolores River. However, erosion and the collapse of the settling pond berm have lead to additional point discharges that exist currently. It appears that this pond requires maintenance and perhaps additional footprint area to assist with the passive treatment of the water. It appears that the existing passive treatment procedures for these combined flows are not sufficient to address the water quality concerns. Significant amounts of metals are possibly being released to the Dolores River as a result of these flows. It is recommended that these flows be further studied to identify a more aggressive, suitable remedy.

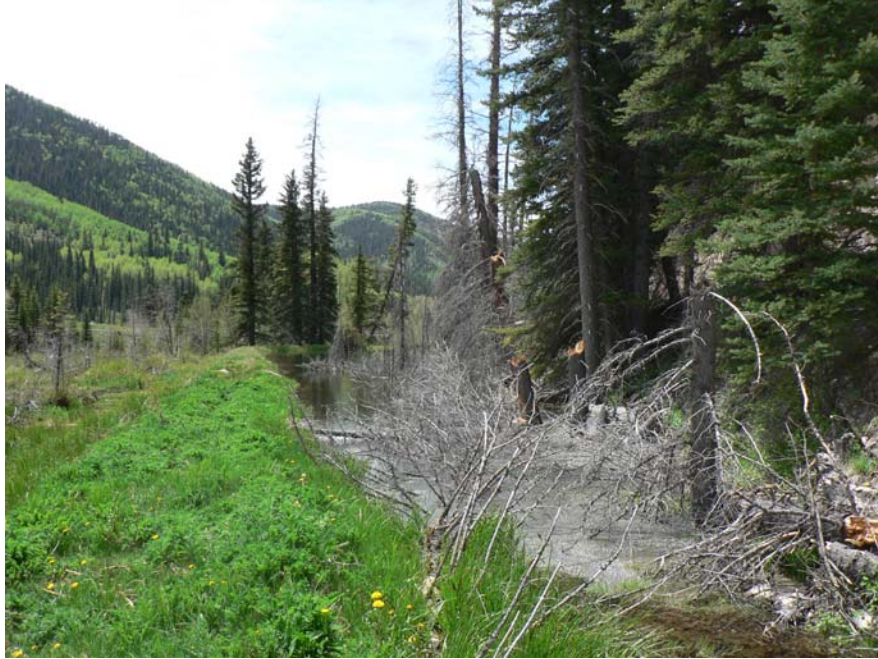
Photo 7.5. The Settling Pond for the Combined Flows from the Rico Boy and Santa Cruz Adits.

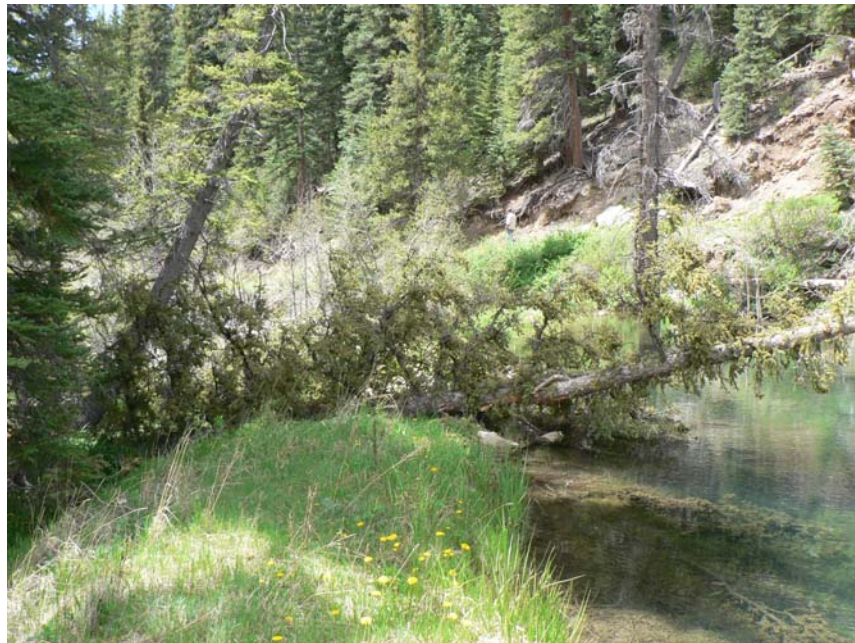
Photo 7.6. The Breach along the Rico Boy/Santa Cruz Settling Pond Created by a Fallen Tree.

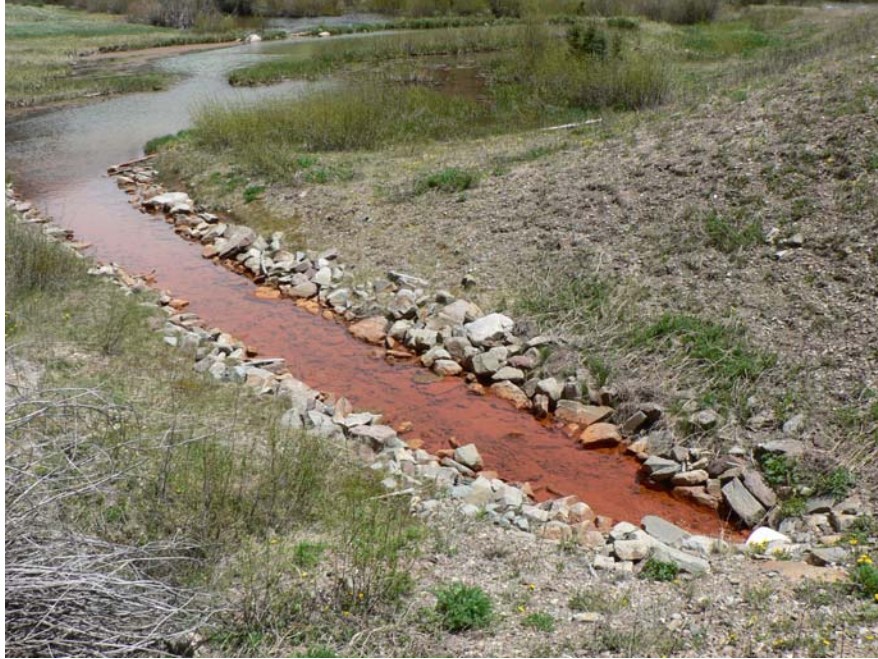
Photo 7.7. Ironoxide Deposits from the Silver Swan Point of Discharge into the Receiving Wetlands Area.

3. **For the Silver Swan Adit:** Review of the current conditions of this point source indicates the need for continued study and possible control or treatment of the water. There are two ‘flowing’ features associated with the Silver Swan Site, the flows from the adit provide a significant metals load to the receiving wetlands. There is also, flow associated with the captured nonpoint waste rock seep and stormwater collection system. These flows are routed to a settling pond and released at a distinct point to the Dolores River. The water quality associated
