Rocky Mountain
Field Institute

Upper Ski Creek Watershed Erosion Control and Restoration Project- Phase 2

Task 3 Final Report

**El Paso and Teller Counties, Colorado
Pike National Forest**

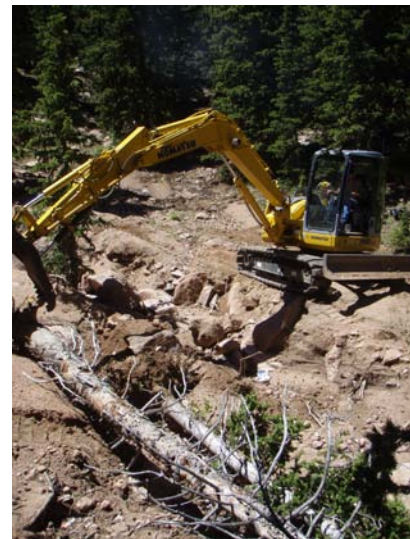
Figure 1. Installing bank stabilization structure

In addition to the structures, the heavy equipment was used to construct or reconstruct approximately 330' of bank. Sixteen large trees (12" - 18" DBH, and approximately 30 feet long) were identified for removal by the District forester and were imbedded into the toe of the channel bank to aid in stabilizing the bank walls. Large rocks were then placed behind the trees and back filled with channel sediment in preparation for revegetation efforts by the hand crews.

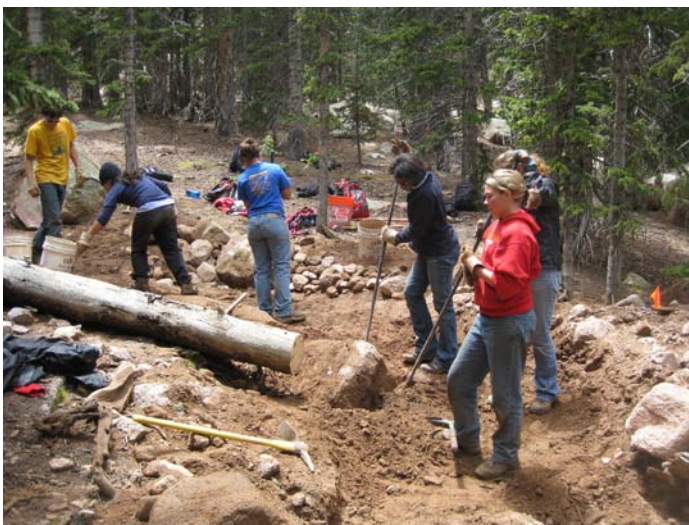
Figure 2. Pikes Peak Corps members completing bank stabilization work

keep the flow in the main reach and then completed stabilization work within the disconnected gully channels through the construction of check dams and placement of boulders and woody debris along the toe slope. This work required an additional 25 tons of native rock. In addition, 6,528 sq/ft of erosion control matting and almost 1 acre of seed and soil amendment was laid down to restore degraded areas adjacent to the main reach and these disconnected channels.

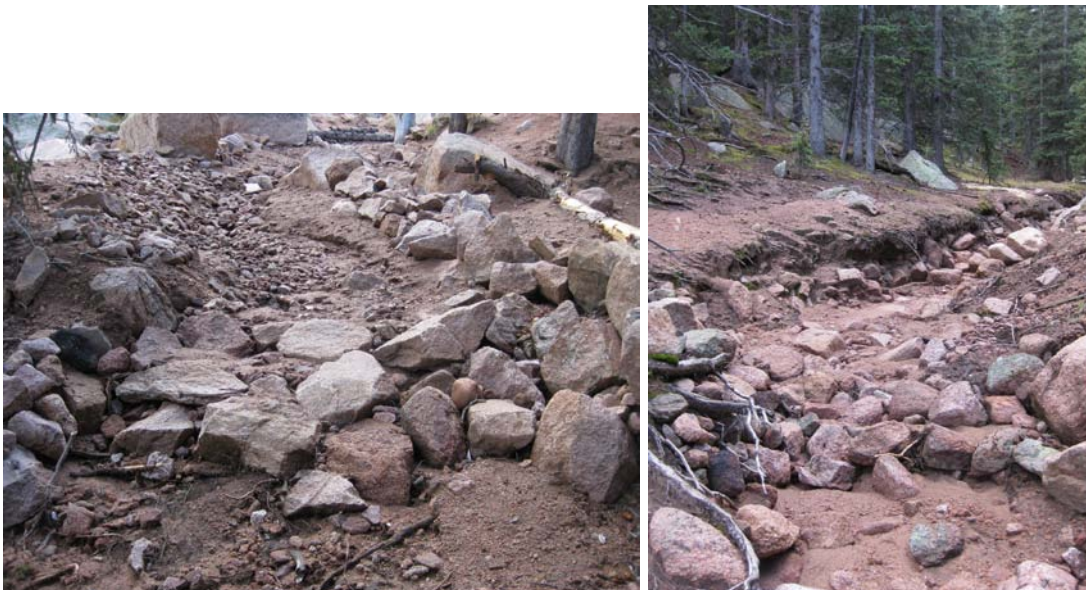
Figure 3 and 4. Completed Cross-vanes in Lower Sub-Reach of Ski Creek.

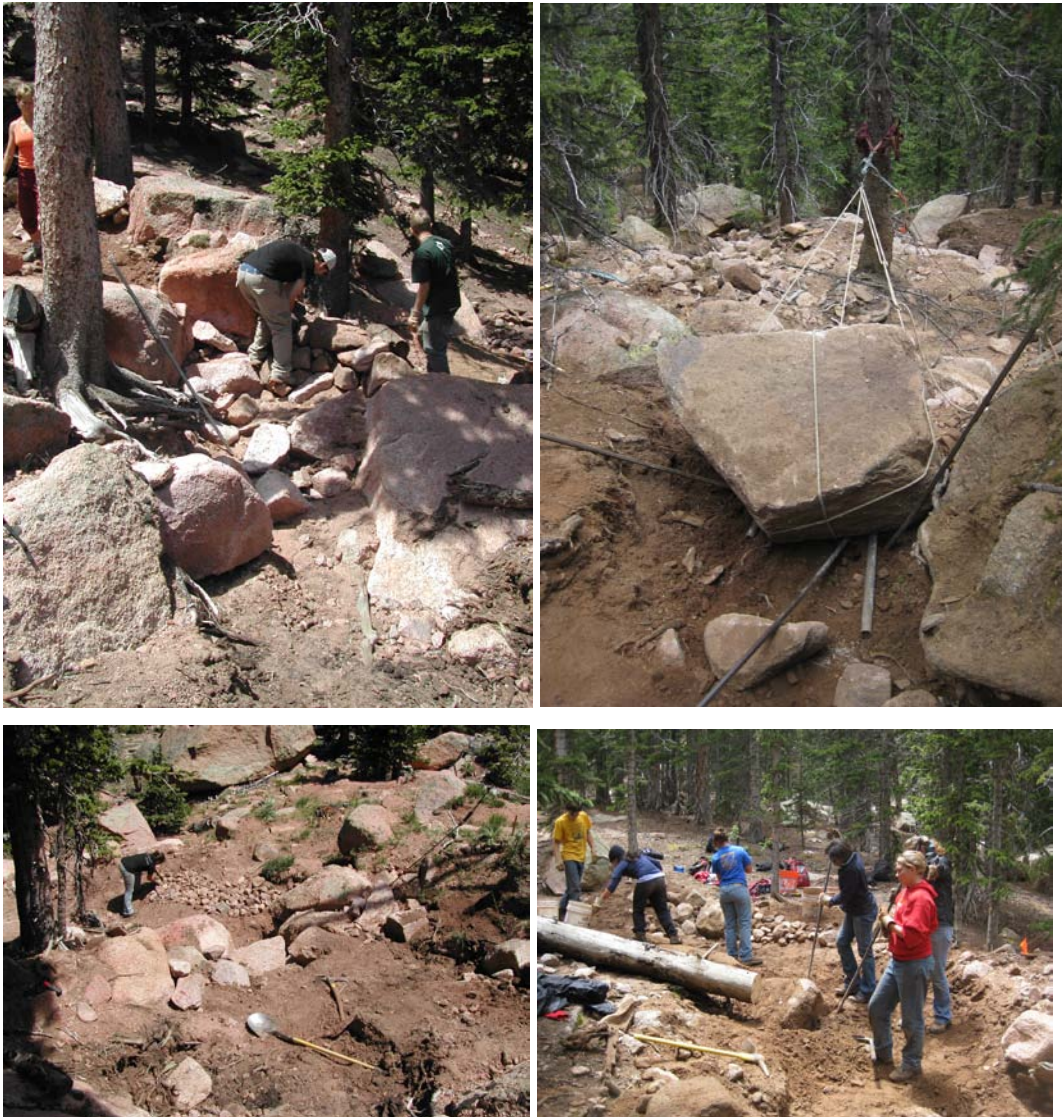
Figure 5-8. Pikes Peak Corps crew completing bank stabilization.

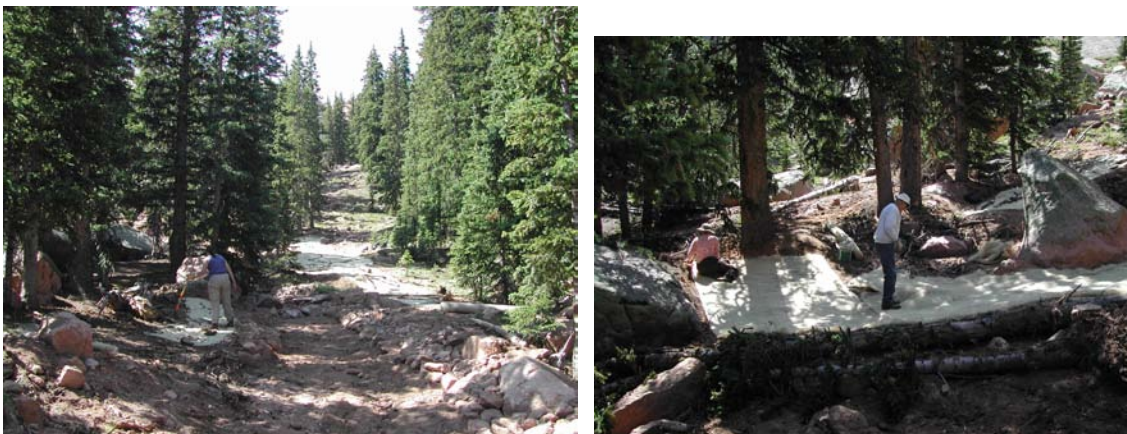
Figure 9 and 10. Sierra Club volunteers completing revegetation of channel banks.
